SITE INFORMATION						
	Report Type: Work Plan						
General Site Info	ormation:	I					
Site:		Lusk Deep U	nit A #22H				
Company:		COG Operati					
Section, Townsl	hip and Range			T 19S	R 32E		
Lease Number:		API No. 30-02	25-40705				
County:		Lea County					
GPS:			32.6668205º N		10	3.7912445º W	
Surface Owner: Mineral Owner:		Federal					
Directions: From intersection of 126A & Dry Lake Rd travel EAST on Dry Lake for 0.25 mi to location south side of the road.				e for 0.25 mi to location on			
Release Data:							
Date Released:		11/29/2016					
Type Release:	- in - tie	Produced Wa	iter				
Source of Contar	nination:	Water Line					
Fluid Released:12 bblsFluids Recovered:6 bbls							
Official Commu		0 0015					
					I		
Name:	Robert McNeil				Ike Tavarez		
Company:	COG Operating, LL	С			Tetra Tech		
Address:	One Concho Cente	r 4000 N. Big Spring					
	600 W. Illinois Ave.				Ste 401		
City:	Midland Texas, 797	01			Midland, Texas

Re: Work Plan for the COG Operating LLC., Lusk Deep Unit A #19, Unit N, Section 17, Township 19 South, Range 32 East, Lea County, New Mexico.

Tetra Tech, Inc. (Tetra Tech) was contacted by COG Operating LLC., (COG) to assess a release that occurred

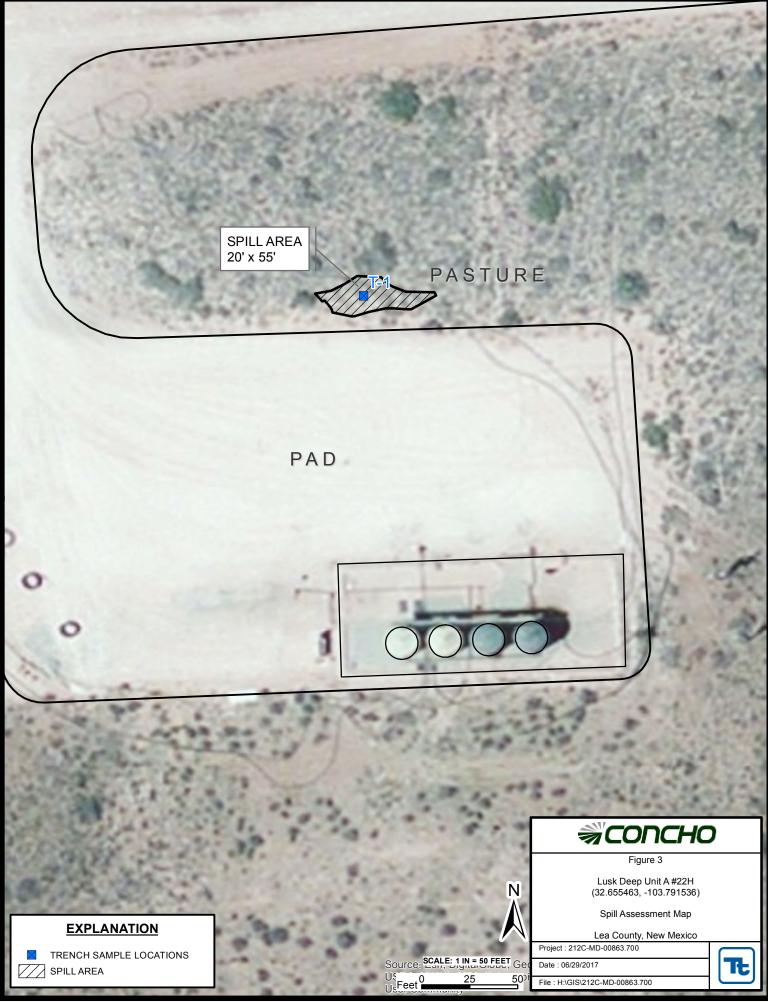
On February 22, 2017, COG personnel were onsite to evaluate and sample the release area. Using a backhoe, one (1) Trench (T-1) was installed in the release area. Selected samples were analyzed for TPH analysis by EPA method 8015 modified, BTEX by EPA Method 8021B and chloride by EPA method 300.0. Copies of laboratory analysis and chain-of-custody documentation are included in Appendix C. The results of the sampling are summarized in Table 1. The trench location is shown on Figure 3.

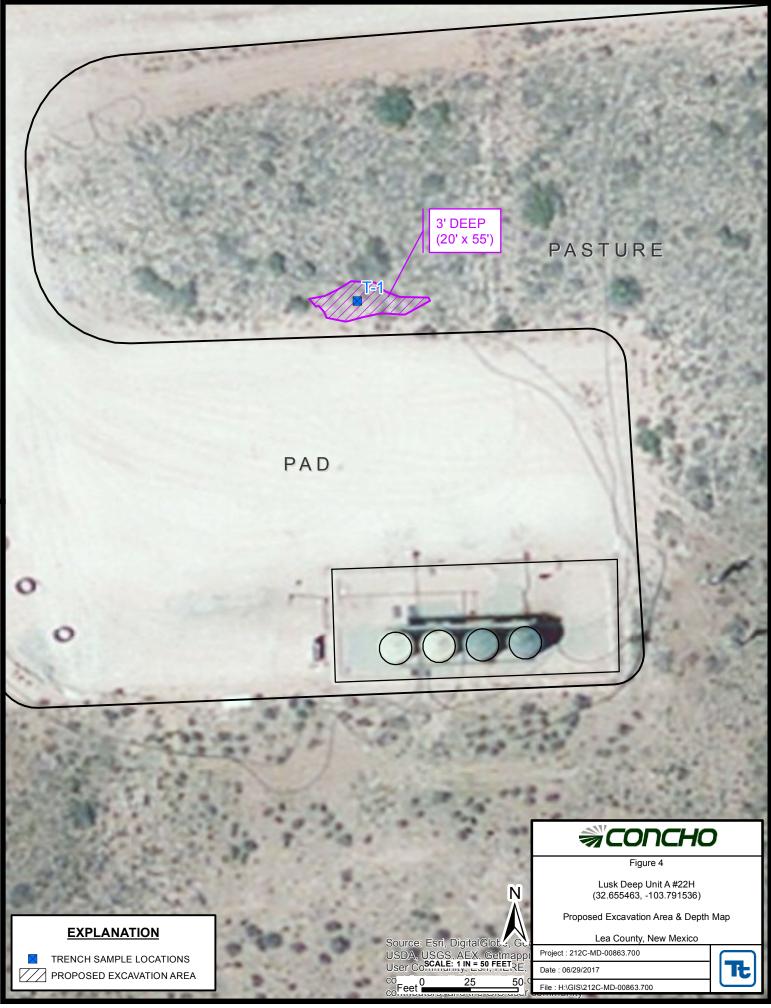
Based on the laboratory results, COG proposes to remove the impacted material as highlighted (green) in Table 1 and shown on Figure 4. The area of Trench (T-1) will be excavated to 3.0' below surface to remove the elevated chloride in the subsurface soils. Once completed, the area will be backfilled with clean material to surface grade. All of the excavated material will be transported offsite for proper disposal.
