D-1-2 Line Leak  
Lea County, New Mexico  
1RP 4719

## Summary

Tasman Geosciences, Inc. (Tasman) has prepared this Project Summary on behalf of DCP Midstream, LP (DCP) to document the results of field activities that were conducted at the D-1-2 Line Leak. The site is located approximately 2.3 miles north of Hobbs, New Mexico at UL/O sec. 11 T18S R38E. NMOSE well records indicate that groundwater will likely be encountered at a depth of approximately 83 +/- feet.

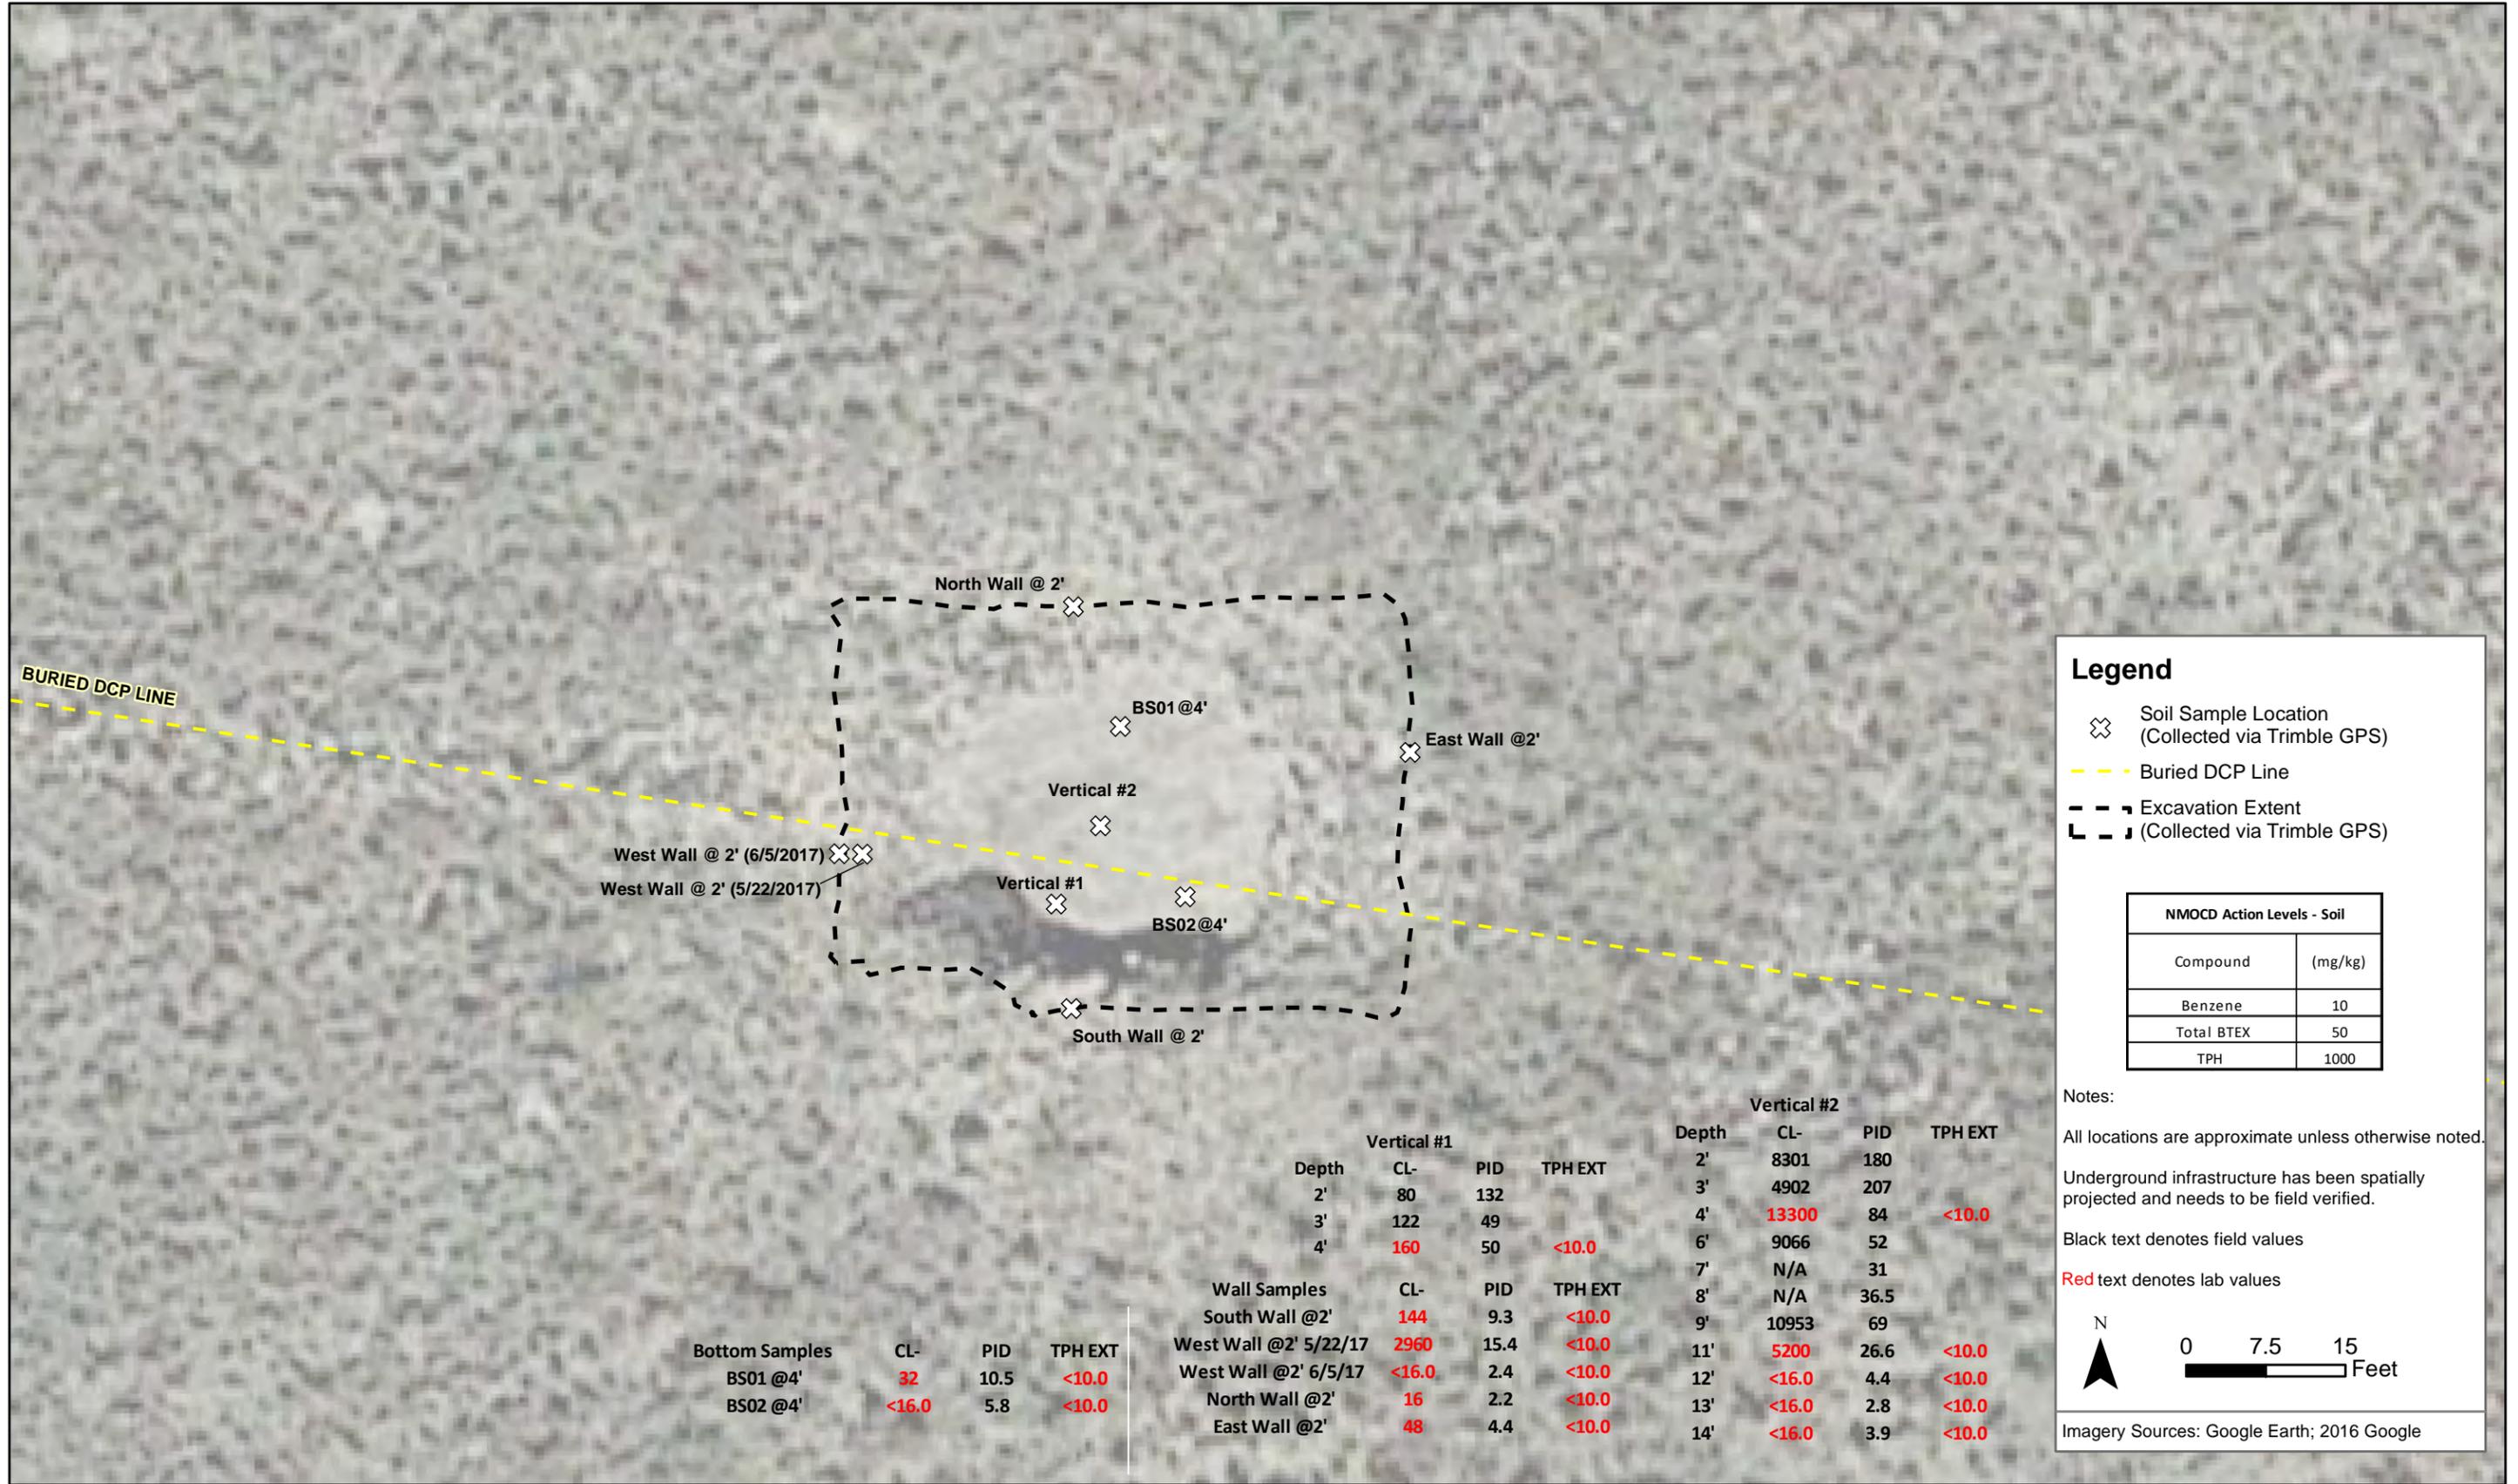
Figure  
1

Vertical #1			Depth	Vertical #2		TPH EXT
	CL-	PID	TPH EXT		CL-	PID	
				2'	8301	180	
				3'	4902	207	
				4'	13300	84	<10.0
				6'	9066	52	
				7'	N/A	31	
Wall Samples	CL-	PID	TPH EXT	8'	N/A	36.5	
South Wall @2'	144	9.3	<10.0	9'	10953	69	
West Wall @2' 5/22/17	2960	15.4	<10.0	11'	5200	26.6	<10.0
West Wall @2' 6/5/17	<16.0	2.4	<10.0	12'	<16.0	4.4	<10.0
North Wall @2'	16	2.2	<10.0	13'	<16.0	2.8	<10.0
East Wall @2'	48	4.4	<10.0	14'	<16.0	3.9	<10.0

Bottom Samples	CL-	PID	TPH EXT
BS01 @4'	32	10.5	<10.0
BS02 @4'	<16.0	5.8	<10.0

Excavation Overview  
Figure

Based on the assessment and sampling data, we propose a 20-mil reinforced poly liner that will be installed and properly seated at four feet in area 1 and area 2 (figures 1 and 2). The excavations will then be backfilled with clean soil.

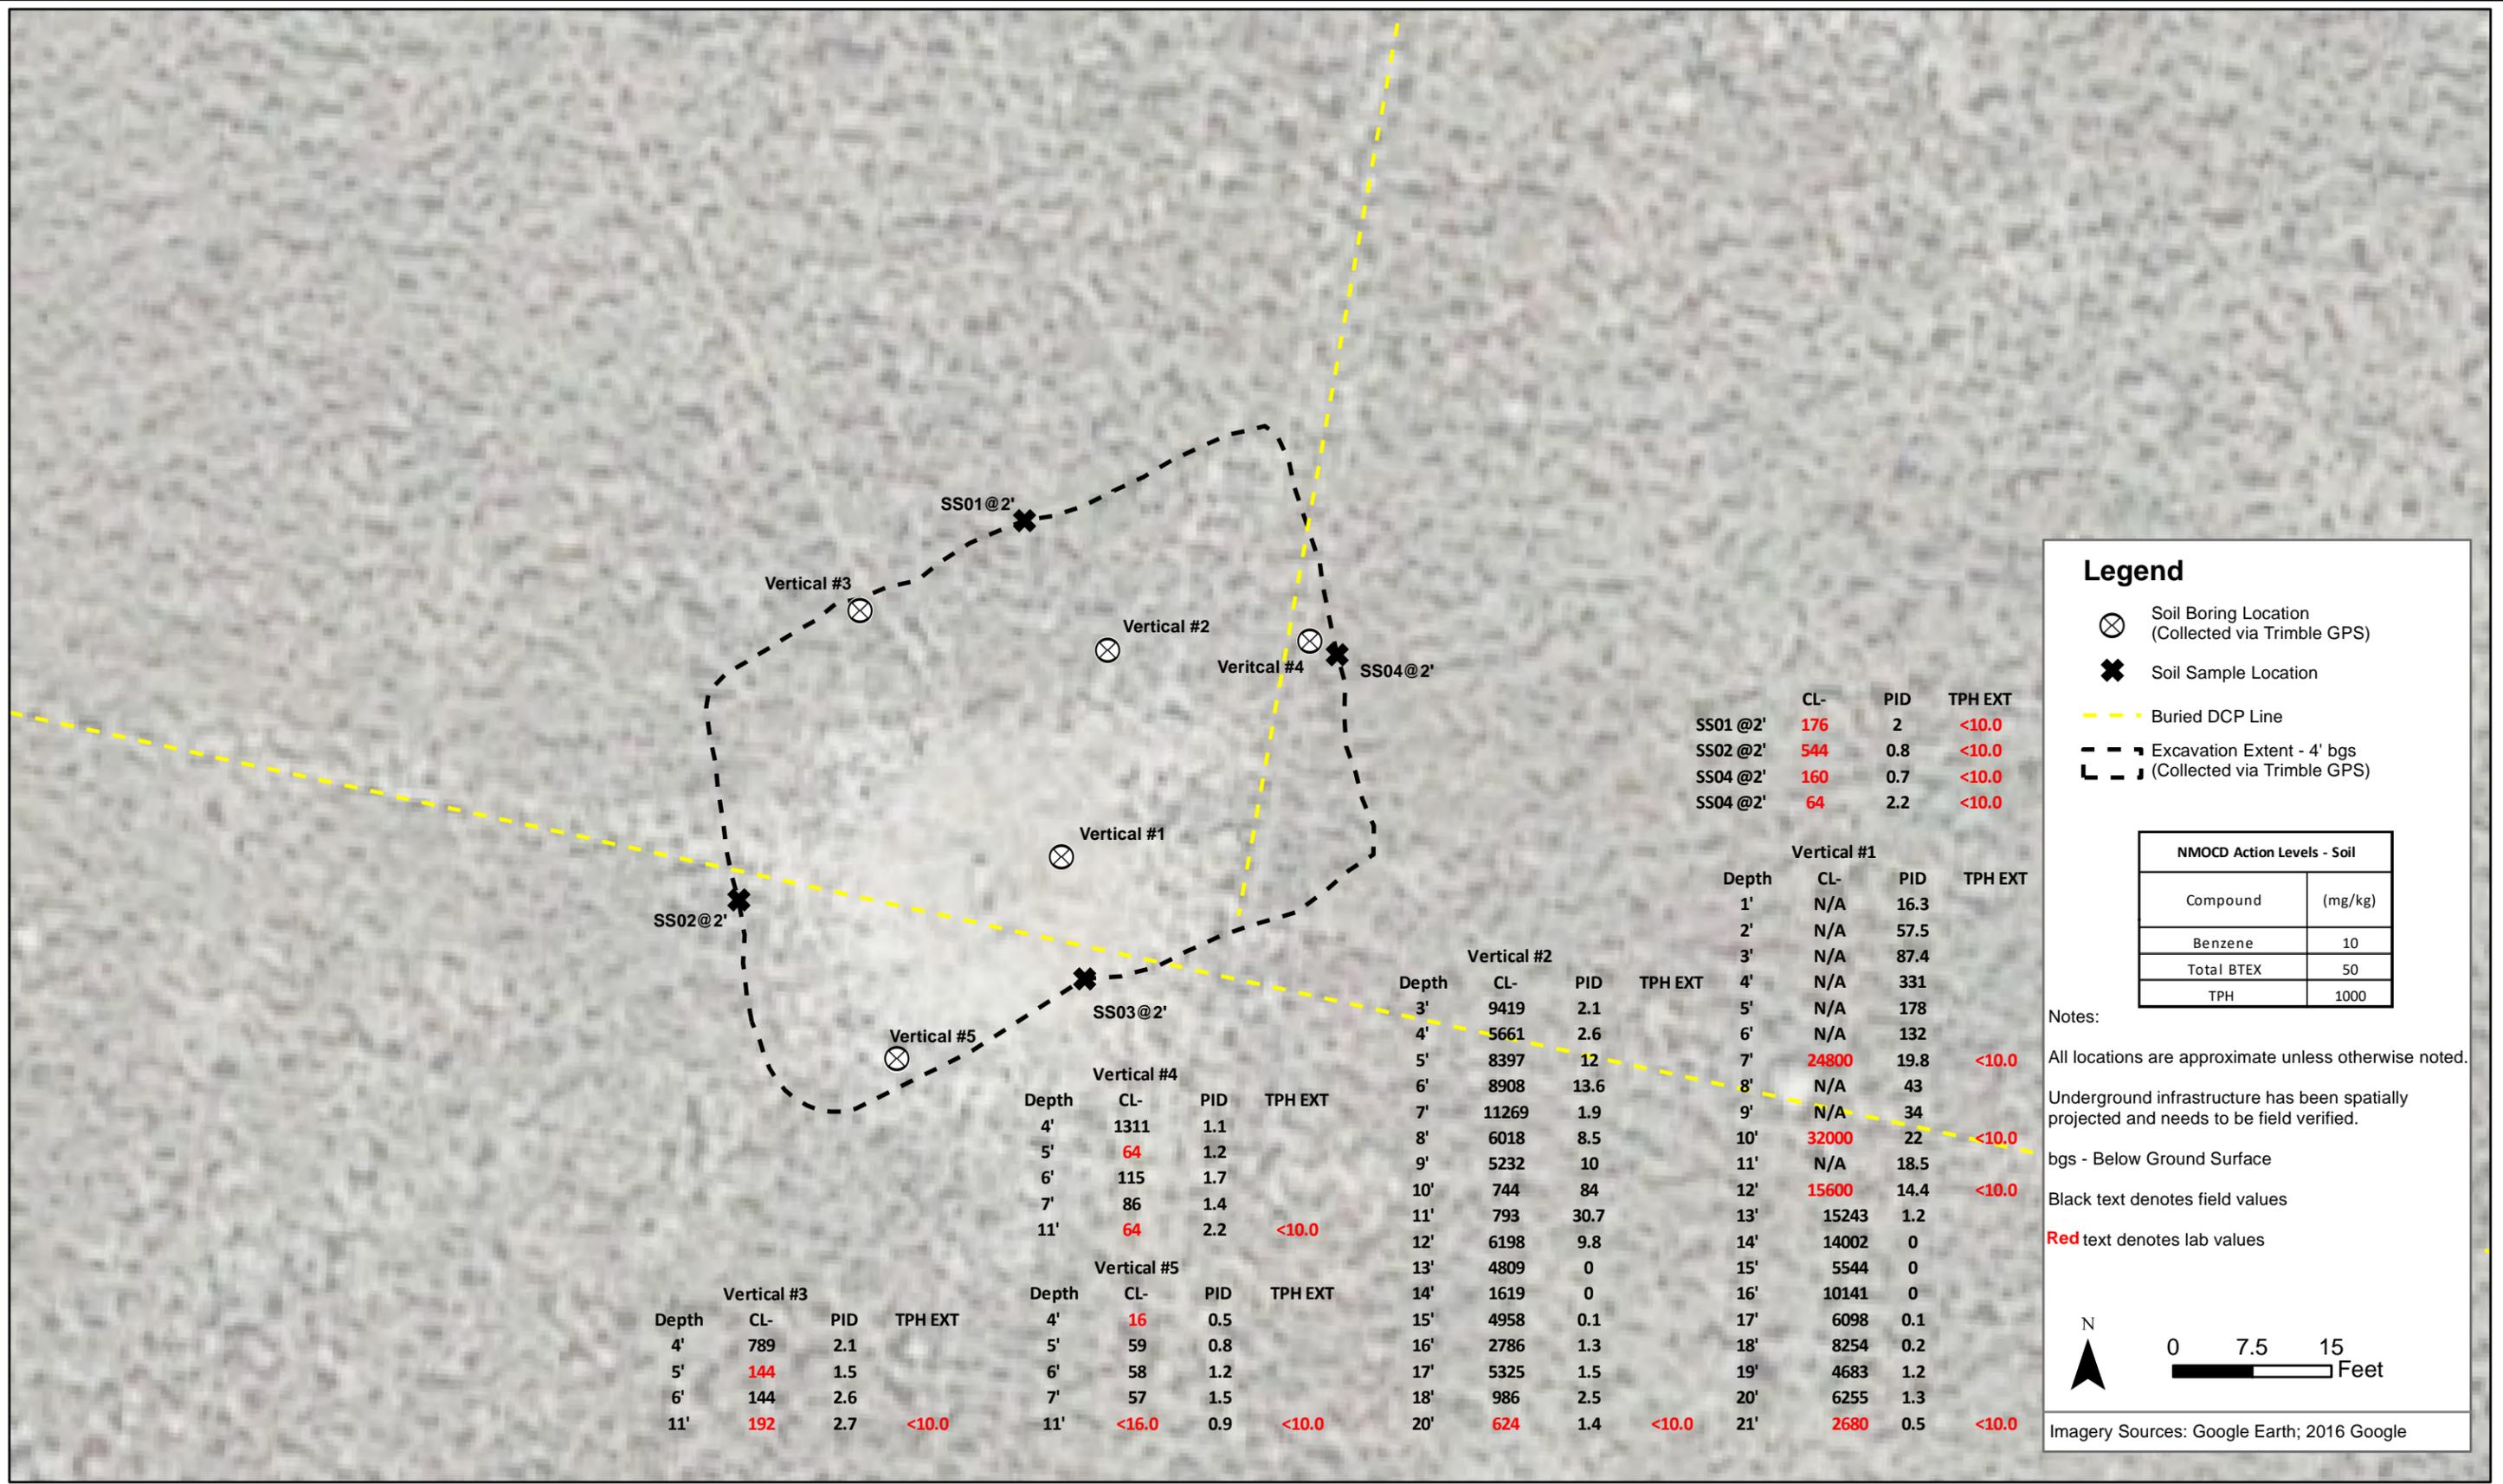
Figure  
 2

Soil Analytical Results  
 Map

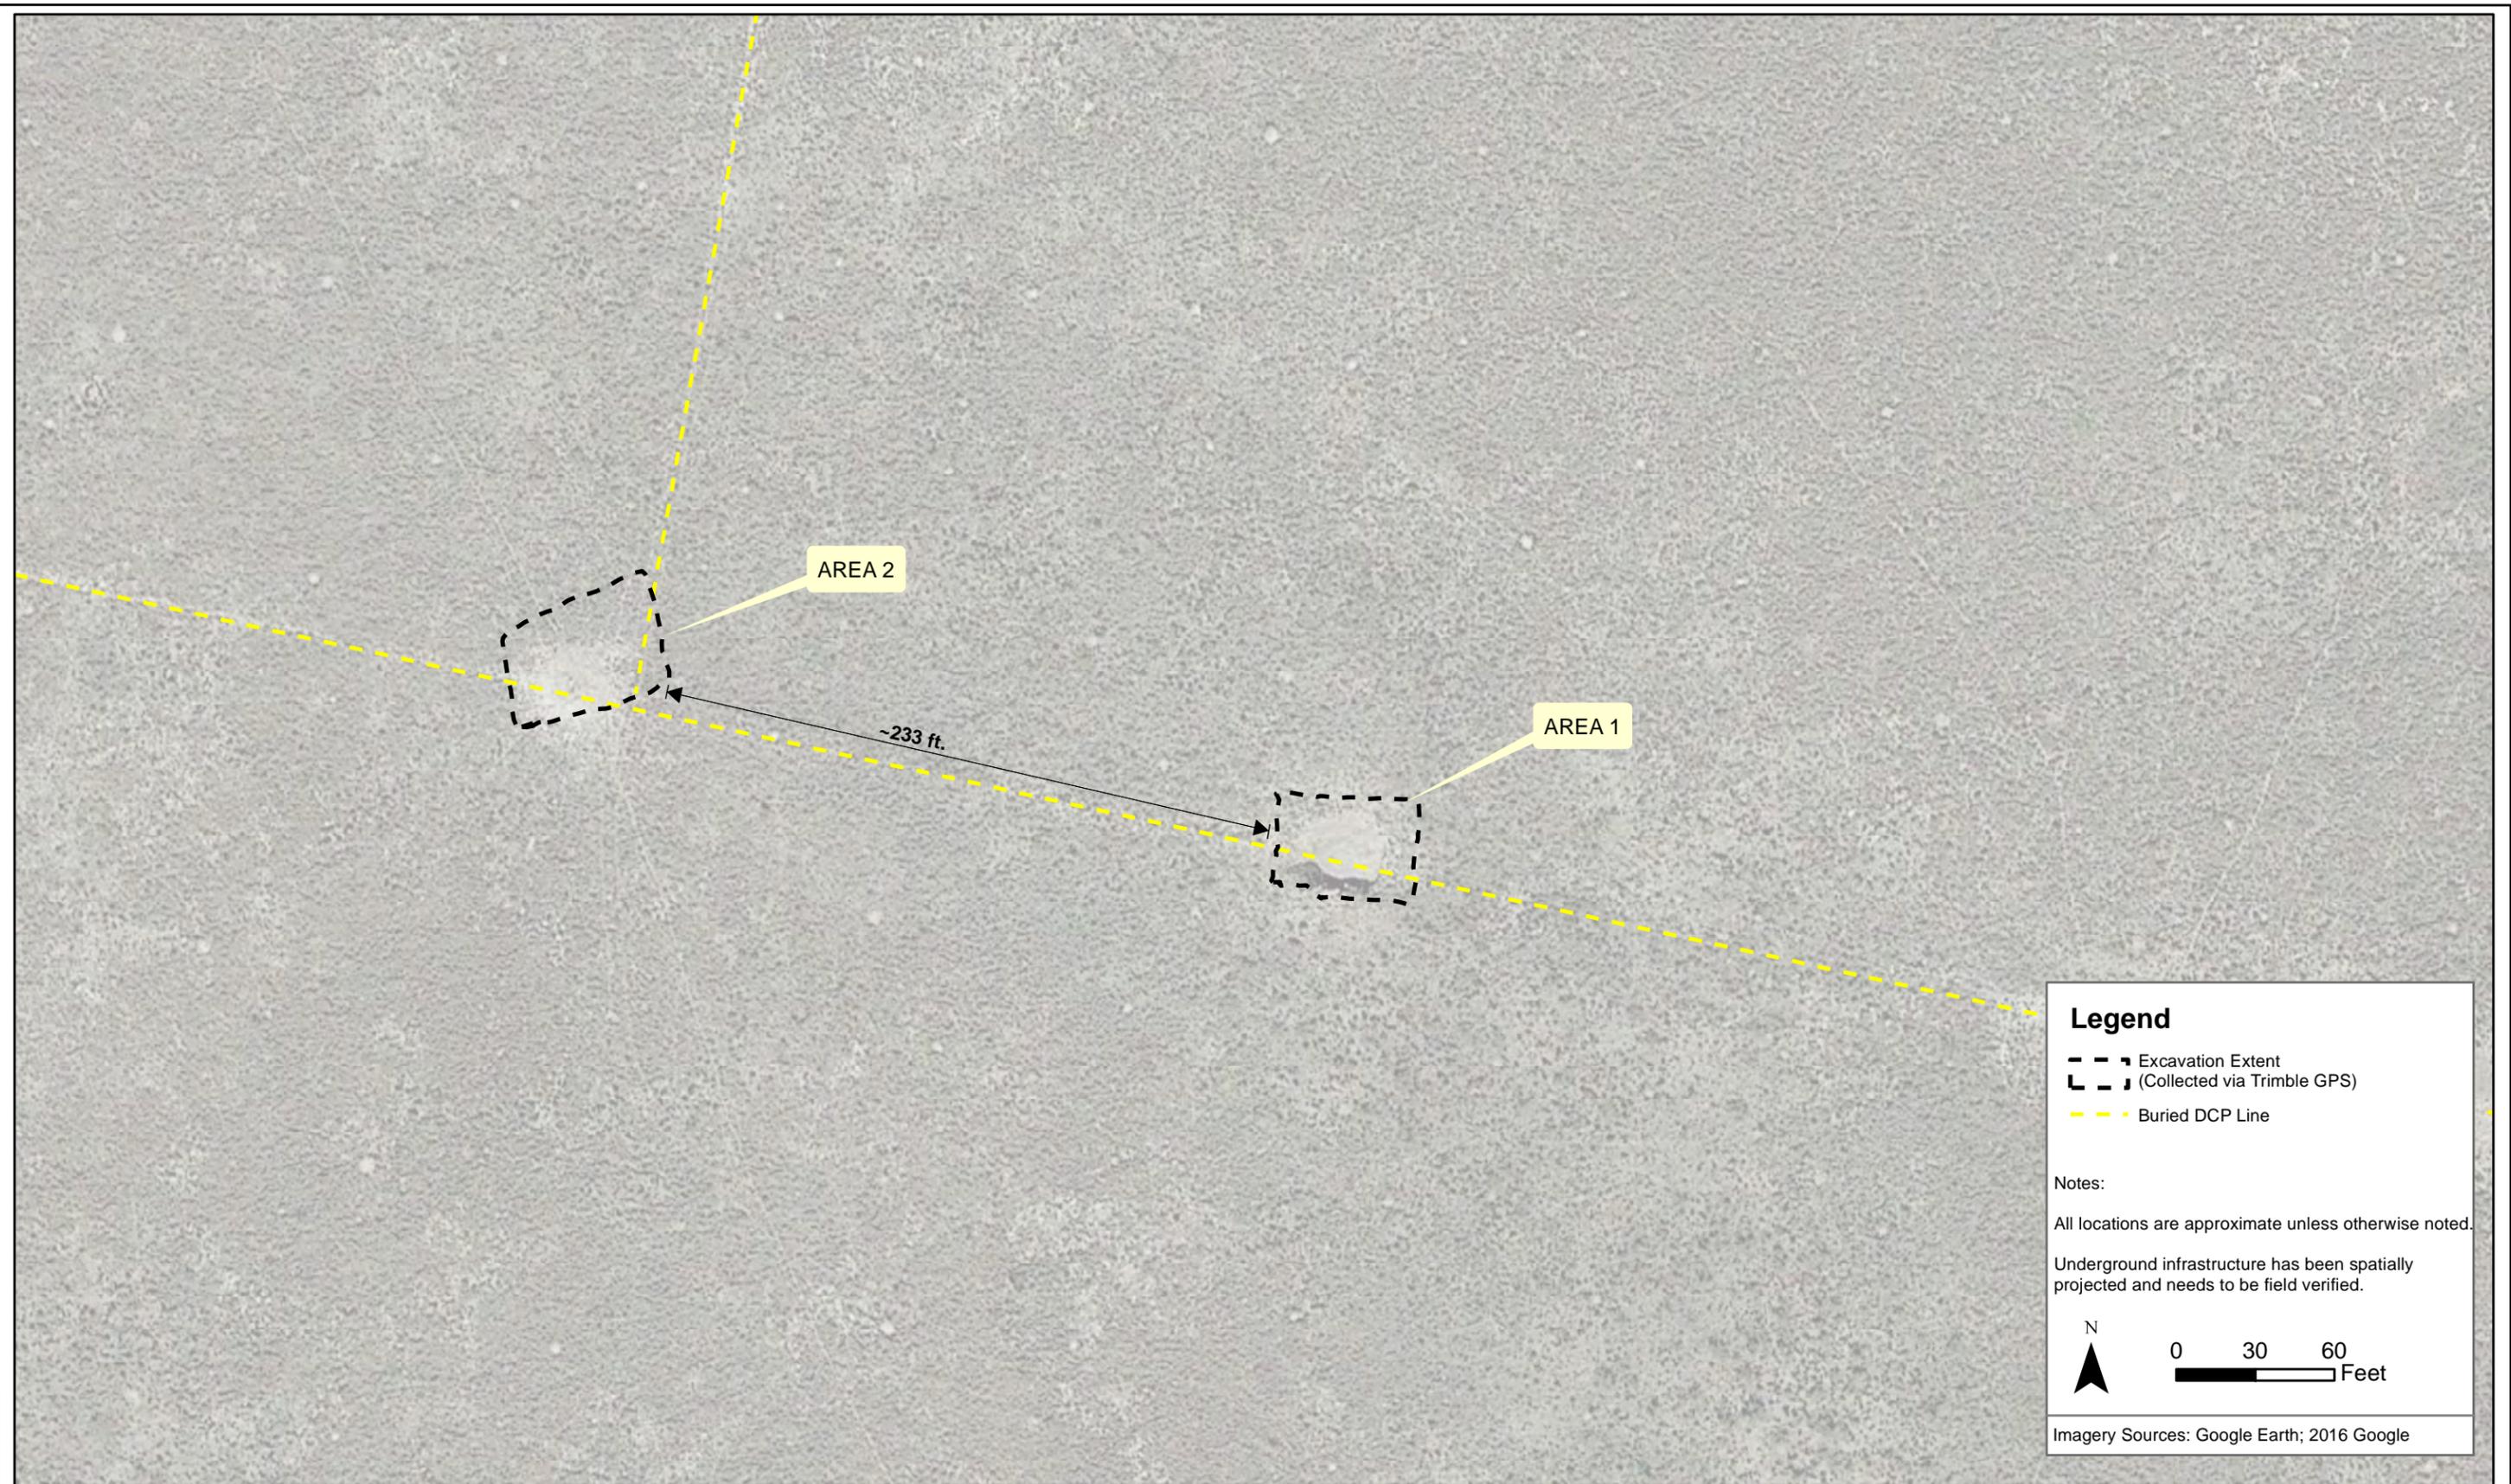
Figure  
3

Excavation  
Overview Map

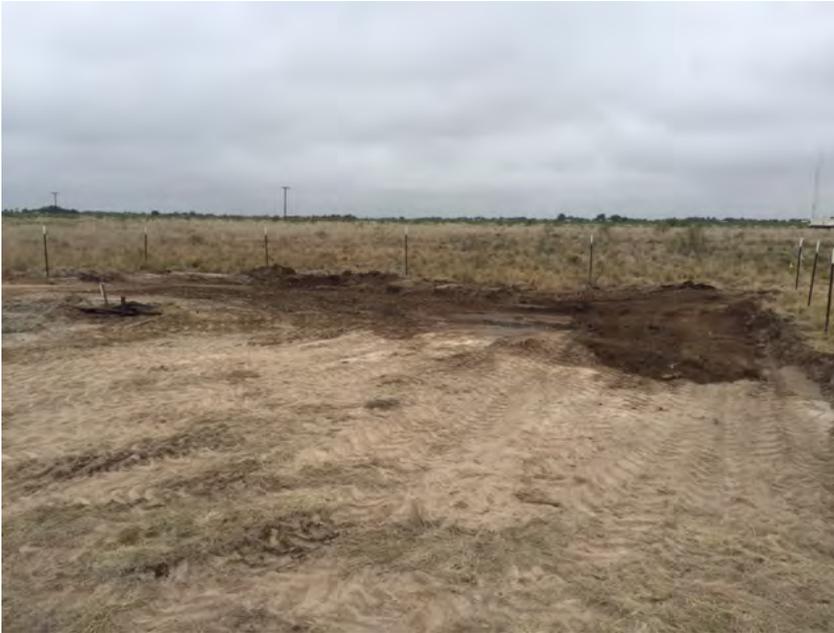
5/22/17

Area 2 initial leak

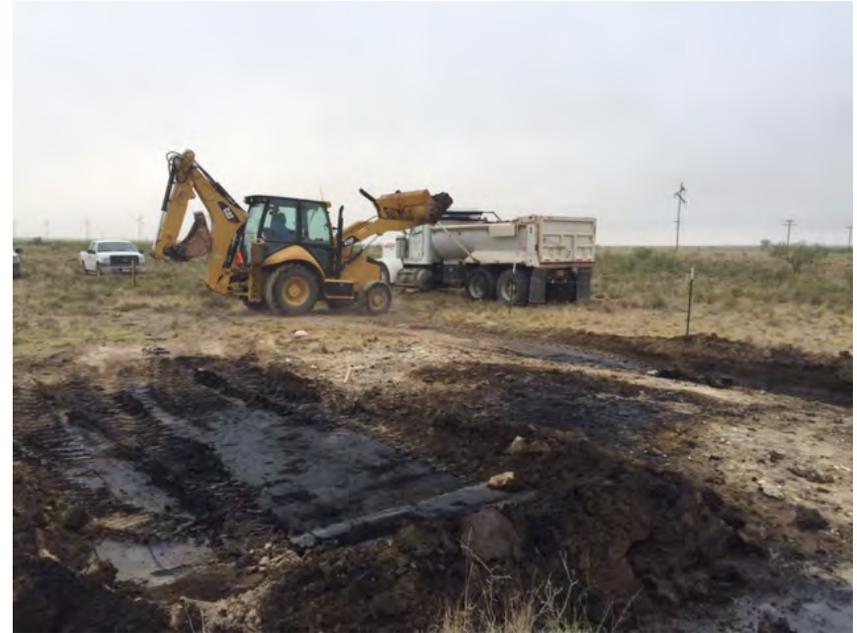
5/22/17

Area 1 export soil

Approximately 700 cubic yards of contaminated soil was exported and disposed of at a NMOCD approved facility.

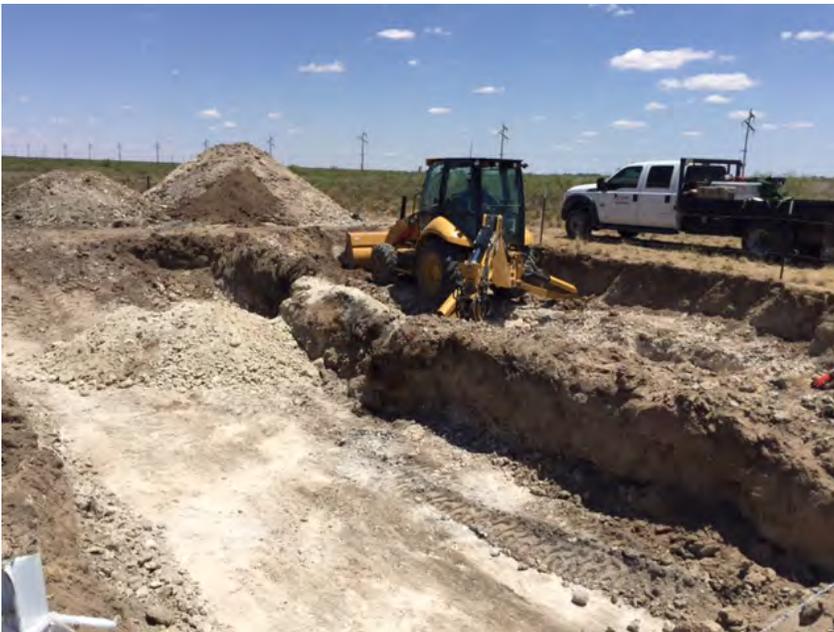
6/05/17

Area 1 excavating vertical 1

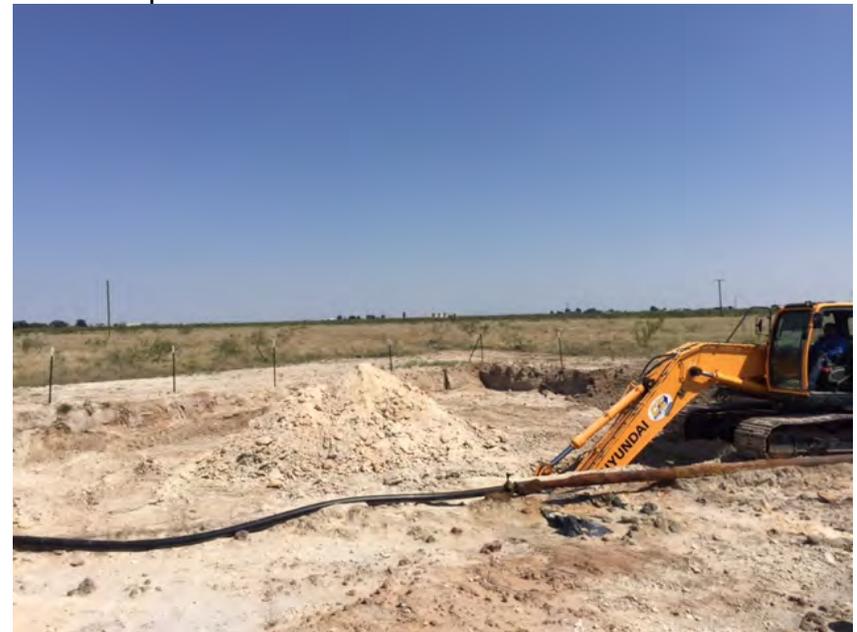
9/11/17

Area 2 excavating vertical 1

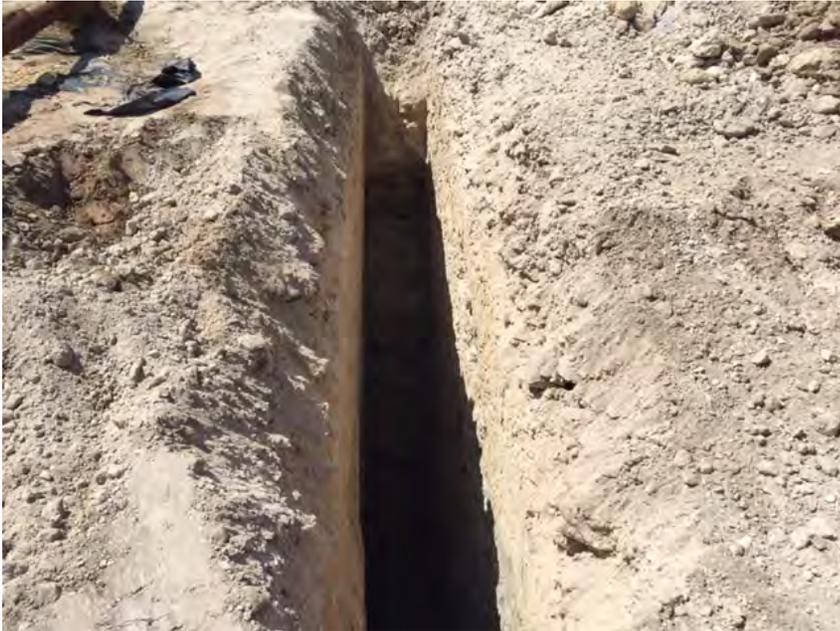
9/11/17

Area 2 vertical 1

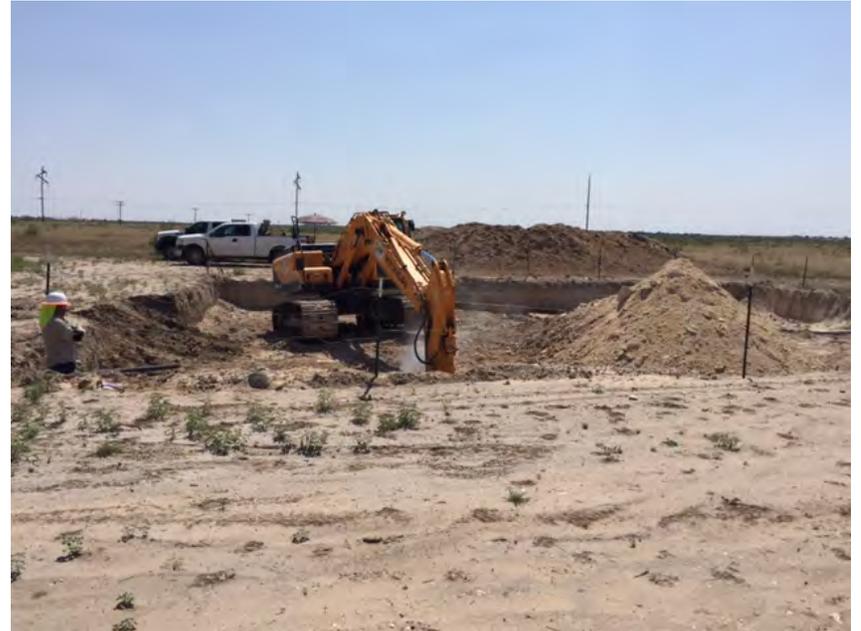
9/11/17

Area 2 excavating vertical 2
