**ENERGYQUEST II, LLC**

**PROPOSAL FOR REMEDIATION – RP #4359**

**STATE A0 AND STATE C LEASES – GRASS FIRE FROM LIGHTNING**

## PROPOSAL FOR REVEGETATION OF STATE AO/STATE C LEASE LOCATIONS

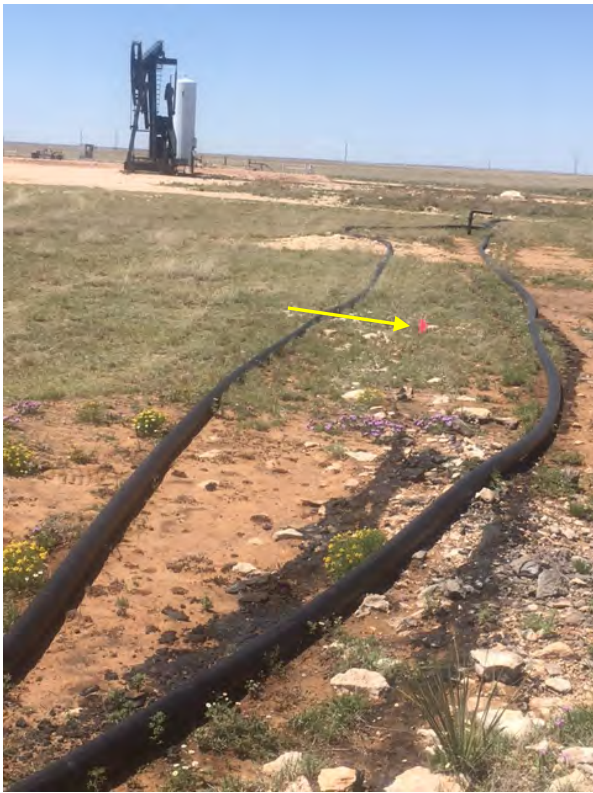
*Sample Location # 1 – Single Flag*  
Lat 33.3133556°, Long -103.6205222°

Three (3) Soil Samples taken. All were within the fire damaged areas where lines were replaced. In photos of Sample Locations 1 and 3, evidence of melted poly line still can be seen near the sample site.

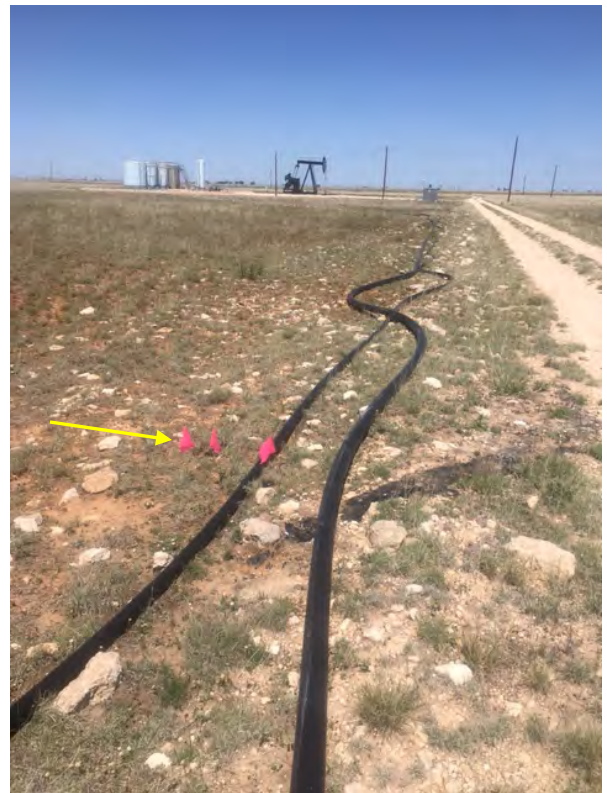
*Sample Location # 3 – Three (3) Flags*  
Lat 33.3116306°, Long -103.6210417°

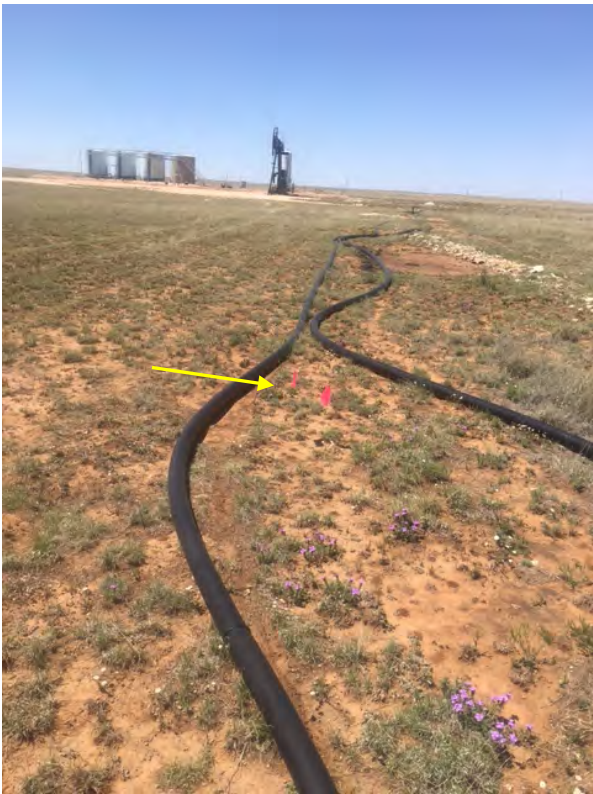
*Sample Location # 2 – Two (2) Flags*  
Lat 33.3133278°, Long -103.6202917°
