RE: C&J Energy Services
State AB SWD #1
Hobbs, Lea County, New Mexico
Case Number: 1RP-4836

Please accept this letter as a formal Work Plan for the above referenced project site, as required by the OCD in their directive attached to the Release Notification and Corrective Action Form, dated October 4, 2017.

Figure 1
Site Location Map
CJES - State AB SWD #1
Hobbs, New Mexico

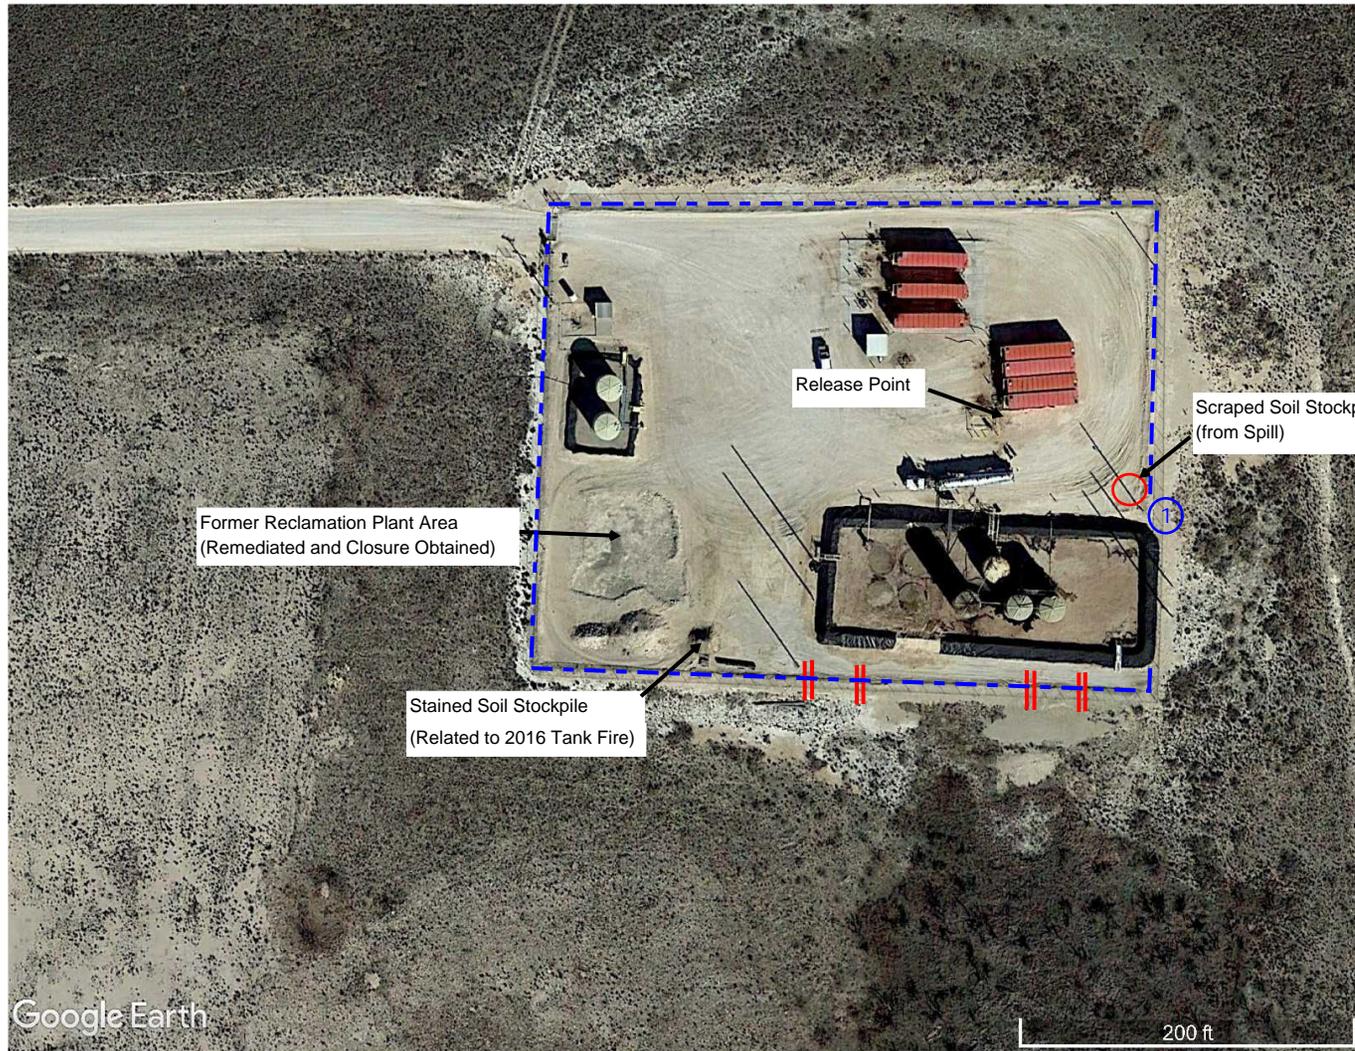
Figure 2
Site Layout
CJES -State AB SWD #1
Hobbs, New Mexico

The Site consists of a storage yard, equipped with numerous tanks and a truck unloading area. On September 22, 2017, an offload valve attached to a hose was left partially open during a night offload. The hose was stored vertically so that the release was not seen until it filled the hose and spilled. The fluids were discovered the next morning on September 23, 2017, when the valve was properly closed. The released fluids were immediately removed through the use of a vacuum truck from the yard. The immediate release area was scraped, with affected soils stockpiled at the site. The site reportedly experienced thunderstorms on the 23rd-25th of September. The storm water outfall for the site is located on the east side of the facility. The heavy rains produced storm water which migrated off the well pad via the storm water outfall. The spill area and storm water outfall will be treated as an area of concern for the purpose of the work plan.

On October 31st, representatives of CJES and EnTech met with the New Mexico Oil Conservation Division (OCD) and State Lands. Based on these discussions, additional areas of concern will also be addressed in this work plan. Offsite areas south of the tank battery will be investigated to delineate possible impacts from breaks in the southern portion of the earthen berm that surrounds the Site. A stockpile along the southern property boundary, that contains stained soils related to a 2016 tank fire, will be sampled along with a potentially impacted area south of the containment berm of the tank battery. The liner in the tank battery will be inspected to verify impacts from fires and repairs resulting from the fire incidents did not affect its integrity (**Figure 2 and Figure 5**).

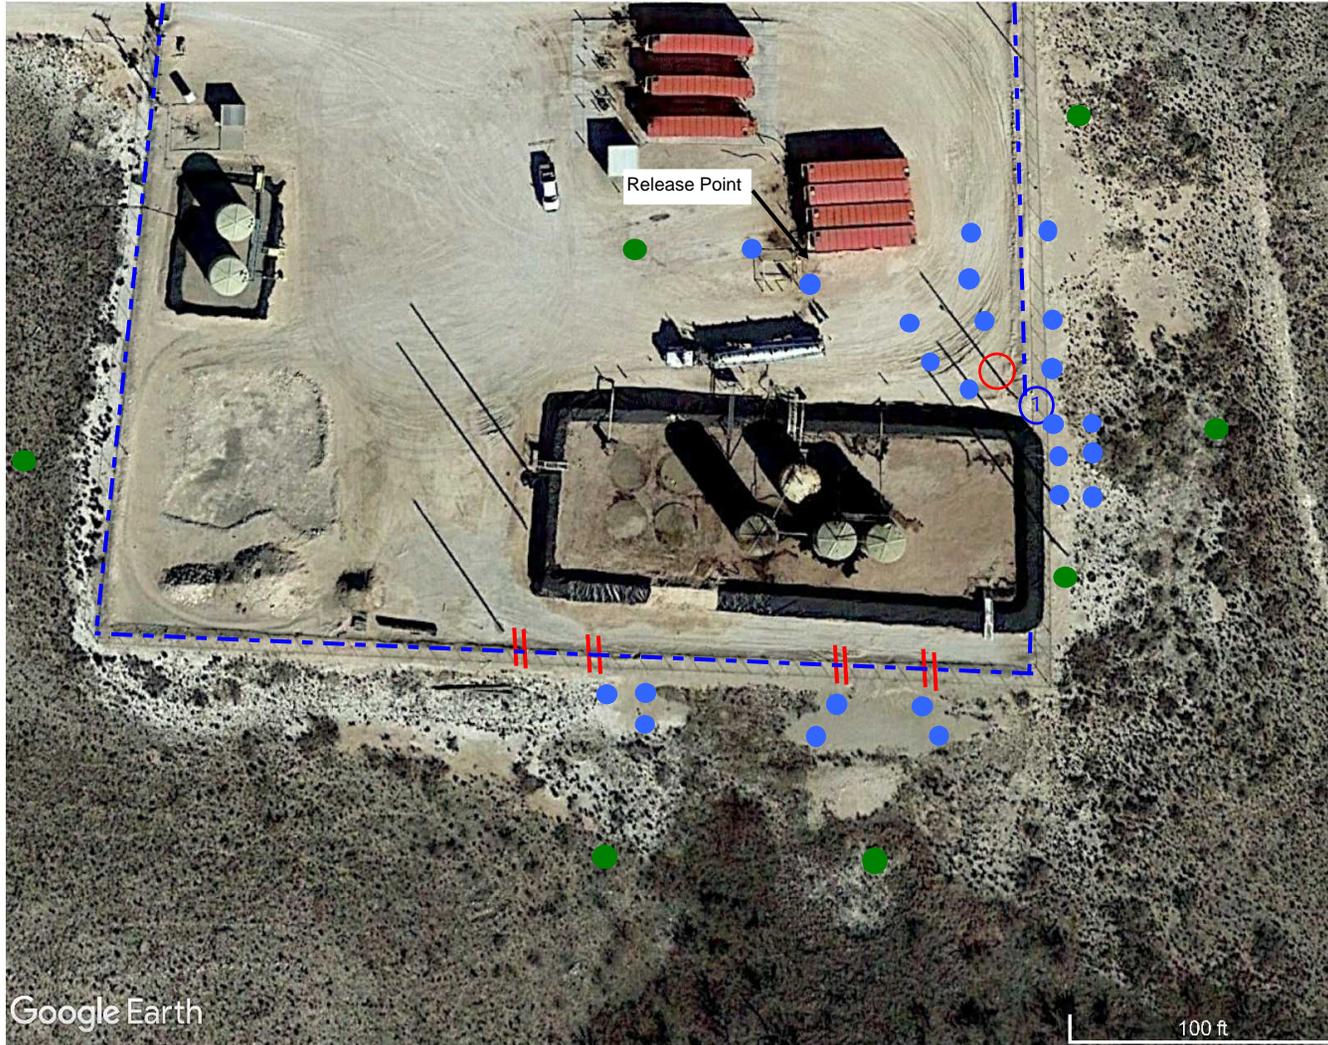
Figure 3
Site Layout with Sample Locations
CJES - State AB SWD #1
Hobbs, New Mexico

During the assessment process, EnTech personnel will collect soil samples in and around the area of concern. A backhoe will scrape each sample location and a sidewall grab sample will be taken from the sample location at the shallow surface (0 to 6-inches below ground surface (bgs)) and just above the hard pan (18 to 24-inches bgs) using a hand trowel. Based on the geology observed during a previous tank closure occurring on the Site and documented in an October 7, 2015 report, the area underlying the Site consists of a dense, well cemented caliche rock (hardpan), which will limit the initial investigation to a depth of approximately 1.5-feet below ground surface (bgs). A third sample will be chipped from the hard pan at the base of the scraped sample location using a chisel and hammer. The soils removed by the backhoe to provide access for sampling will be placed back in the sample locations once the samples have been obtained.

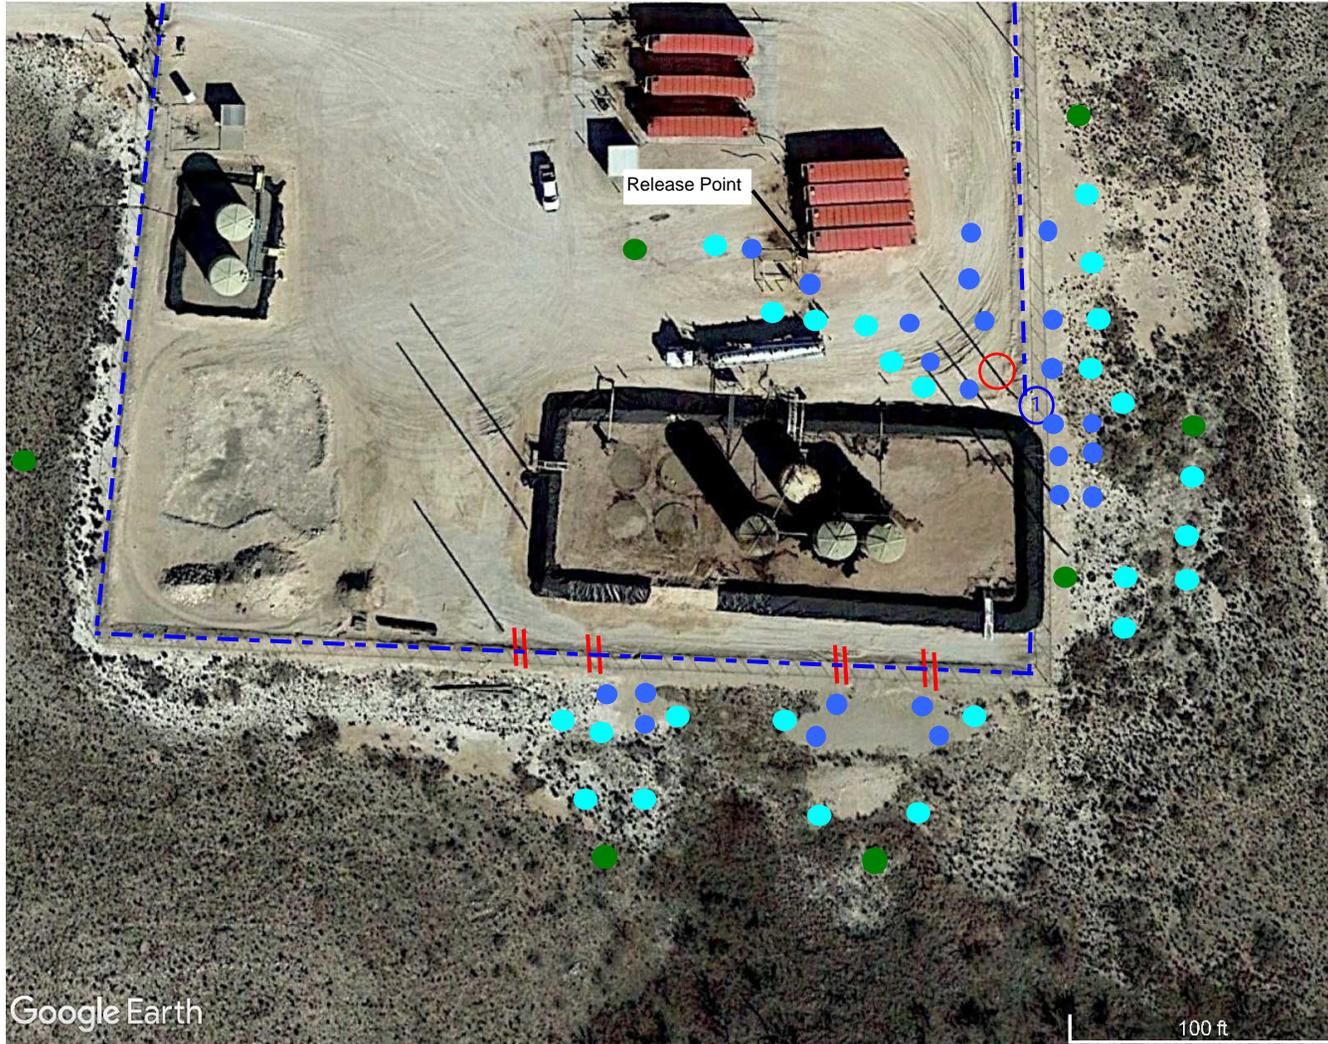
Figure 4
Additional Sample Locations
for Delineation
CJES -State AB SWD #1
Hobbs, New Mexico

An Organic Vapor Meter (OVM) will be utilized for field screening to assist in verifying the vertical and lateral extent of residual soil impact. Soil screening will be completed by placing soil samples in zip-lock bags, allowing the sample to equilibrate for 10-minutes, and then collecting a headspace reading using the OVM. Readings below 100 ppm can be used for field screening residual soil to determine if they are below cleanup level for BTEX and TPH. A maximum of 24 discreet soil samples will be collected from and just outside the areas of concern, as well as seven (7) additional discreet soil samples from the four (4) cardinal compass directions in unimpacted areas (**Figure 3**). An additional 25 soil samples will be taken in the same mobilization from areas beyond the above-mentioned sample locations, and held under a separate chain-of-custody in the event that further delineation sampling is required (**Figure 4**).

In the event that laboratory analyses and/or field screening does not indicate residual soil concentrations below the OCD remediation standards in excavated and/or overexcavated areas, soil samples will be taken from soil borings placed into and just below the hard pan to determine if contaminants have migrated through the hard pan. If residual soil concentrations are still not below the OCD remediation standards, an additional work plan will be submitted for approval to install at least one (1) monitor well in the area of likely maximum contamination to establish that shallow groundwater has not been impacted by the release.

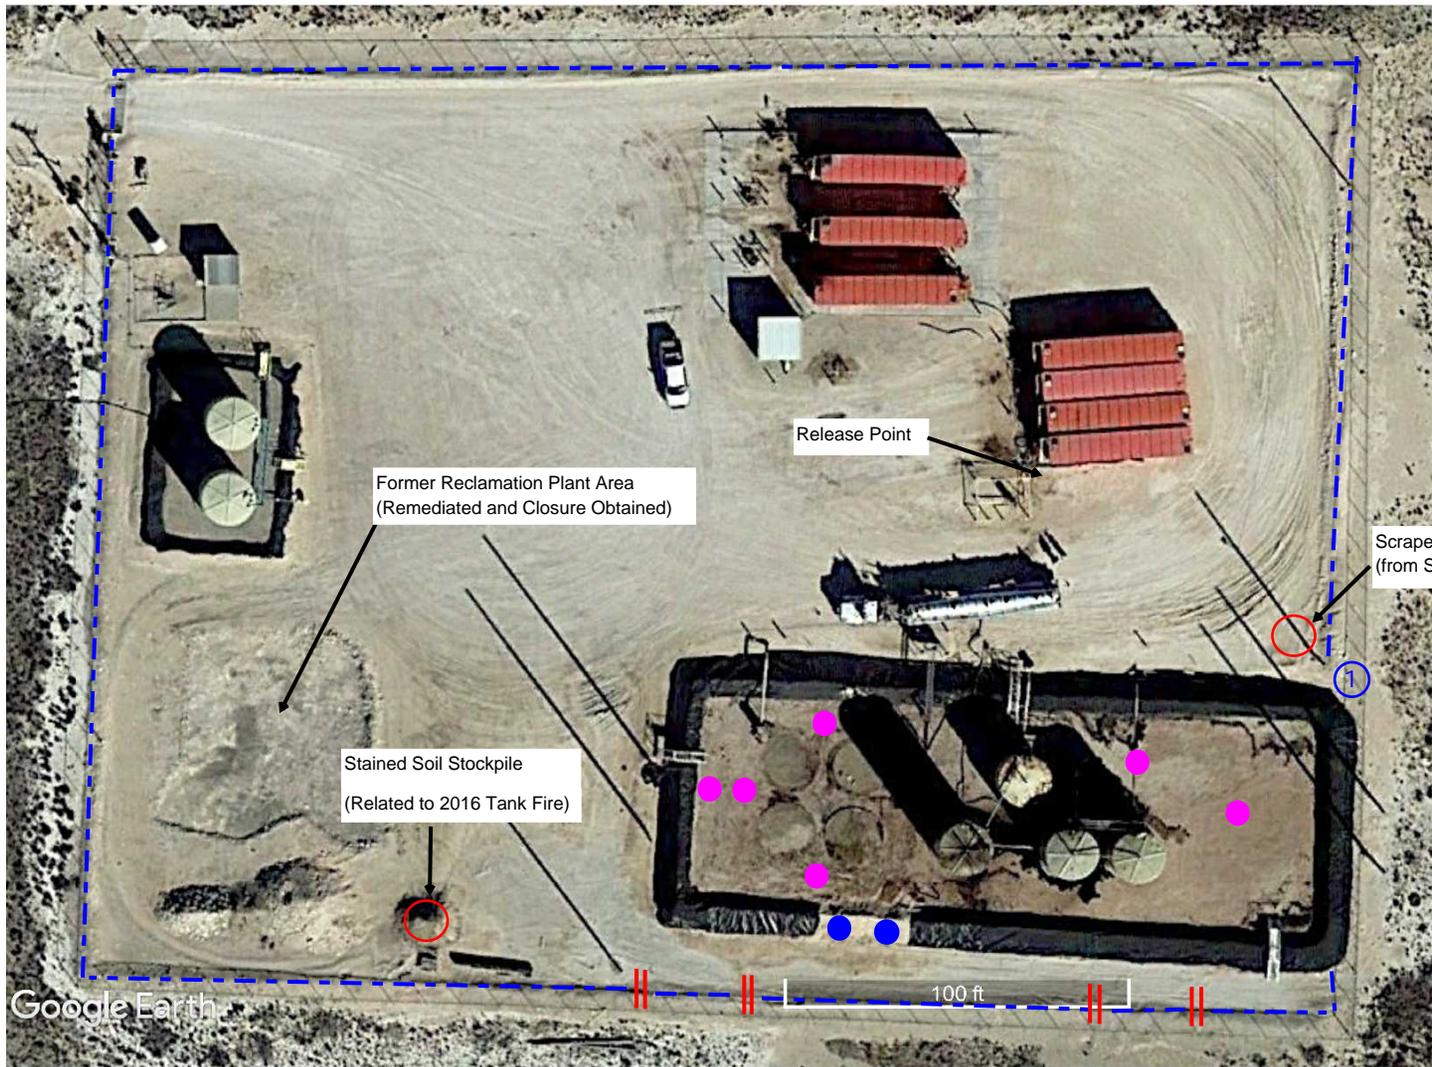
Figure 5
Soil Grab Sample Locations
and Liner Inspection Points
CJES -State AB SWD #1
Hobbs, New Mexico

Visual inspection of the liner will be made to verify that the 2015 and 2016 fires and subsequent repairs did not affect the integrity of the liner. The liner will be inspected at six (6) locations inside the tank battery (**Figure 5**). Four inspection locations will be north, west and south of tanks that were removed as a result of the fires. Two additional visual inspections will be made to the north and east of the existing tanks in the battery. Using a hand trowel, the inspections areas will be scraped and pea gravel removed to expose the liner. Liner integrity will be documented and photographs will be taken of the surface before material atop the liner is removed and of the liner once it has been exposed. Repairs will be made to the liner as necessary, based on the visual inspections.

An area of the southern tank battery containment berm will have grab samples taken from two locations in the berm, at the location where former tanks were removed from the battery. These tanks were involved in September 2015 and September 2016 fire incidents. The liner over the berm will be lifted and the samples will be collected six (6) inches into the berm. A stained soil stockpile west of the tank battery will also have a grab sample taken, as this stockpile contains scraped soils related to the 2016 incident. All samples will be collected utilizing a hand trowel and will be analyzed for BTEX, TPH and chloride by the methods listed below.

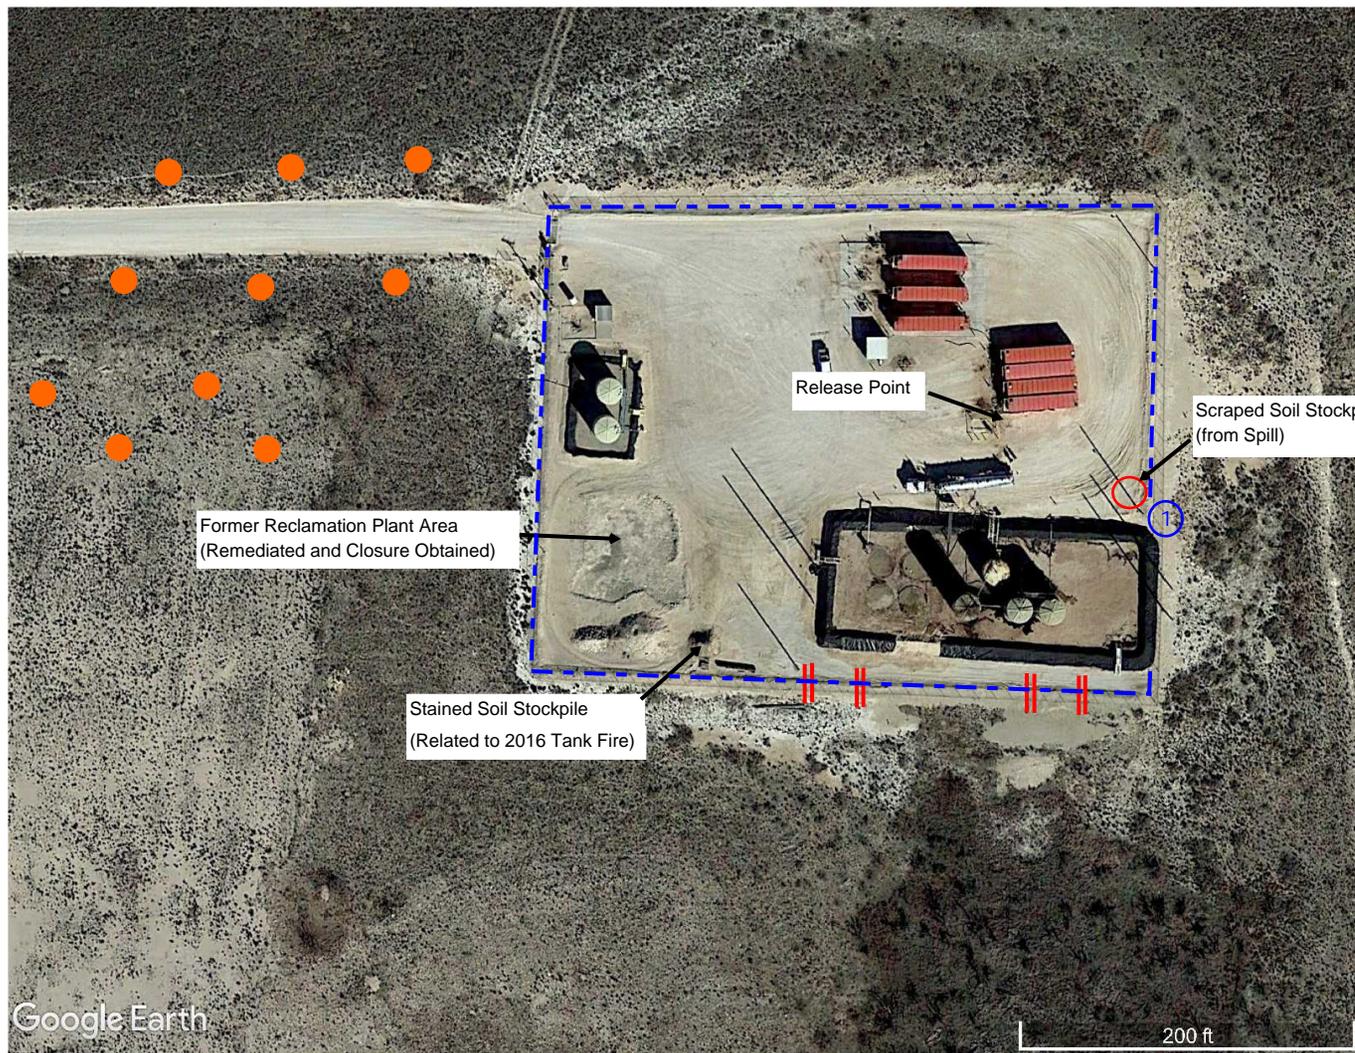
Figure 6
Background Sample Locations
CJES -State AB SWD #1
Hobbs, New Mexico

Background samples will be collected at locations shown on **Figure 6**. Samples will be collected 6-inches bgs. Per NMOCD regulations (NMAC 19.15.17), closure criteria for soil can be based on background concentrations or numerical limits, whichever is greater.
