Confirmation of Corrective Actions

South Hat Mesa
Lea County, New Mexico
1RP-4803

Confirmation of Corrective Action

Tasman Geosciences, Inc. (Tasman) has prepared the Confirmation of Corrective Action on behalf of DCP Midstream, LP (DCP) to document the results of field activities that were conducted at the South Hat Mesa (GPS 32.5072 -103.6721) located in Lea County, New Mexico.

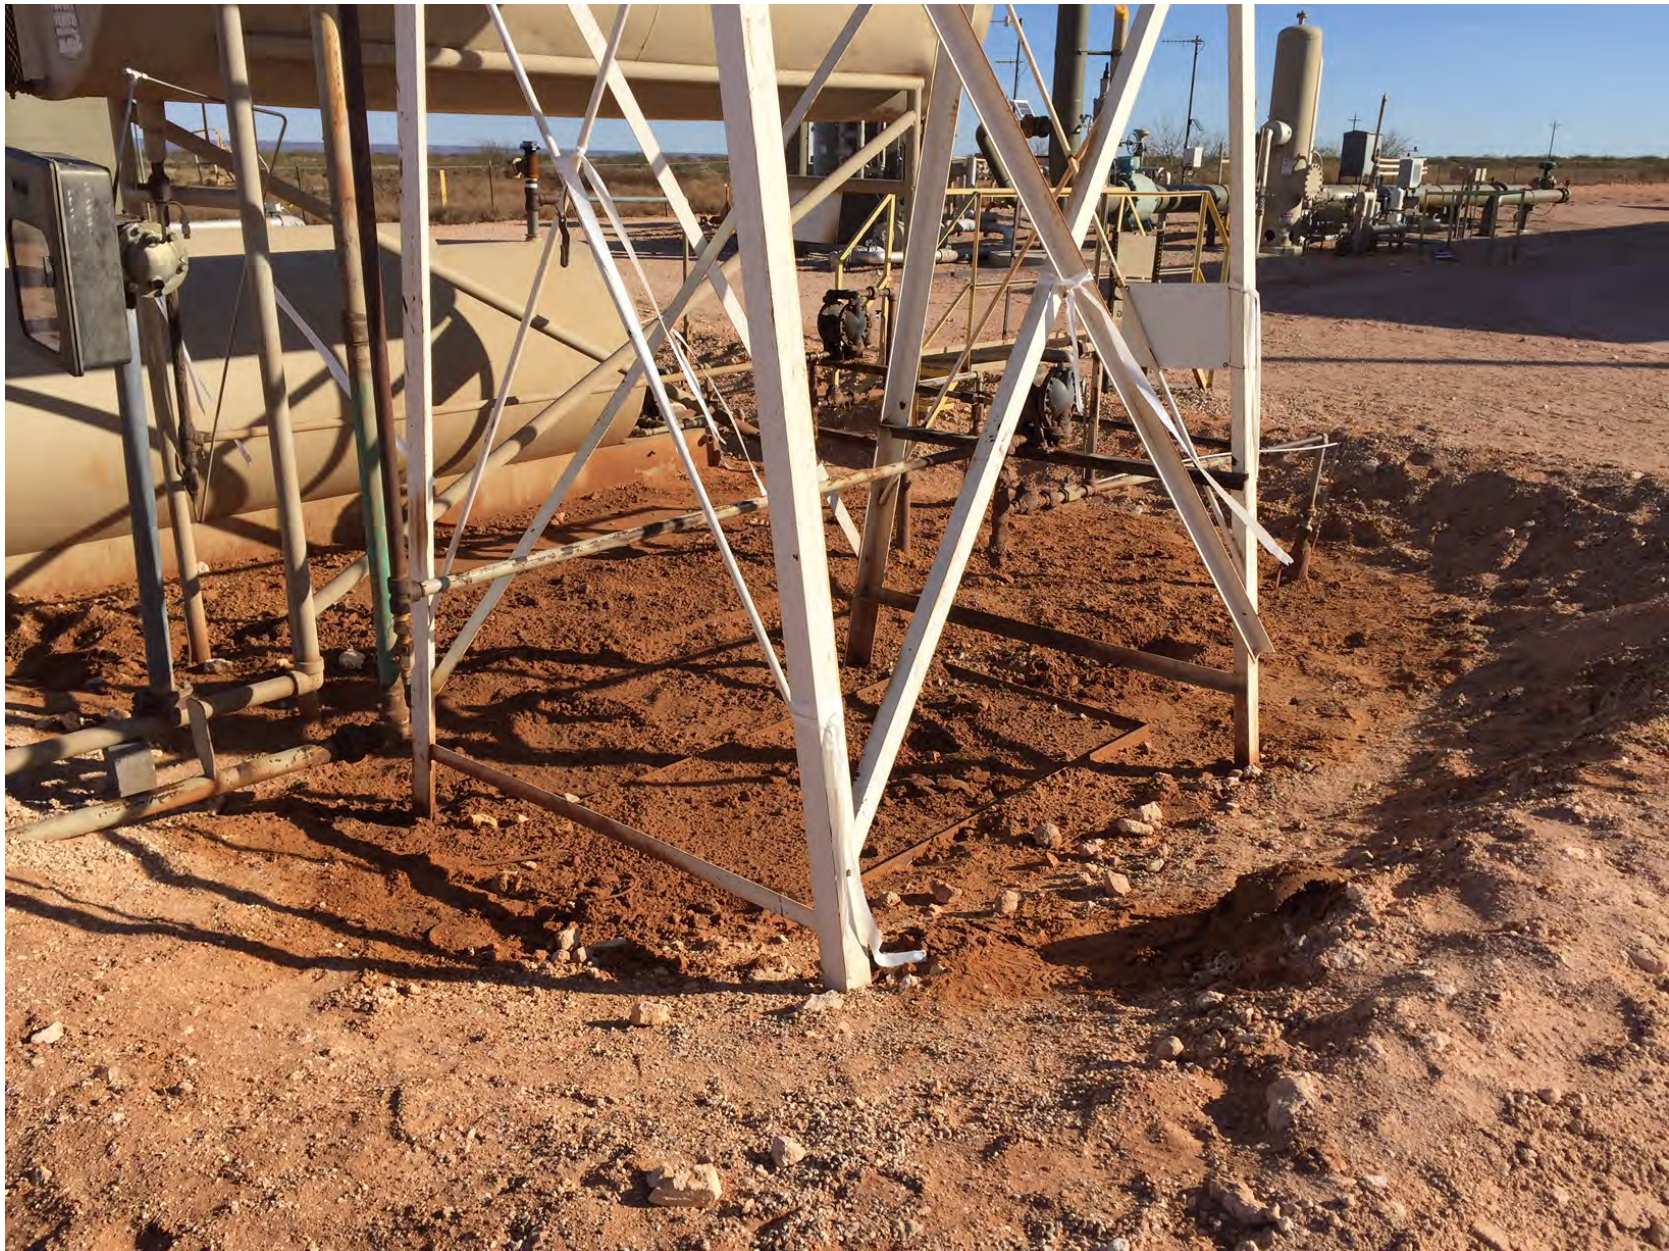
Release, facing NE 11/29/2017

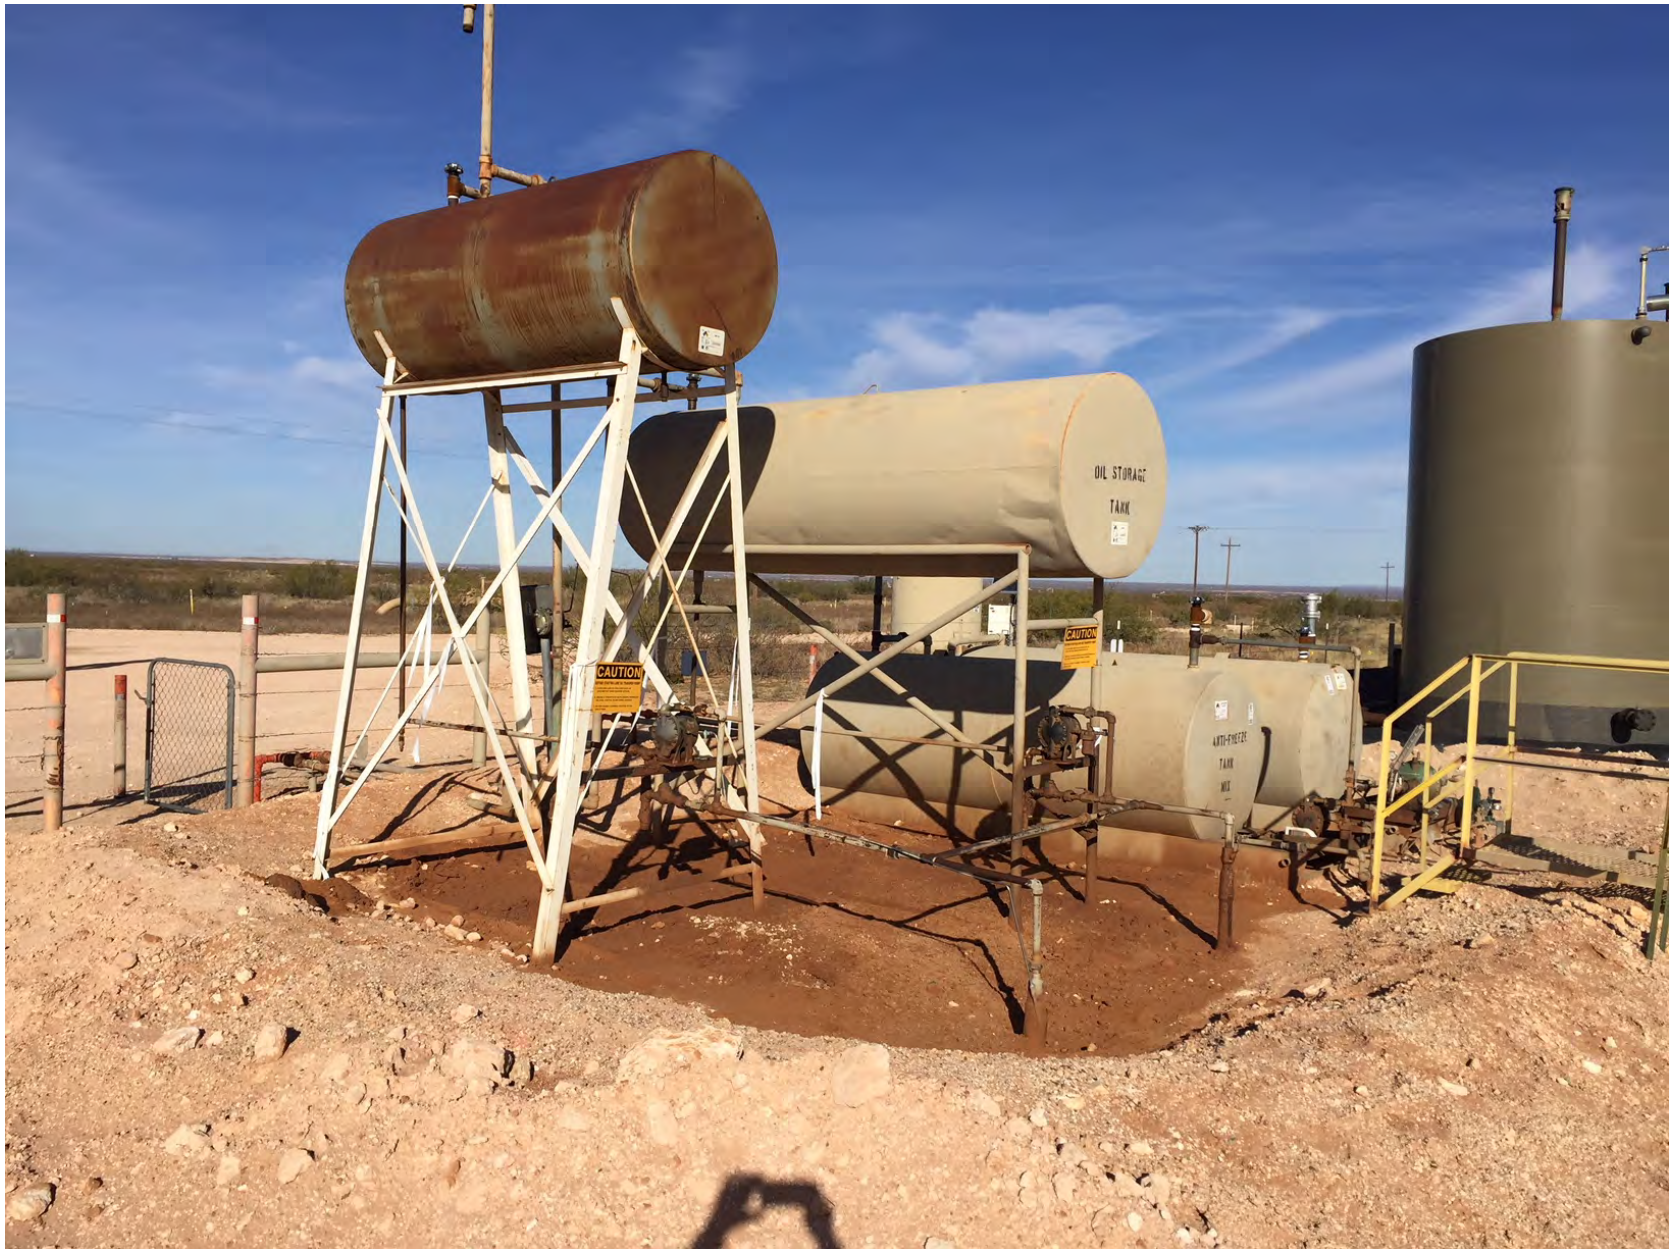
Release, facing NNW 11/29/2017

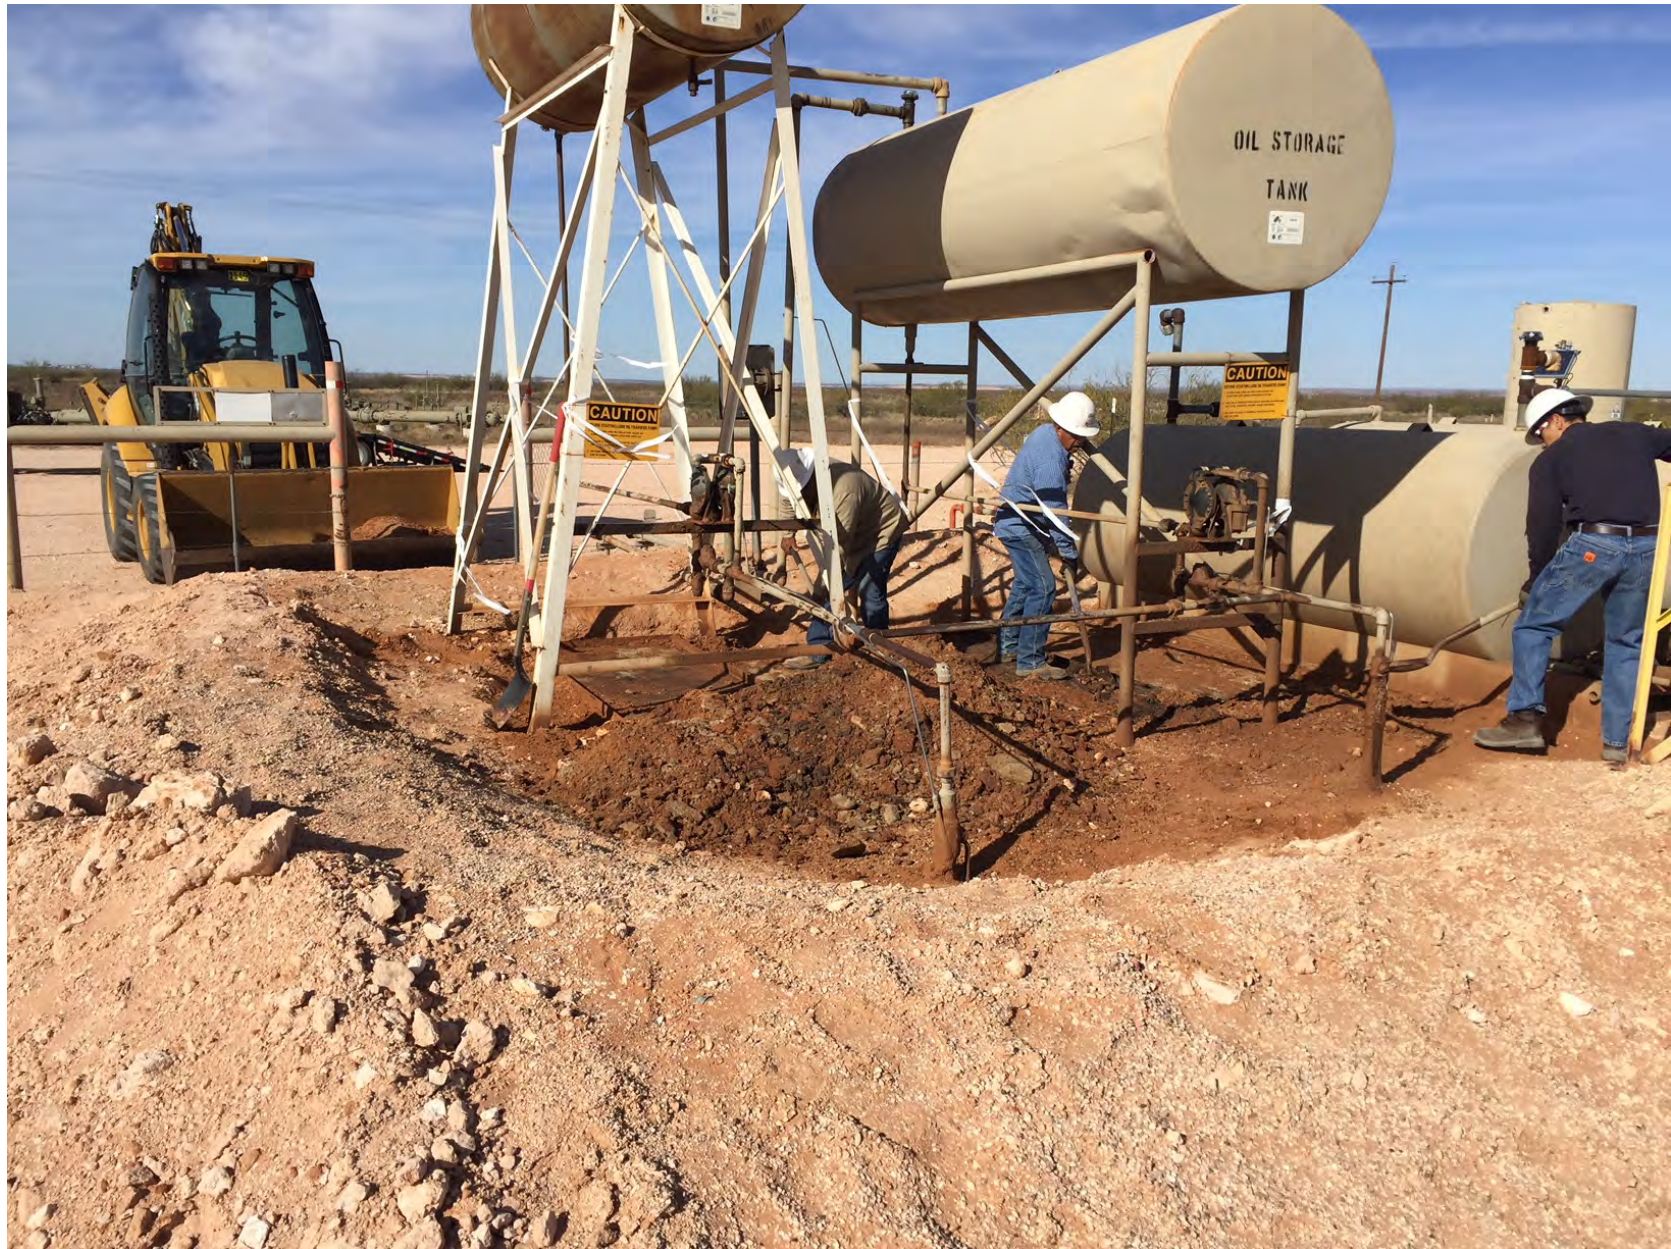
Excavating, facing W 11/29/2017

A total of 12 cubic yards of contaminated soil were exported and disposed of at Lazy Ace Land Farm. A total of 12 cubic yards of 1" gravel was imported for backfill.

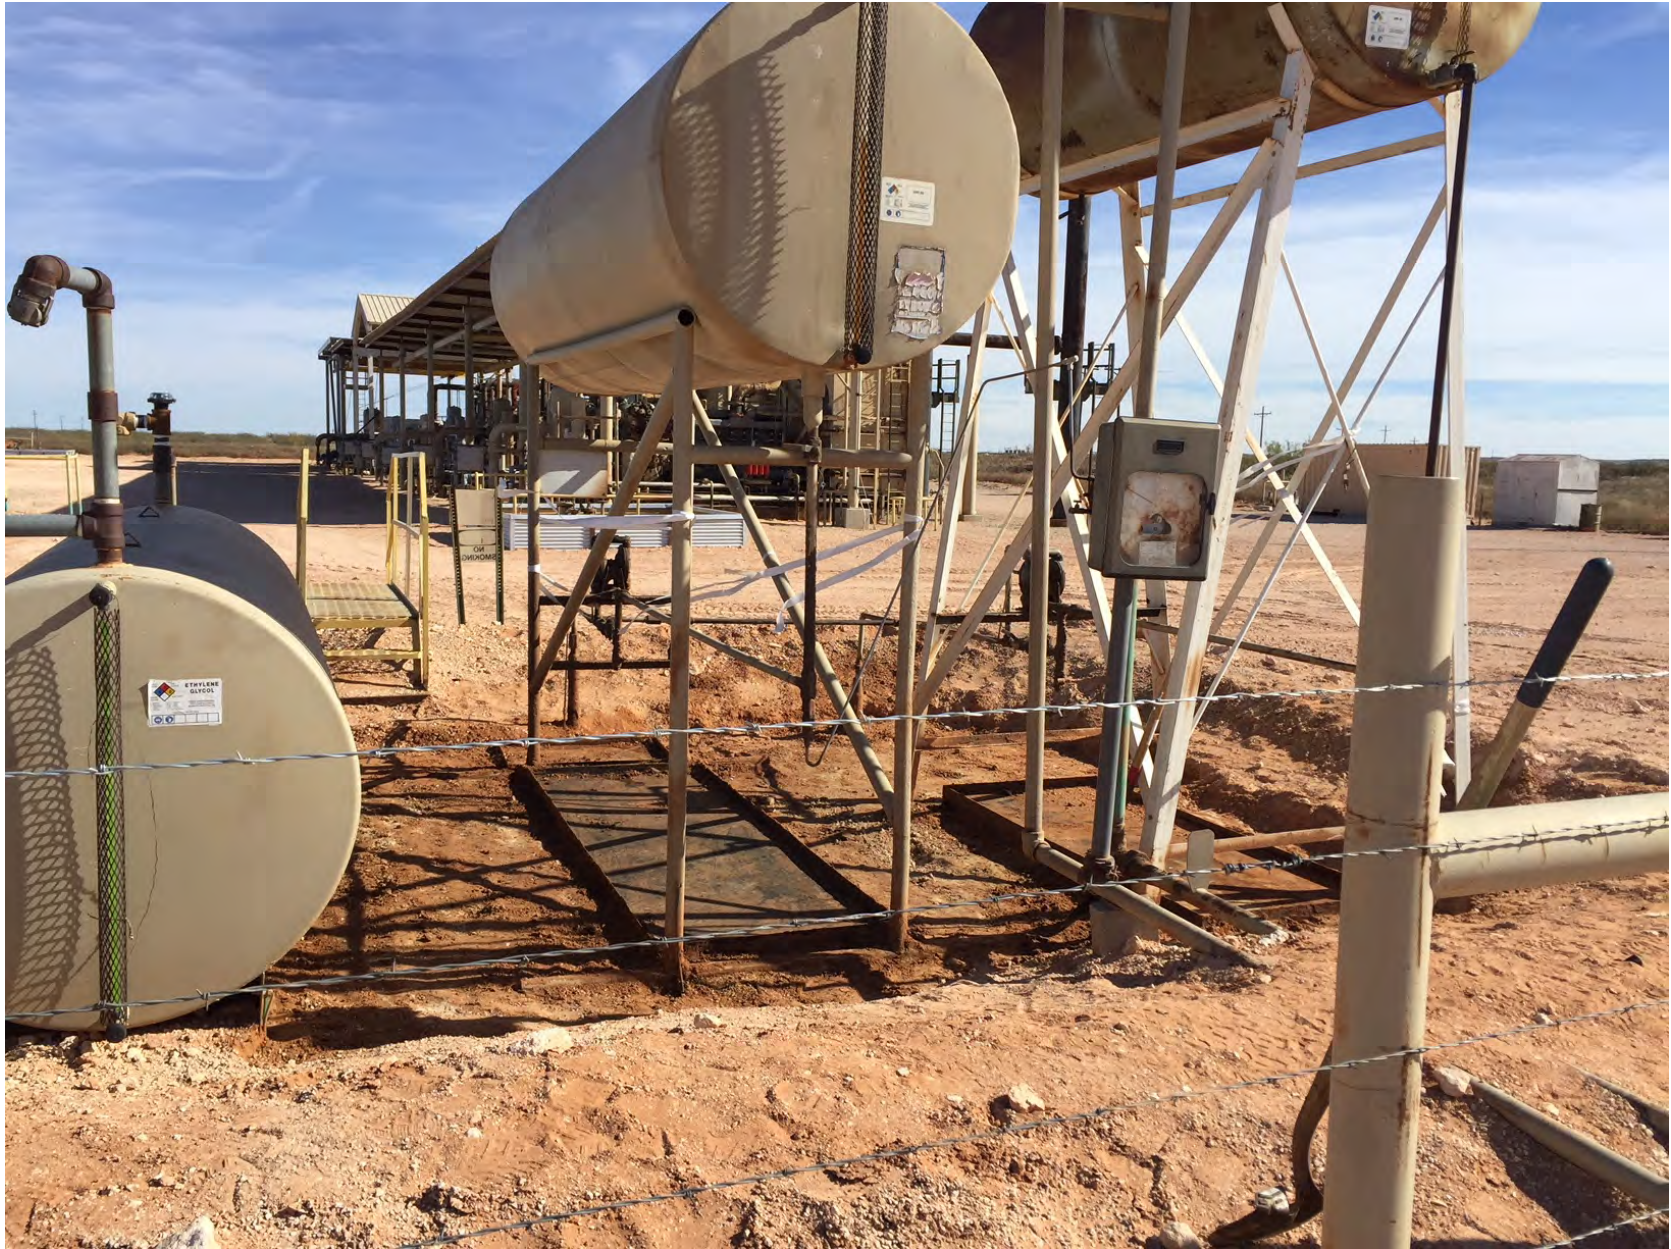
Excavated, facing E 11/29/2017

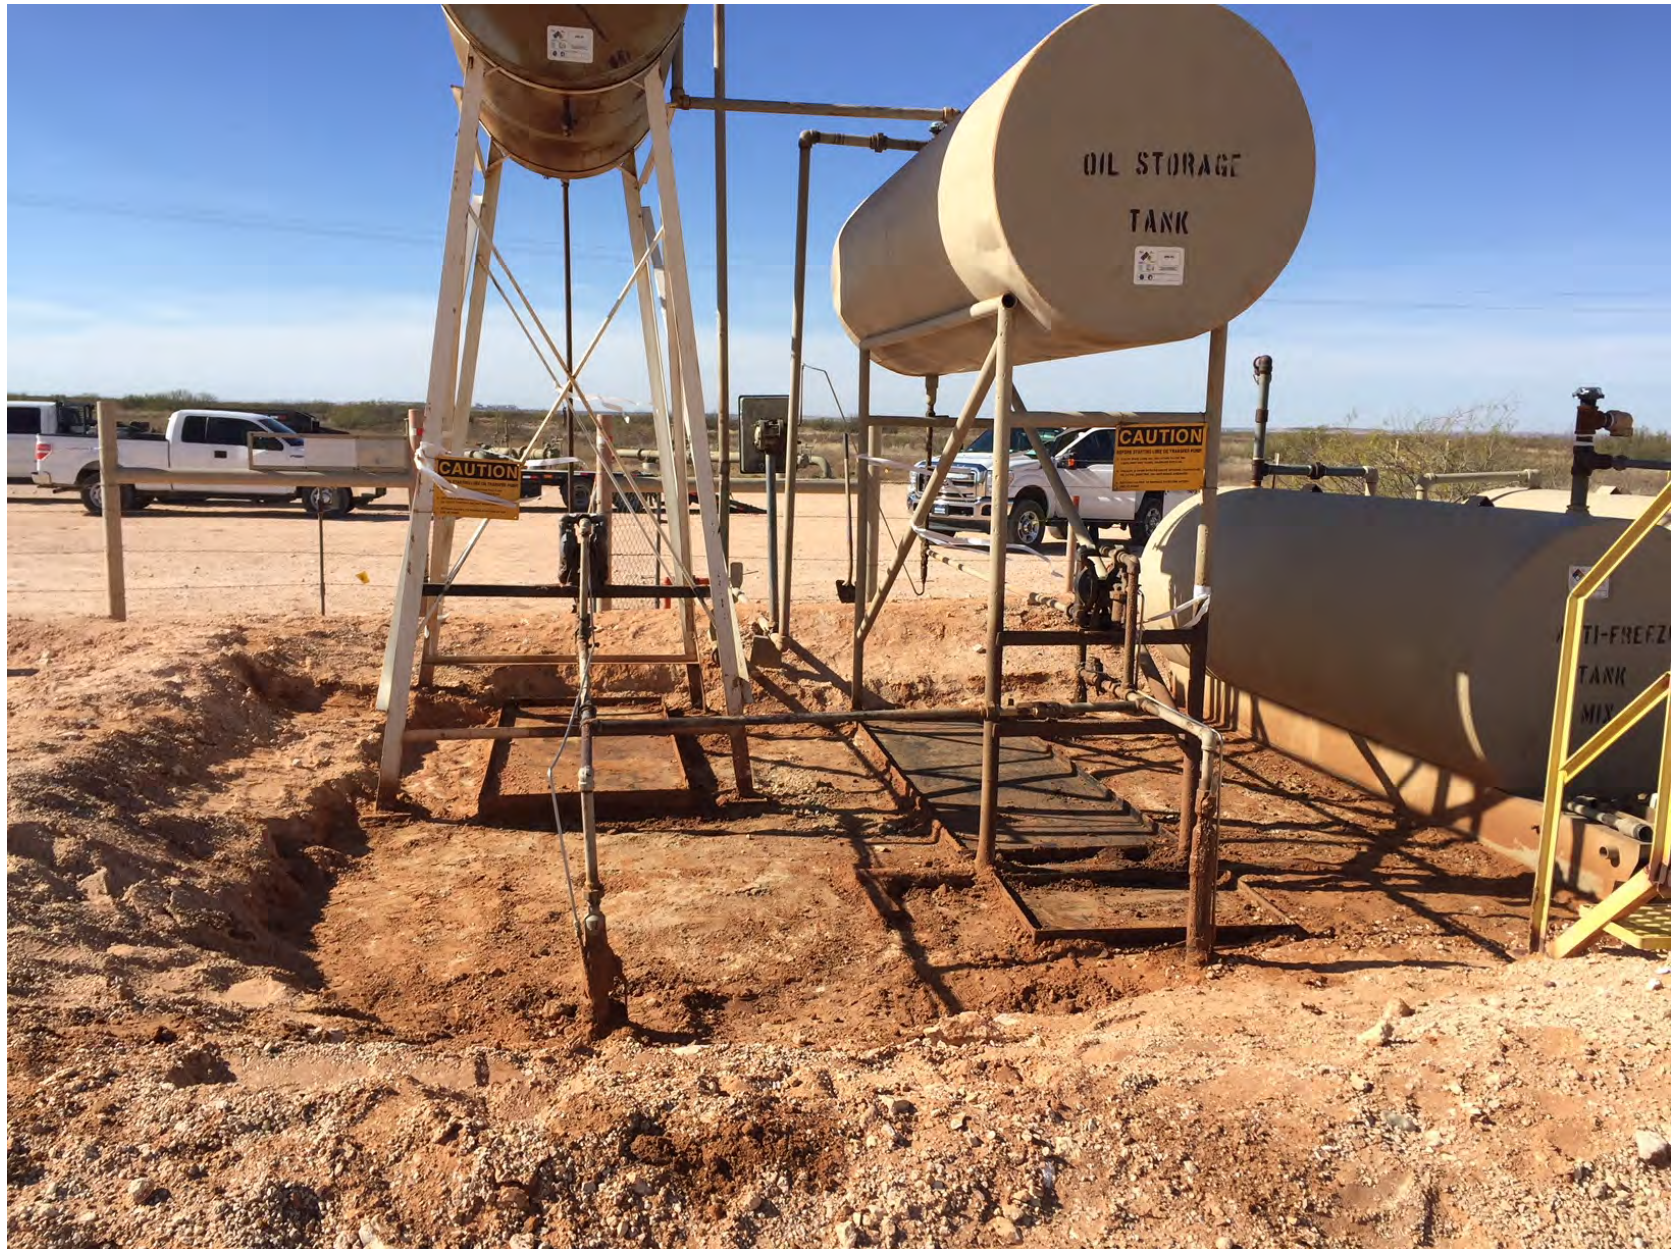
Excavated, facing W 11/29/2017
