Re: LPU 59 Site Assessment Report

LPU 59 – 2016 Soil Assessment and Delineation Report, Unit G - Section 1 – Township 17 South

Site Assessment Report

Lovington Paddock Unit 59 Produced Water Release Lea County, New Mexico

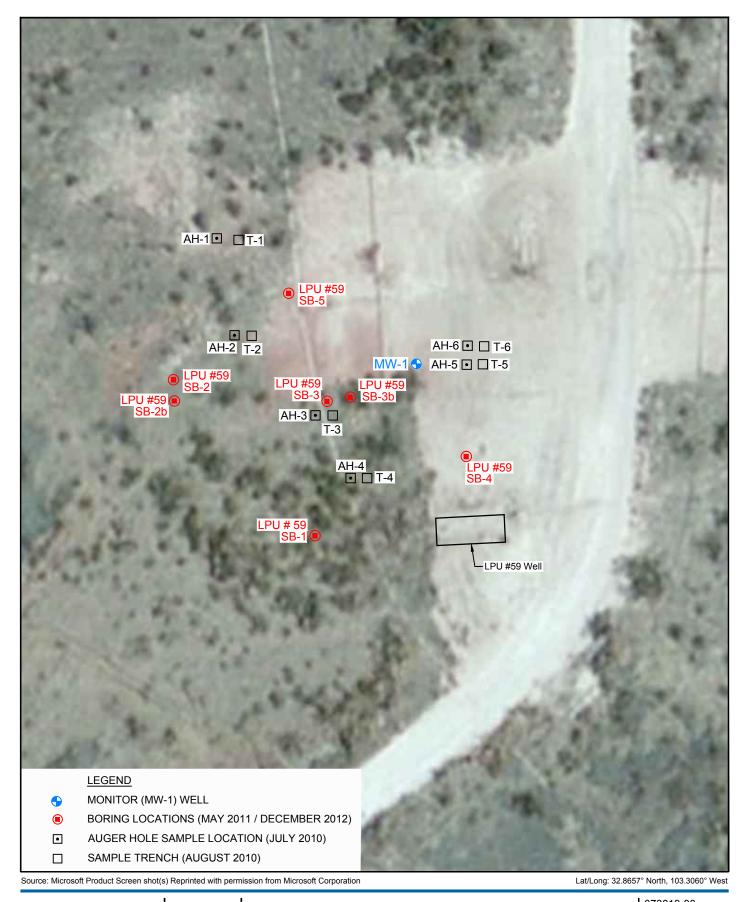
FIGURE 3

On behalf of Chevron Environmental Management Company (CEMC), GHD Services Inc. (GHD - formerly Conestoga-Rovers & Associates) prepared this report summarizing site assessment activities at the Lovington Paddock Unit (LPU) 59 site (hereafter referred to as the "Site"). The Site is located approximately 5 miles southeast of Lovington in Lea County, New Mexico in Unit G, Section 1, Township 17 South, Range 36 East. The land surface is owned by the City of Lovington and the minerals are managed by the State of New Mexico. The location of the Site is identified on the vicinity map of Figure 1 and the aerial map of Figure 2. Site details are shown on Figure 3.

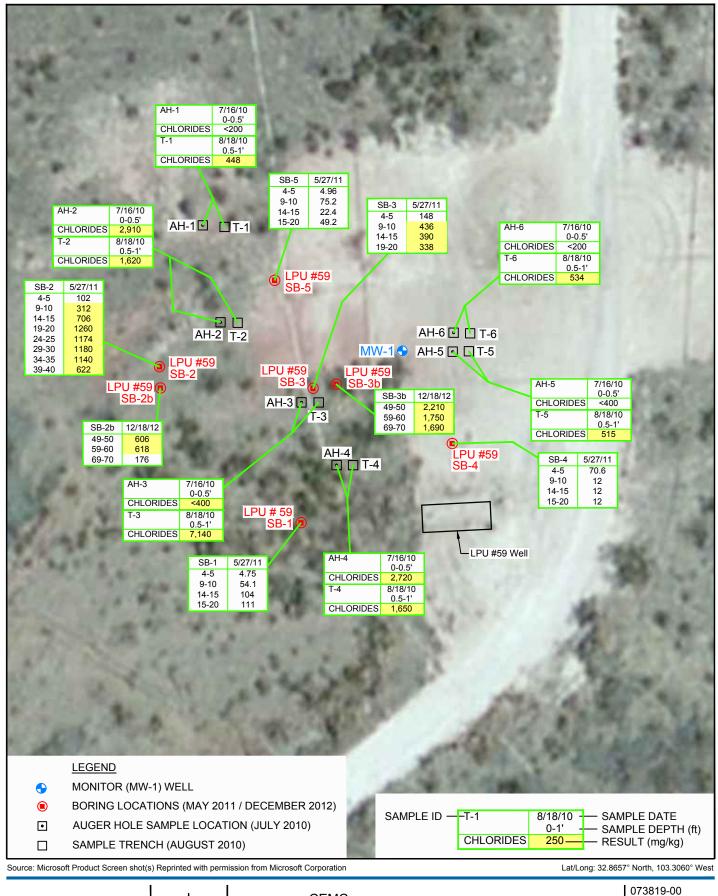
Figure 3 Site Map
