**1RP-4538  
DELINEATION PLAN  
LMPSU 1 CTB  
Produced Water Spill  
Lea County, New Mexico**

LAI Project No. 17-0175-39

February 15, 2018

**Legacy, L.P.  
LMPSU 1 CTB  
Lea County, New Mexico  
Unit Letter "O", Section 27, Township 22 South, Range 37 East  
Latitude 32.356572 North, Longitude 103.149062 West  
NMOCD Reference #1RP-4538**

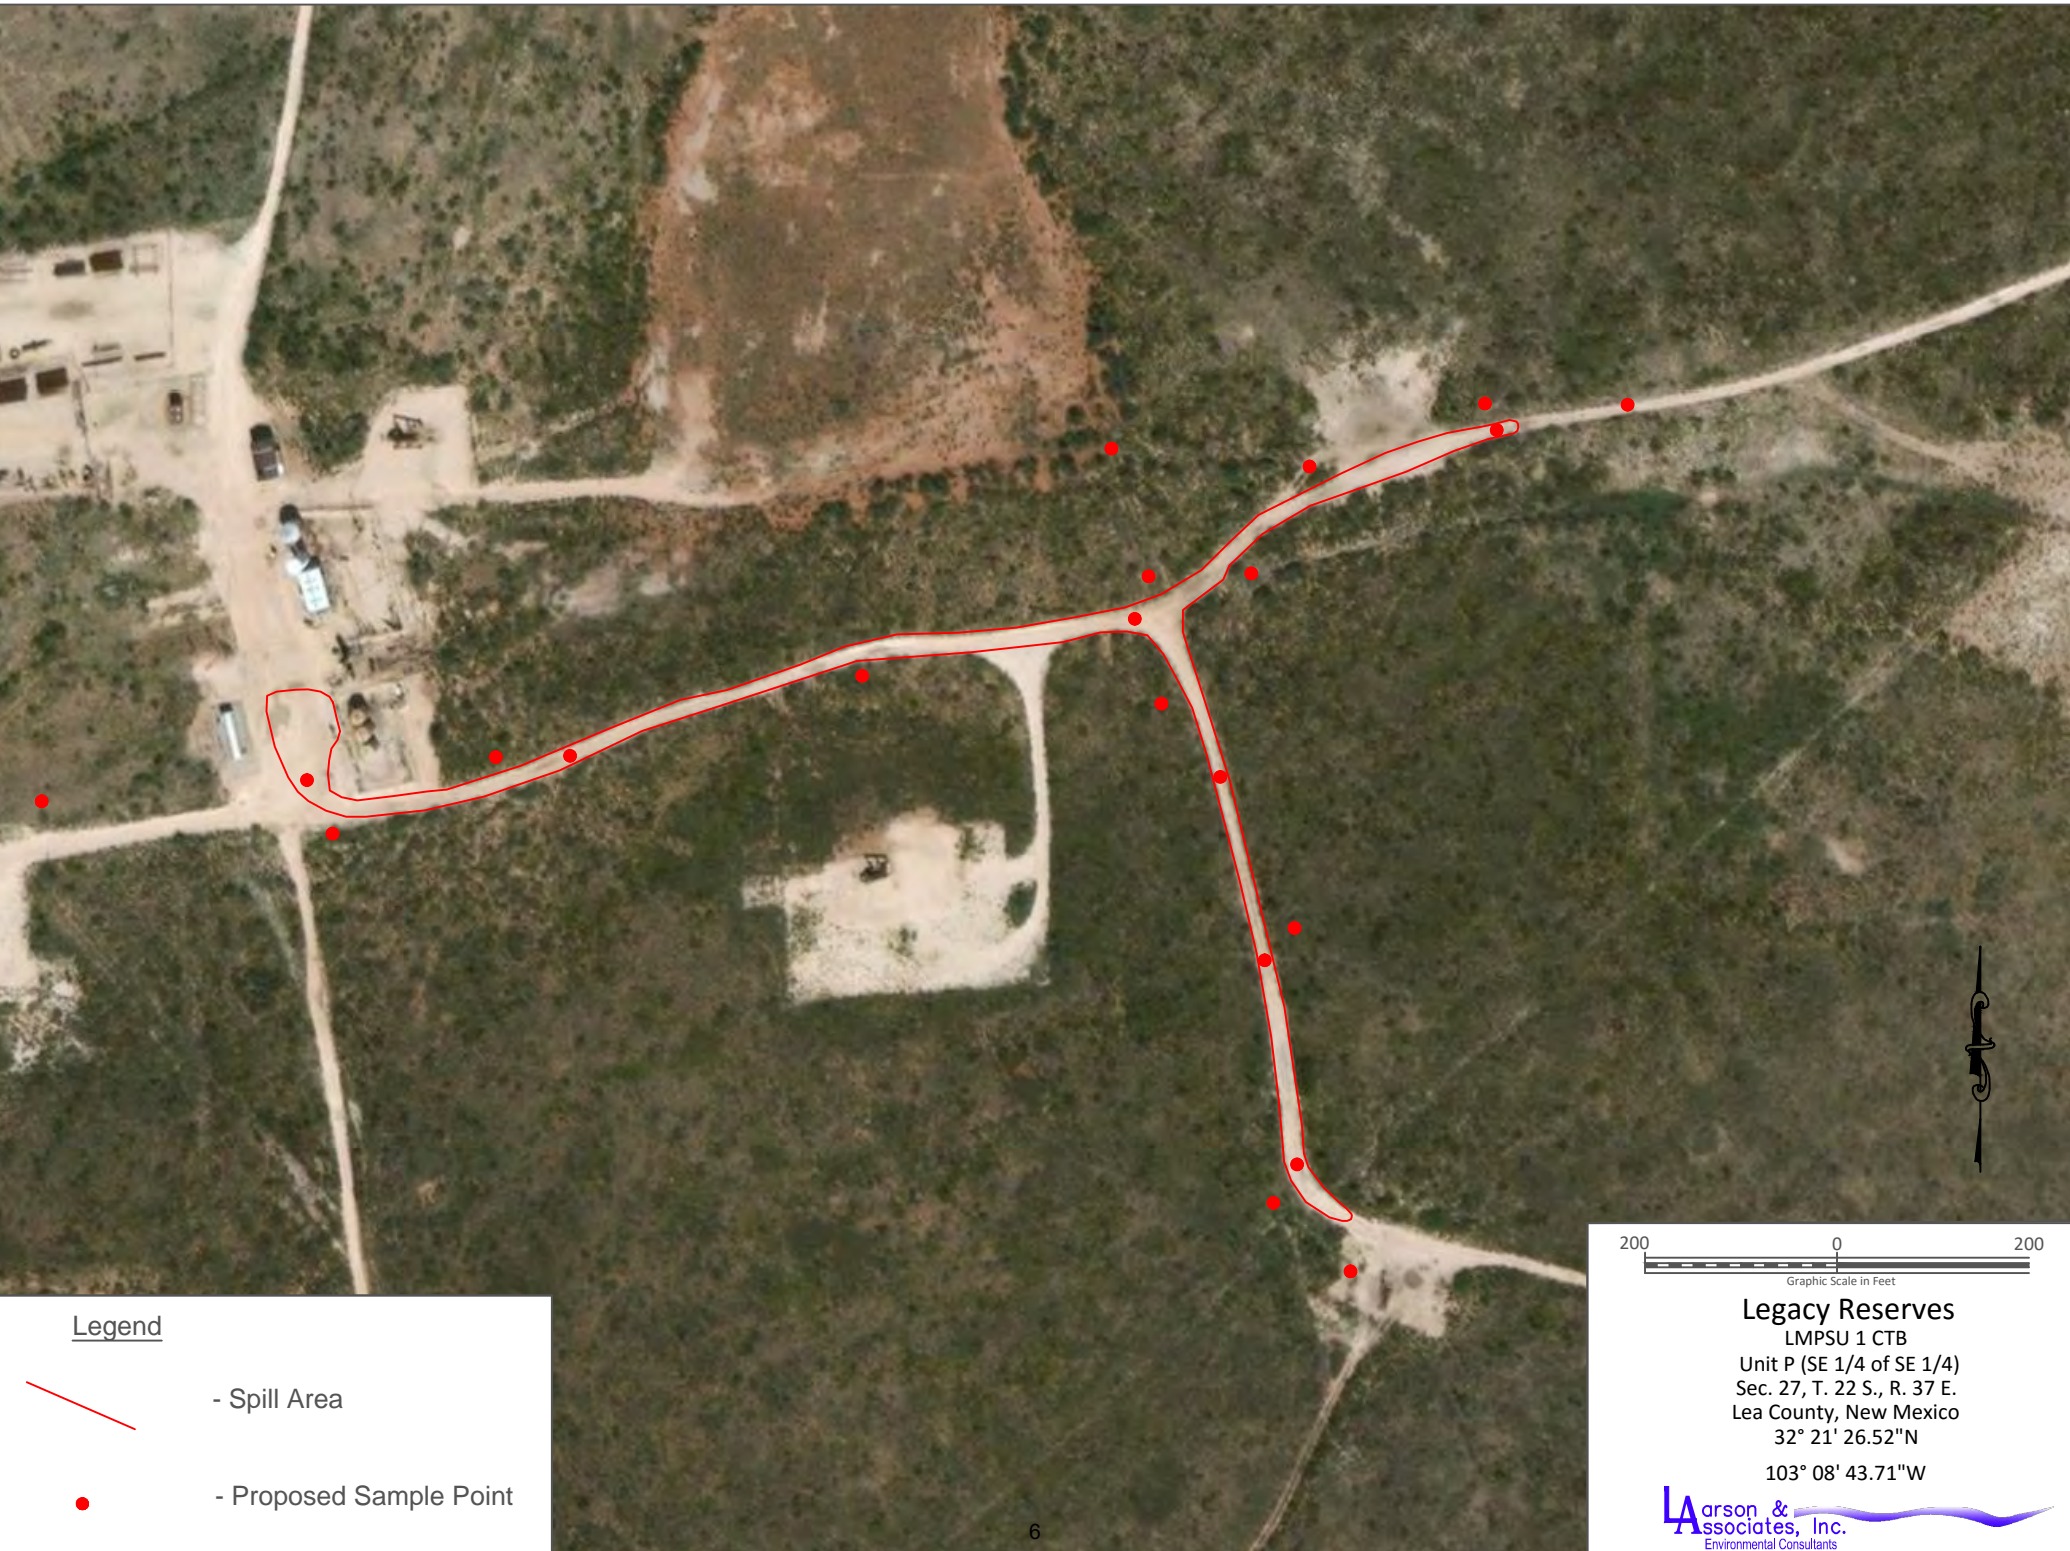
Figure 2 - Aerial Map with Proposed Sample Points

LAI proposes to collect soil samples at eight (8) locations within the spill area. The samples will be collected at 1 foot intervals to approximately 4 feet bgs and 2 foot intervals to approximately 12 feet bgs using direct push technology (DPT) depending on subsurface conditions. Additional samples will be collected in each cardinal direction (north, south, east and west) of the spill area at the same depth intervals for horizontal delineation. The soil samples will be delivered under preservation and chain of custody to Xenco Laboratories (Xenco) in Midland, Texas. The upper samples (0 to 1 foot) will be analyzed for BTEX, the sum of benzene, toluene, ethylbenzene and xylenes and TPH, total petroleum hydrocarbons, including gasoline range organics (GRO), diesel range organics (DRO) and oil range organics (OR) by EPA SW-846 Methods 8021B and 8015M, respectively. Additional samples will be analyzed for BTEX and TPH for vertical delineation should the initial samples report concentrations above the RRAL. All samples will be analyzed for chloride by Method 300 respectively. Pending laboratory results, further delineation will be determined to reach cleanup level standards. Appendix C presents photographs.

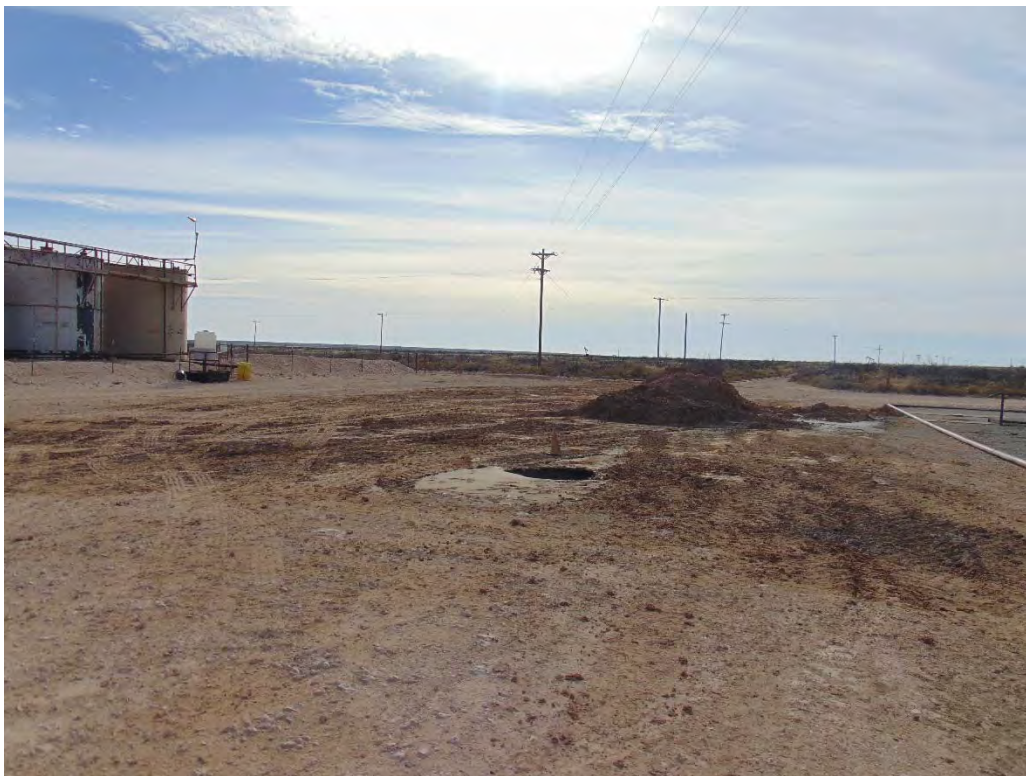
Photograph #1- Point of release

An injection line developed a leak releasing fluid to lease road. A vacuum truck was dispatched to collect standing fluid.

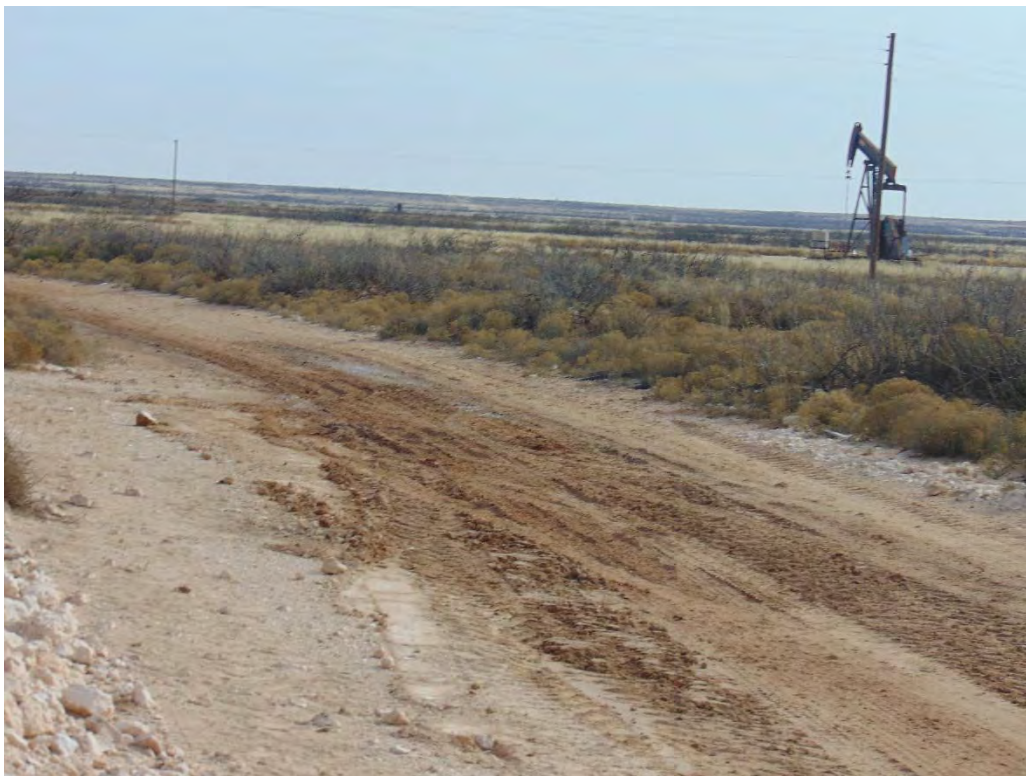
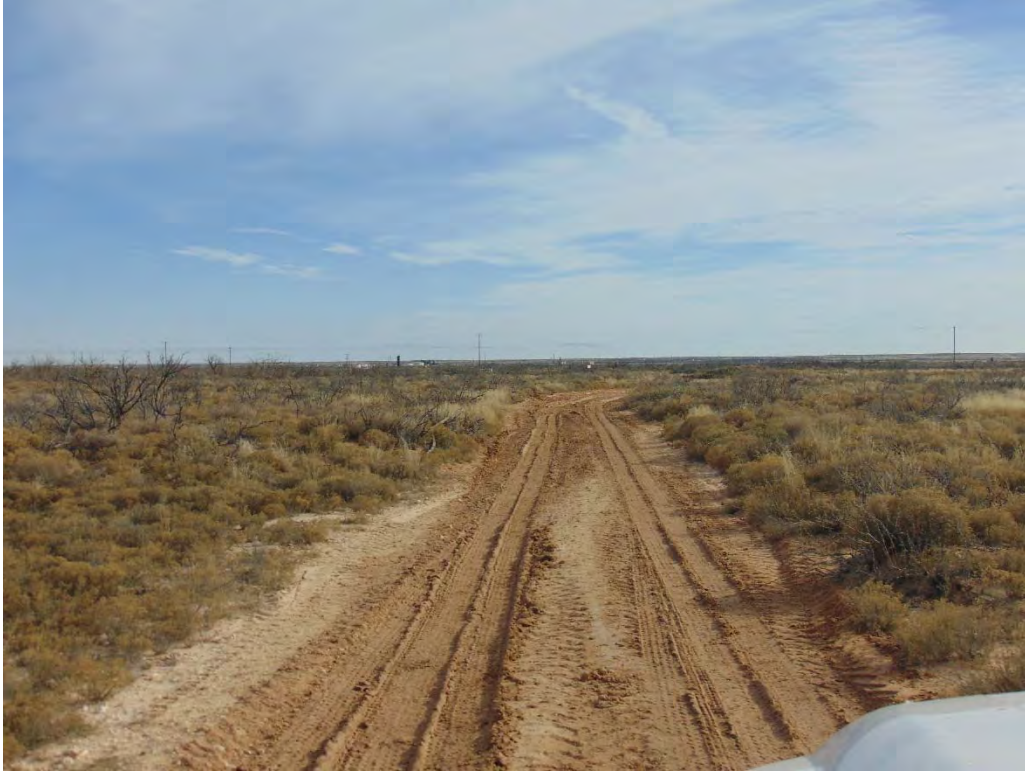
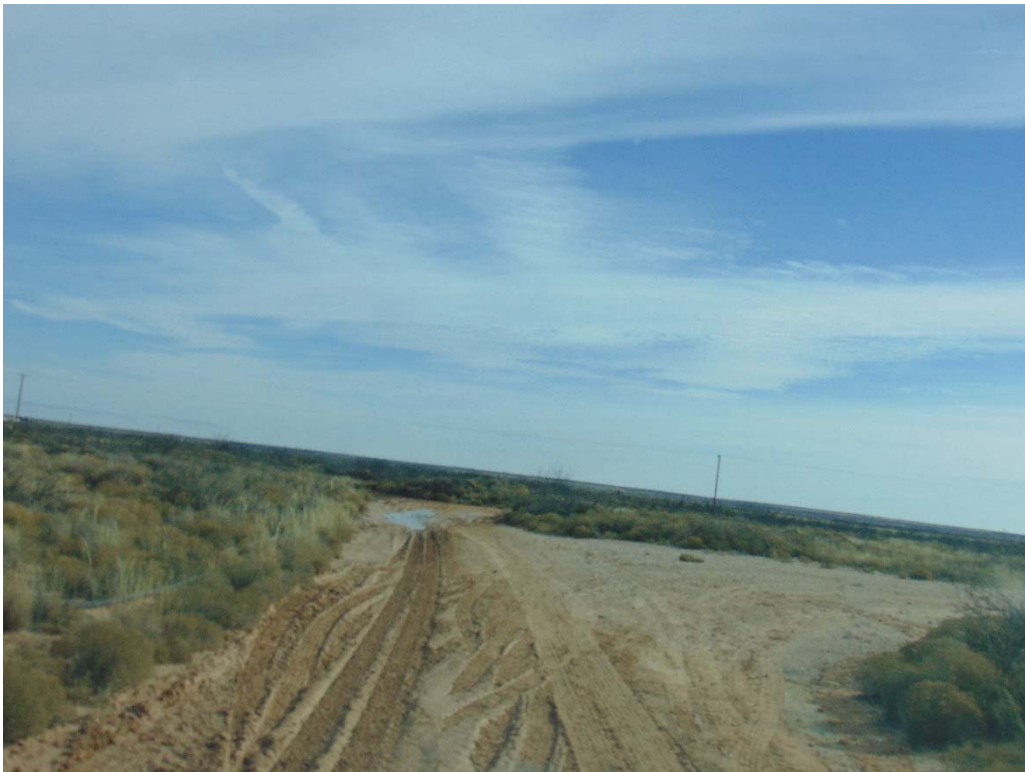
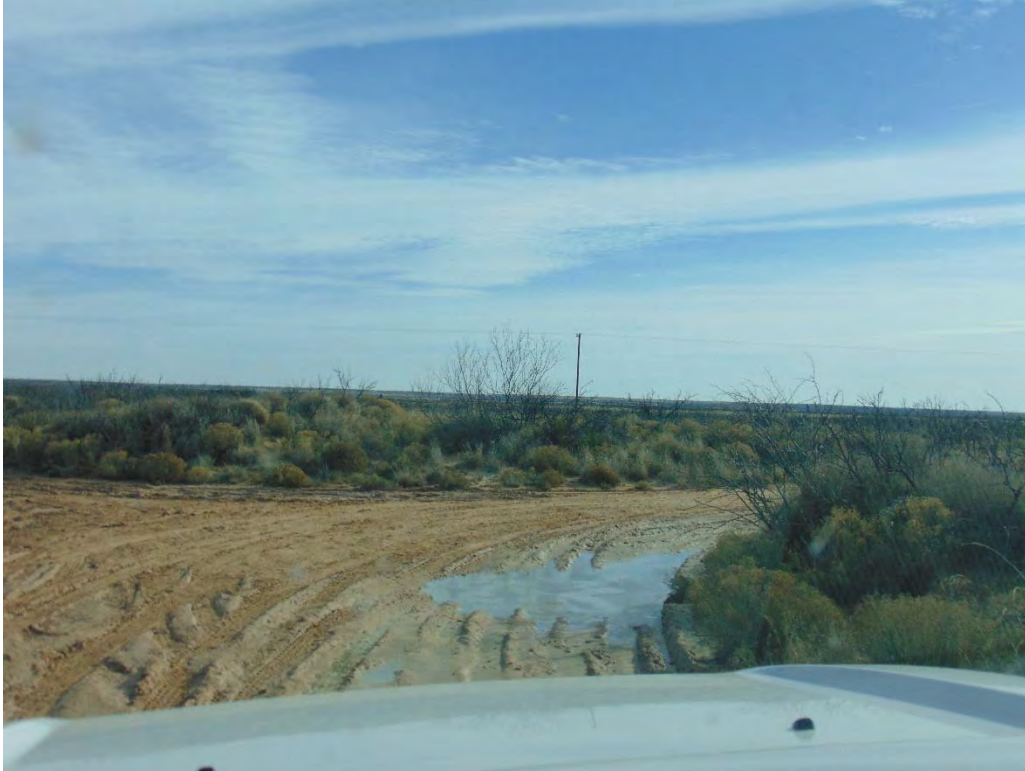
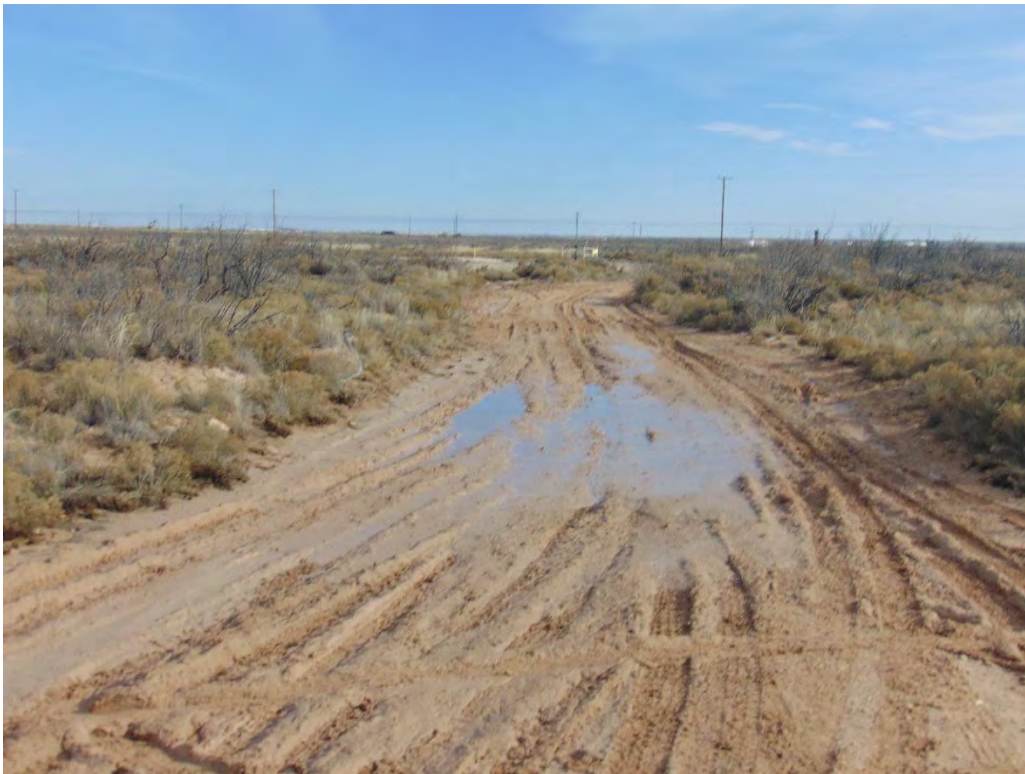
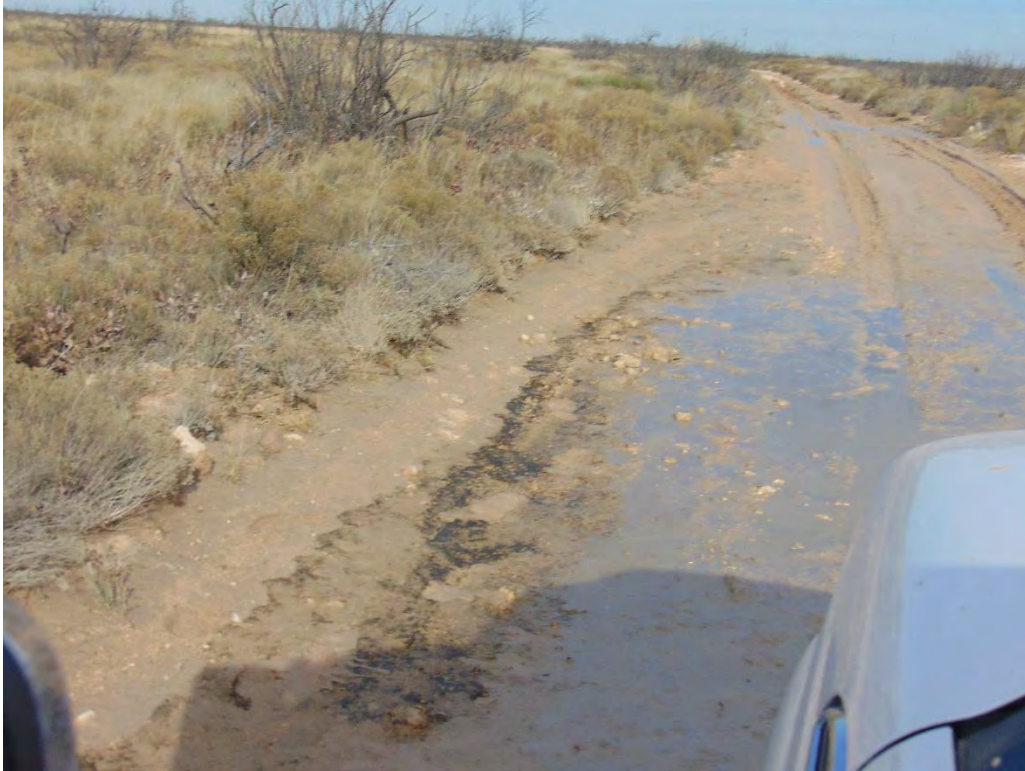
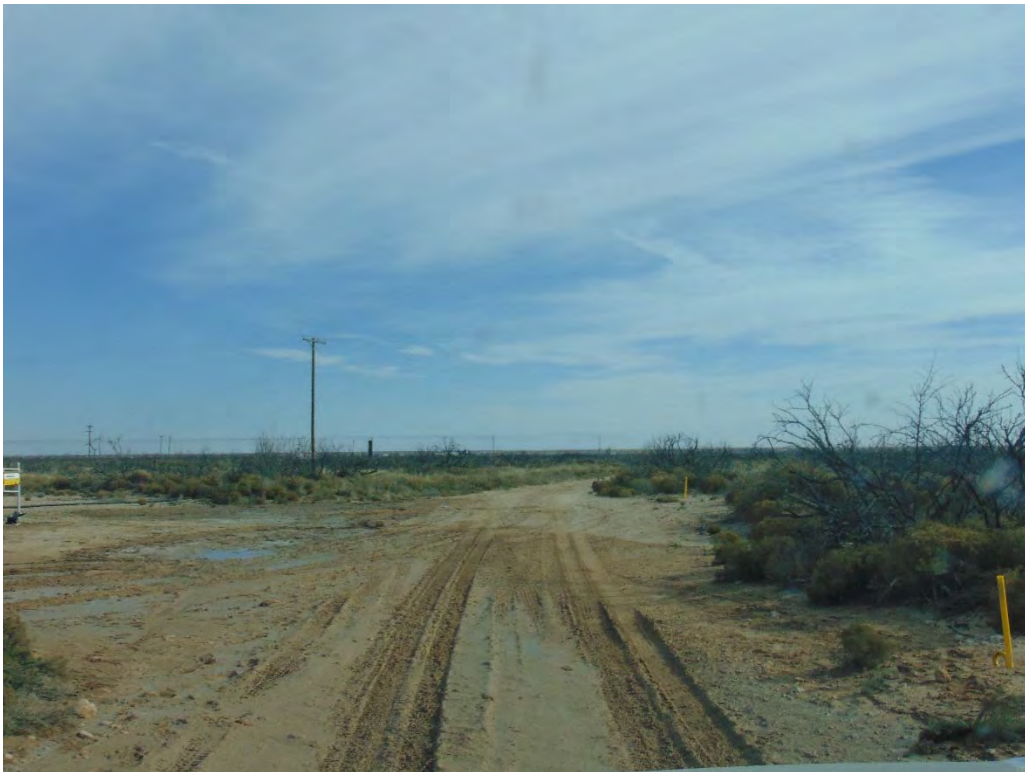
The produced water flowed south off the tank battery pad and east down the lease road approximately 1,500 feet and approximately 600 feet down another lease road. This area is caliche.

Photograph #2- Looking across release area.

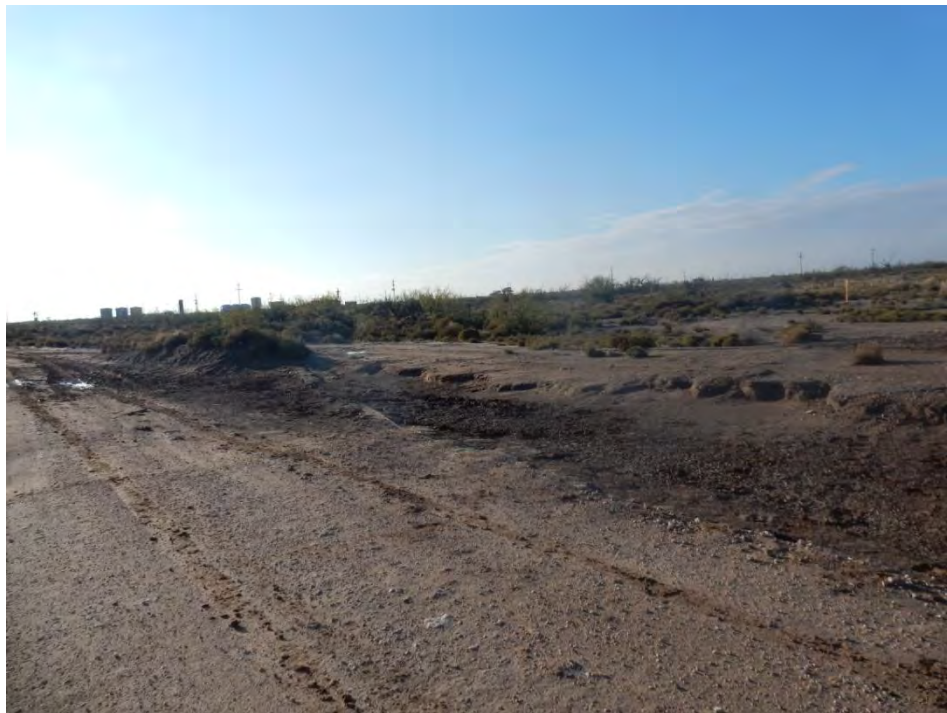
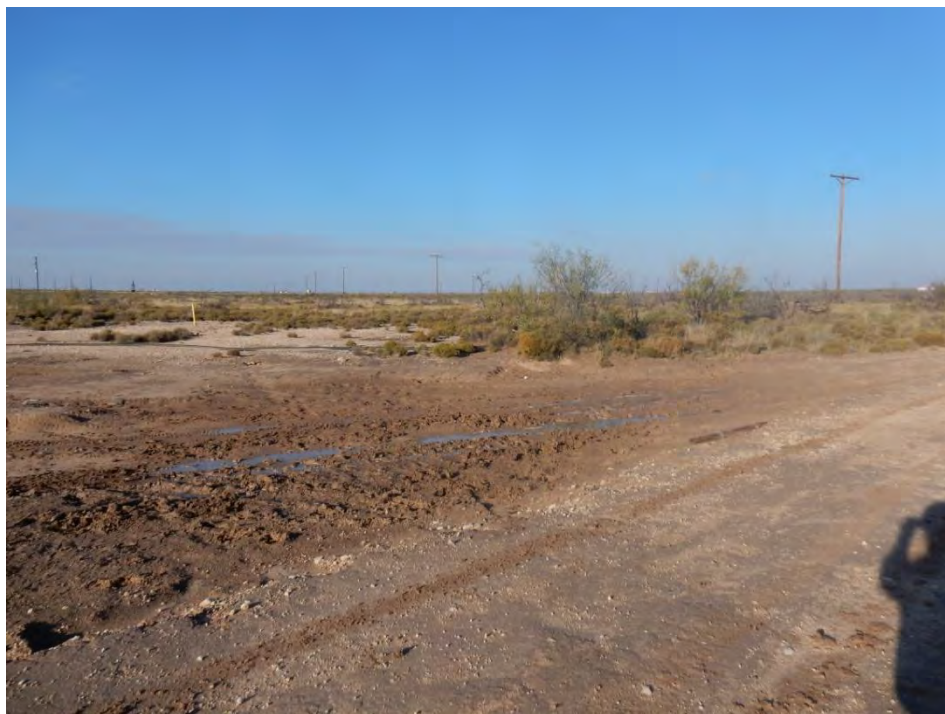
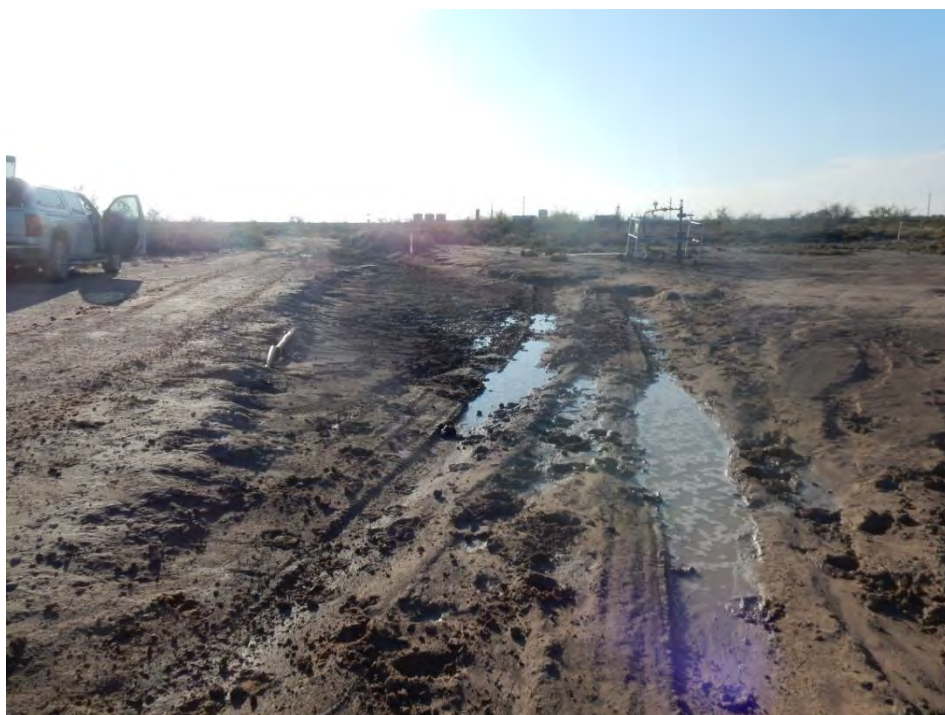
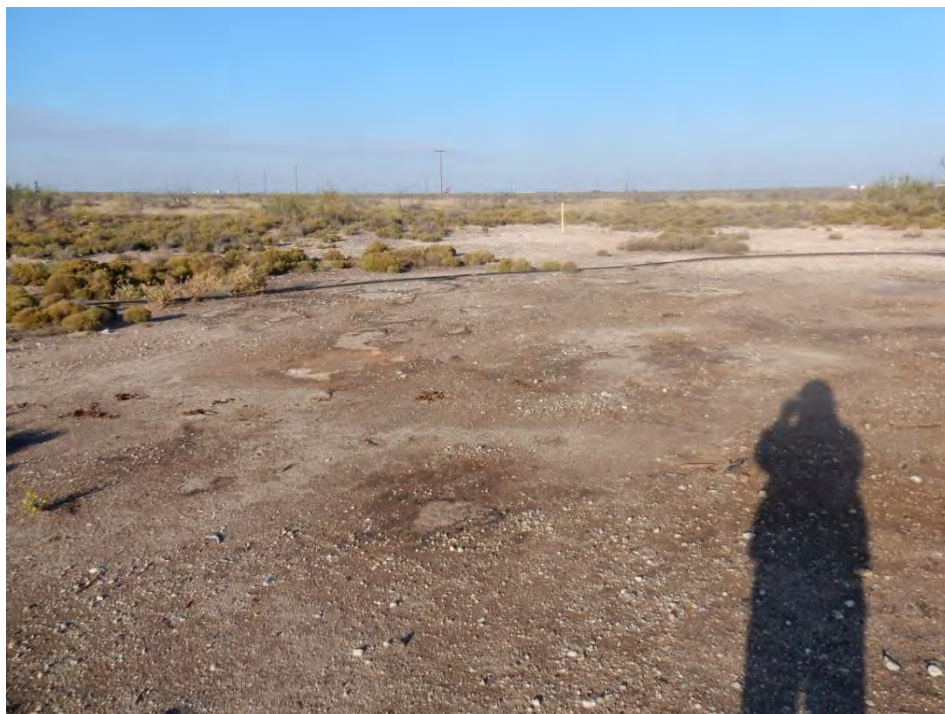
Site Prior to Remediation Viewing West, November 8, 2017

Site Prior to Remediation Viewing Northeast, November 8, 2017

Site Prior to Remediation Viewing North, September 8, 2017

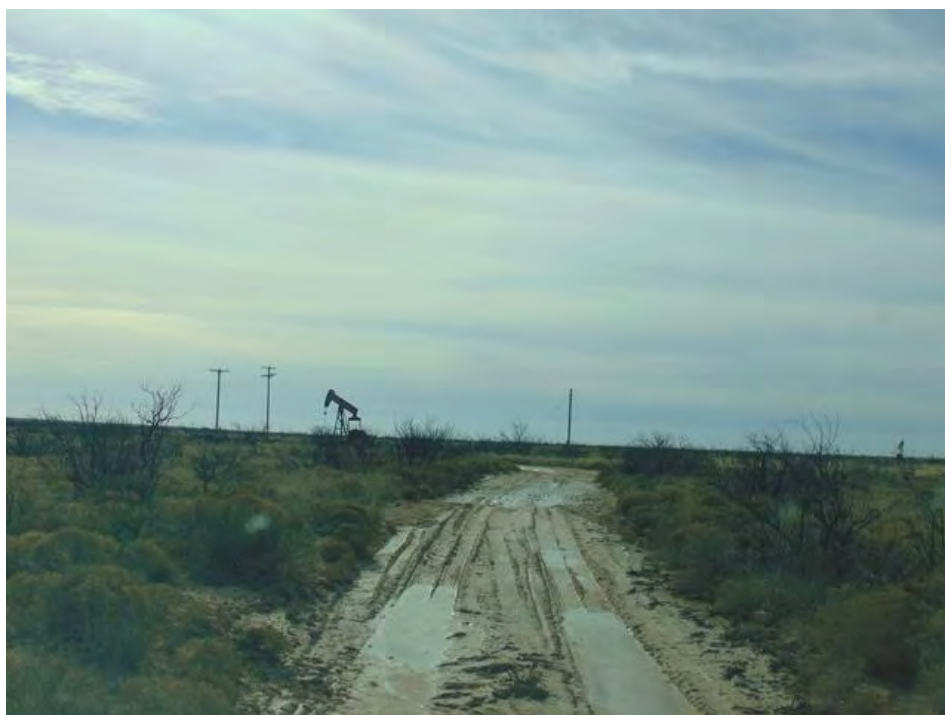
On an unknown date, EPI excavated the release area to a depth of 2 feet bgs. Appendix B presents the EPI work plan.

EPI Photograph Viewing South, October 6, 2017
