R. T. HICKS CONSULTANTS, LTD.

RE: Advance Energy – Merchant Containment/Merchant State 503H Release(s)
Delineation Plan and Potential Corrective Actions - **1RP-4953**

Advanced Energy Partners Hat Mesa, LLC
Merchant Containment/Merchant State 503H Release(s)

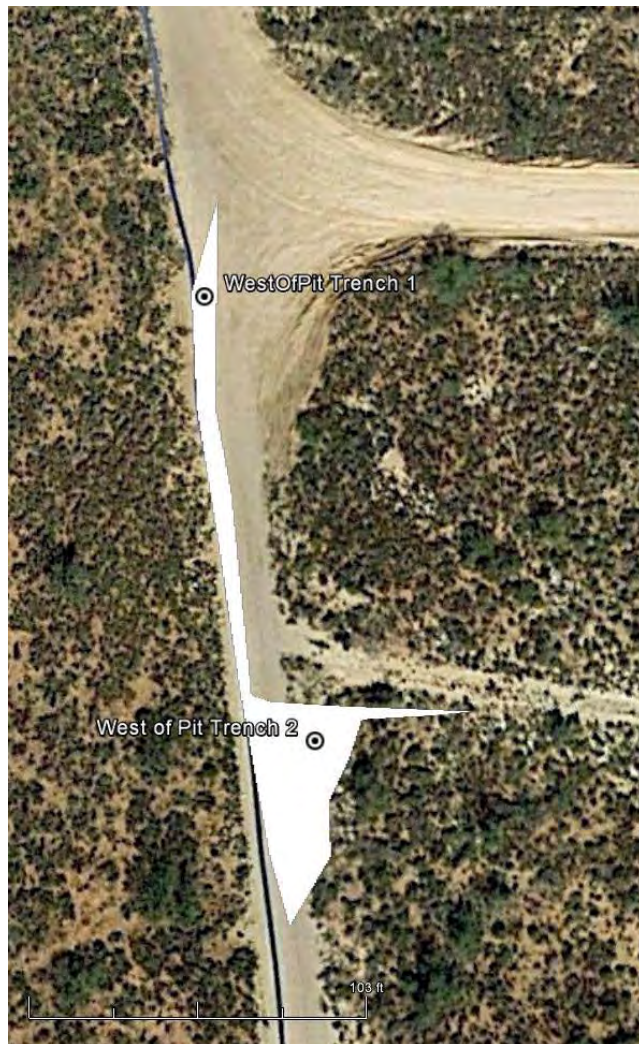
West of Merchant Pit Produced Water Transfer Line Release

Trench 1 is at the source of the release and we expect the deepest sample at 8-10 feet or at hard caliche. Trench 2 is in a pooling area in the pasture near the terminus of the spill footprint and we expect the deepest sample at 6-8 feet. The area of the footprint is about 250 square yards.

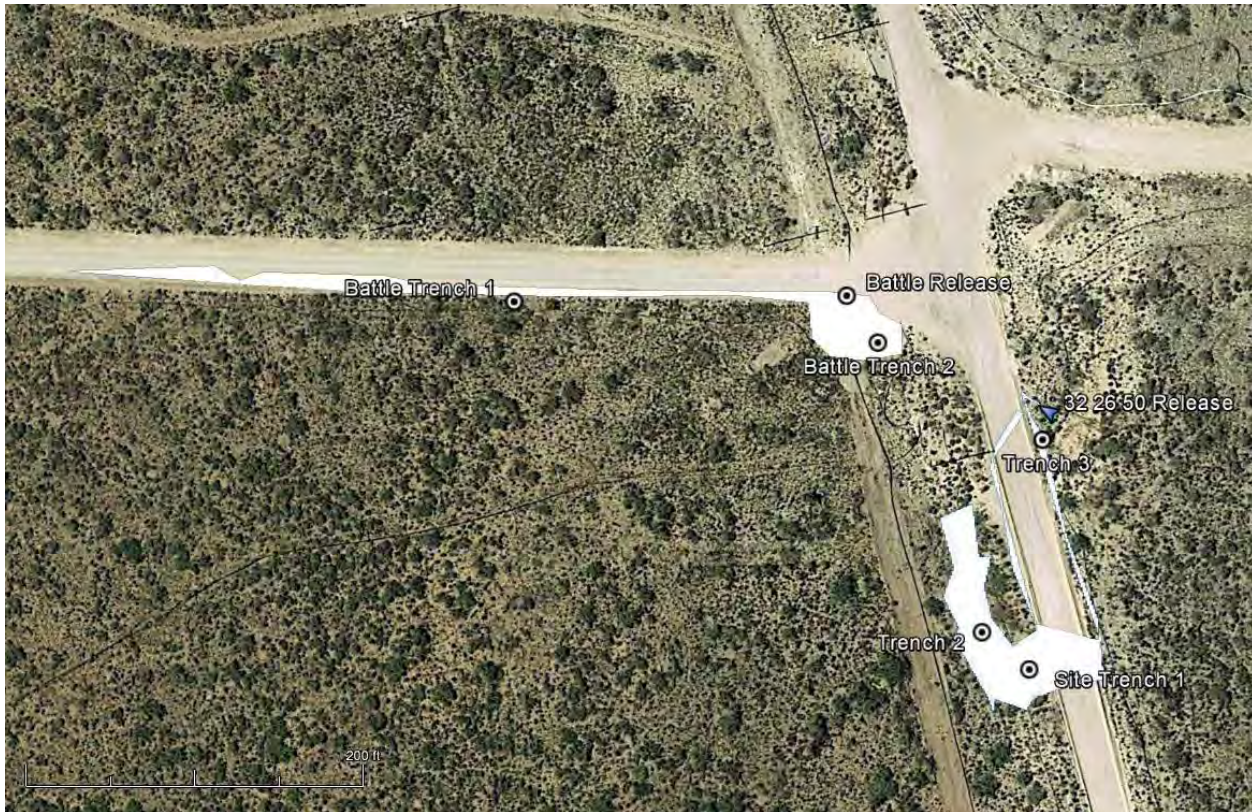
36 22 50 and Battle Produced Water Transfer Line Releases

North is to the right.

The Battle Release consists of three separate incidents and the footprint traced is about 450 square yards. Trench 1 will test the depth of impact at a pooling site next to the road and Trench 2 is a pooling location associated with all three incidents. A third sampling trench location will be selected in the field.

The 32 26 50 Release is a single release incident with an area of flow covering about 500 yards. Trench 1 is at the location of the release at the top of a sand dune. Trench 2 is in a pooling area and Trench 3 is at the terminus of the release just off the road. A fourth sampling trench may collect samples north of Trench 2.
