SUBJECT: UPDATE REPORT FOR INCIDENT 1RP-3771 RED HILLS WEST SWD #001, LEA COUNTY, NEW MEXICO

UPDATED REPORT FOR REVEGETATION OF INCIDENT 1RP-3771

MEWBOURNE OIL COMPANY
RED HILLS WEST SWD #001
API# 30-025-40162
SECTION 16, T26S R32E, NMPM
LEA COUNTY, NM

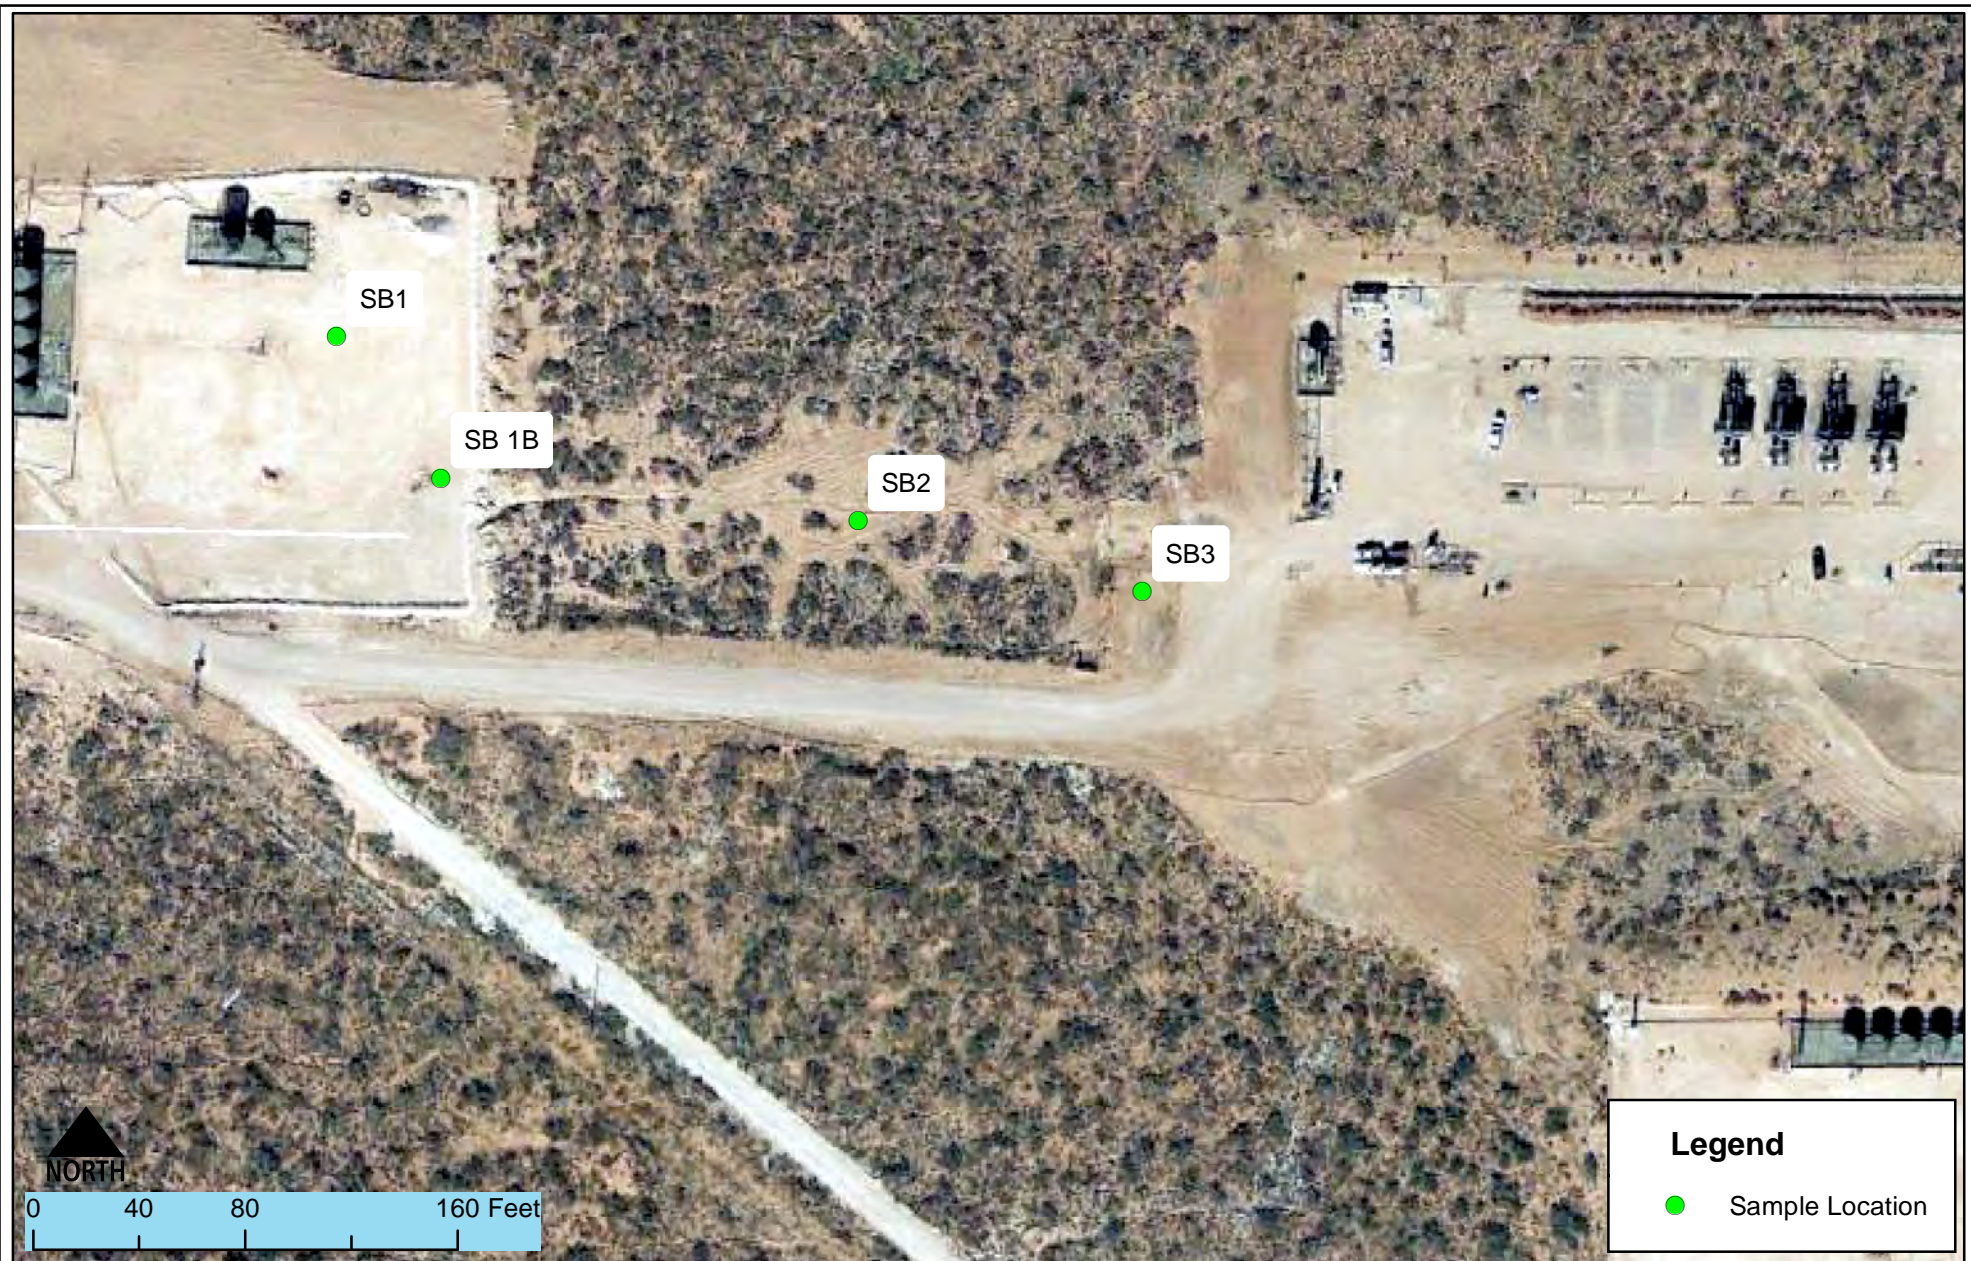
FIGURE 2

The site delineation soil bores were carried to depths of 12 feet below surface grade (bgs). all samples from the surface to four feet below surface grade were found to exhibit only background levels of all contaminants of concern. Specific sample locations for all samples are depicted on Figure 2 (Sample Location Map) along with sampling details. Field screening results are noted in Table 3 in the appendices along with the summary of laboratory analytical results. Samples were collected and processed by SMA field personnel per NMOCD soil sampling procedures and SMA best practices.

All the field samples collected on November 1st 2016 indicated that the salt plume has moved down in the soil profile but there is no evidence of capillary action has returned any chloride to the root zone. The laboratory confirmed field data Figures 2. All raw data is located (Appendix A).

Detailed Sample Map
Mewnourne -Red Hills West SWD
Malaga, New Mexico
