## **PRELIMINARY RESULTS**

Re: Judson AUU State Com #2  
1RP-4826  
30-025-36886  
Section 26, T10S-R34E  
Lea County, New Mexico

EOG Y Resources, Inc. is submitting the enclosed remediation work plan for the above referenced site.

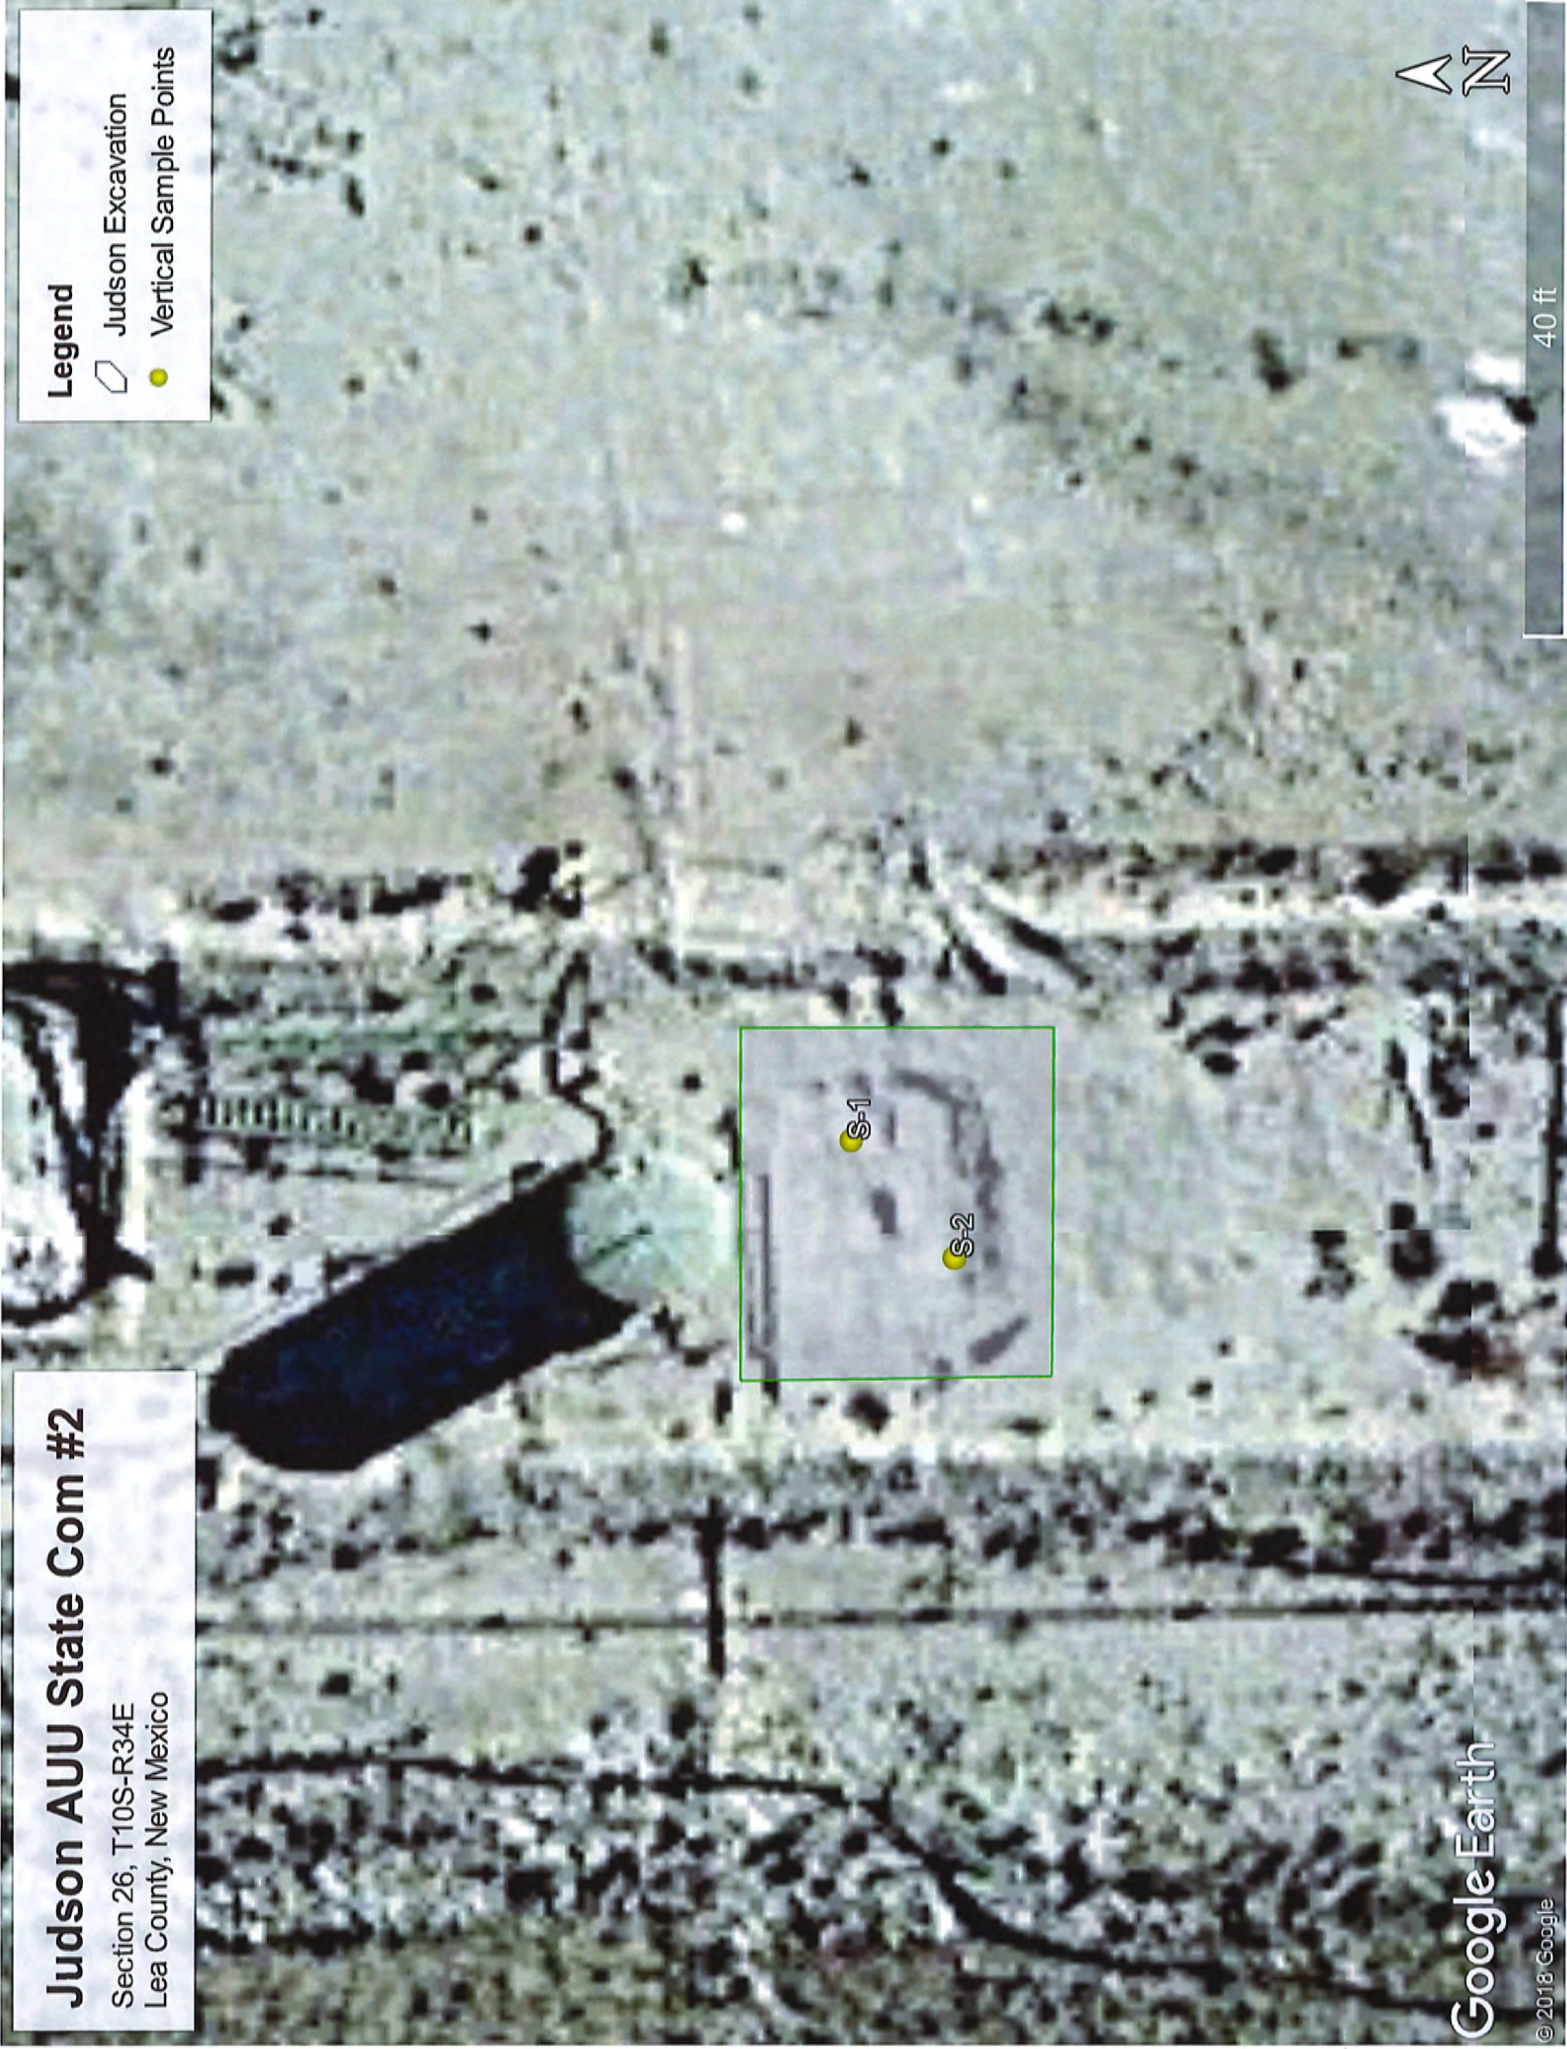
## **Figure 2**

### **Vertical Sample Point(s)**

- Judson Excavation
- Vertical Sample Points

During the sampling (GPS coordinates below), of 2/6/2018, backhoe refusal did not allow EOG Y to sample any further than the point of four (4) feet below surface. Based off of that fact, the enclosed analytical results and the site ranking of zero, EOG Y Resources, Inc. will excavate four (4) feet of impacted soils from the release area to the hardpan caliche layer. A six (6) inch layer of clean native or like soil will be placed in the bottom of the excavation to cushion a 20 millimeter synthetic liner, this will protect the liner from puncture or damage. The excavation will then be backfilled with approximately 42-46 inches of clean native or like soil to be slightly above grade to allow for settling. The soils initially excavated that were stockpiled on plastic will be taken to an NMOCD approved facility.
