## **REMEDIATION SUMMARY AND SITE CLOSURE REQUEST**

**Plains Pipeline, L.P.**  
**COG Boone 16 2H**  
**LEA COUNTY, NEW MEXICO**  
**UNIT LETTER "O", SECTION 16, TOWNSHIP 21 SOUTH, RANGE 33 EAST**  
**GPS: N 32.47246° W 103.57525°**  
SRS #: 2018-032  
NMOCD Reference: 1RP-4965

May 2018

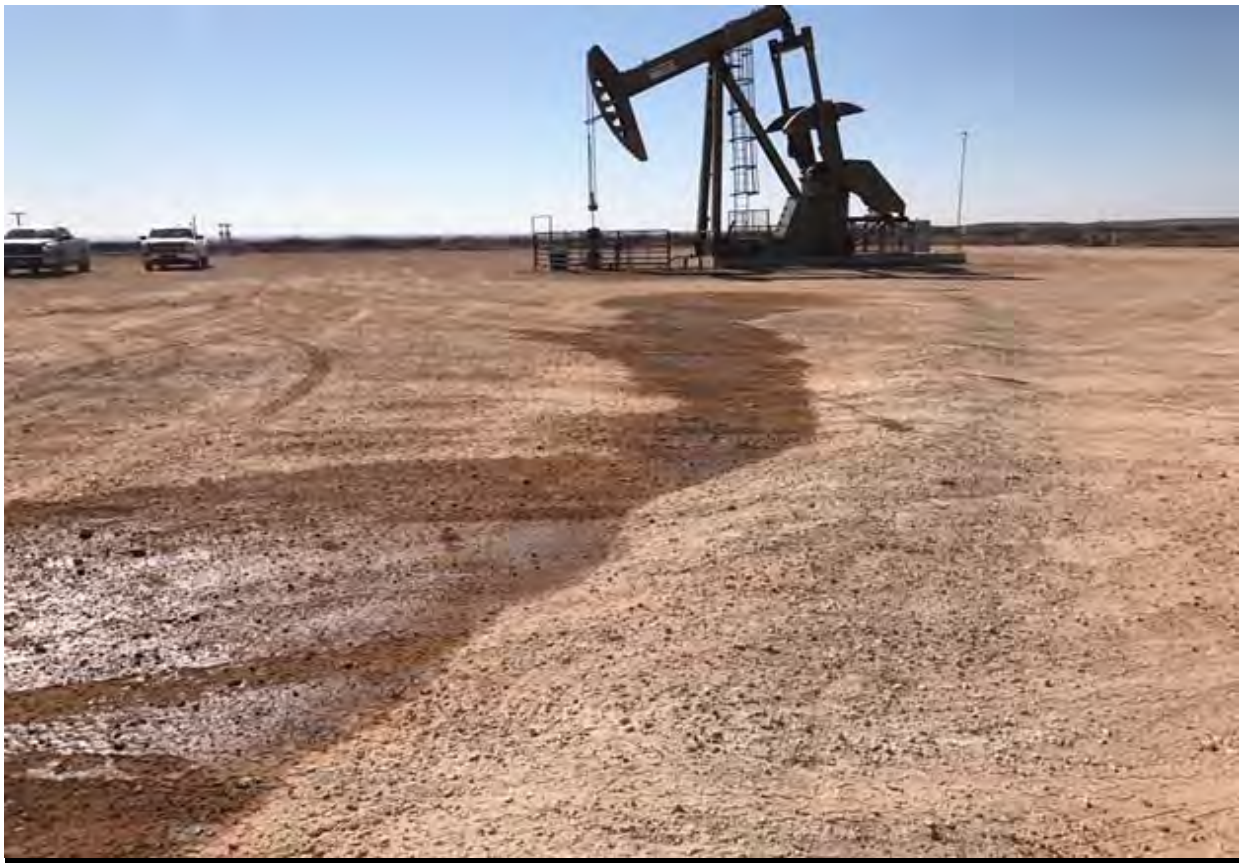
**Figure 1** - View of surface staining from the initial release, facing South.

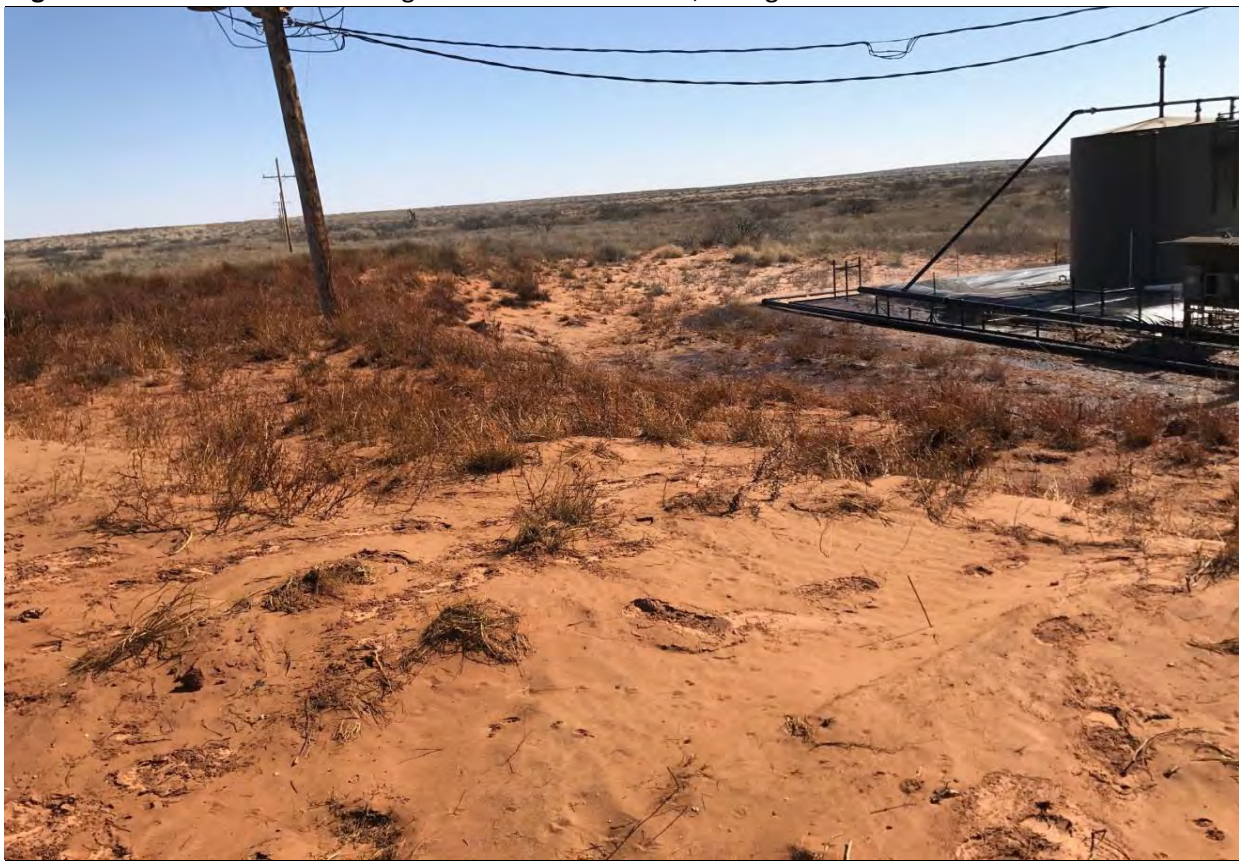
**Figure 2** - View of surface staining from the initial release, facing Southeast.

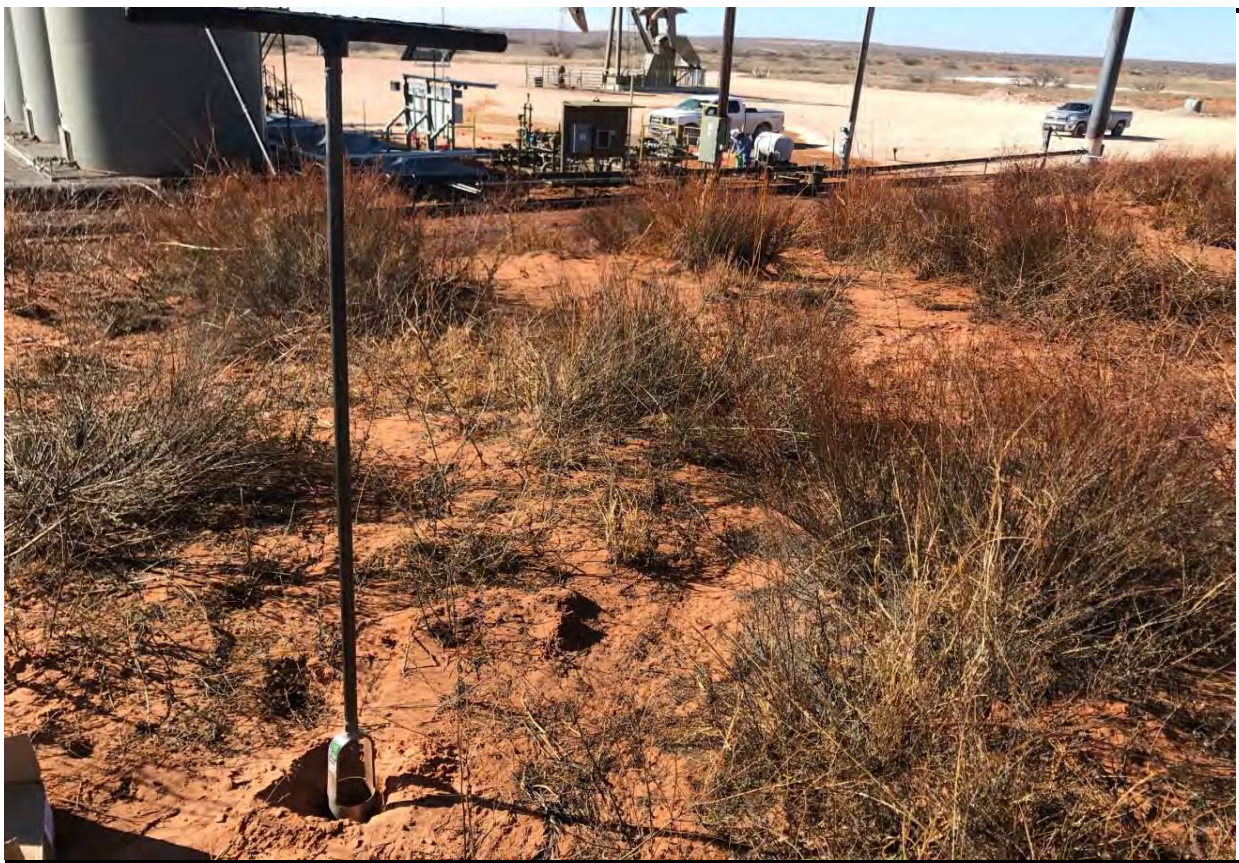
**Figure 3** - View of surface staining from the initial release, facing Southwest.

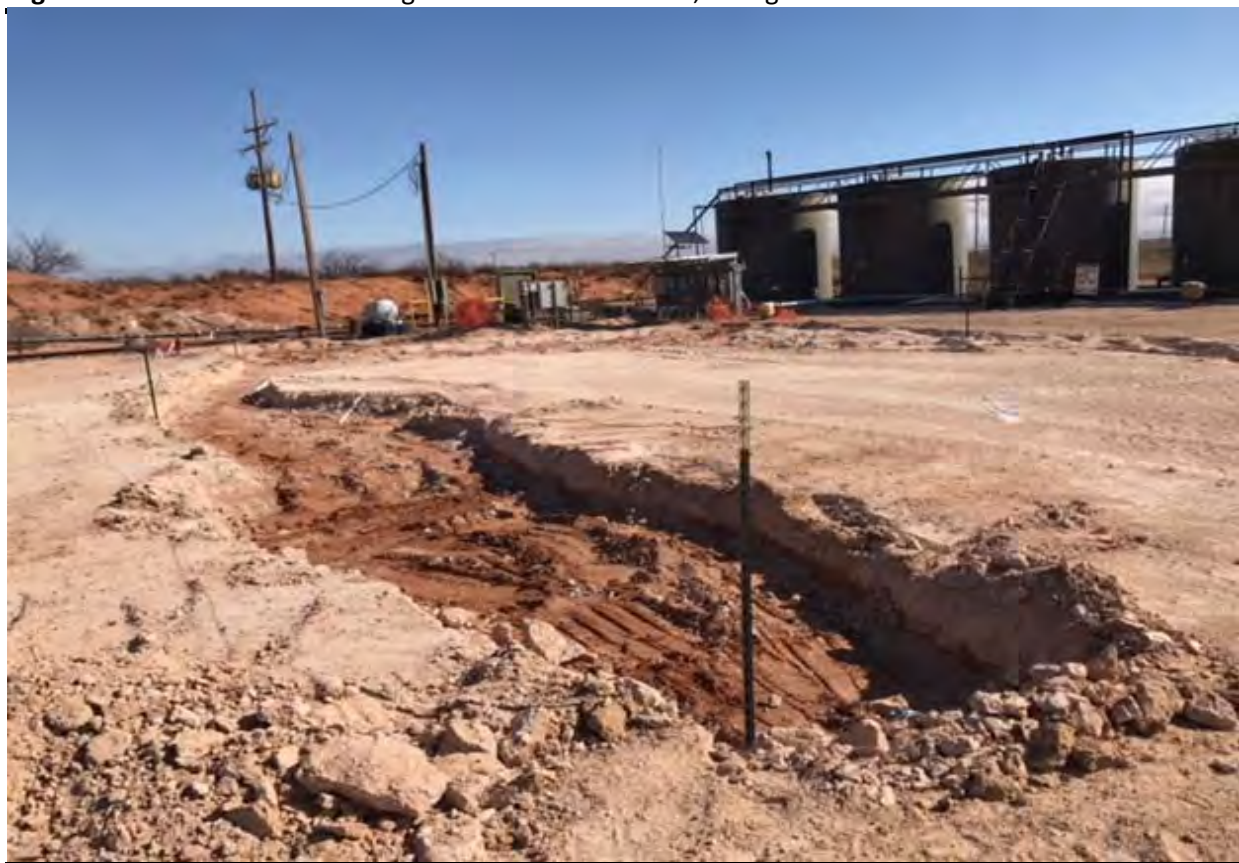
**Figure 4** - View of portion of the excavated area, facing Northeast.

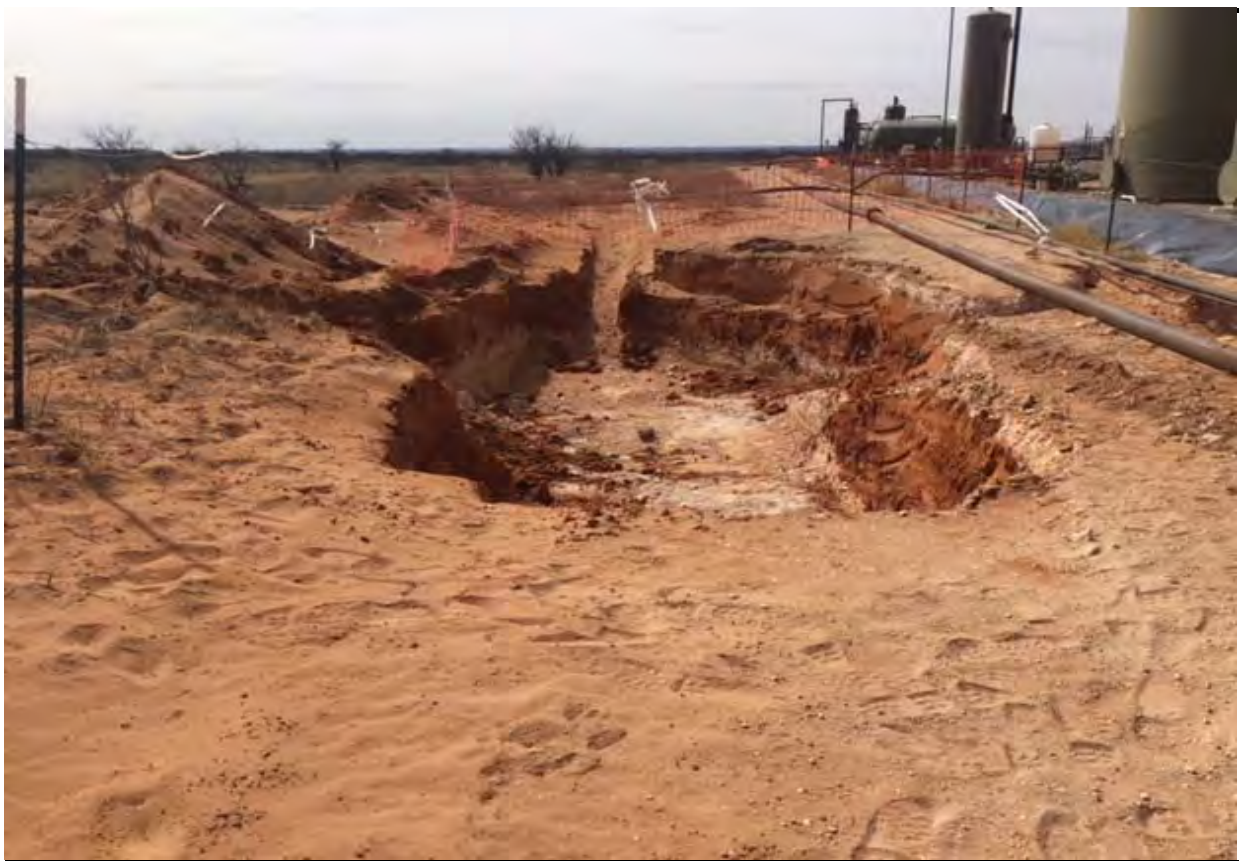
**Figure 5** - View of portion of the excavated area, facing South.

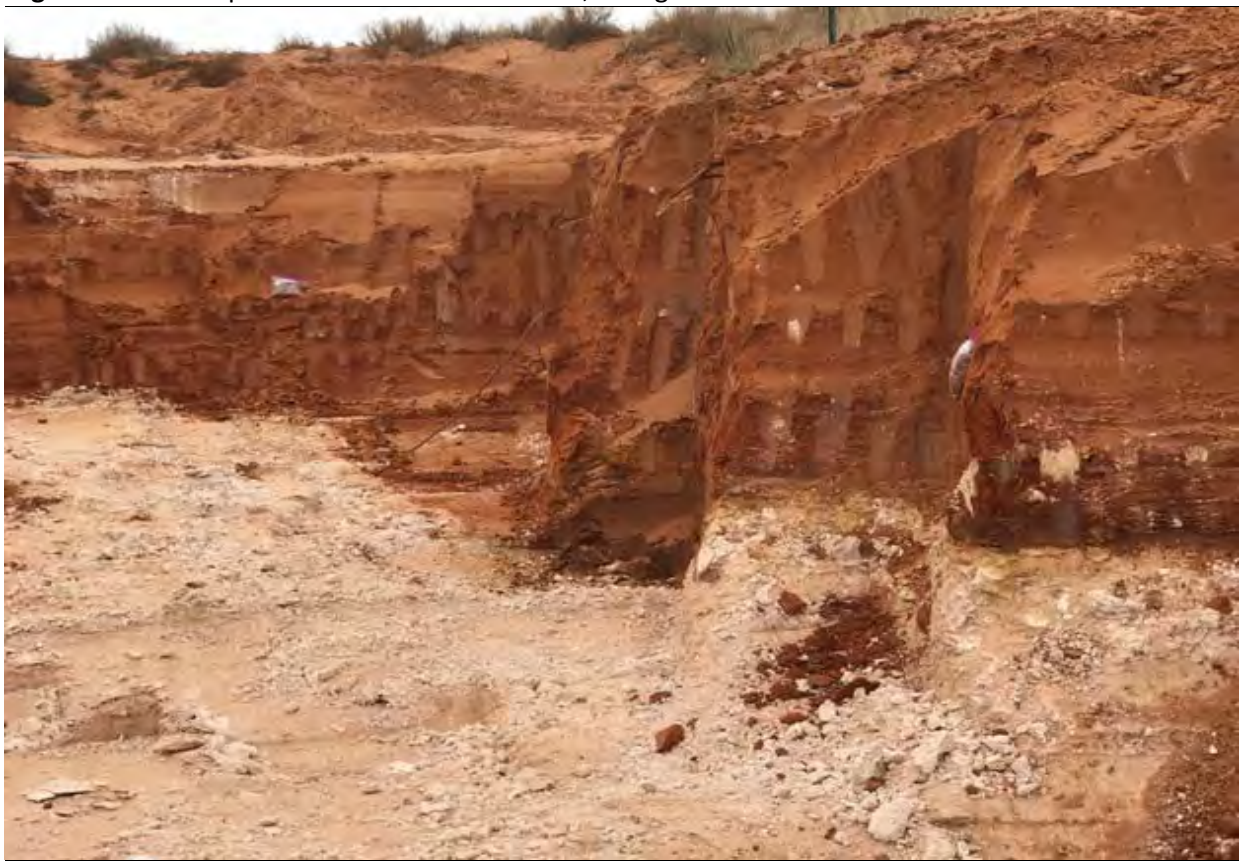
**Figure 6** - View of portion of the excavated area, facing South.

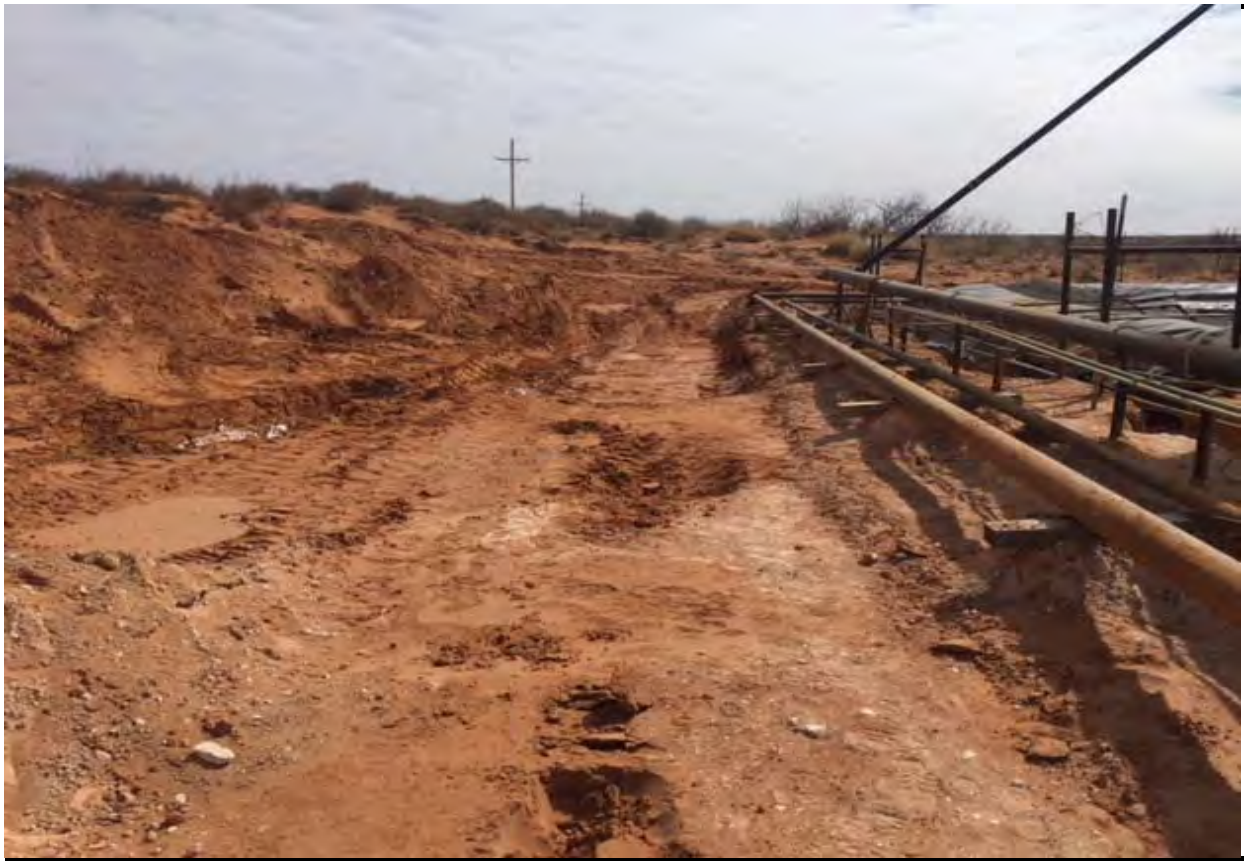
**Figure 7** - View of portion of the excavated area, facing East.

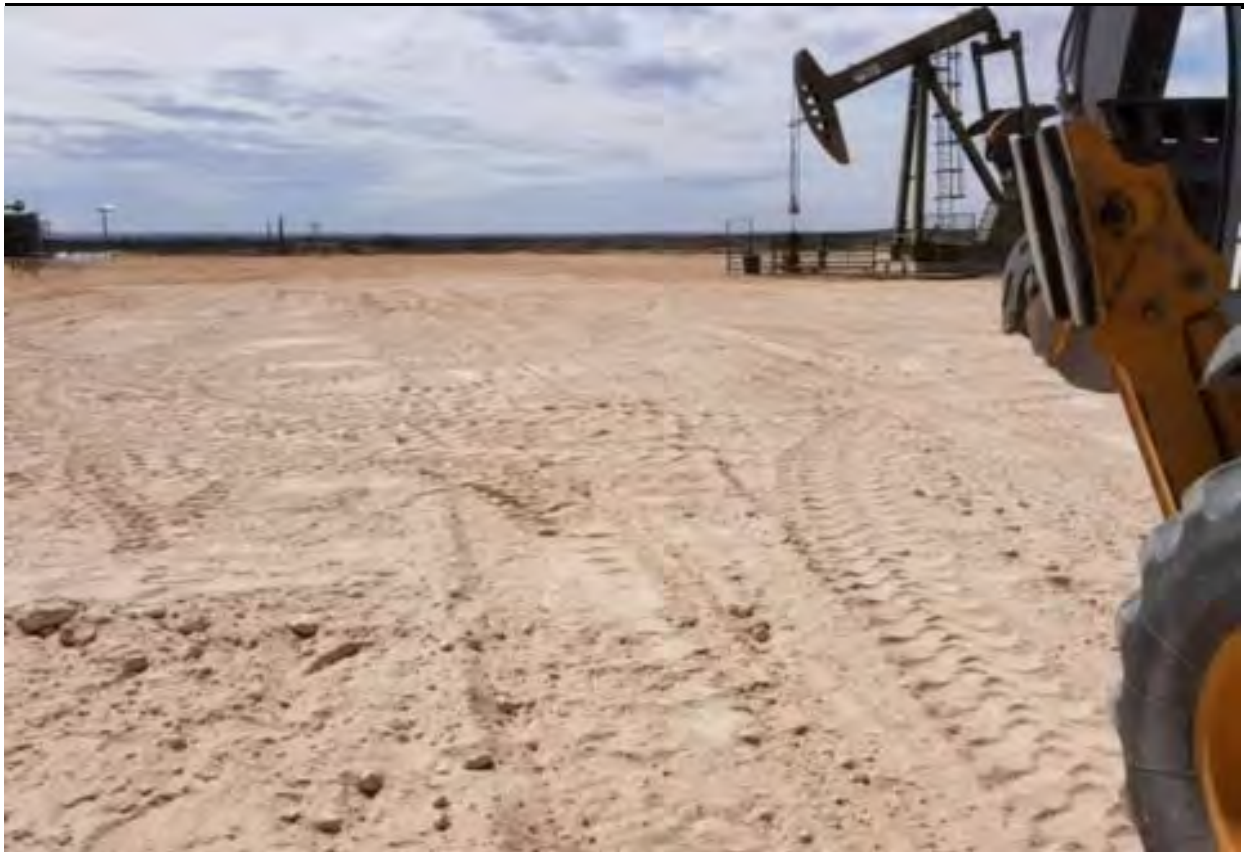
**Figure 8** - View of the affected area after remediation activities, facing South.

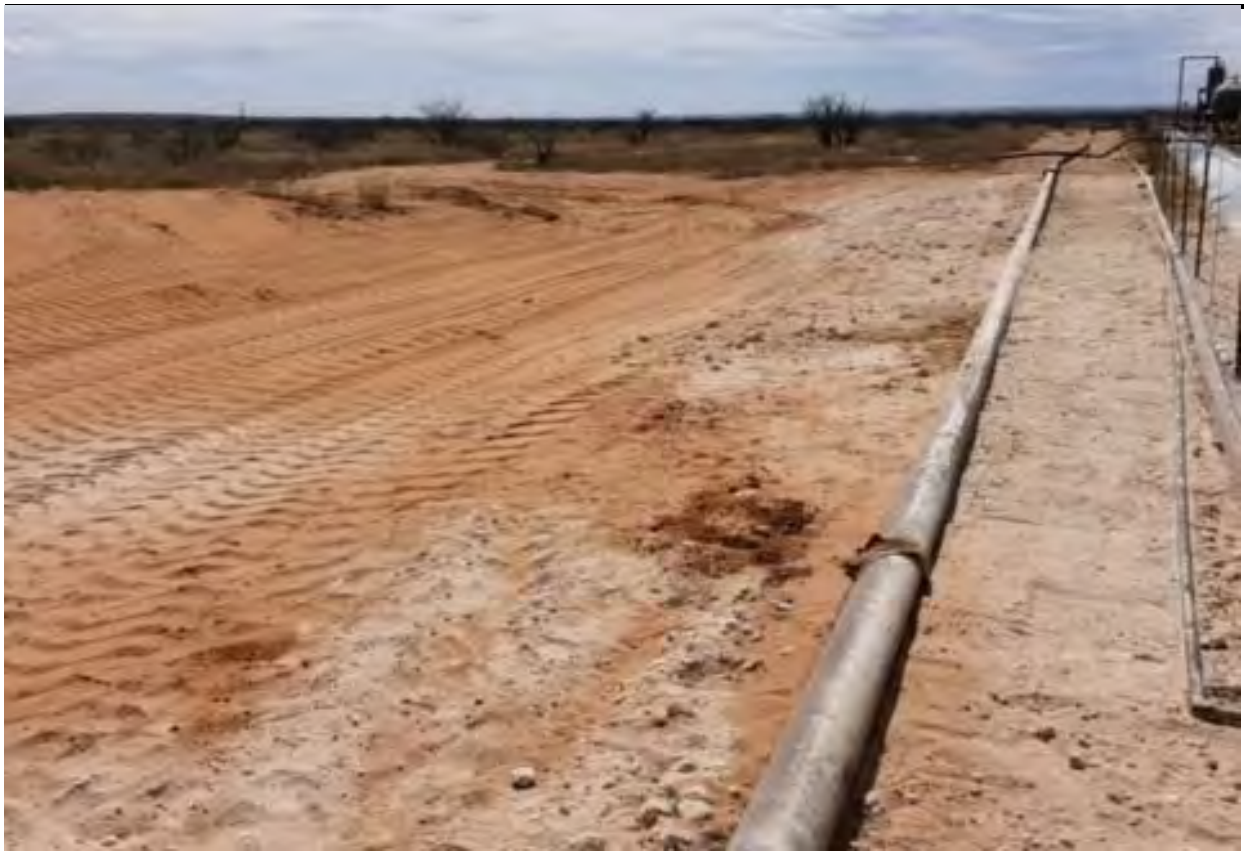
**Figure 9** - View of the affected area after remediation activities, facing South.

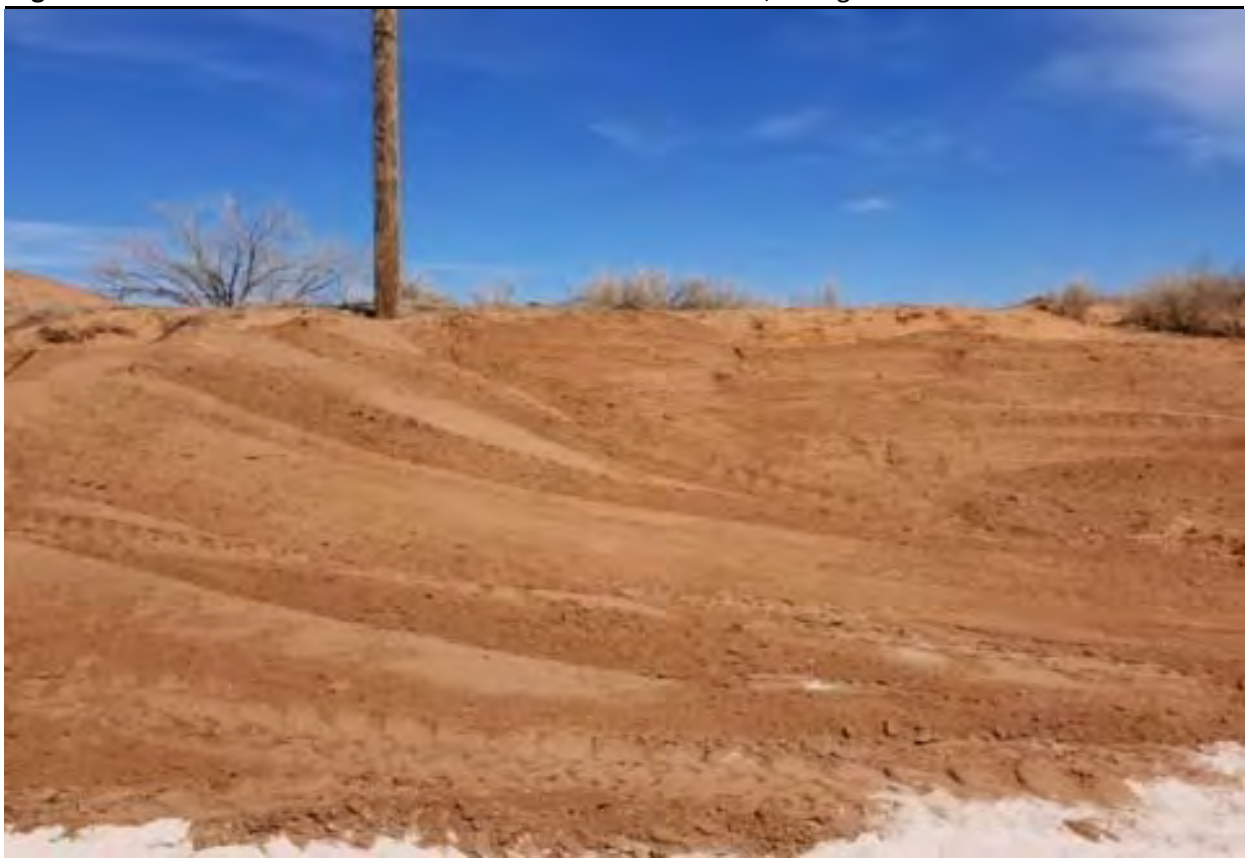
**Figure 10** - View of the affected area after remediation activities, facing Northeast.
