RE: Purvis Operating Antelope #001 Site Characterization Report and Remediation Plan
API: 30-025-38867. Unit A, 7, T15S. R35E. Lea County, NM
1RP-4896 & 1RP-4925

Purvis Operating Company
Antelope #001

December 2017/January 2018 Initial Response

April 2018 Characterization

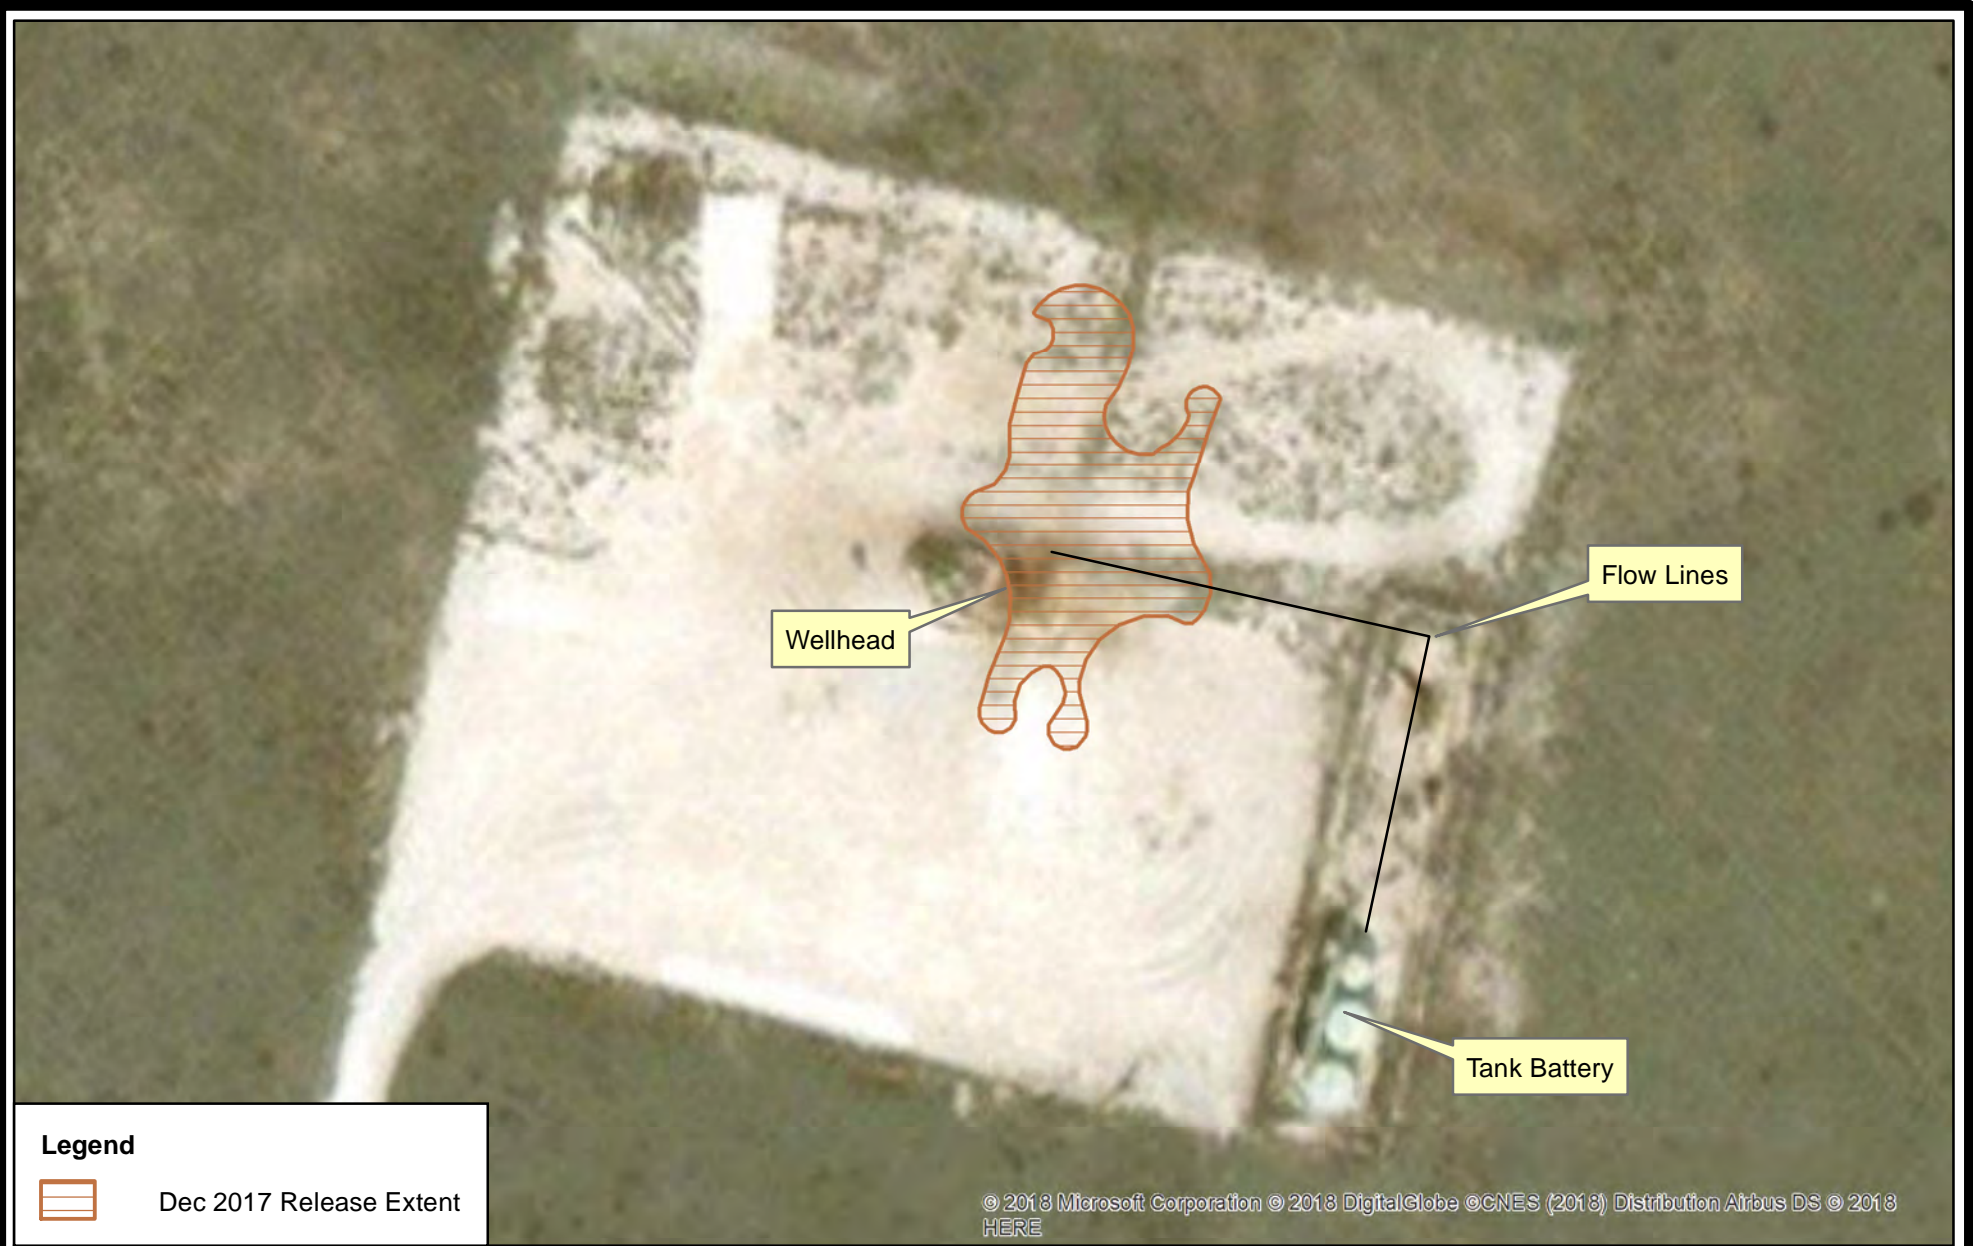
Release Extent Mapped on Jan 10th, 2018

- Removal of materials beneath the footprint of the January 25 release to a depth of 2-feet or extent practical; whichever is less. We estimate the extent practical at 9-inches to 1-foot due to the hard caliche observed during drilling and past restoration activities. Our past observations also documented that the depth of penetration of crude stopped within the upper 5-inches of the hard caliche. Assuming a 9-inch removal depth, total volume of removed material will be approximately 4,405 cu. ft (=5874 sq ft x 0.75 ft). Plate 10 shows the release extent.
- Replace with clean, uncontaminated material.

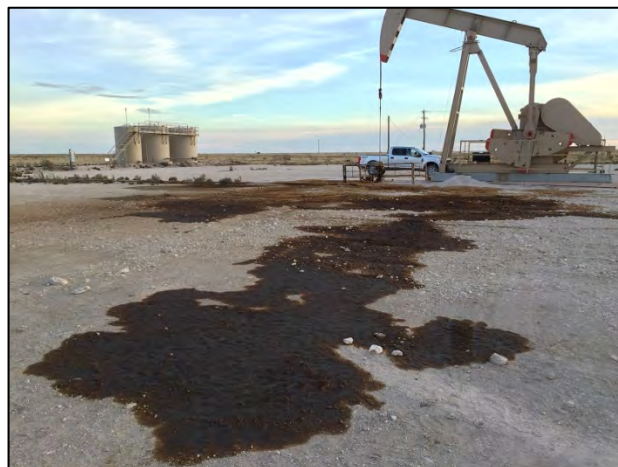
On January 8th and 10th, 2018; Andrew Parker of R.T. Hicks Consultants was on-site to inspect the December 18th release (Figure A-1 & Plate 10). During our January 10th inspection, we collected surface soil samples at 3-inches below grade. As shown in Figure A-2, below, at 3-inches below grade no hydrocarbon staining was observed. We elected not to submit the surface samples for laboratory testing and to collect samples the following day (January 11th) after the impacted area was excavated.

Figure A-1: Photo of the Dec. 18, 2017 release as observed on Jan. 8th 2018. Photo is viewing south-southwest.

On January 11th, the December 18th release was excavated to a depth of 0.5 feet – the extent of visual hydrocarbon impairment. The excavated soil, along with the stockpiled soil from the December 7th release, was hauled off-site for proper disposal. The excavated area was backfilled with clean caliche.

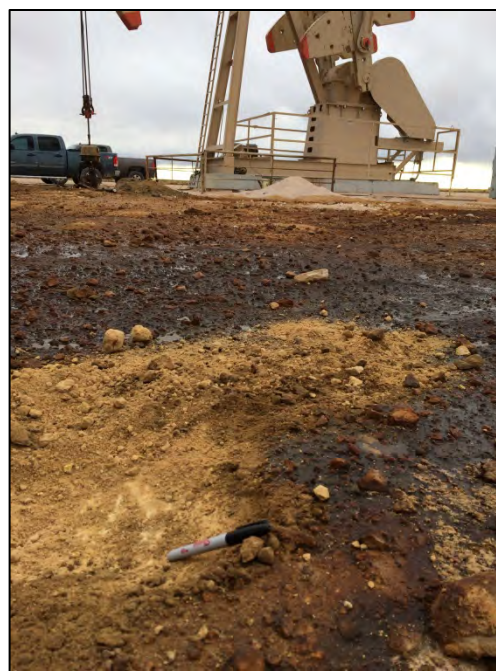
Figure A-2: No visual impairment at 3-inches below grade from the Dec. 2017 Release. (Jan 11th 2018)

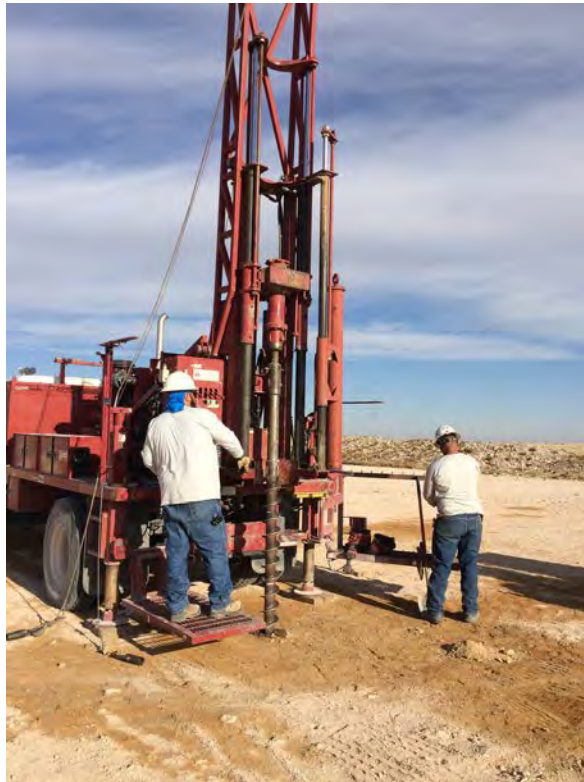
The boring within the area of the highest potential of liquid pooling (SB-Central) vertically delineated the release. Soil samples were collected vertically every 2 feet from the surface to 4 feet bgs; then every 5 feet to total depth. Vertical delineation ceased at 11 feet when:

Photo 1: Drilling at SB-Central, the area where release pooling was observed.

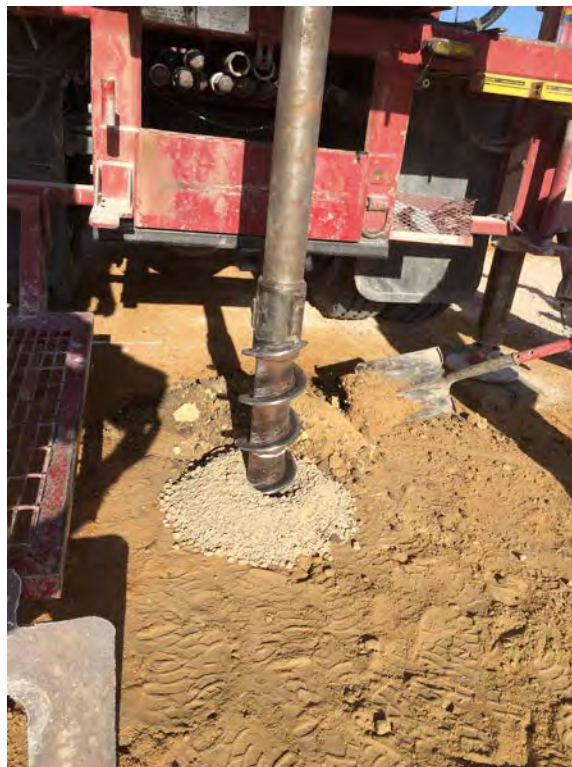
Photo 2: Drilling at SB-West at a depth of 3 feet.

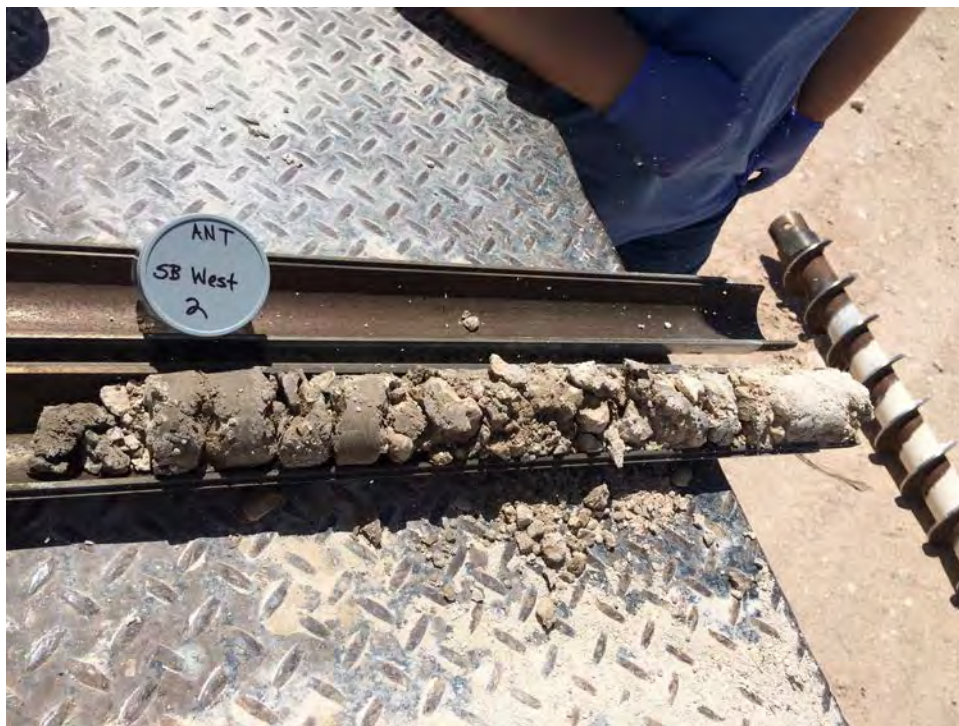
Photo 3: SB-West. Spilt spoon sample from 0.5-feet (left) to 2-feet (right). Interface of weathered hydrocarbon caliche is present in the upper two feet of soil column.

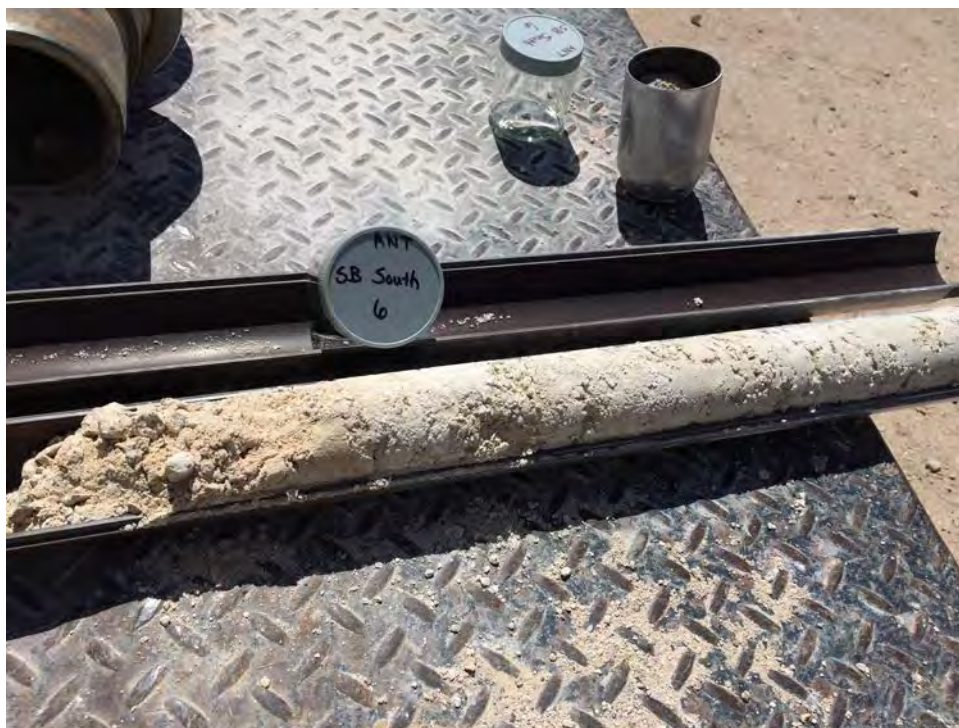
Photo 4: SB-South. Spilt spoon sample of caliche from 4-feet (left) to 6-feet (right).

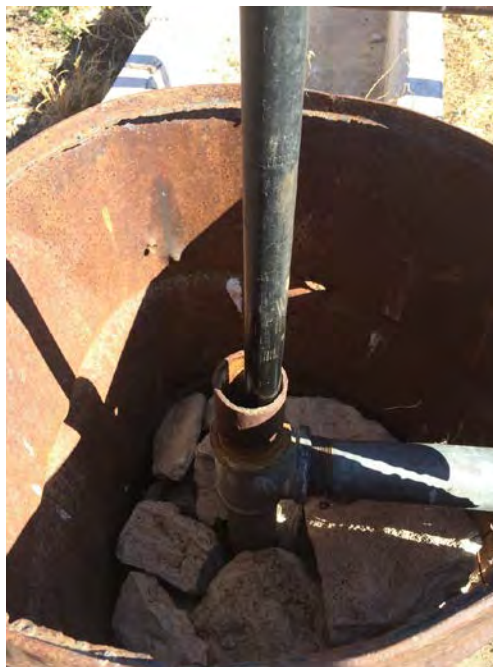
Depth to water at a nearby windmill located approximately 900 feet southeast (down gradient) of the release measured 50.28 feet in 1996 (USGS-13551; Plate 1) with an average depth to water at 51.03-feet between 1961 and 1996. Since 1961, the depth to water in the windmill has been greater than 50 feet with the exception in 1976, when the depth to water was 49.17 feet. Figure B-1 and Table B-1 shows measured water levels in the windmill since USGS started gauging the well. During our April 2018 characterization, we attempted to gain access to the USGS-13551 well (Figure B-2) to obtain a current groundwater measurement. We meet with the ranch manager to tour the well. The water well is operational but there was no access port to obtain a groundwater measurement.

Figure B-2: Photo of USGS Well-13551. Access to obtain a depth to water measurement was limited.
