PRELIMINARY RESULTS

June 26, 2018

Re: Remediation Summary and Permission to Backfill Request
Phillips State #001 (IRP-4883)
GPS: N 32.4744949° W 103.3875351°
Unit Letter "O", Section 17, Township 21 South, Range 35 East
Lea County, New Mexico

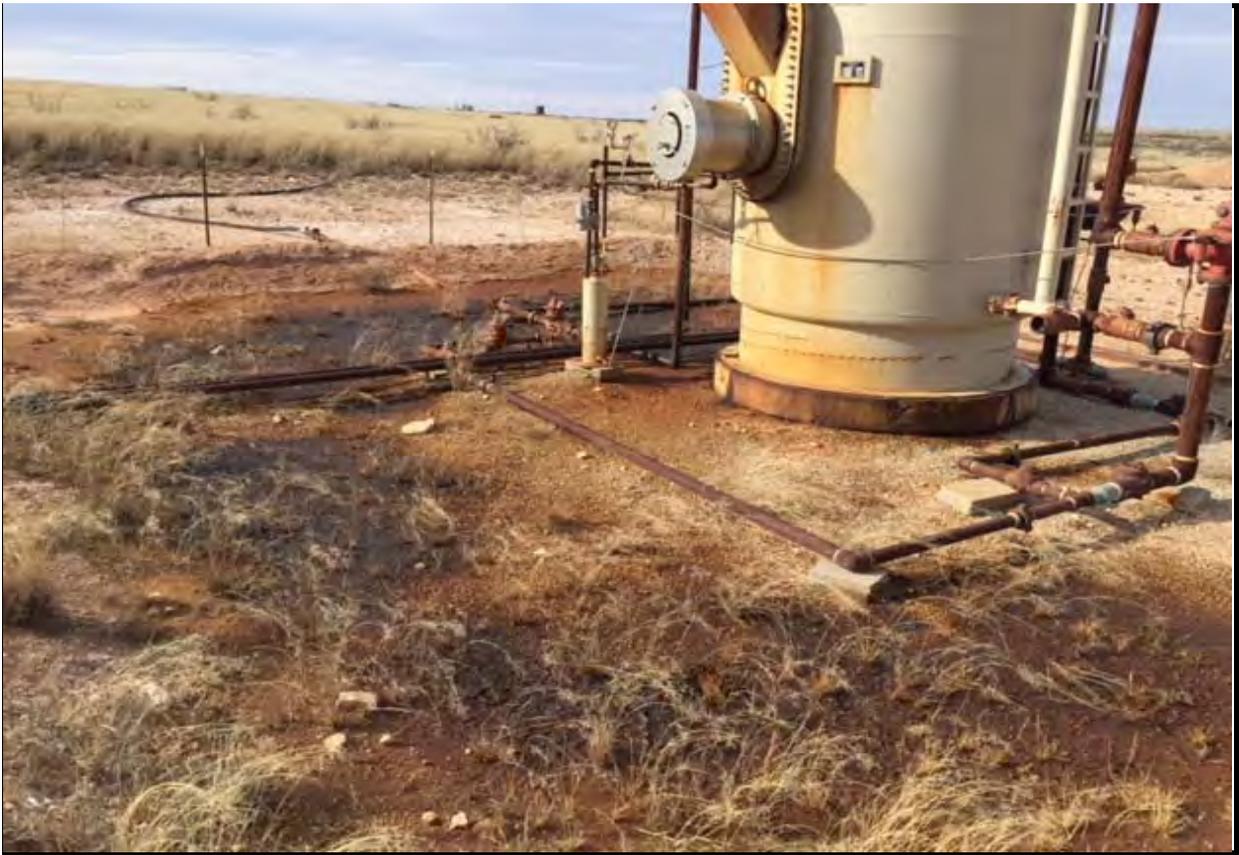
Figure 1 - View of the affected area, facing northwest.

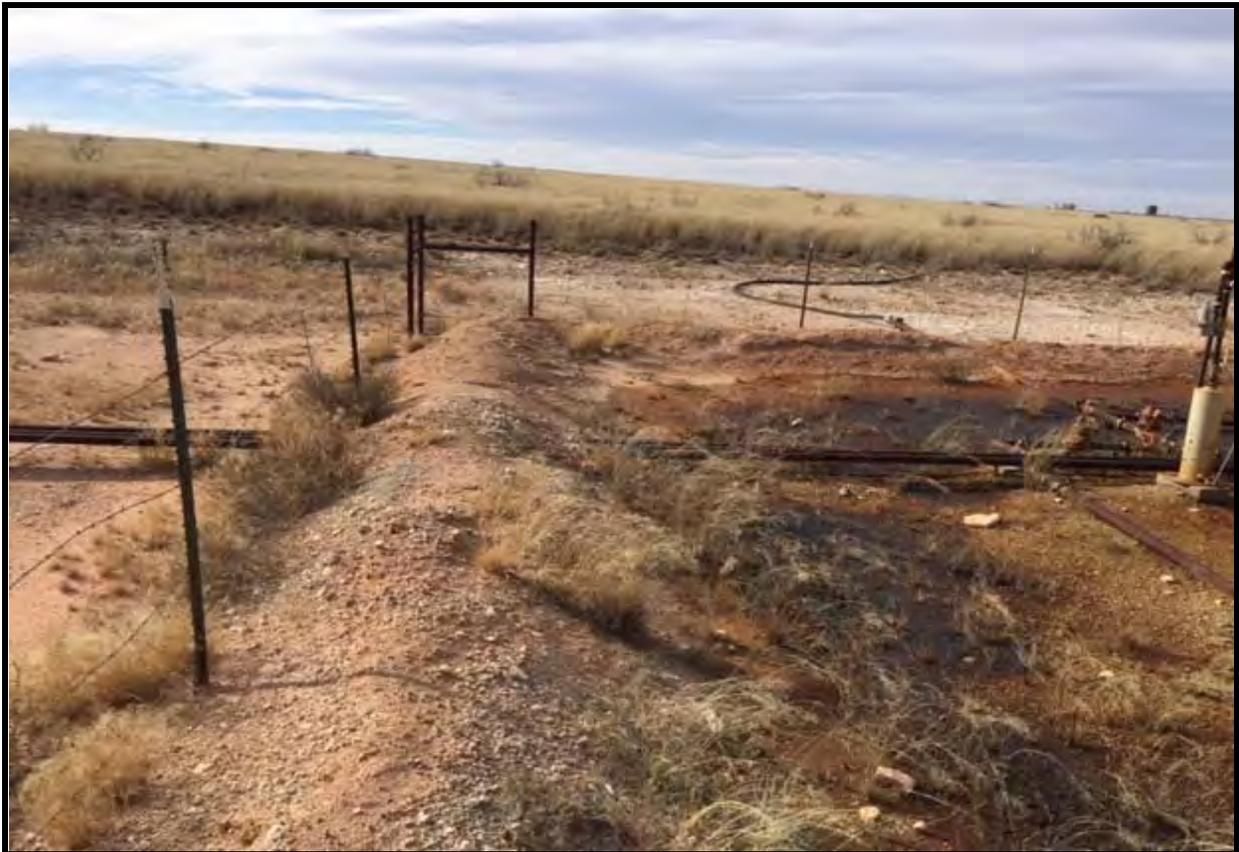
Figure 2 - View of the affected area, facing west.

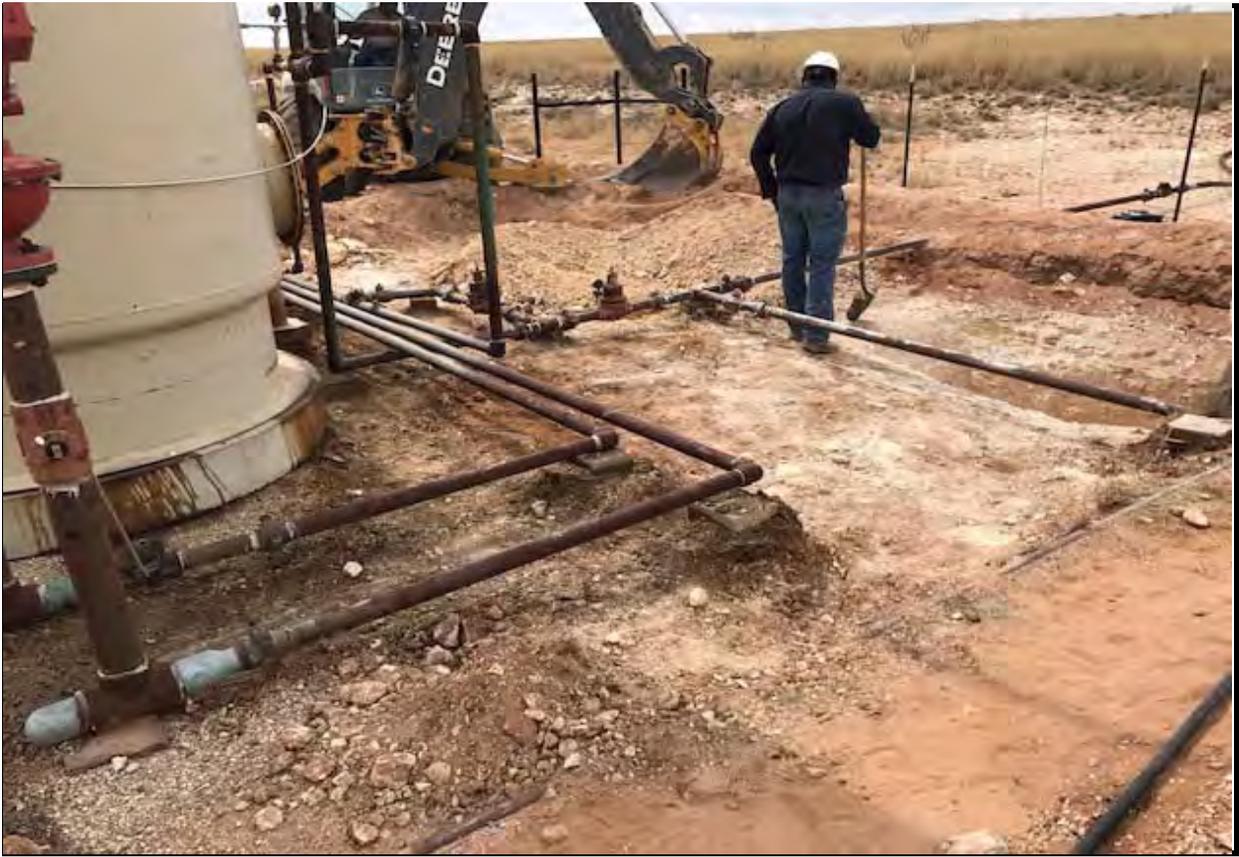
Figure 3 - View of portion of the excavated area, facing southwest.

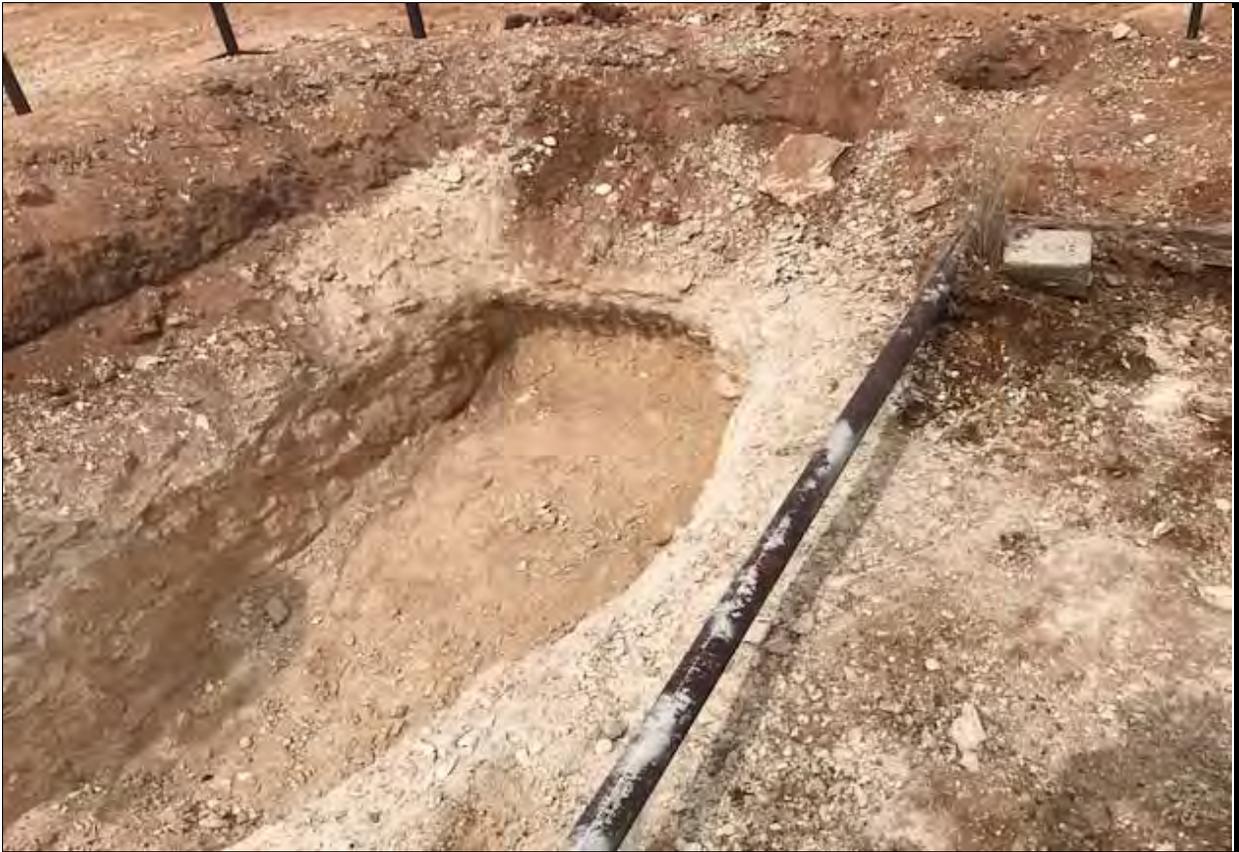
Figure 4 - View of portion of the excavated area, facing north.

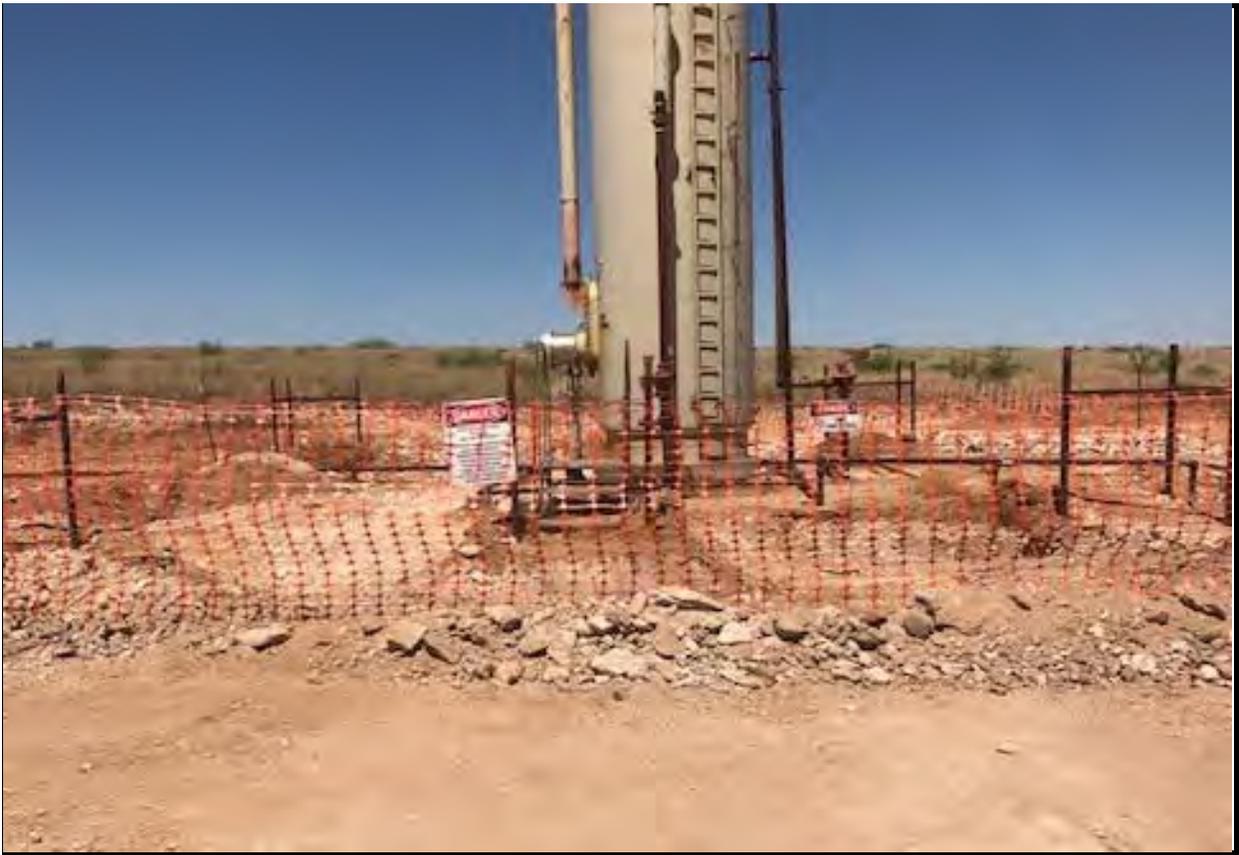
Figure 5 - View of portion of the excavated area, facing west.
