Disclosure Report

RICE OPERATING COMPANY
JUNCTION BOX DISCLOSURE* REPORT
BOX LOCATION

SWD SYSTEM	JUNCTION	UNIT	SECTION	TOWNSHIP	RANGE	COUNTY	BOX DIMENSIONS - FEET		
Blinebry-Drinkard (BD)	L-8 EOL	L	8	21S	37E	Lea	Length - n/a	Width - n/a	Depth - n/a
							same location

BD L-8 EOL

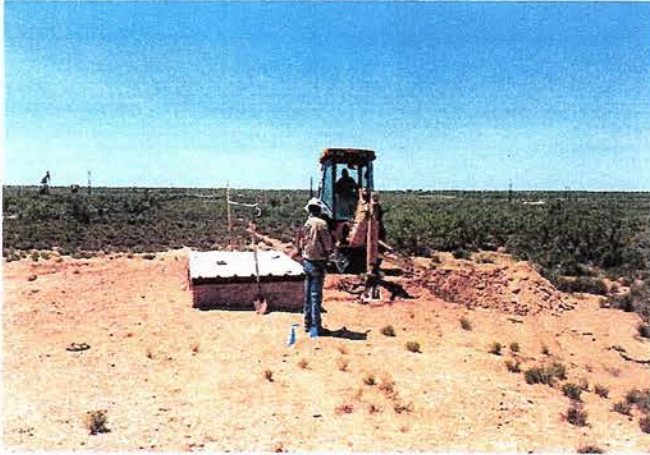
Current box with vertical excavated to the west,
facing south 6/21/2017

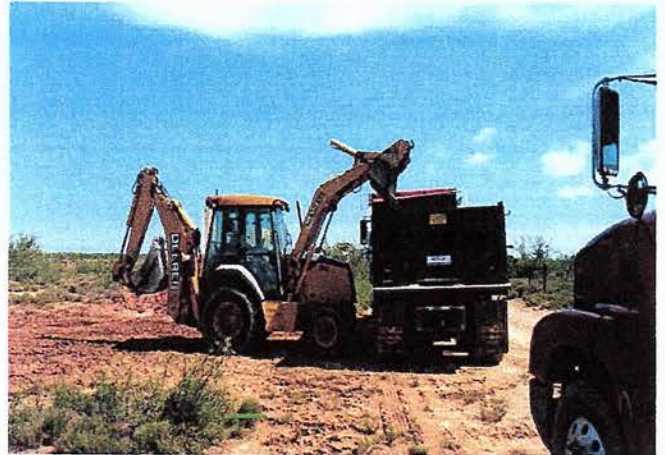
Exporting excavated soil,
facing north 6/26/2017

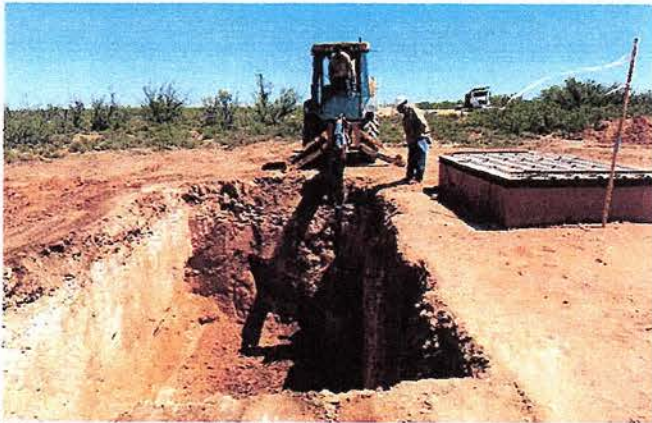
Excavating and collecting soil samples,
facing north, 6/27/2017

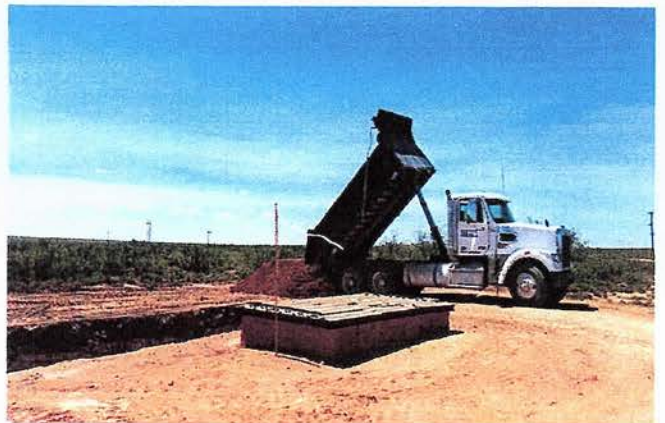
Importing soil,
facing northwest 6/27/2017

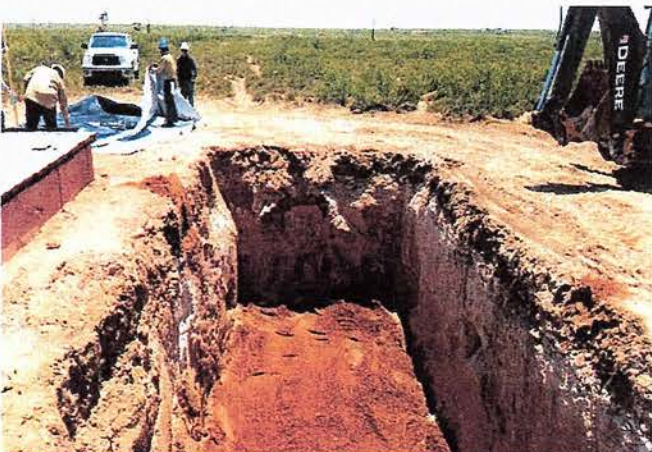
6 inch pad of imported soil,
facing south 6/28/2017

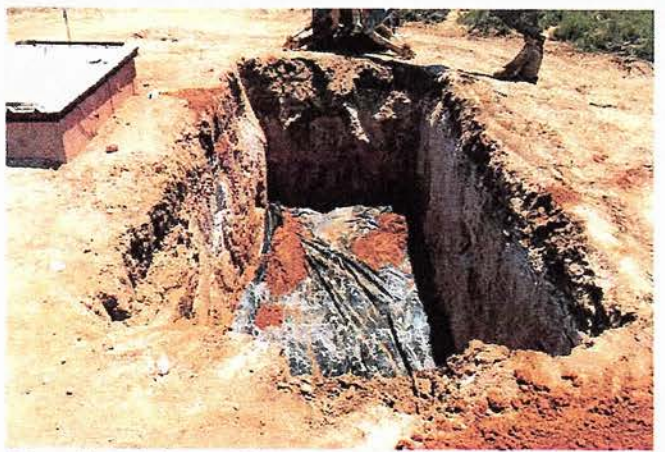
20-mil, reinforced liner installed at 11.5 ft bgs,
facing south 6/28/2017

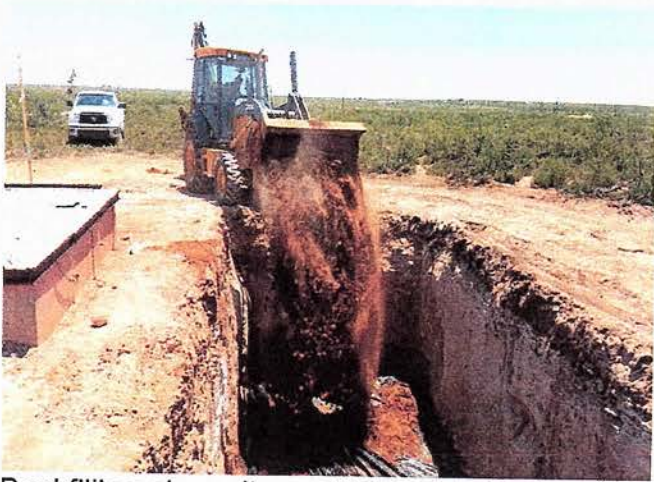
Backfilling above liner with imported soil,
facing south 6/28/2017

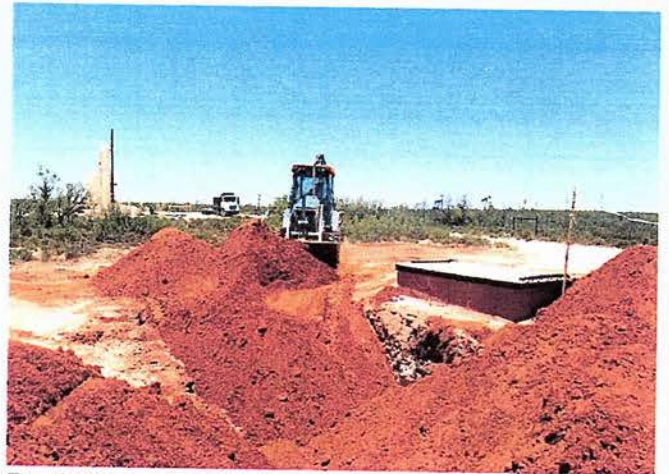
Backfilling excavation,
facing northeast 6/29/2017

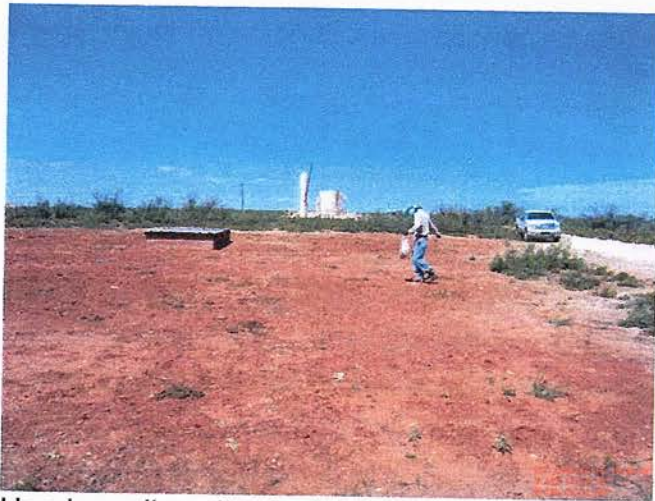
Hand seeding site, facing north 9/15/2017

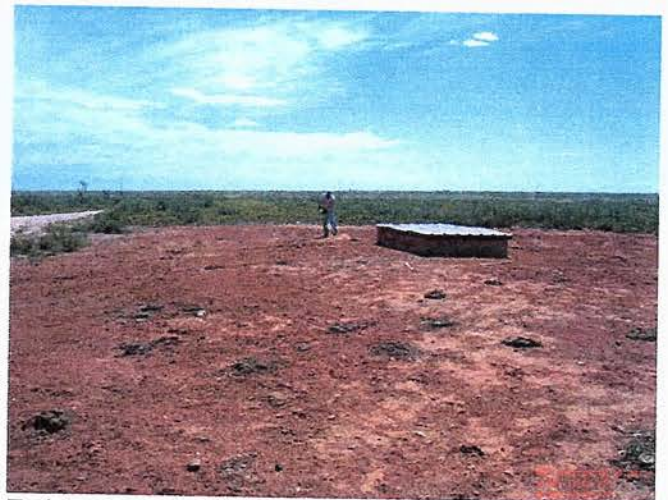
Raking in the seed,
facing southwest 9/15/2017

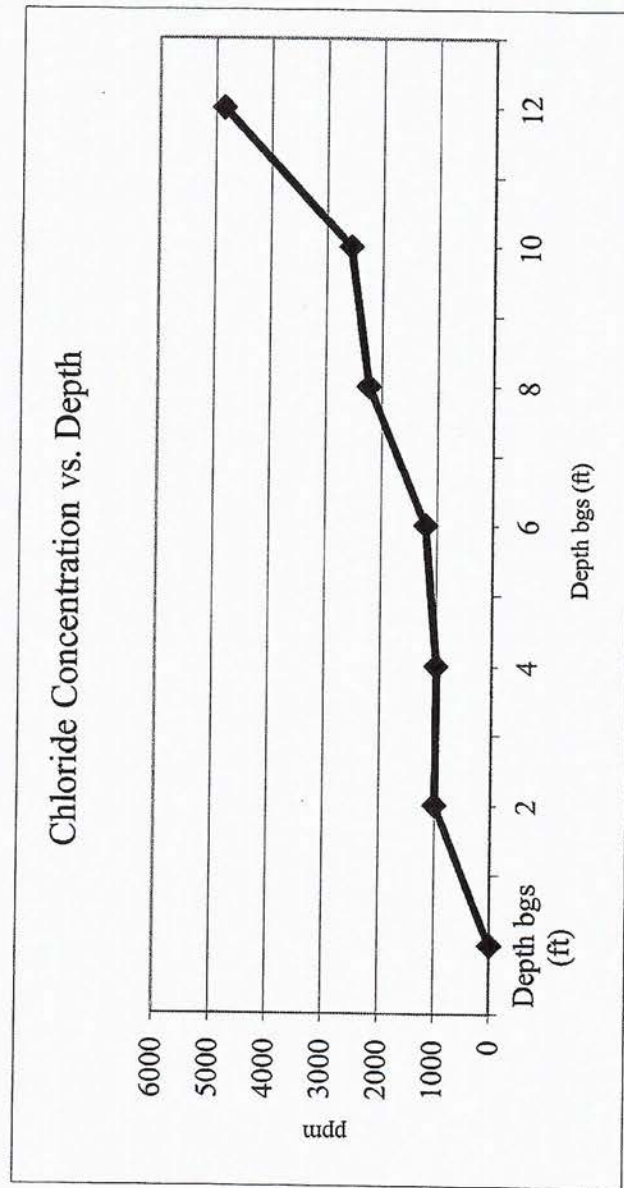
CHLORIDE CONCENTRATION CURVE

Backhoe samples at 15' west of junction

Depth bgs (ft)	[Cl ⁻] ppm
2	1,001
4	991
6	1,204
8	2,234
10	2,571
12	4,852

Groundwater = 79 ft
