**RE: Corrective Action Plan (CAP) Report and Soil Closure Request
Rice Operating Company – BD SWD System
BD L-36 EOL (1R426-278): UL/L, Sec. 36, T21S, R37E**

CAP Report and Soil Closure Request

Liner Installation

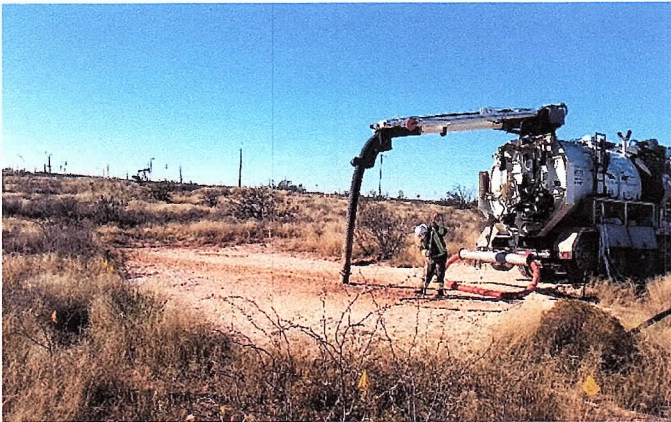
Spotting lines with hydrovac,
facing southwest

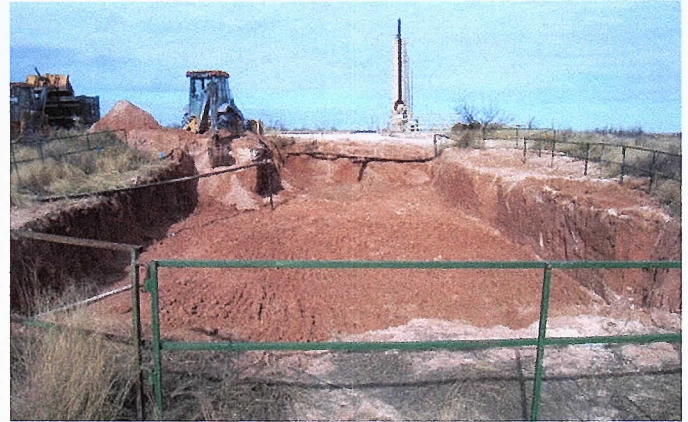
Excavating the site to 5 ft bgs,
facing north

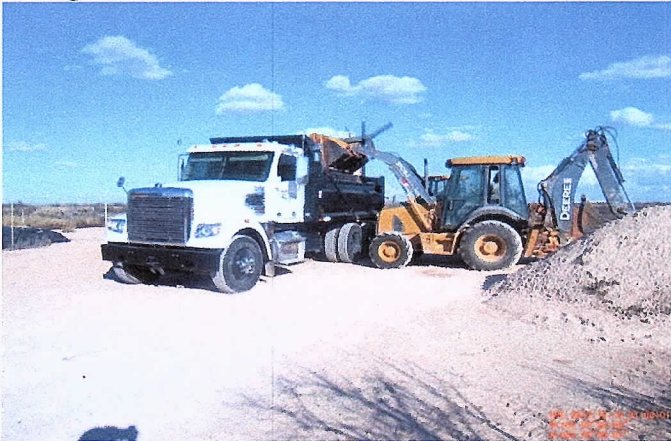
Exporting excavated soil,
facing northeast

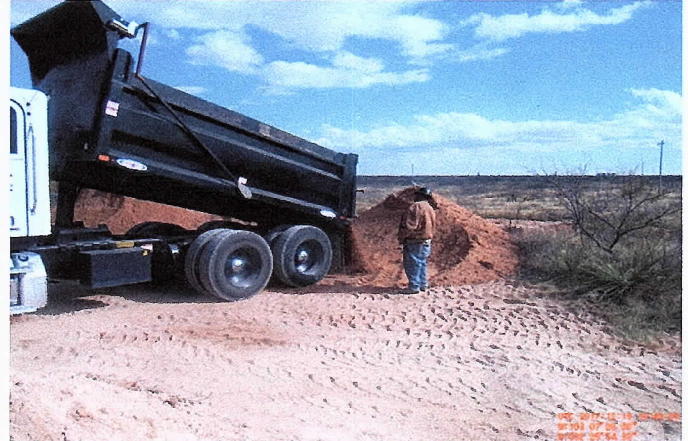
Importing blow sand,
facing south

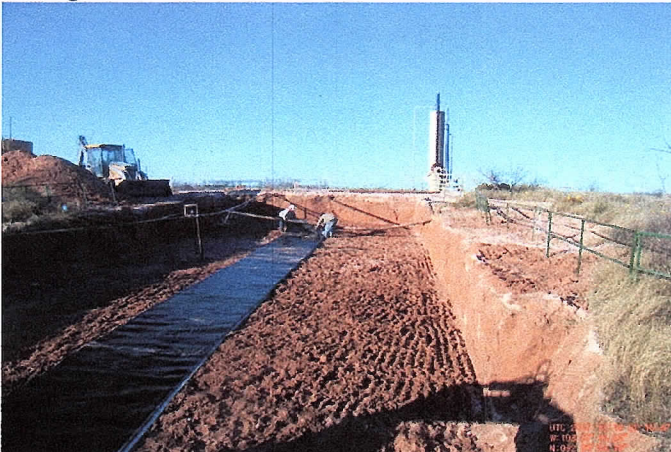
Installing 20-mil, reinforced liner at 4.5 ft bgs,
facing north

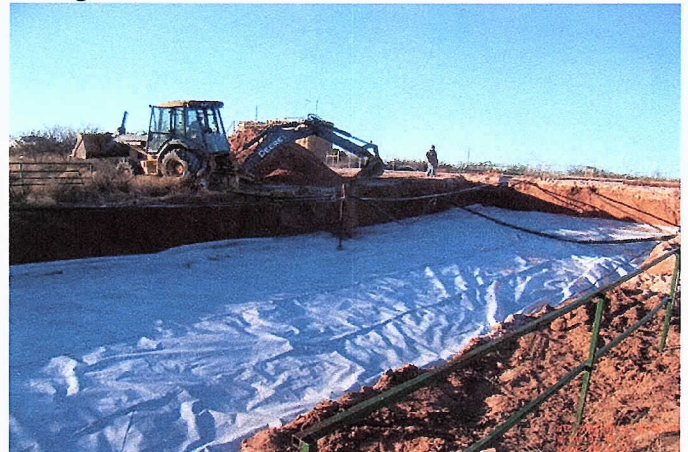
Padding the 20-mil, reinforced liner with imported
soil, facing northeast

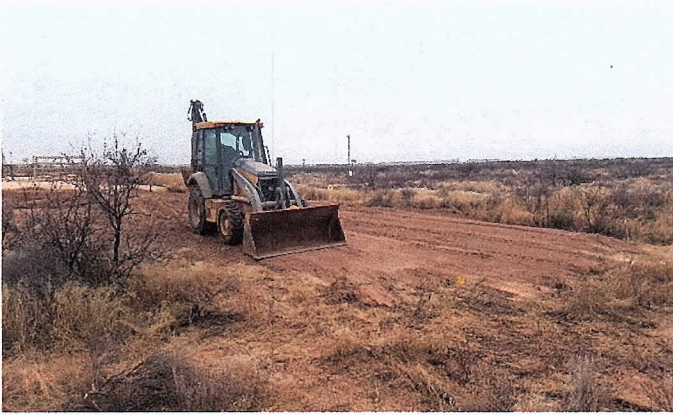
Backfilling and contouring the site with imported soil, facing west
12/27/2017

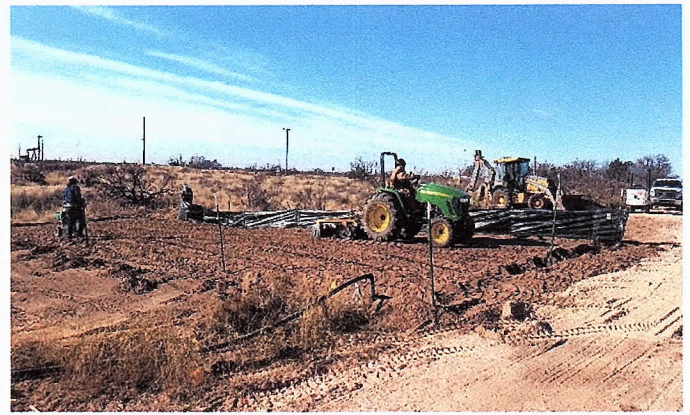
Tilling and seeding backfilled site, facing southwest
12/28/2017

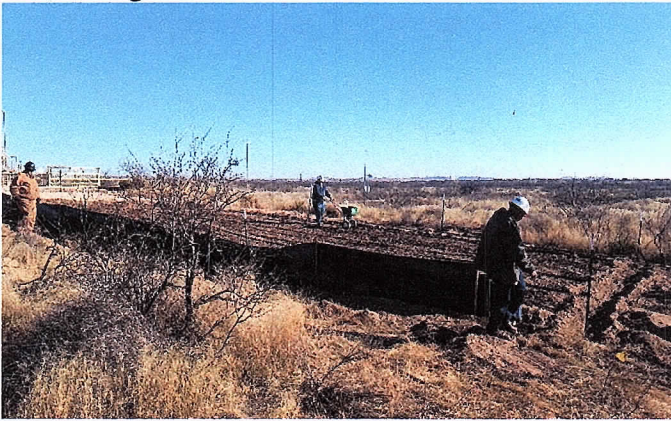
Seeding site, completing silt net fencing, facing northeast
12/28/2017

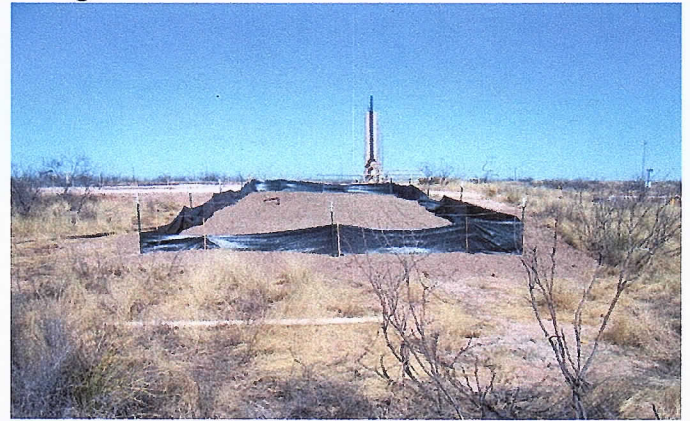
Site complete, facing north
