Release Notification and Corrective Action

Name of Company Rice Operating Company	Contact Katie Jones Davis
Address 112 W. Taylor	Telephone No. (575) 393-9174
Facility Name EME E-21 AD	Facility Type Salt Water Gathering System

1RP-5127

**EME
 E-21 AD**

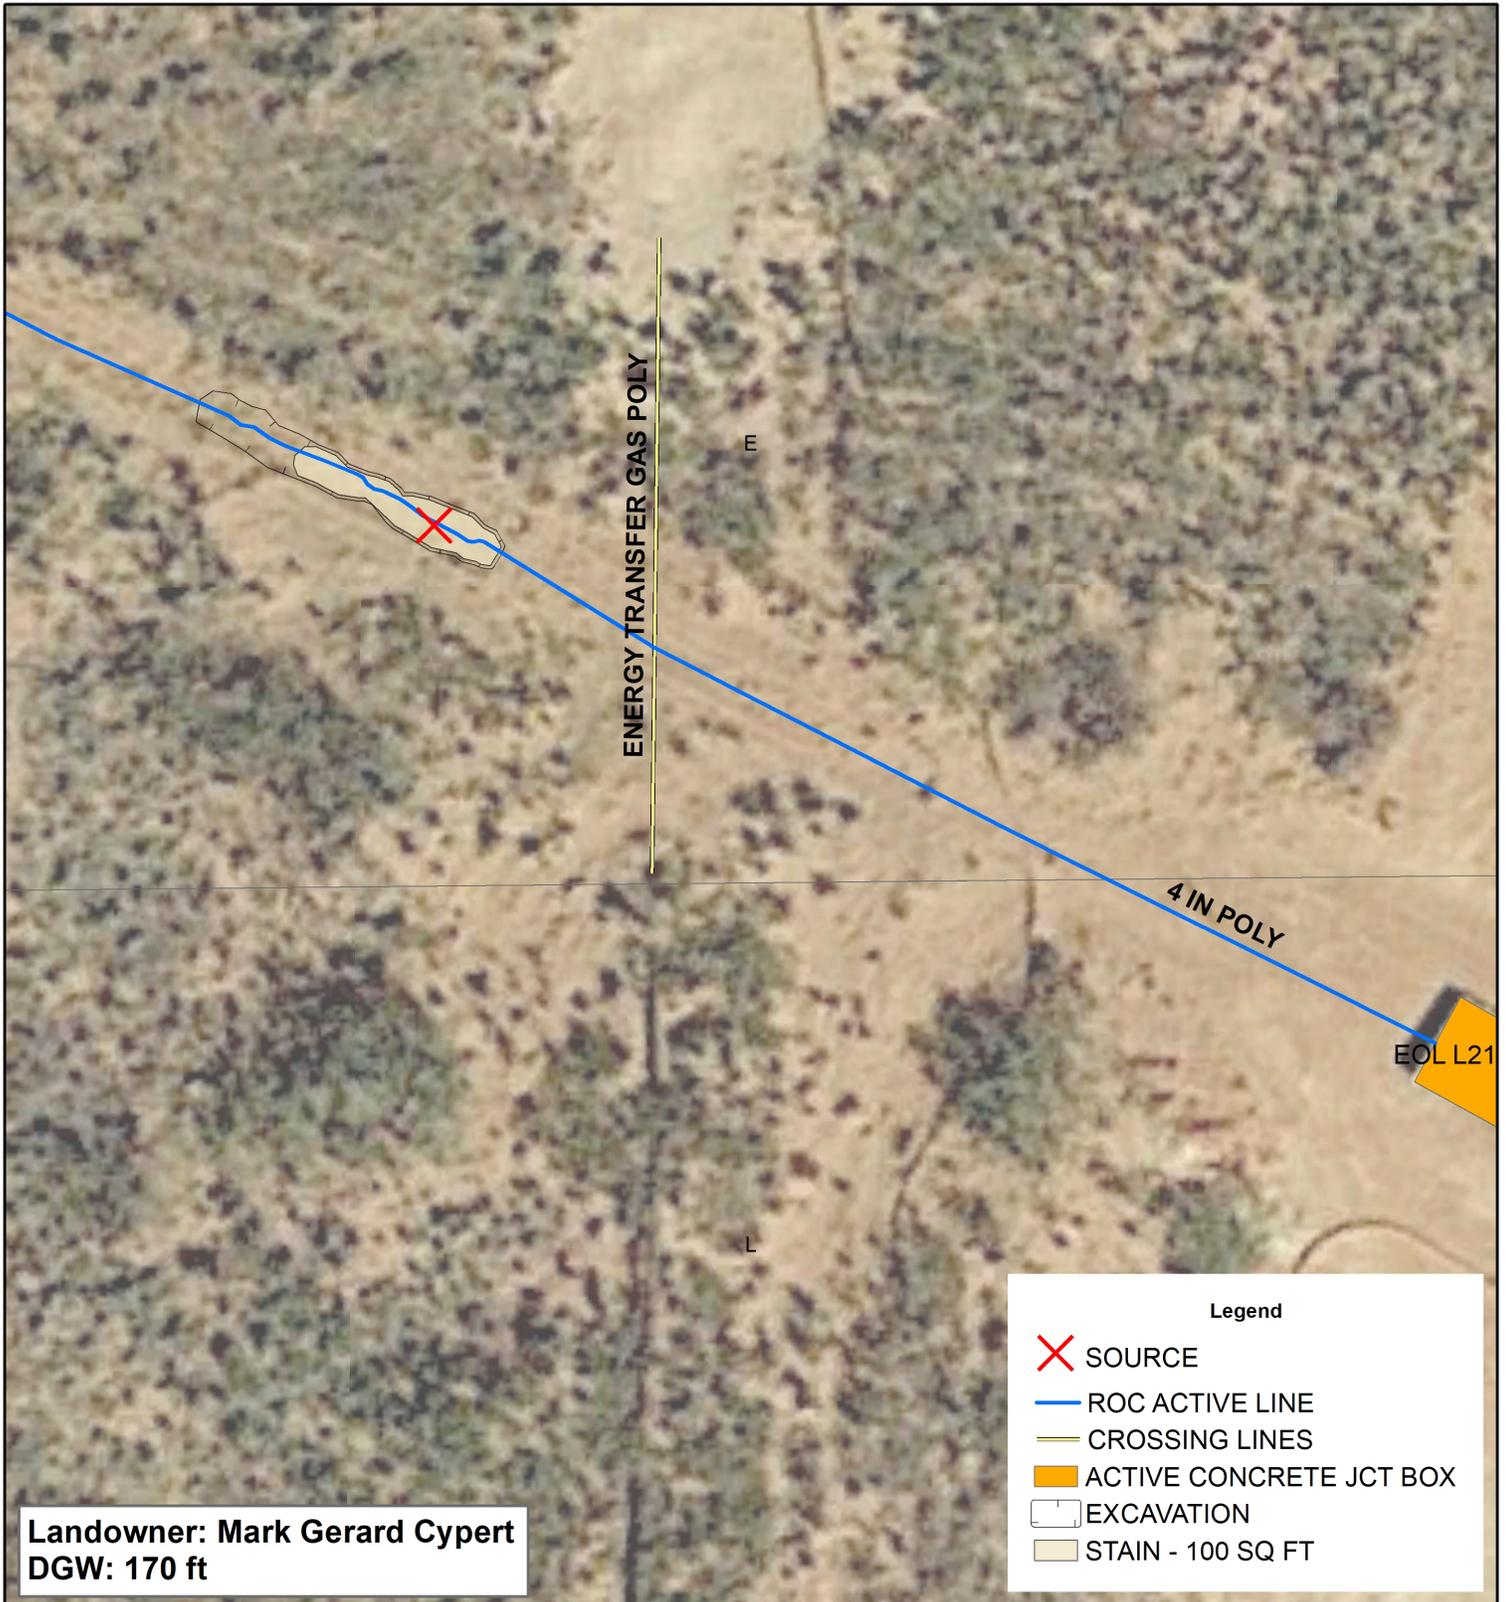
Landowner: Mark Gerard Cypert
 DGW: 170 ft

- SOURCE
- ROC ACTIVE LINE
- CROSSING LINES
- ACTIVE CONCRETE JCT BOX
- EXCAVATION
- STAIN - 100 SQ FT

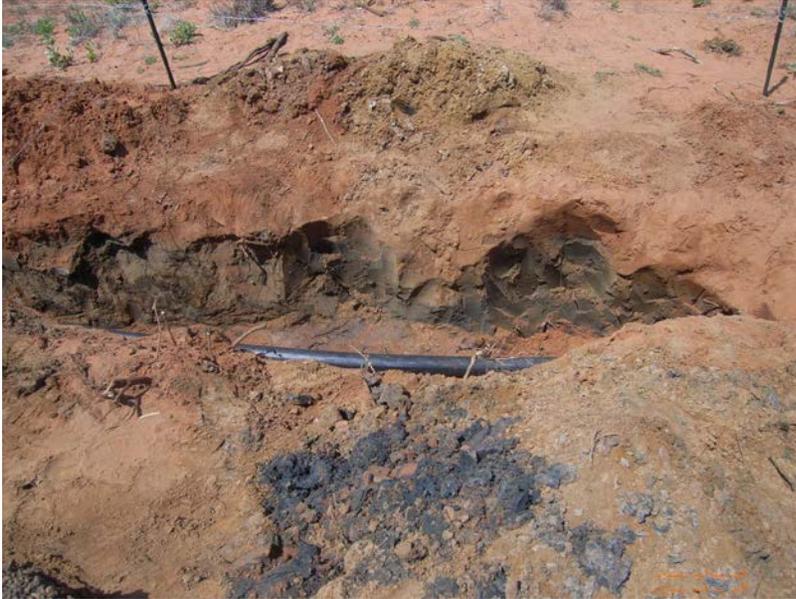
7/3/2018

Toward source, facing north

Describe Cause of Problem and Remedial Action Taken.*
A hole in a 4 inch poly line released approximately 7 bbls of produced water. The line was shut in and isolated. The damaged segment of line was replaced.

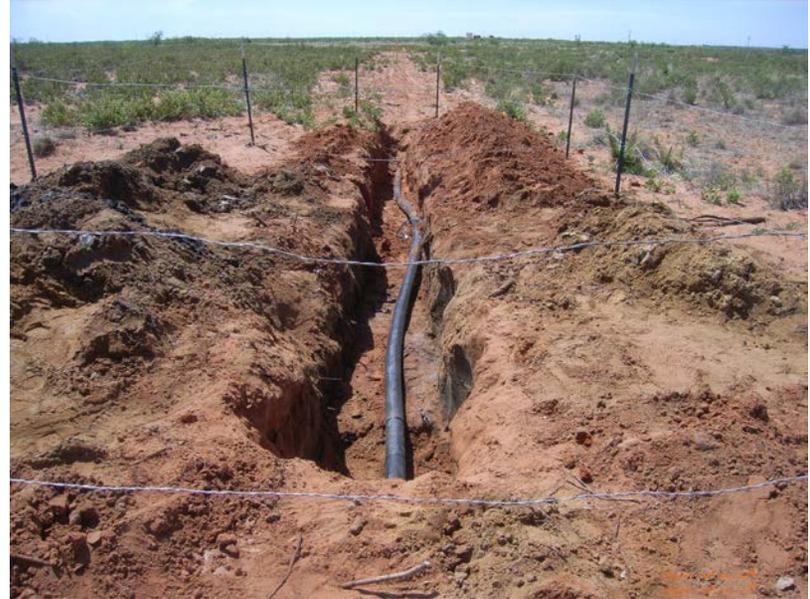
7/3/2018

Excavation facing NW

Attached is an Initial C-141, map, and photos of the EME E-21 AD. The leak occurred on July 3, 2018. Due to the small leak area, we initially believed the leak was less than 5 bbls and non-reportable. However, hand auger samples collected last week showed chloride concentrations to increase to a depth of 10.5 ft bgs. Hand auger samples couldn't be collected any deeper due to a hard caliche layer. We plan to collect additional samples next week with a backhoe. Please let me know if you have any questions or need any additional information.

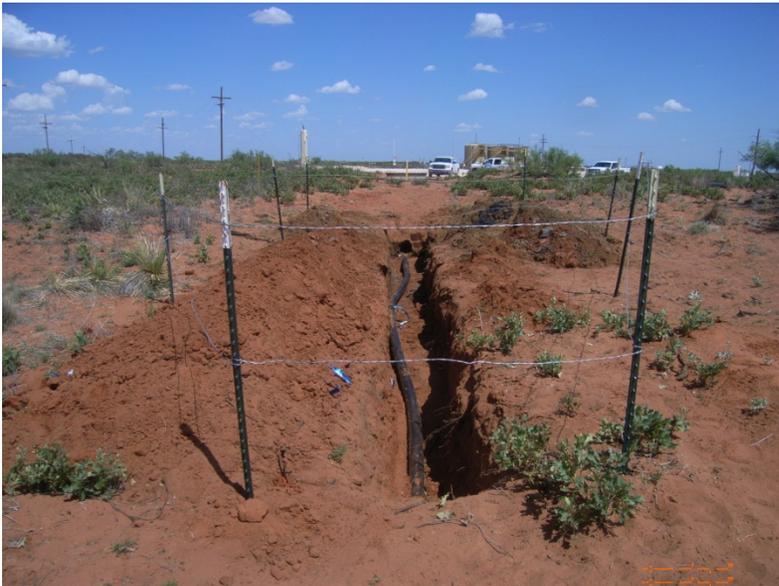
7/3/2018

Excavation facing SE

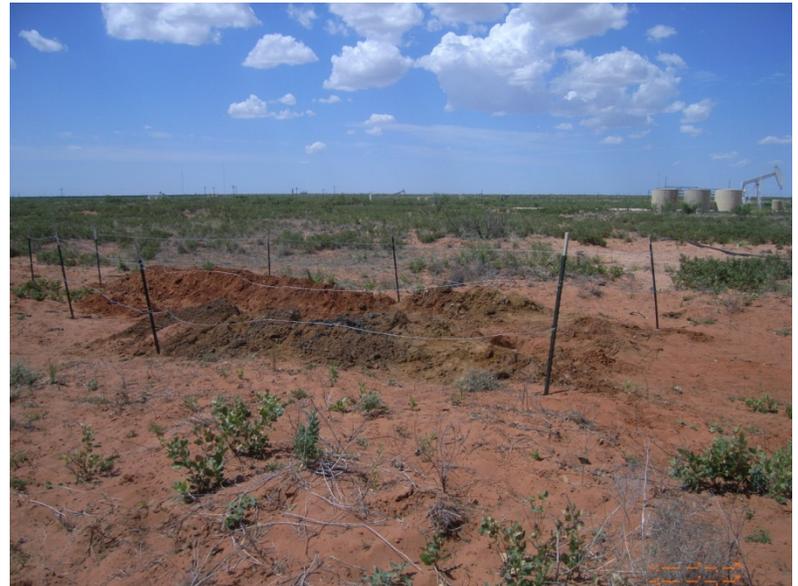
7/3/2018

Excavation facing north
