**From:** [Yu, Olivia, EMNRD](#)  
**To:** [zach.robbins@rxsoil.solutions](mailto:zach.robbins@rxsoil.solutions)  
**Cc:** "[Mann, Ryan](#)"; "[Todd Passmore](#)"; "[Jace Caraway](#)"  
**Subject:** RE: 1RP-5047, 1RP-5065, 1RP-5066 - Work Plan - Slick Mesa 27-1H  
**Date:** Tuesday, July 24, 2018 2:09:00 PM  
**Attachments:** approved\_1RP-5047, 1RP-5065, 1RP-5066 Slick Mesa Work Plan - RXSoil 06222018.pdf

Thank you for the file. NMOCD will agree that the release area for 1RP-5047, 1RP-5065, and 1RP-5066 did not overlap the reserve pit area. Please be advised that the horizontal delineation requirement as mentioned in the email dated June 27, 2018 still applies.

Attached is RXSoil's proposed Work Plan for the remediation project of the releases listed in the subject line.

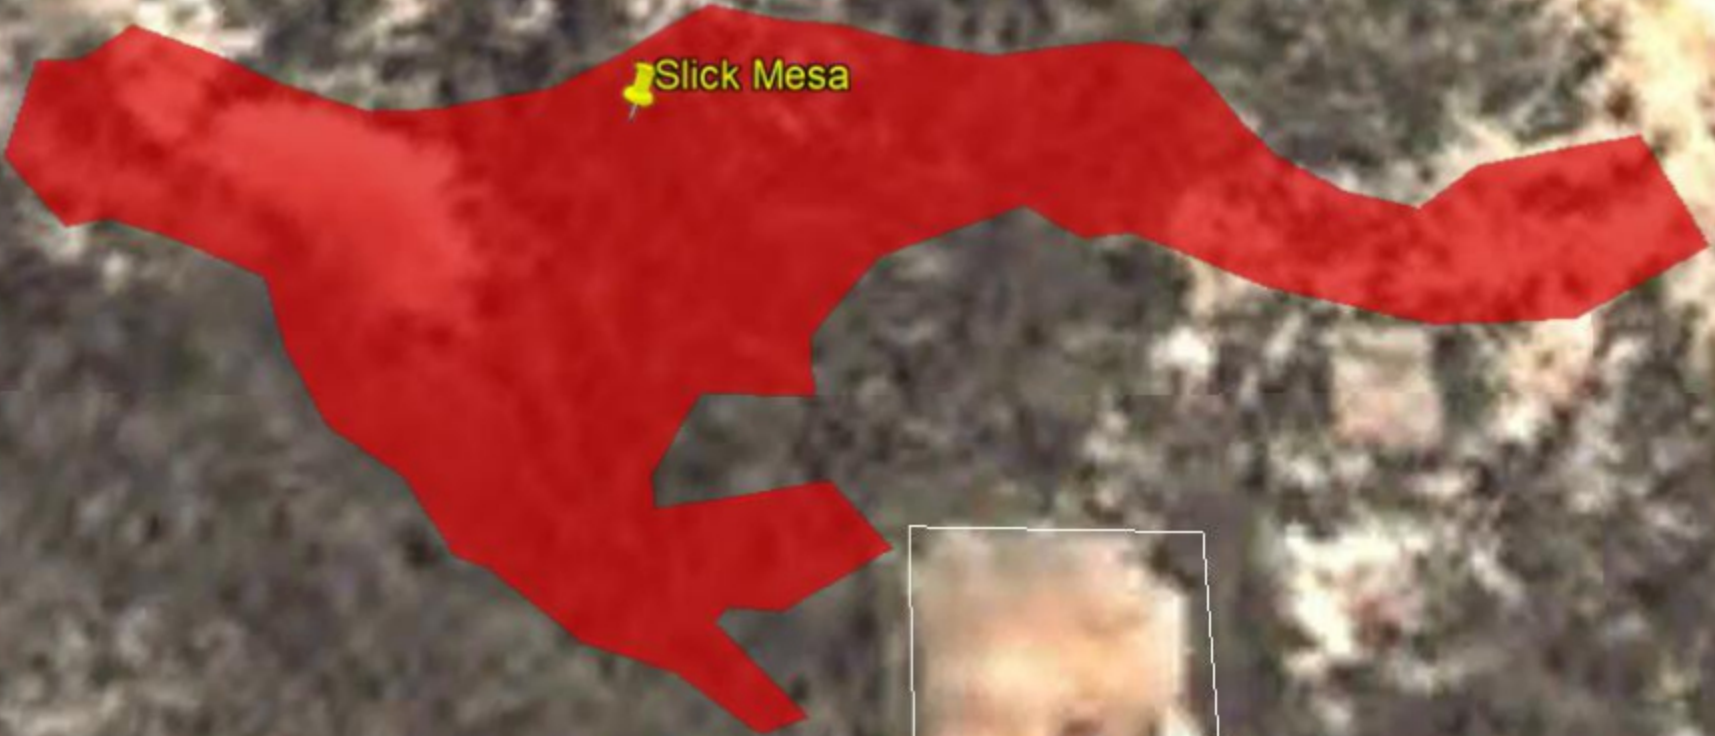
Spill Map

The current evidence of this reserve pit are raised soil, salt scars and plastic remnants in the ground. The outline was determined from historical satellite imagery from Google Earth dated 6/30/2005 (attached). The current spill map provides evidence that this release did not come in contact with this pit. RXSoil would like to keep all excavation at least 10' from this pit to not disturb any of the soil or liner in it. Sidewall samples will still be taken throughout the excavation areas.

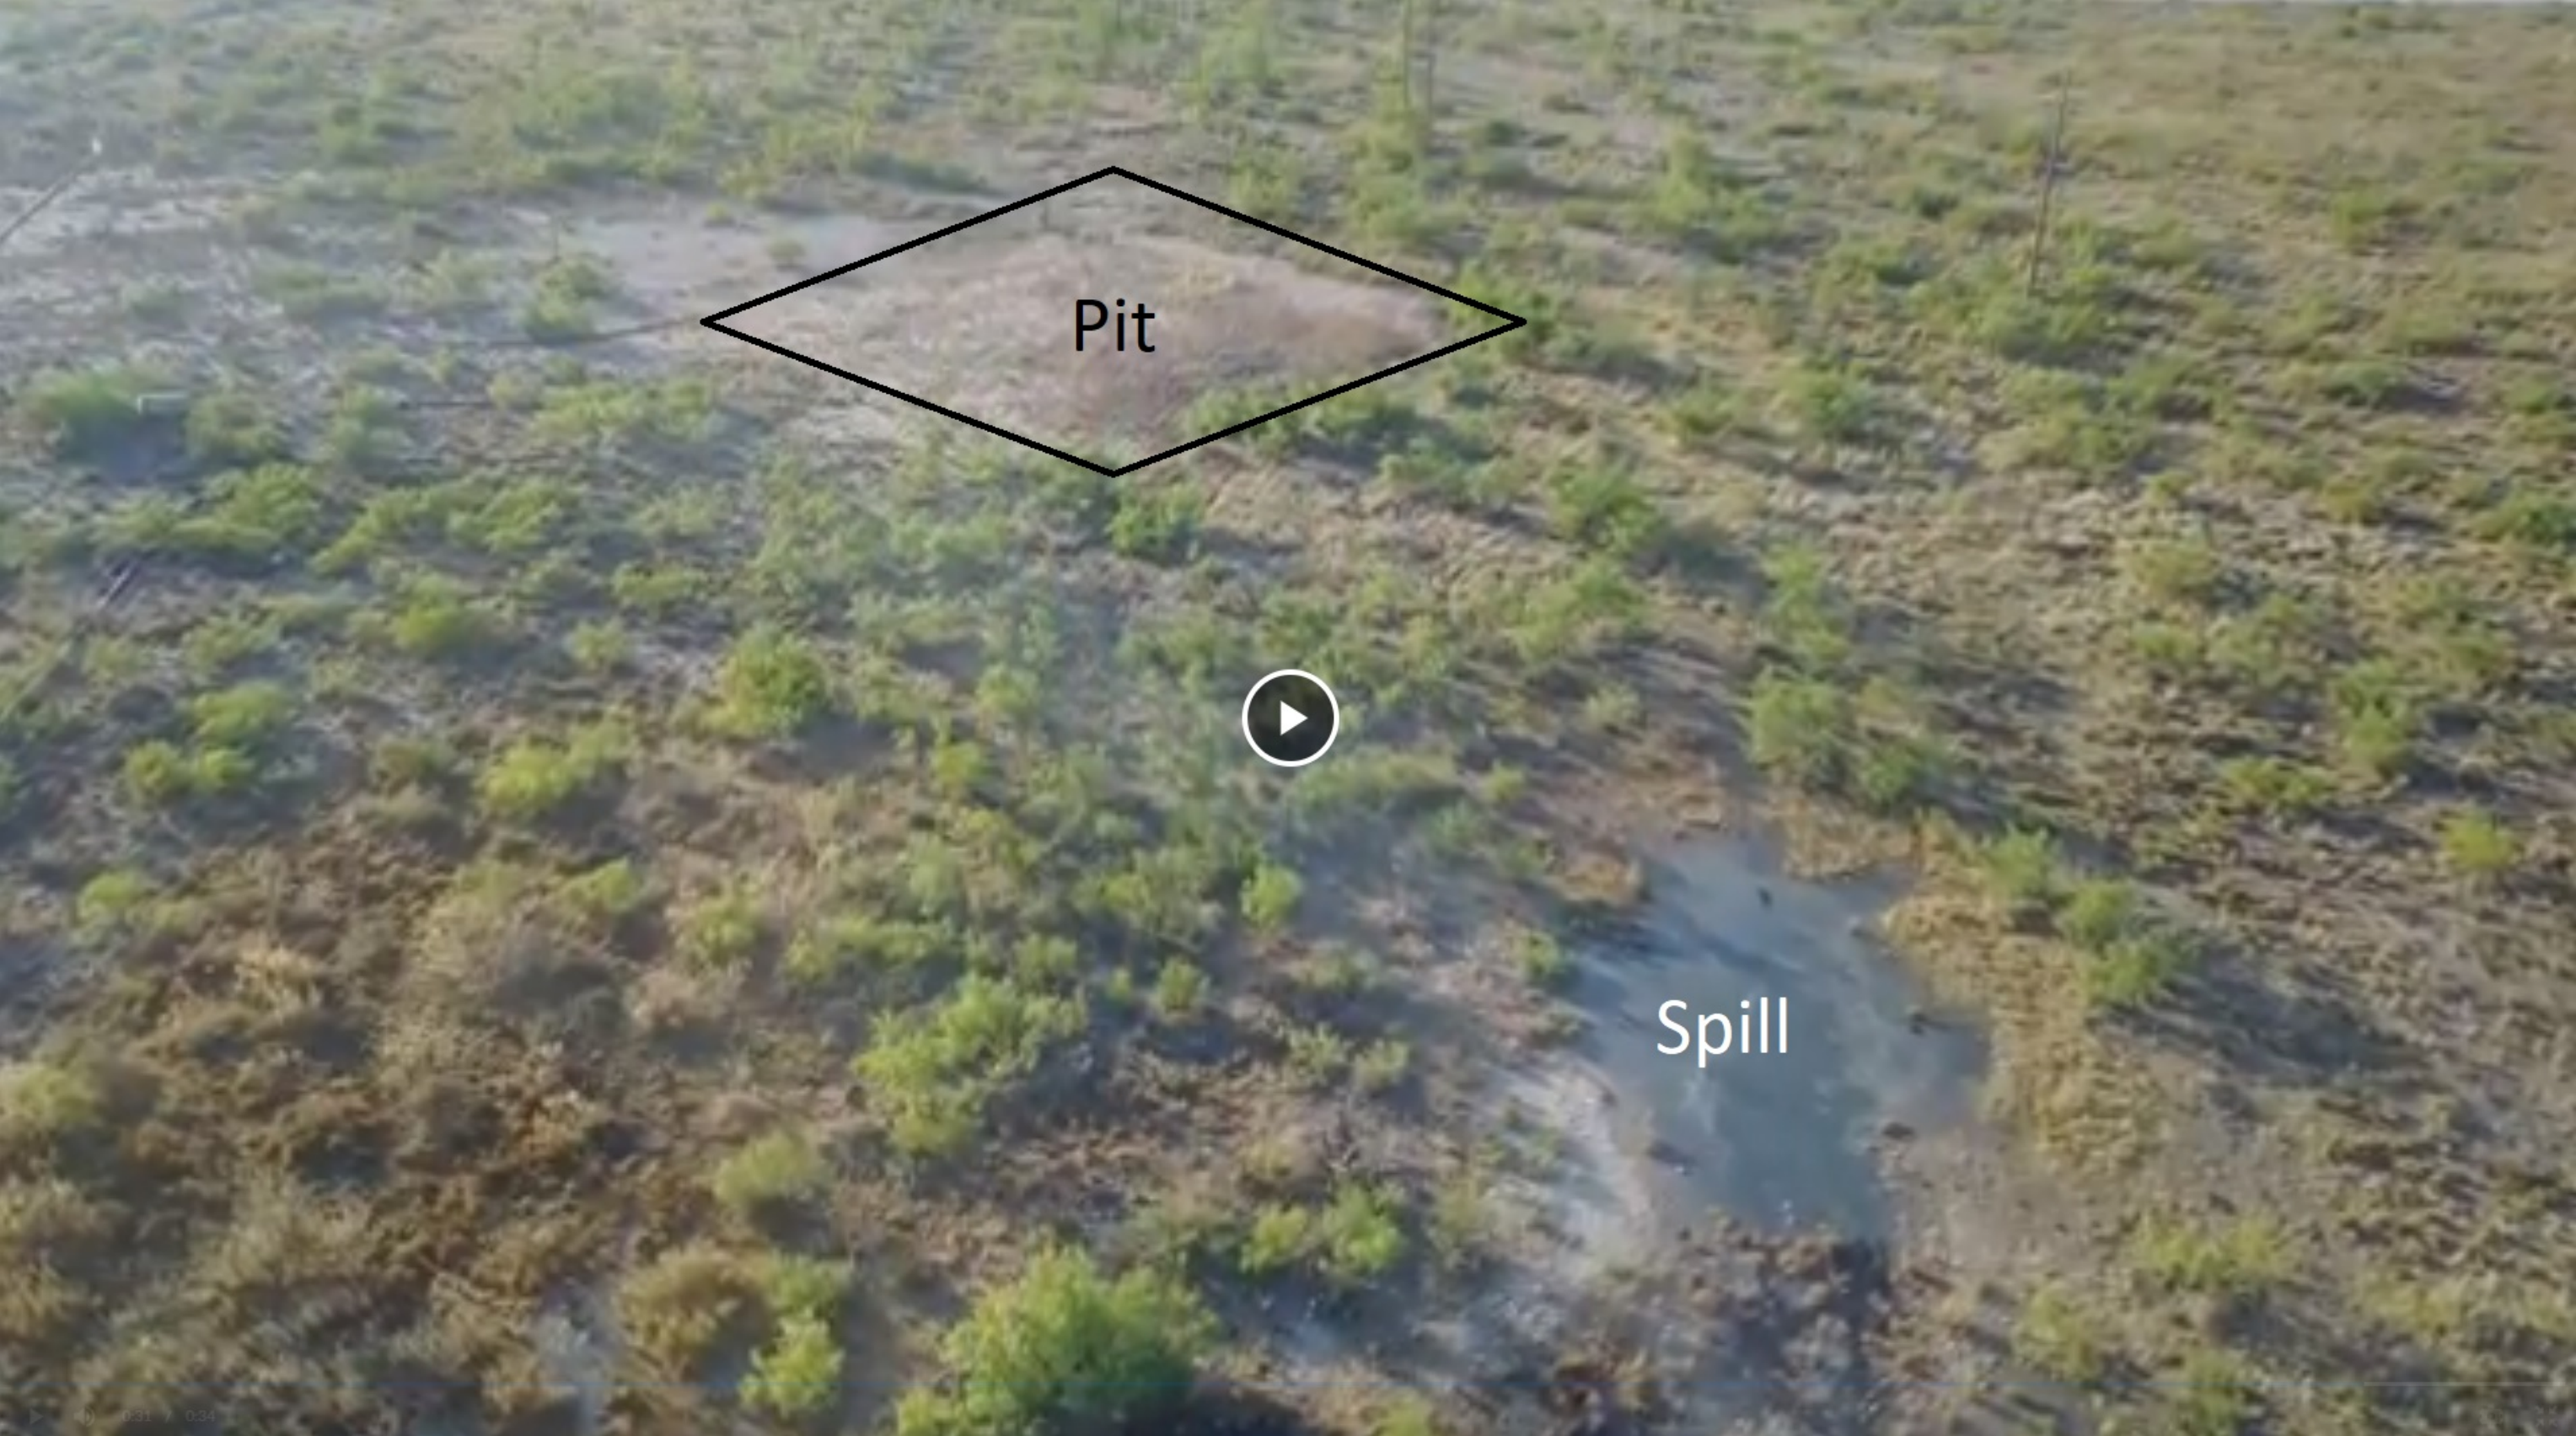
Slick Mesa

The best visualization we have is the video at the following link:  
<https://app.box.com/file/304115479533> . I have attached a screenshot from this video. This is from 05/16/2018.

NMOCD requests actual dated photos verifying that the edge of the release area for 1RP-5047, 1RP-5065, and 1RP-5066 did not flow over the nearest margin of the aforementioned reserve pit.

An aerial photograph of a field with sparse green vegetation. A diamond-shaped area in the upper center is outlined in black and labeled 'Pit'. In the lower right, a dark, irregularly shaped area is labeled 'Spill'. A play button icon is centered in the image.
