RE: Closure Request EK 30 BS2 Federal Com 1H Remediation Permit Number 1RP-5019 Lea County, New Mexico

LT Environmental, Inc. (LTE), on behalf of McElvain Energy, Inc. (McElvain), is pleased to present the following letter report detailing excavation and confirmation soil sampling activities at the EK 30 BS2 Federal Com 1H (Site). The purpose of the excavation activities was to address impacts to soil in response to a release of approximately 25 barrels (bbls) of crude oil from the vapor recovery unit (VRU) on April 12, 2018. A third-party crude oil hauler shut a production valve on one of the crude oil storage tanks before manually gauging liquid levels. The valve was never reopened after gauging activity was completed and crude oil flooded the vapor recovery tower, then discharged through a relief valve on the VRU scrubber. The release collected on the production equipment within a lined secondary containment and misted offsite northwest of the well pad. This report documents McElvain's response to the release, including removal of free-standing liquids, washing of affected equipment, and excavation of impacted vegetation and soil. Based on the results of the confirmation sampli

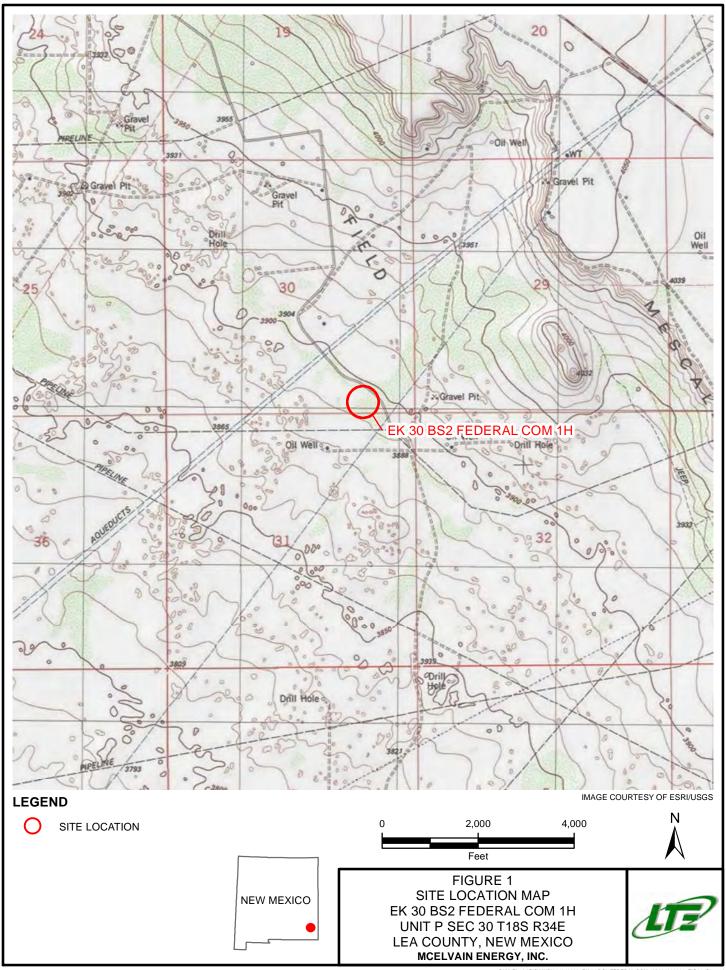
The Site is located in Section 30, Township 18 South, Range 34 East, in Lea County, New Mexico (Figure 1). Depth to groundwater at the Site is estimated to be greater than 100 feet below ground surface (bgs) based on the nearest water well data, drilling logs, and known aquifer properties. The nearest permitted water well is CP-01584, located approximately 4,051 feet northwest of the Site with a total depth of 500 feet. Depth to water is not listed for CP-01584 in the New Mexico Office of the State Engineer's database; however, the well was drilled by McElvain, who owns the drilling log. The drilling log indicates the well was drilled to 500 feet bgs and no water was identified. The closest surface water to the Site is a stream located approximately 407 feet to the southeast of the Site. Based on these criteria, the NMOCD site ranking for remediation action level is a 10 and the following remediation action levels apply: 10 milligrams per kilogram (mg/kg) benzene; 50 mg/kg benzene, toluene, ethylbenzene, and total xylenes (BTEX); and 1,000 mg/kg total petroleum

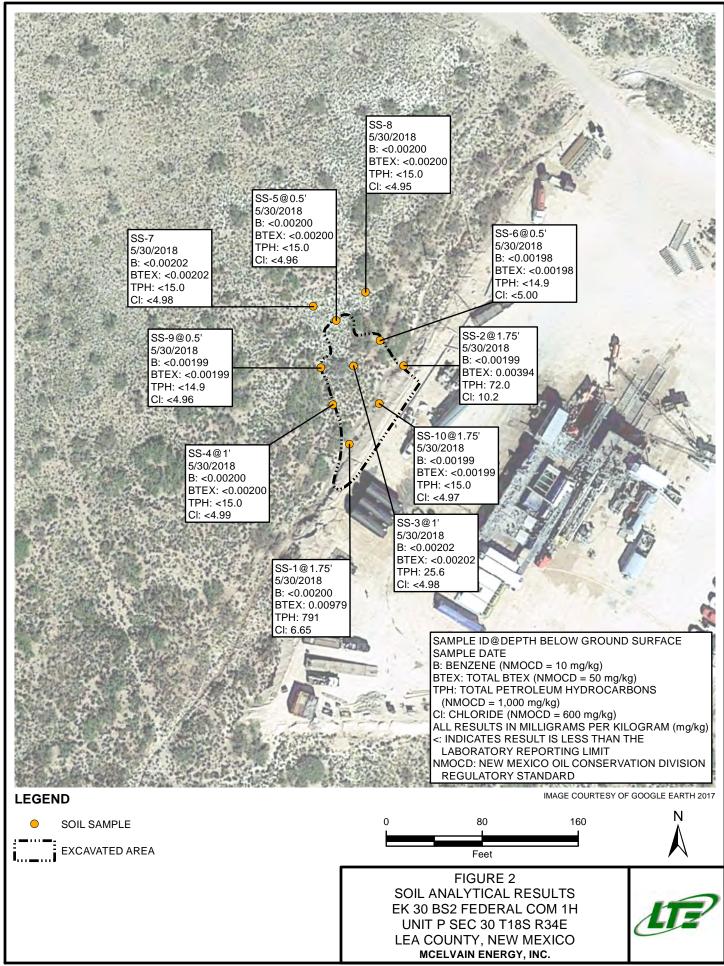
The final excavation was approximately 6,177 square feet in area and ranged in depth from 0.5 feet bgs to 1.75 feet bgs. Approximately 105 cubic yards of impacted soil were removed from the excavation. All impacted soil was transported and properly disposed of at Lea Land, Inc., in Carlsbad, New Mexico. The excavation outline and confirmation soil sample locations are depicted on Figure 2.

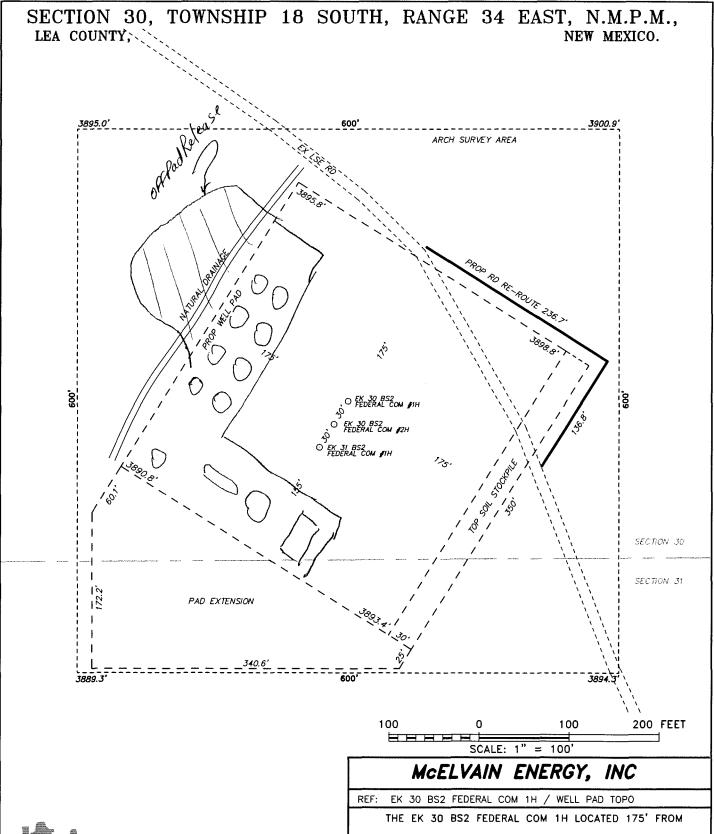
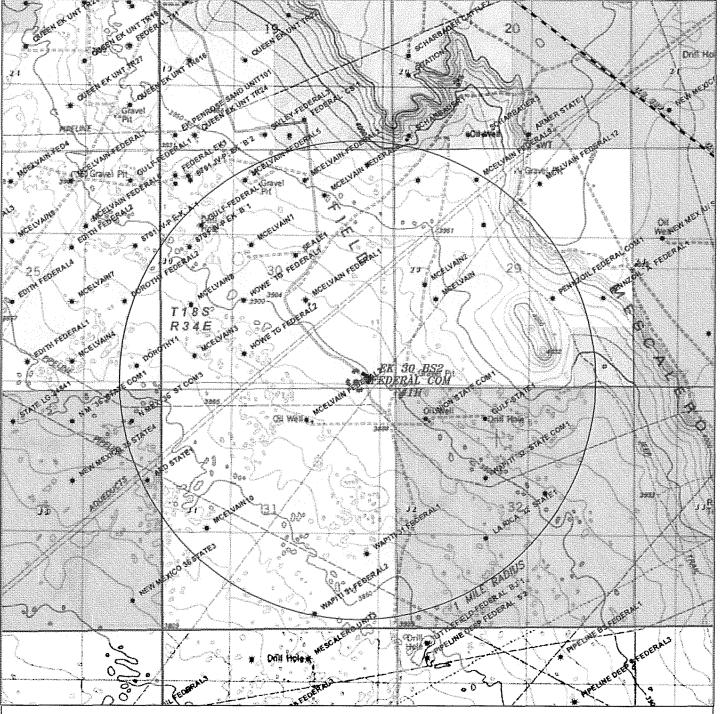
EK 30 BS2 FEDERAL COM 1H

Located 175' FSL and 860' FEL Section 30, Township 18 South, Range 34 East, N.M.P.M., Lea County, New Mexico.
