Re: Work Plan
Transfer line from Terrapin Frac Pond to Arabian 30-19 Fed Com 1H
NMOCD Reference #: 1RP-4871

RXSoil, Inc. is pleased to submit the work plan summarizing the on-site remediation of treated produced water impacted soil for the above release, associated with the Arabian 30-19 Fed Com 1H site located in Lea County, New Mexico. Remediation work plan follows in the attached report.

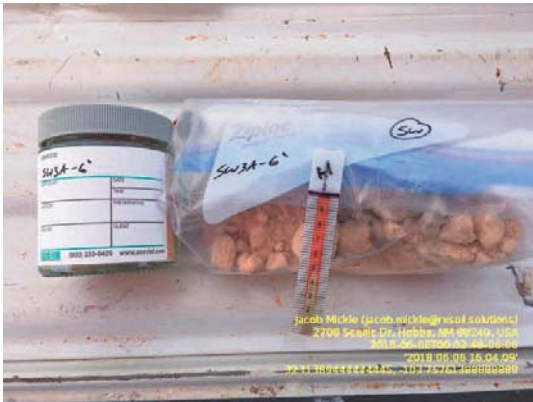
Picture of Result or Sample Taken

Type of Field Test	Soil
Method of Testing	Sample to Lab
Name of Sample Point	SW3A-6'
Method of Sample Collecting	DRILL RIG
Depth (inches)	6'
Comments	FIELD TEST: CHLORIDES (1:4) LOW: 5.2 = 980 PPM HIGH: ND

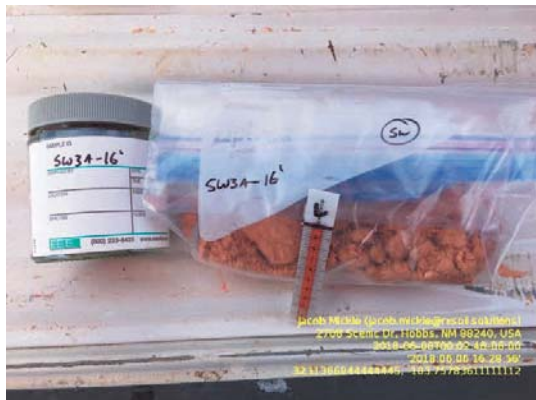
Picture of Result or Sample Taken

SW3A-16'
DRILL RIG
16'
FIELD TEST: CHLORIDES (1:4)
LOW: 2.0 = 228 PPM
HIGH: -

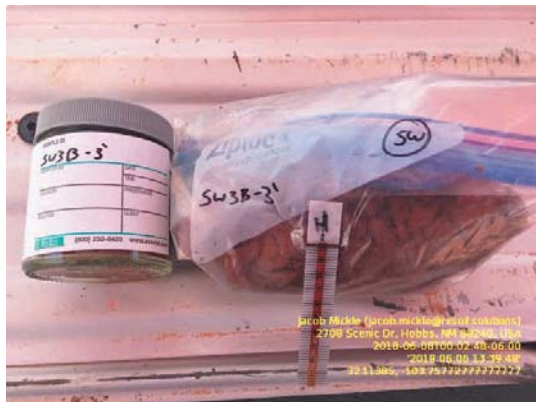
Picture of Result or Sample Taken

SW3B-3'
DRILL RIG
36"
FIELD TEST: CHLORIDES (1:4)
LOW: -
HIGH: 4.0 = 2,704 PPM

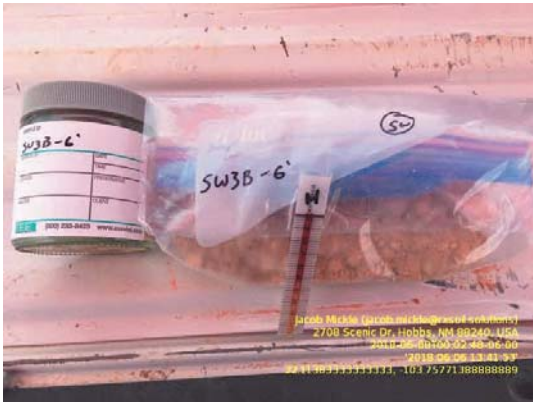
Picture of Result or Sample Taken

Type of Field Test	Soil
Method of Testing	Sample to Lab
Name of Sample Point	SW3B-6'
Method of Sample Collecting	DRILL RIG
Depth (inches)	6'
Comments	FIELD TEST: CHLORIDES (1:4) LOW: - HIGH: 4.8 = 3,752 PPM

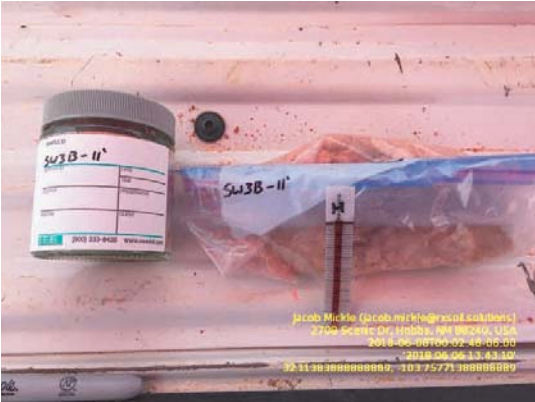
Picture of Result or Sample Taken

Type of Field Test	Soil
Method of Testing	Sample to Lab
Name of Sample Point	SW3B-11'
Method of Sample Collecting	DRILL RIG
Depth (inches)	11'
Comments	FIELD TEST: CHLORIDES (1:4) LOW: - HIGH: 2.4 = 1,272 PPM

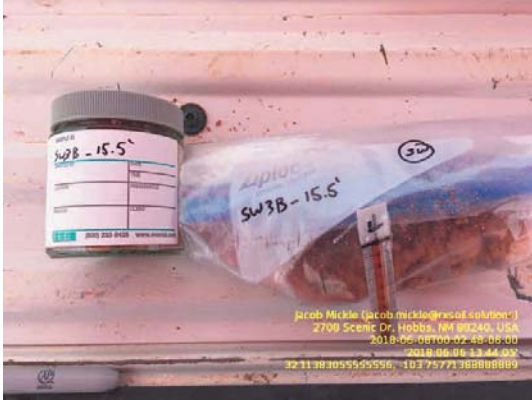
Picture of Result or Sample Taken

SW3B-15.5'
DRILL RIG
15.5'
FIELD TEST: CHLORIDES (1:4)
LOW: 1.0 = ND
HIGH: -

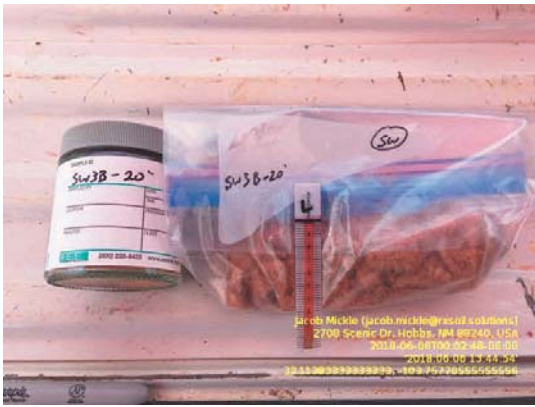
Picture of Result or Sample Taken

Soil
Sample to Lab
SW3B-20'
DRILL RIG
20'
FIELD TEST: CHLORIDES (1:4)
LOW: 1.0 = ND
HIGH: -

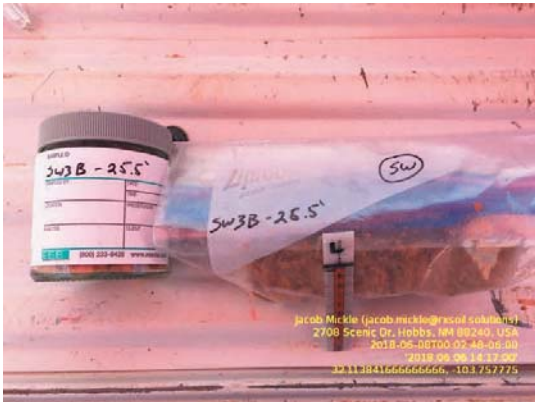
Picture of Result or Sample Taken

Type of Field Test	Soil
Method of Testing	Sample to Lab
Name of Sample Point	SW3B-25.5'
Method of Sample Collecting	DRILL RIG
Depth (inches)	25.5'
Comments	FIELD TEST: CHLORIDES (1:4) LOW: 1.6 = 172 PPM HIGH: -
