**Report Type: Closure Report    1RP-5023**

Site:	Angell B #2					
Company:	Marathon Oil Company					
Section, Township and Range	Unit B	Sec. 11	T 17S	R 36E		
Lease Number:	API No. 30-025-39076					
County:	Lea County					
GPS:	32.8559071° N			103.3214257° W		
Surface Owner:	Fee					
Mineral Owner:	State					
Directions:	From the intersection of HWY 18 and Stiles Road, travel west on Stiles Rd for 2.4 mi, turn south onto lease road 0.15 mi, turn west onto lease road for 0.35 mile to location.

**Re: Closure Report for the Marathon Oil, Angell B #2, Unit B, Section 11, Township 17 South, Range 36 East, Lea County, New Mexico. 1RP-5023.**

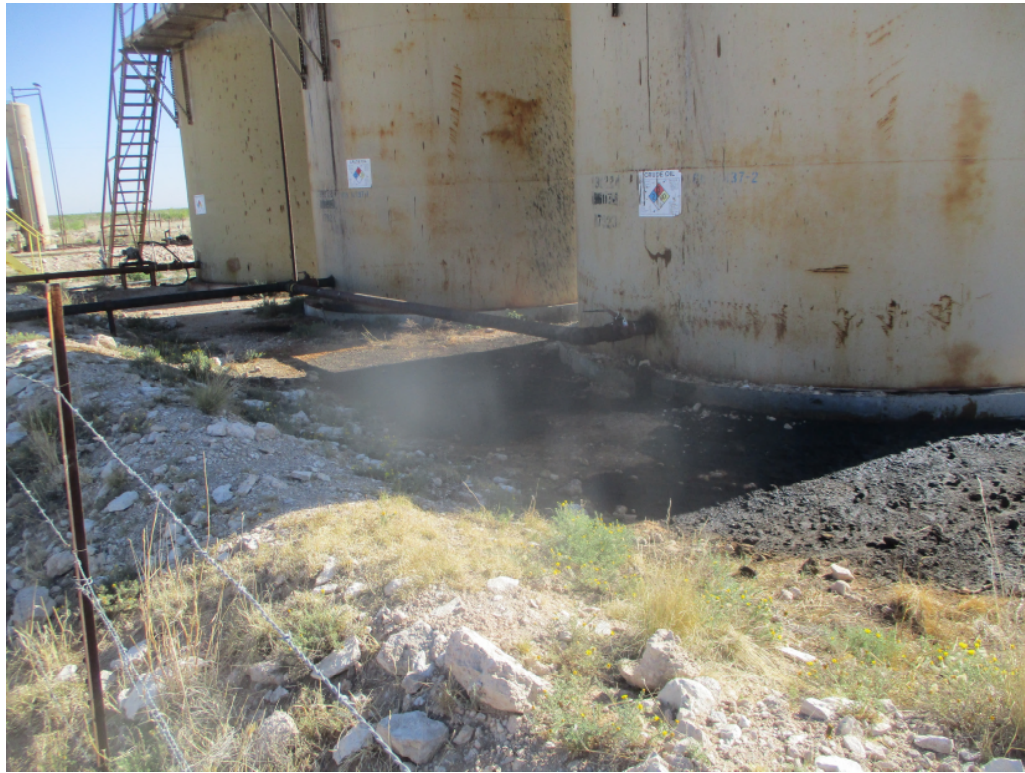
According to the State of New Mexico C-141 Initial Report, the leak was discovered on April 9, 2018, and released approximately eleven (11) barrels of oil from an oil tank. Less than one barrel of oil was recovered. The release occurred around the base of the tank and impacted an area measuring approximately 20' x 30'. The initial C-141 form is included in Appendix A.

View North – Release Area

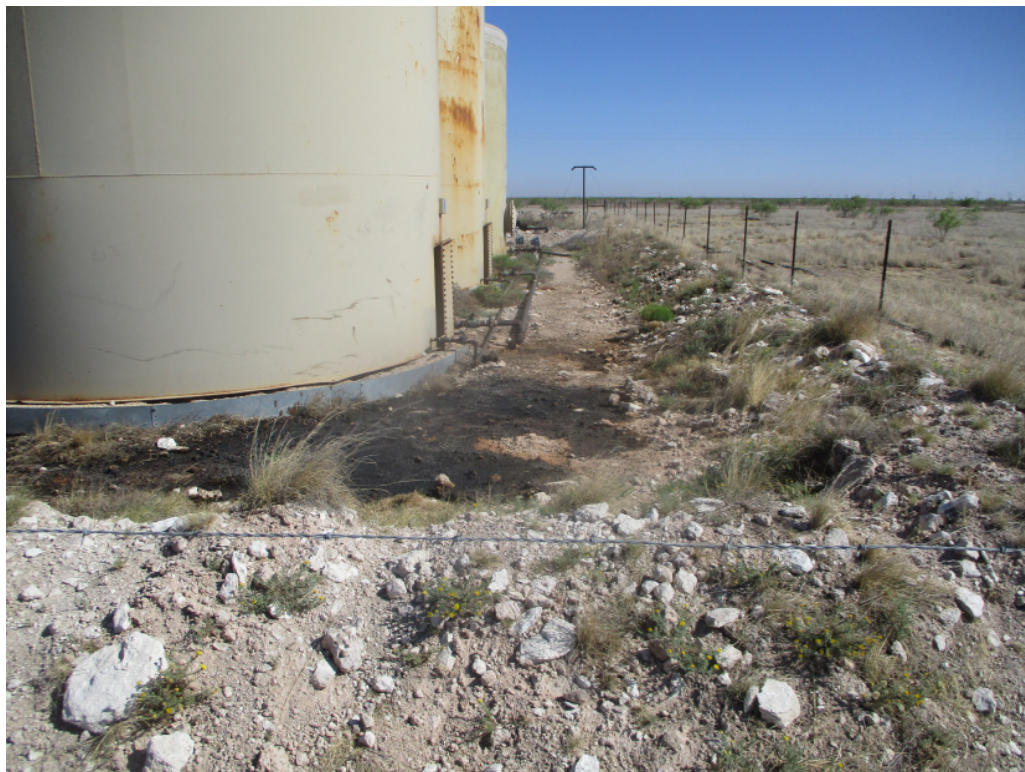
View North – Release Area

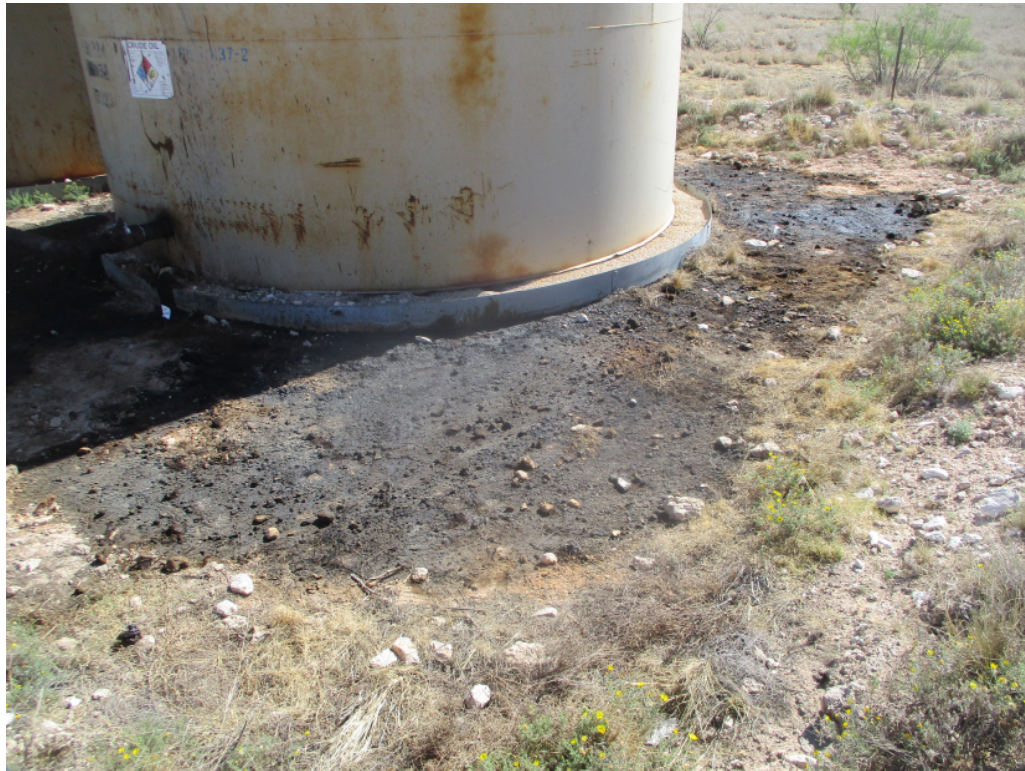
View East – Release Area

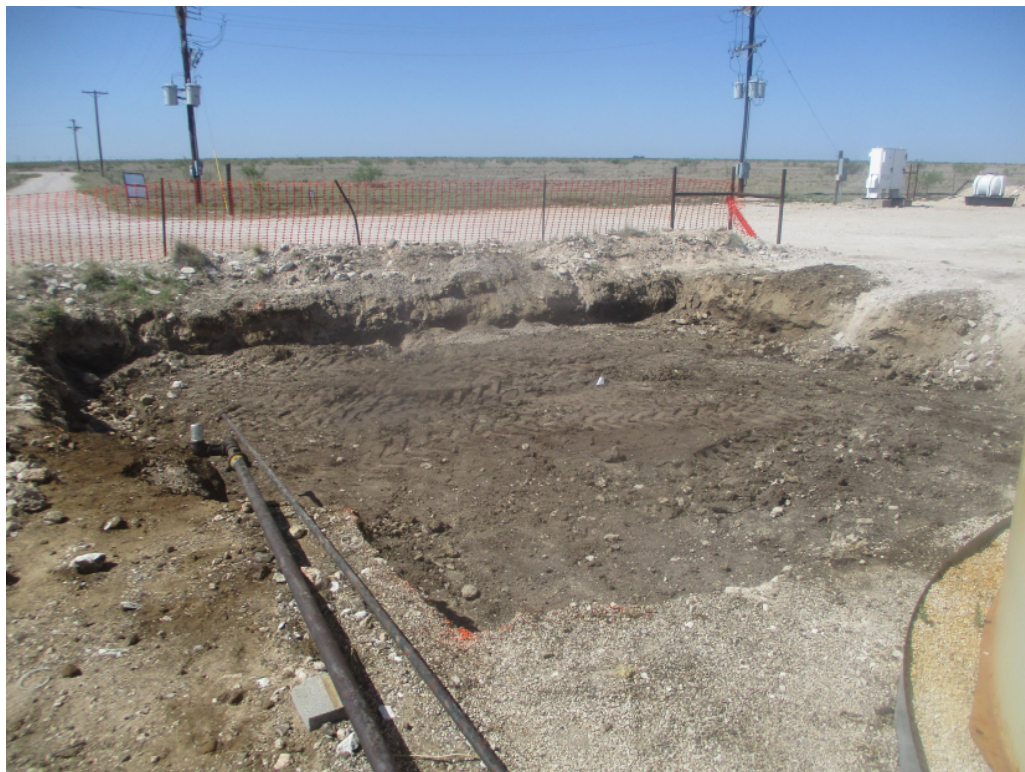
View South – Excavated Area

The release area was excavated to 2.0' below surface. One bottom hole (Bottom Hole #1) and four sidewall samples (North Sidewall, South Sidewall, West Sidewall, and East Sidewall) were collected to ensure proper removal of the impacted soils. The samples were submitted to the laboratory for analysis of TPH by EPA method 8015 extended, BTEX by EPA method 8021B, and chlorides by EPA method 300.0. Copies of the laboratory results and chain-of-custody documentation are included in Appendix C. The laboratory results are summarized in Table 1. The confirmation sample locations are shown in Figure 4.

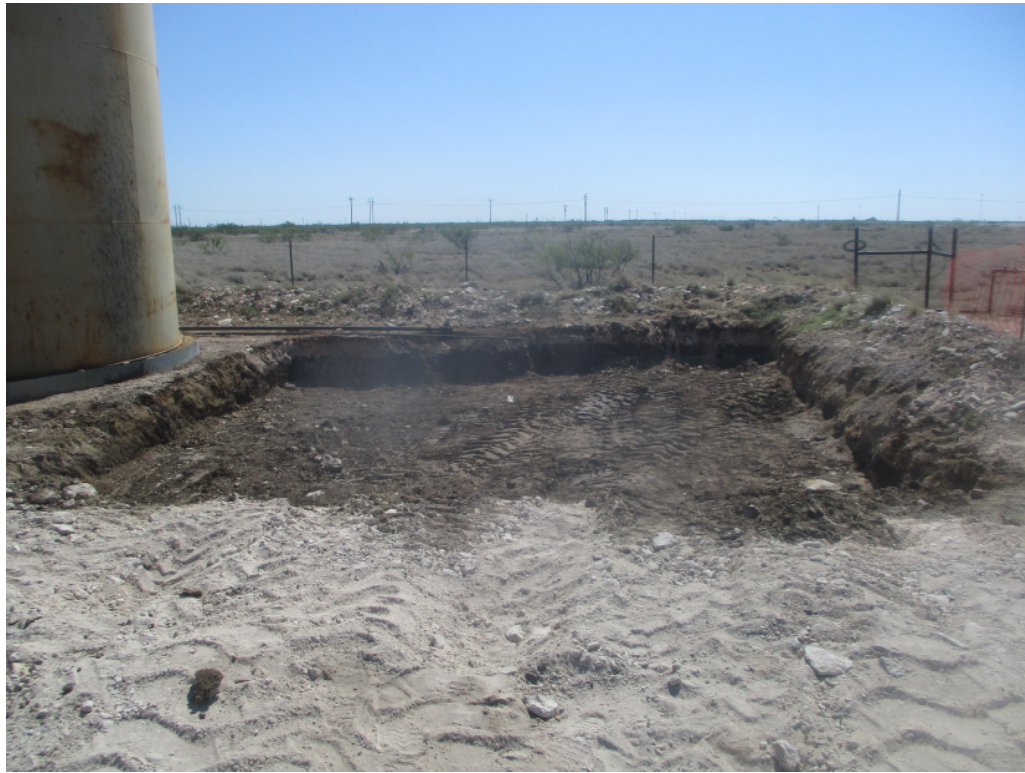
View East – Excavated Area
