Re: Chevron Central Vacuum Unit No. 47H

2017 Soil Assessment Report

Site Assessment Report

Central Vacuum Unit No. 47H

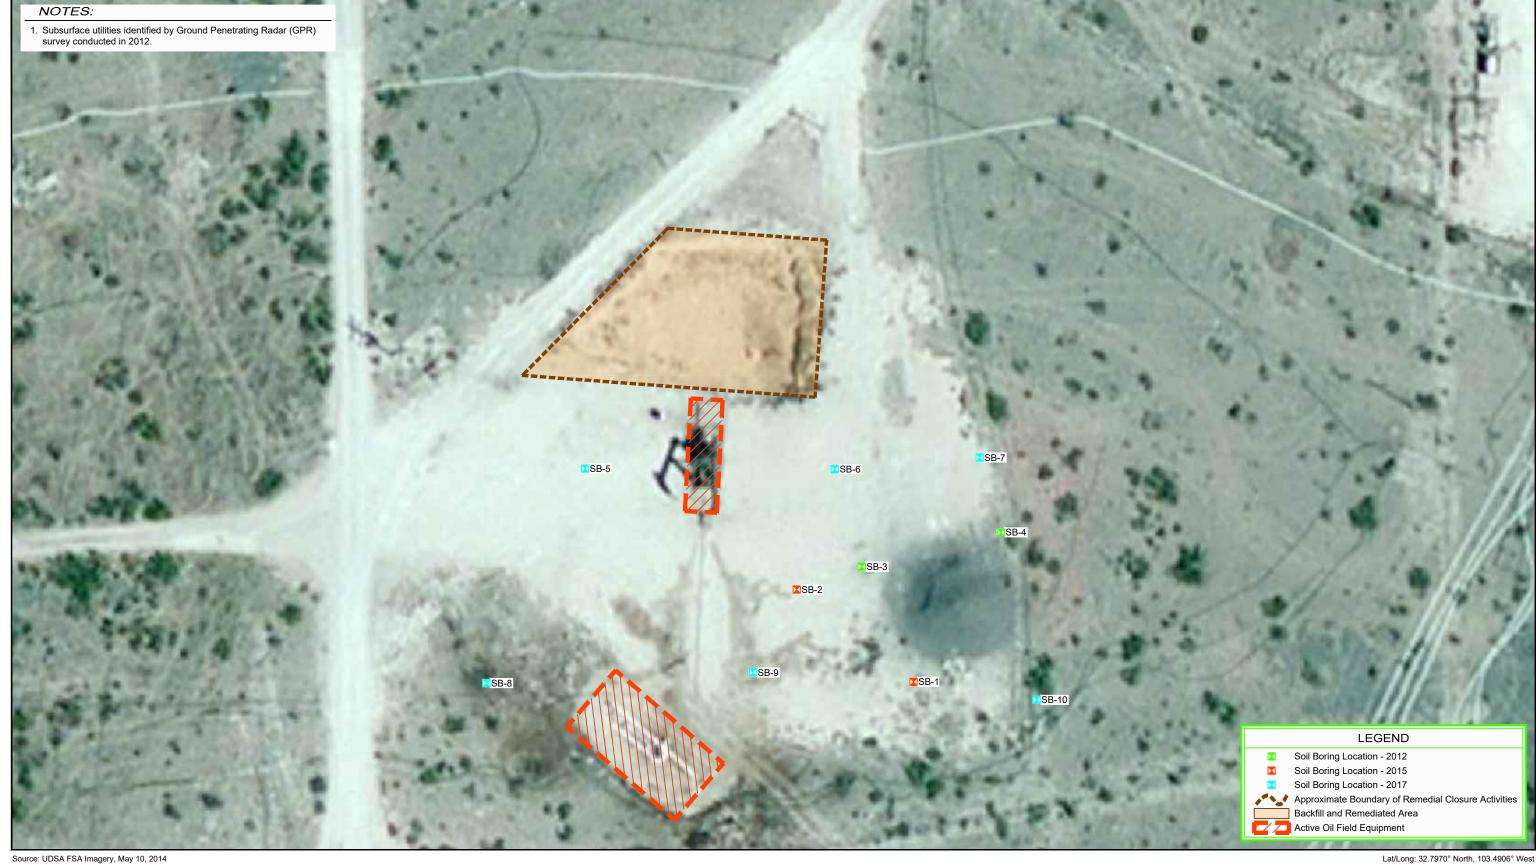
FIGURE 3

SITE DETAILS MAP

licensed water well driller, and GHD mobilized to the Site to begin drilling activities on October 18, 2017. Each boring location was cleared for underground utilities with the use of an air knife up to a depth of 5.0 feet bgs or refusal. SB-5 though SB-10 were advanced to 90 feet bgs. Site details and boring locations are shown on Figure 3.

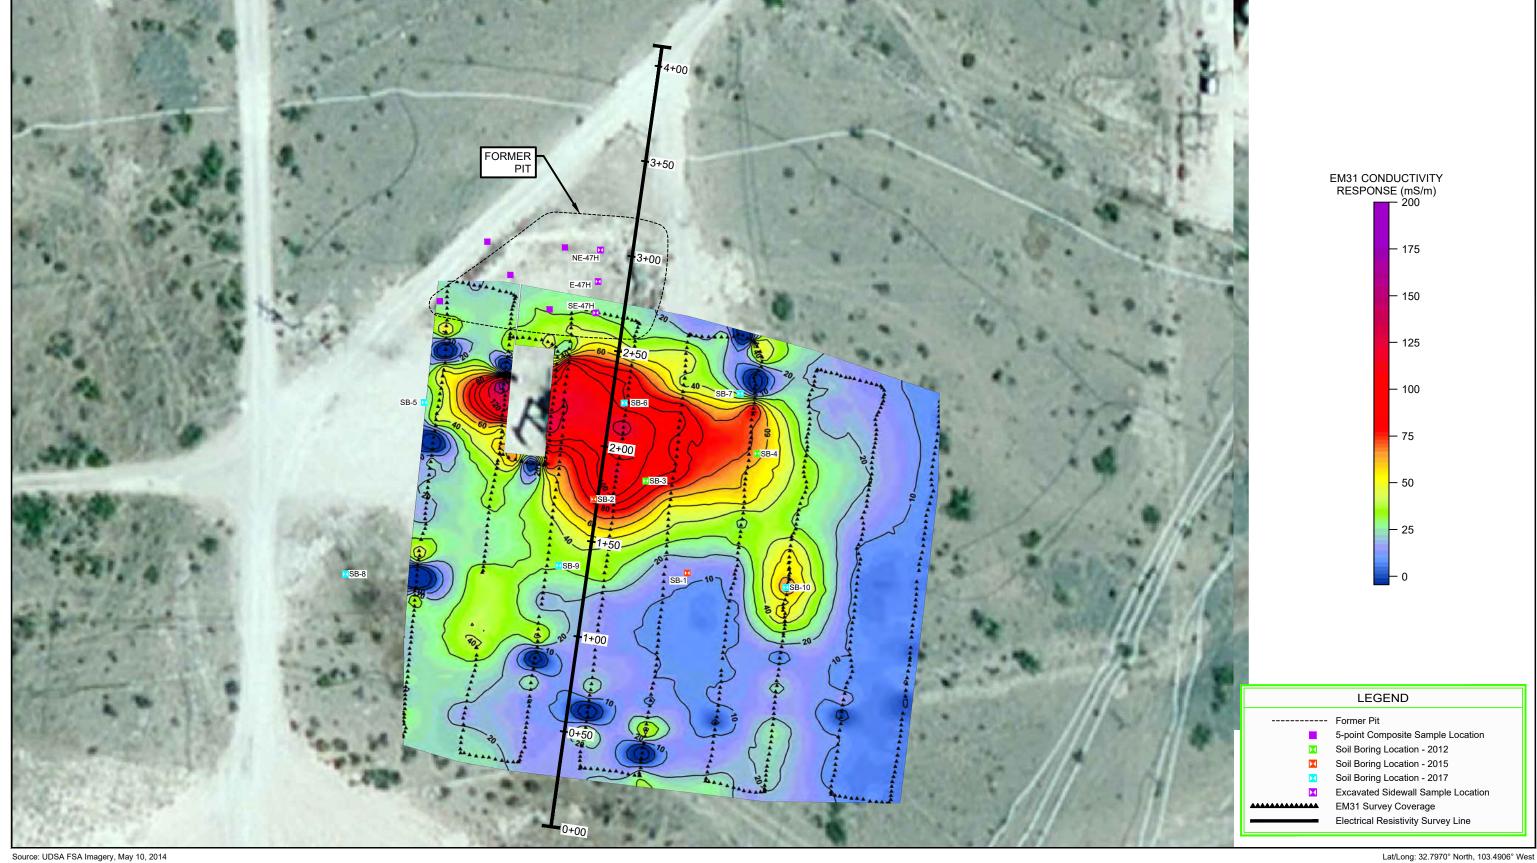
EM31 GEOPHYSICAL INVESTIGATION

The EM31 survey was completed to determine the horizontal extent or limits of chloride impacts in the shallow subsurface soils at the Site. The EM31 consists of transmitter and receiver coils located at opposite ends of a rigid boom. The coil separation for the EM31 is approximately 13 feet, which yields an approximate depth of penetration of 18 feet bgs in vertical dipole mode. Measurements of terrain conductivity from the EM31 were used to assess the extent of chloride impacts at the Site. The data for the EM31 survey were then processed as a colored contour plot. The plot was superimposed on an aerial image of the Site plan, and was used to locate elevated conductivity responses indicative of chloride-impacted areas relative to the Site features. Figure 4 depicts the EM31 survey results.

The colored contour conductivity plot presented on Figure 4 reveals that the highest intensity conductivity responses are colored red to purple, while areas of low response are colored blue. All remaining intermediate responses correspond to the color scale presented on the figure. Results from non-impacted areas within the survey coverage indicate that background conductivity responses were approximately 15 milliSiemens/meter (mS/m). Anomalous responses relative to background were generally 1.5 to 10 times higher, and ranged from approximately 20 to 150 mS/m. The EM31 survey results delineated one main area of suspected brine-impacted soils. The response area is just south of the former pit (previously excavated in 2015).

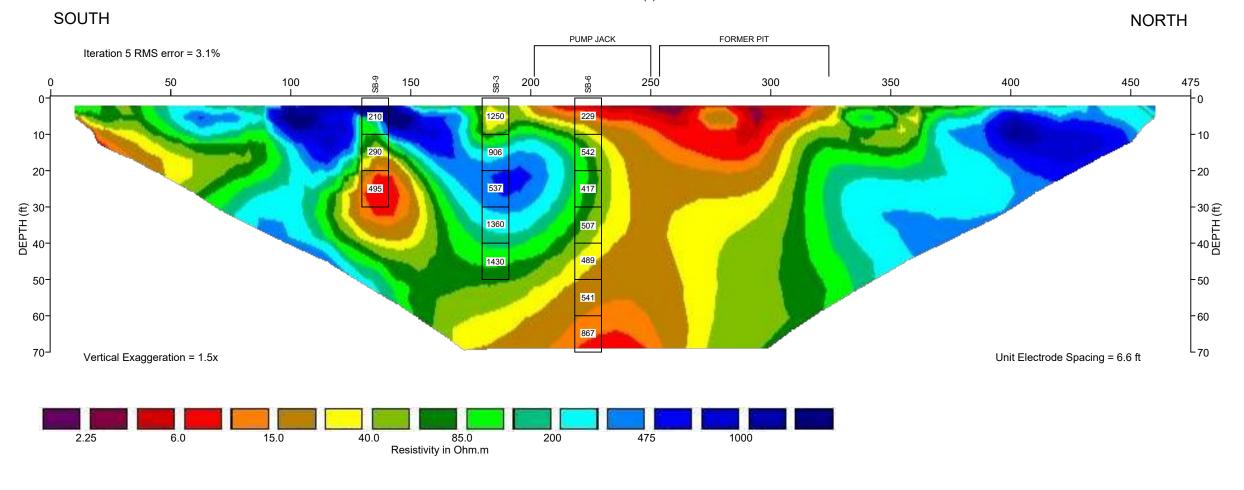
CVU 47H - LINE 1 INVERSE MODEL RESISTIVITY SECTION

CEMC
LEA COUNTY, NEW MEXICO
CENTRAL VACUUM UNIT No. 47H
GEOPHYSICAL INVESTIGATION
ELECTRICAL RESISTIVITY SURVEY RESULTS

The electrical resistivity results for the survey line are presented on Figure 5. These results are based on the measured apparent resistivity values for various depths along the survey line. Calculations of measured apparent resistivity values include the type of ER array (Wenner), the electrode spacing, and raw field data (i.e., applied current and measured voltage for each data point).

The measured apparent resistivity data were processed with the inversion program RES2DINV, to yield the modeled resistivity section presented on Figure 5. The modeled section represents the resistance of earth materials in the shallow subsurface, and thus provides an interpretation of the overburden sequences and areas of suspected brine impacts along the survey line. The highest resistivity values are colored dark blue, while areas of low resistivity (or conversely, high conductivity) are colored yellow to red. All remaining intermediate responses correspond to the color scale presented on the bottom of each section.

The colored plot reveals that the contour intervals ranged from 6.0 to approximately 1,000 Ohm.meters (Ohm.m). The intermediate contour intervals were determined by applying a normalized distribution curve to the data such that the entire range of responses could be identified by discrete colors. The interpreted colored contoured plot suggests that suspected brine-impacted soils can likely be characterized by modeled responses of approximately 6.0 to 40 Ohm.m.

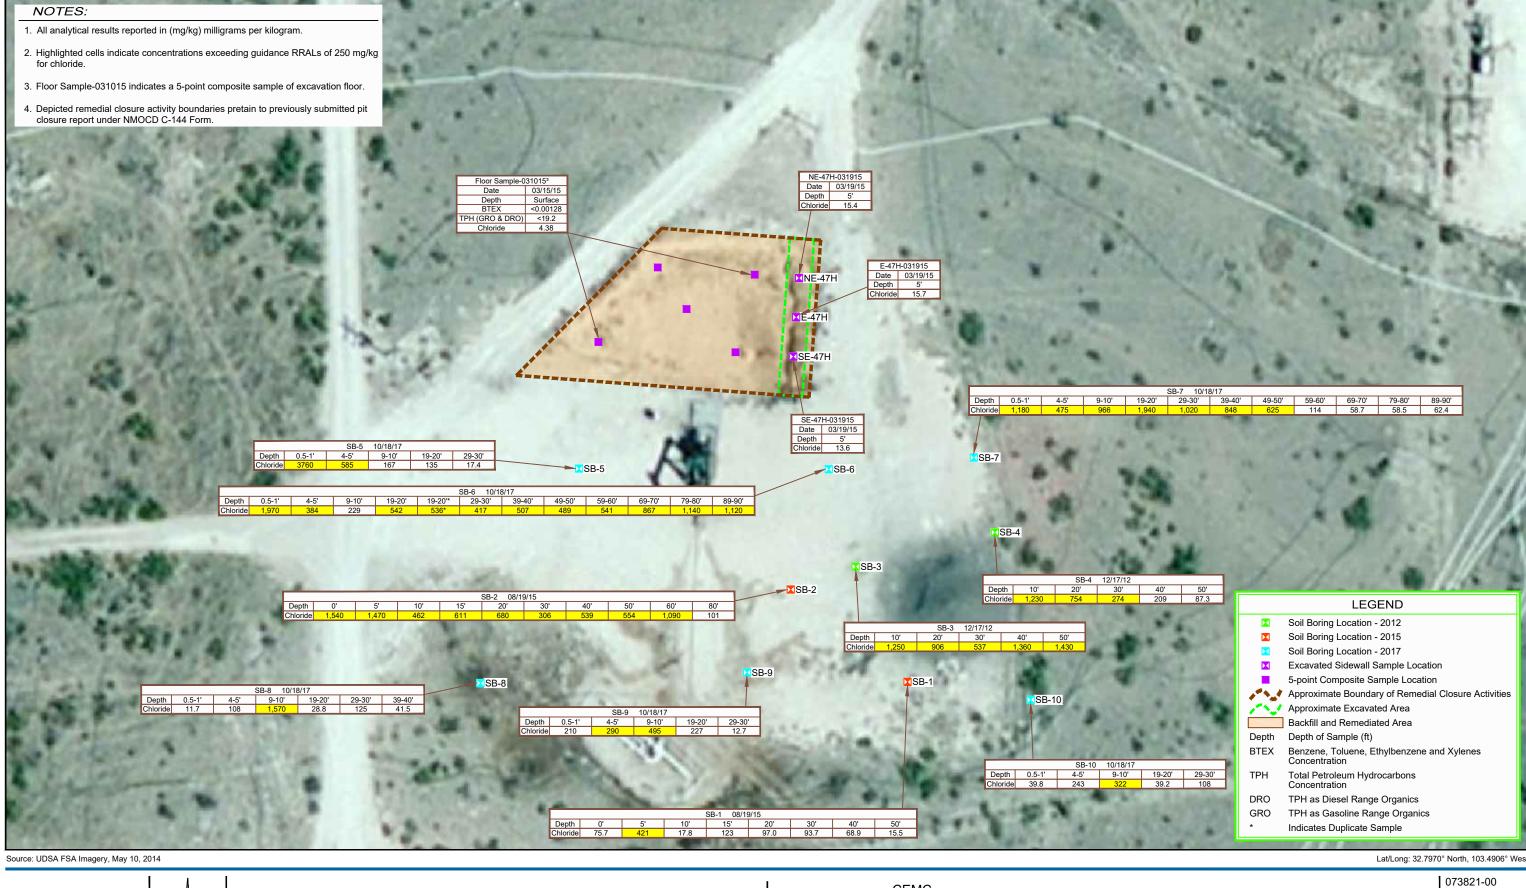
FIGURE 6

Sample ID SB-4 12/17/12 Sample Date
Depth 10' Sample Depth (ft)
Chloride 1,230 Sample Result (mg/kg)

CHLORIDE ANALYTICAL RESULTS MAP

Analytical results associated with the soil boring activities of October 2017 are discussed in the following section. Based on analytical results from the shallow soil samples (below Site RRALs), some deeper soil samples were not analyzed at the direction of GHD. Analytical results are presented in Table 1, shown in map view on Figure 6, and are summarized below:
