**Re: Site Assessment and Remediation Summary Report  
Phillips66 Jal Truck Station Crude Release  
NMOCD #1RP-5165  
Lea County, New Mexico**

On behalf of Phillips 66 Pipeline, LLC (Phillips66), GHD Services Inc. (GHD) is providing this Site Assessment and Remediation Summary letter report for the above-referenced site. The Jal Truck Station site (hereafter referred to as the “Site”) is located on Federal land within Unit Letter A, Section 6, Township 24S, and Range 37E in Lea County, New Mexico. Geographical coordinates for the Site are 32.25327° North, 103.19699° West (**Figure 1**). The Site consists of two approximately 300 barrel (bbl) above ground storage tanks (ASTs) inside a containment berm, a truck dump station and pipeline pumping equipment (**Figure 2**). Across Deep Wells Road, to the north of the Site, is the Jal 4 Booster Station.

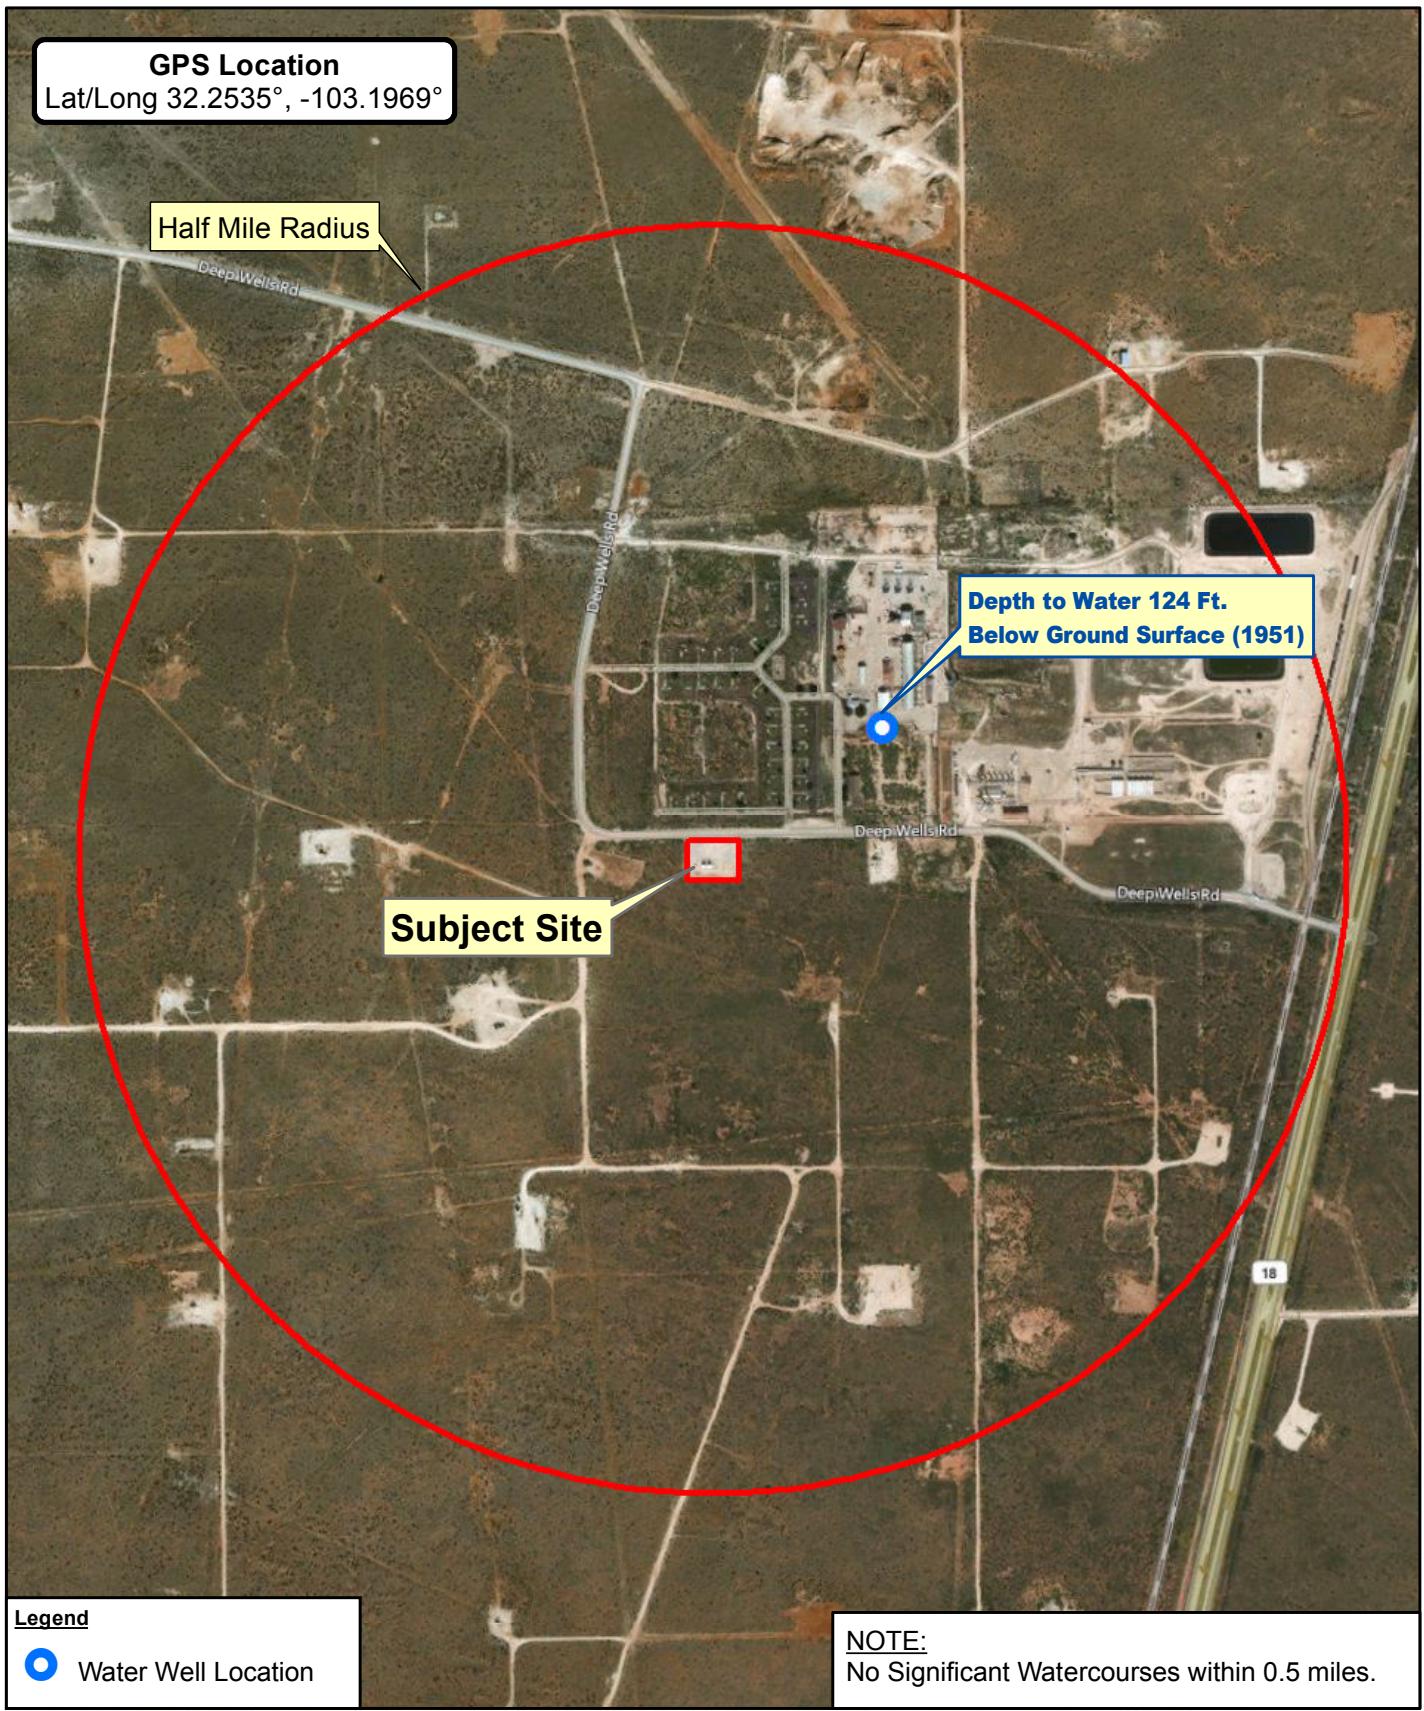
FIGURE 2

The nearest well to the Site, as determined by a well record search on the New Mexico Office of the State Engineer's (OSE) online database, is located approximately 884 feet from the release with a listed depth to water of 124 feet below ground surface (ft bgs) was (See Attachment 2). A list of additional wells within ½-mile of the Site is included in Attachment 2. There is no *significant watercourse* as defined in 19.15.17.7 NMAC within ½ mile of the Site (see Figure 2). The facility across Deep Wells Rd. to the north includes some plant process water ponds, but these are not sources of fresh water. Based on a >100 foot depth to water beneath the Site, as per Table 1 of 19.15.29 NMAC, closure criteria for chloride are 600 milligrams

WATER SOURCES MAP

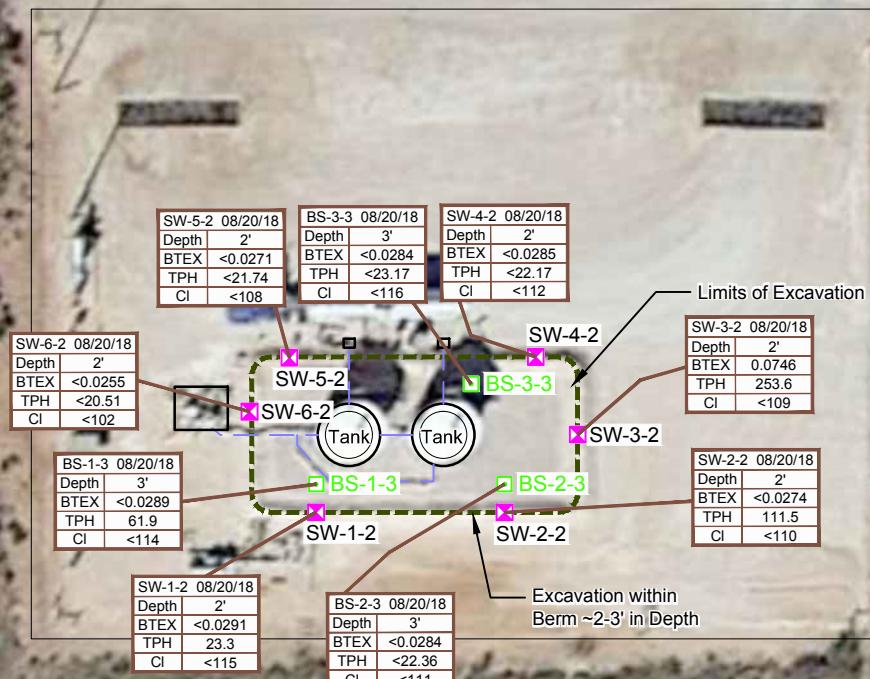
FIGURE 3

A summary of sample locations and analytical results is depicted in Figure 3. Sample locations were not geo-referenced at the time of collection, however, the locations are marked out on the photos (taken on July 20 and July 27, 2018) with approximate GPS coordinates and sample date indicated (see Figure 4).

### SAMPLE LOCATION MAP

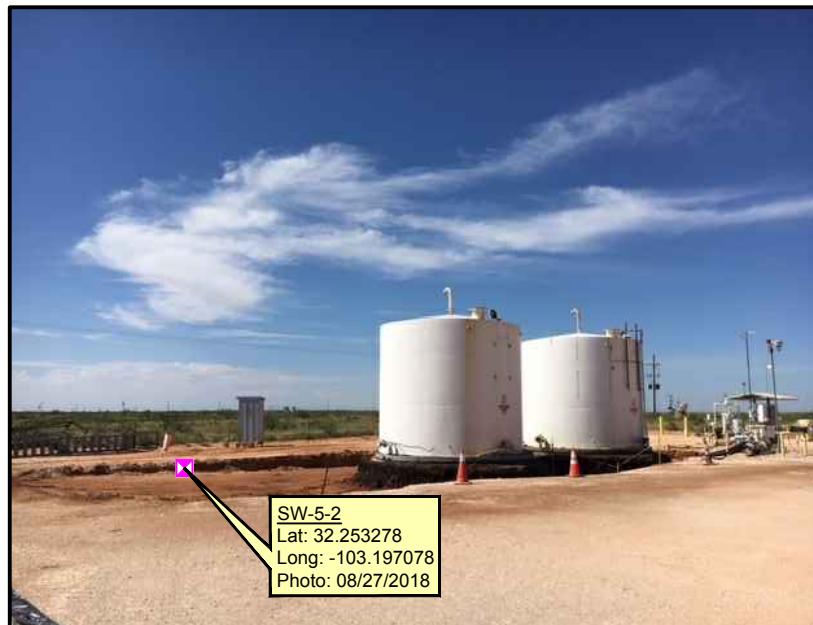
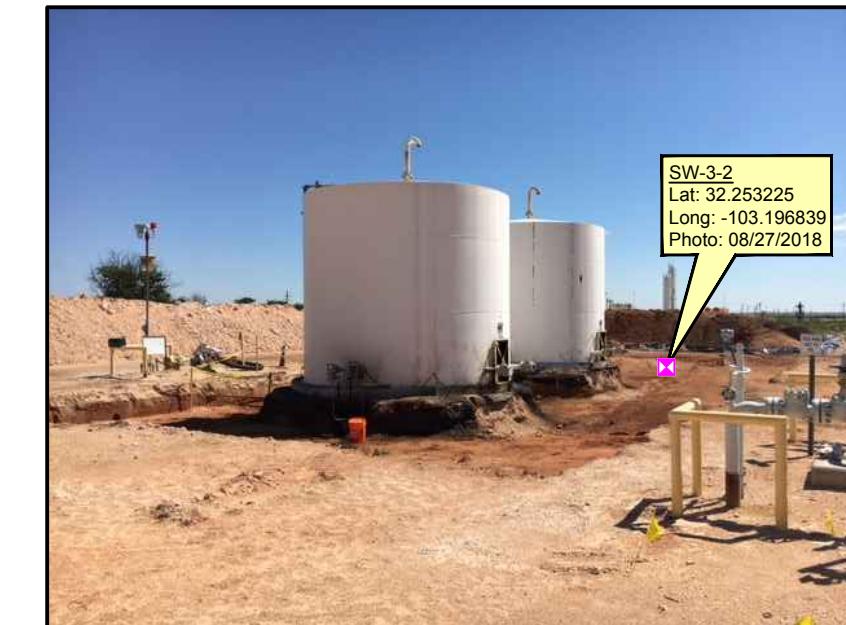
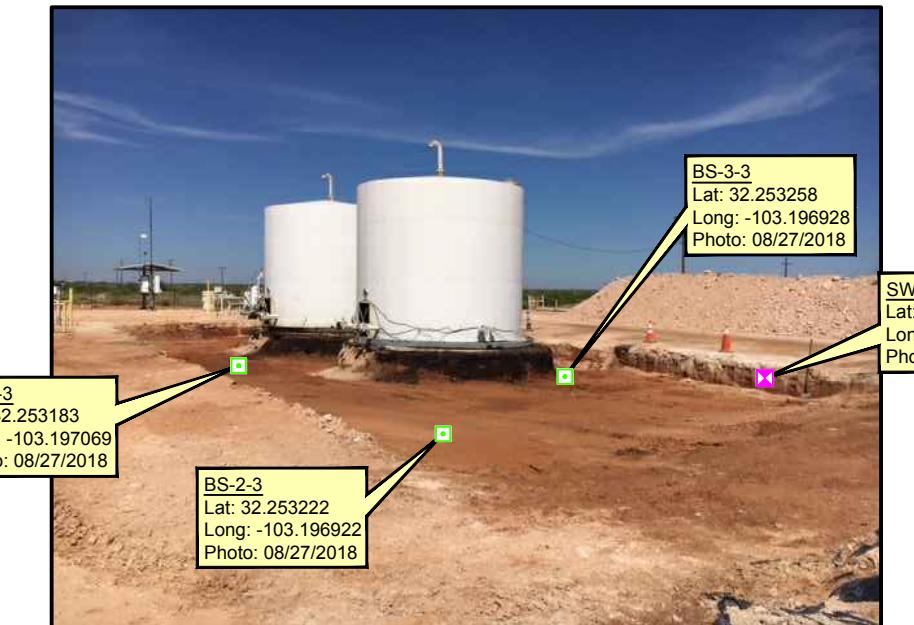
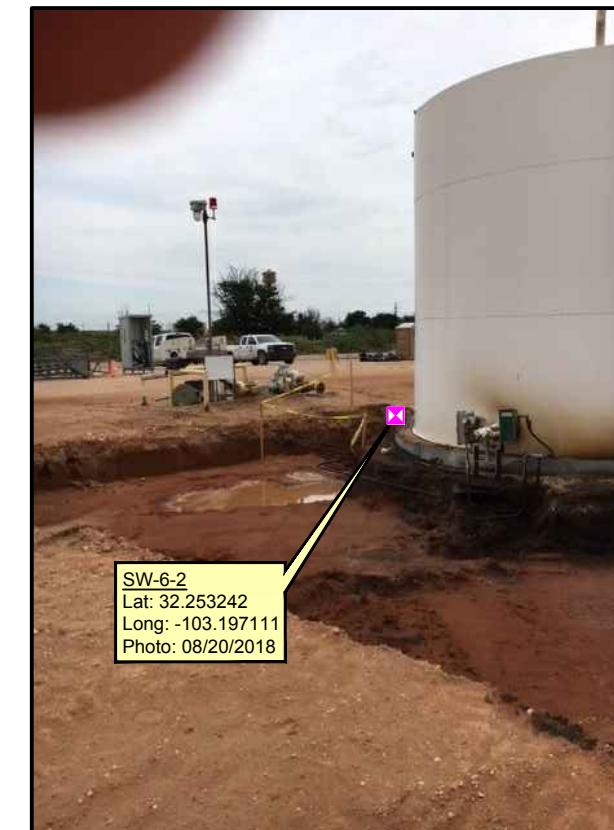
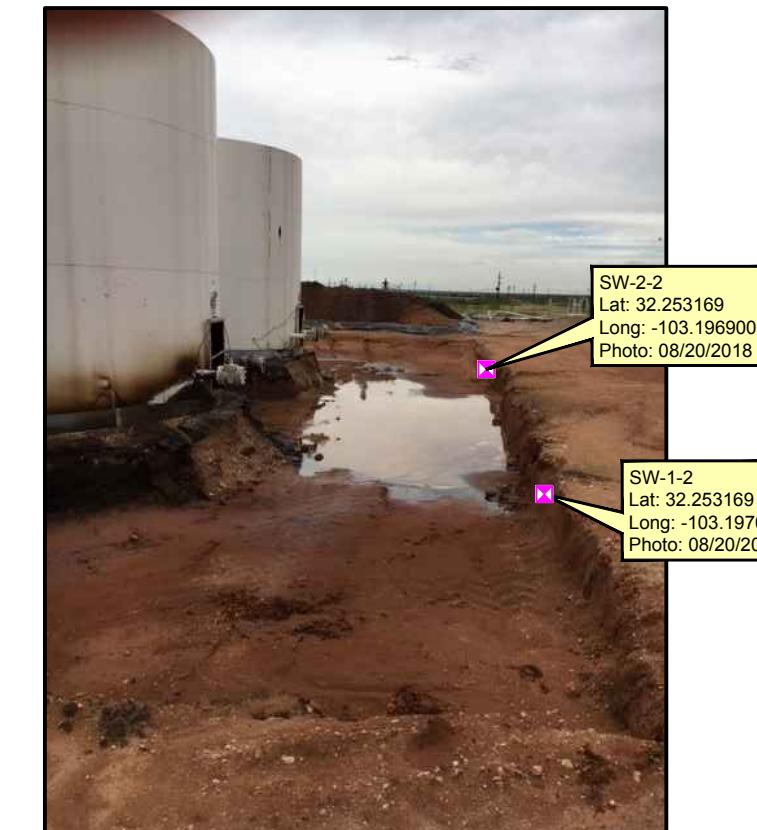
FIGURE 4

1. ALL SAMPLES COLLECTED AUGUST 20, 2018.
2. PHOTOS TAKEN ON DATES NOTED.

PHOTO LOG OF SAMPLE LOCATIONS
