# Soil Remediation Closure Report

COG Fascinator Fee Com #2H  
Lea County, New Mexico  
NMOCD 1RP-5035

Plains All American  
Pipeline, L.P.

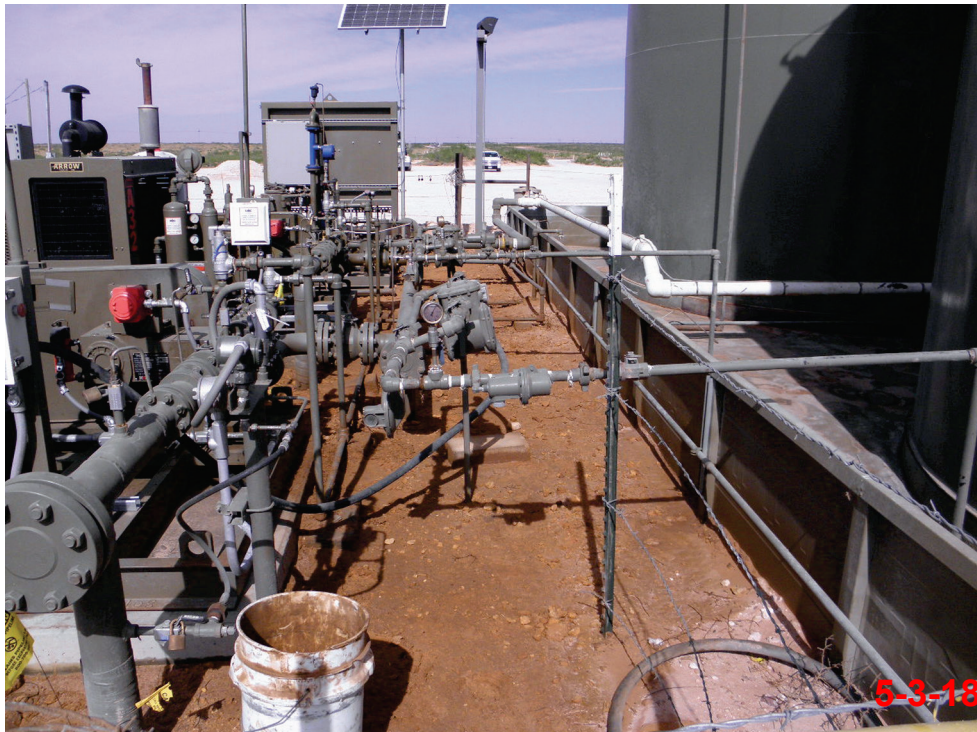
Photo 3 – View of impacted soil along northern edge of LACT Unit facing west

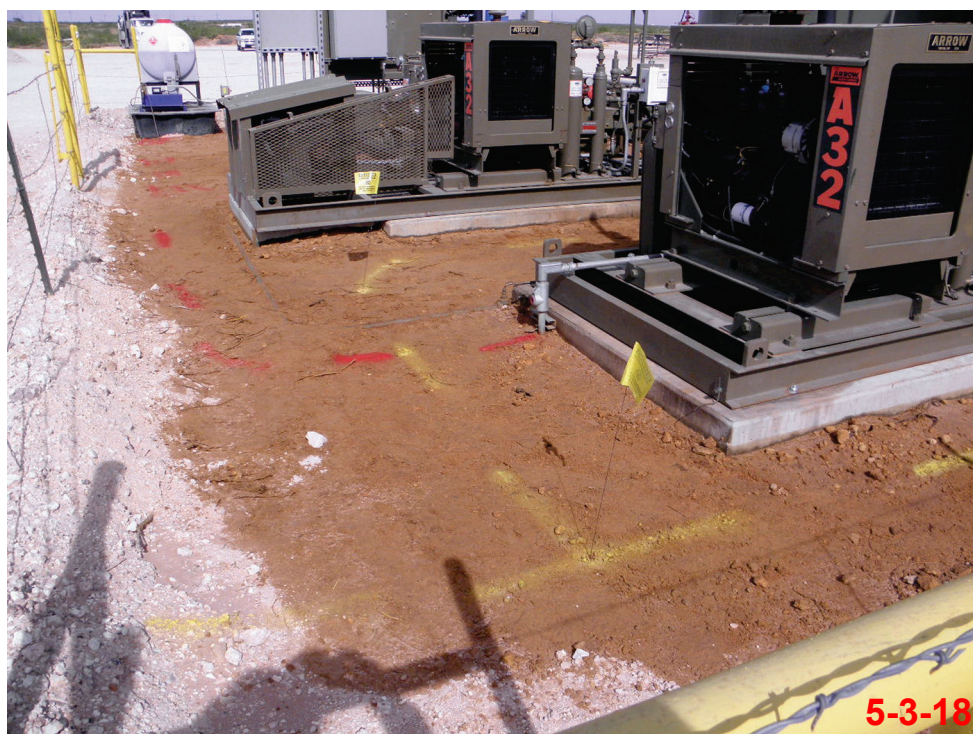
Photo 5 – View of impacted soil along southern edge of LACT Unit facing west

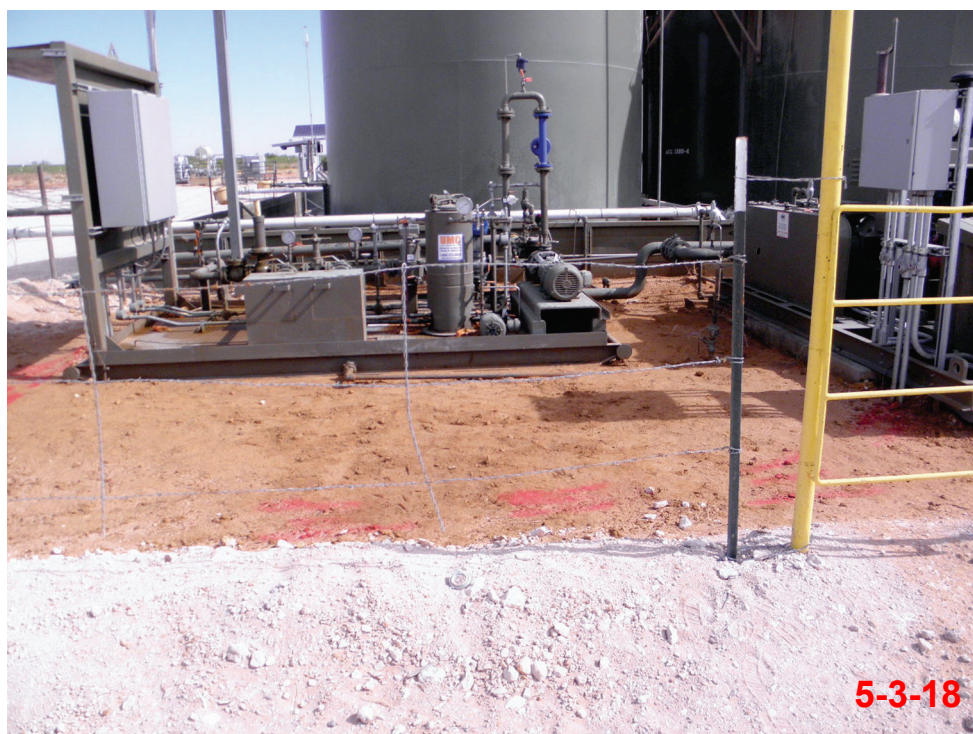
Photo 7 – View of impacted soil around LACT Unit equipment facing north

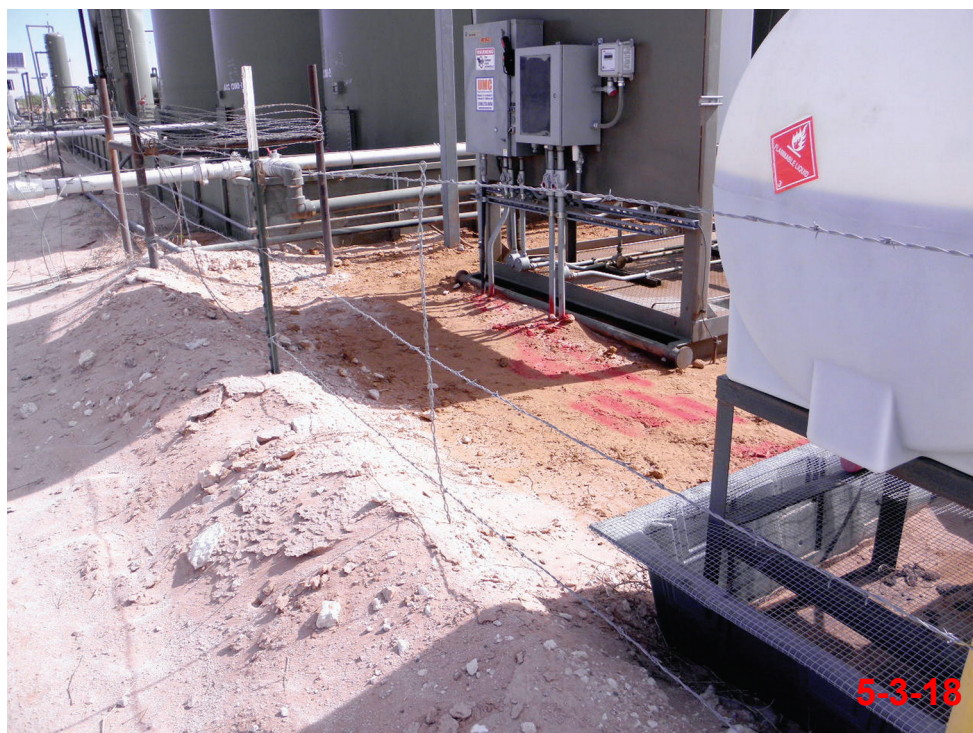
Photo 8 – View of impacted soil along western edge of LACT Unit facing north-northeast

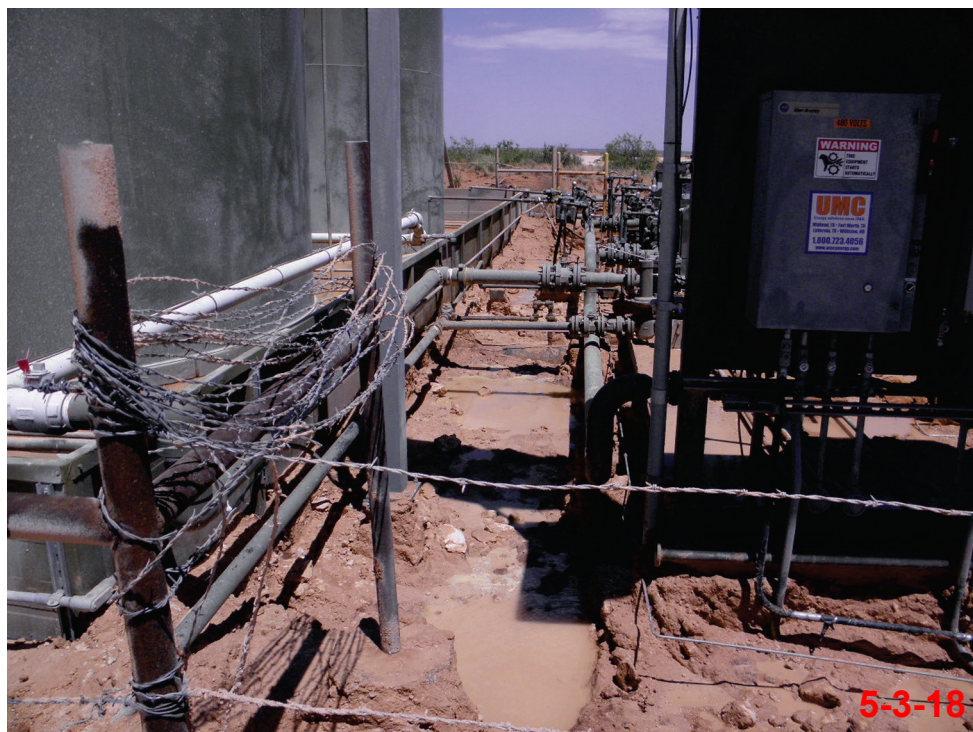
Photo 9 – View of hydrovac activity along northern edge of LACT Unit facing east

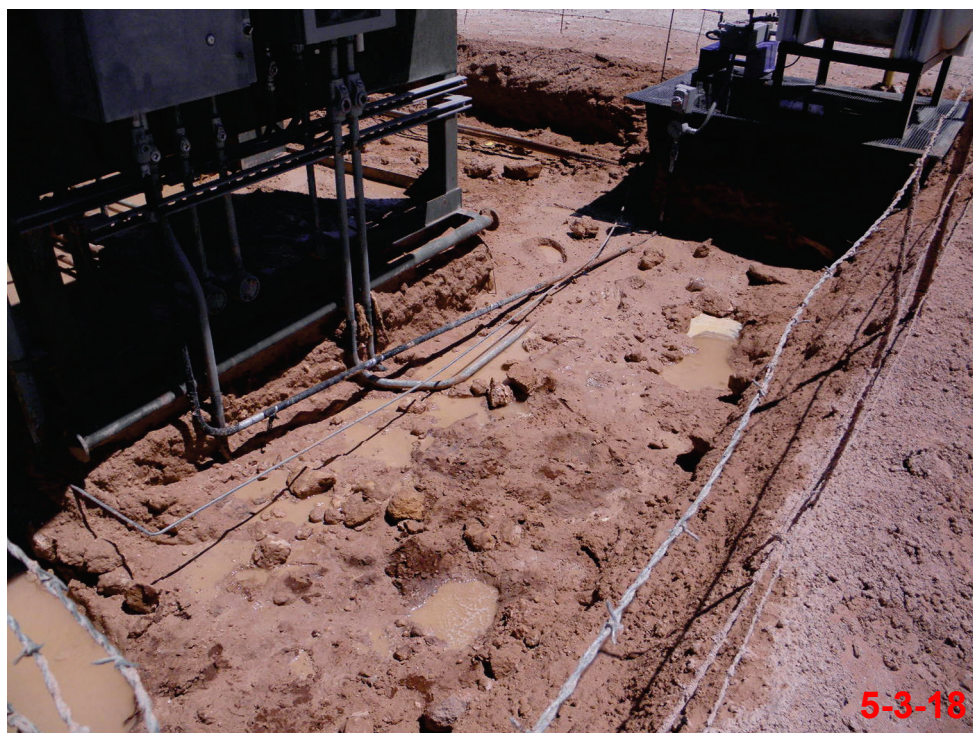
Photo 10 – View of hydrovac activity along western edge of LACT Unit facing south

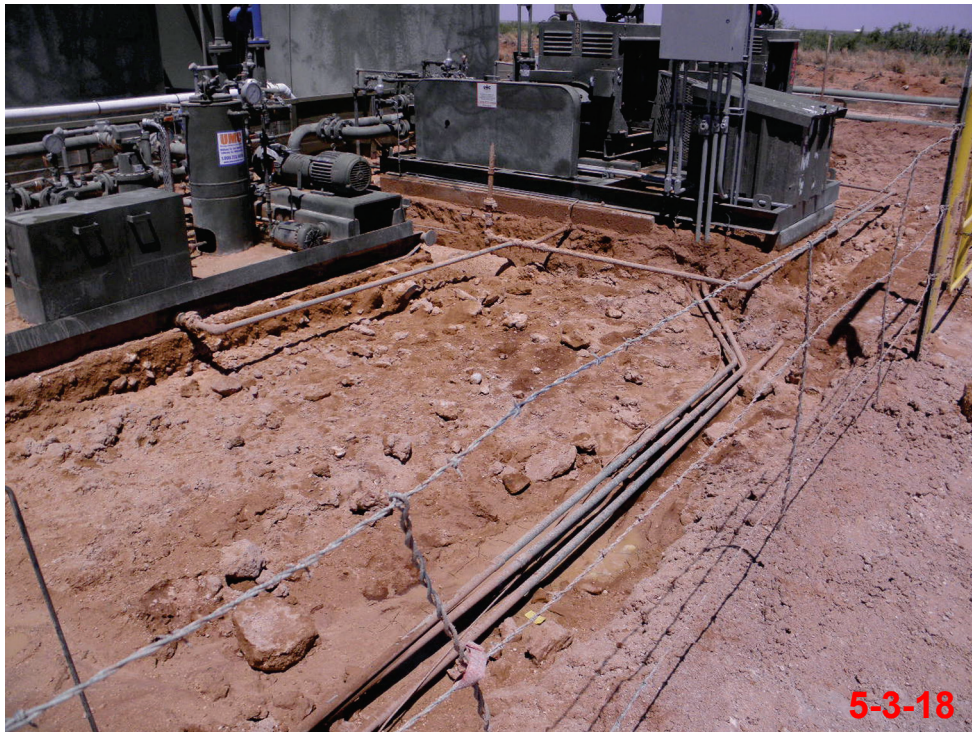
Photo 11 - View of hydrovac activity along southern edge of LACT Unit facing east

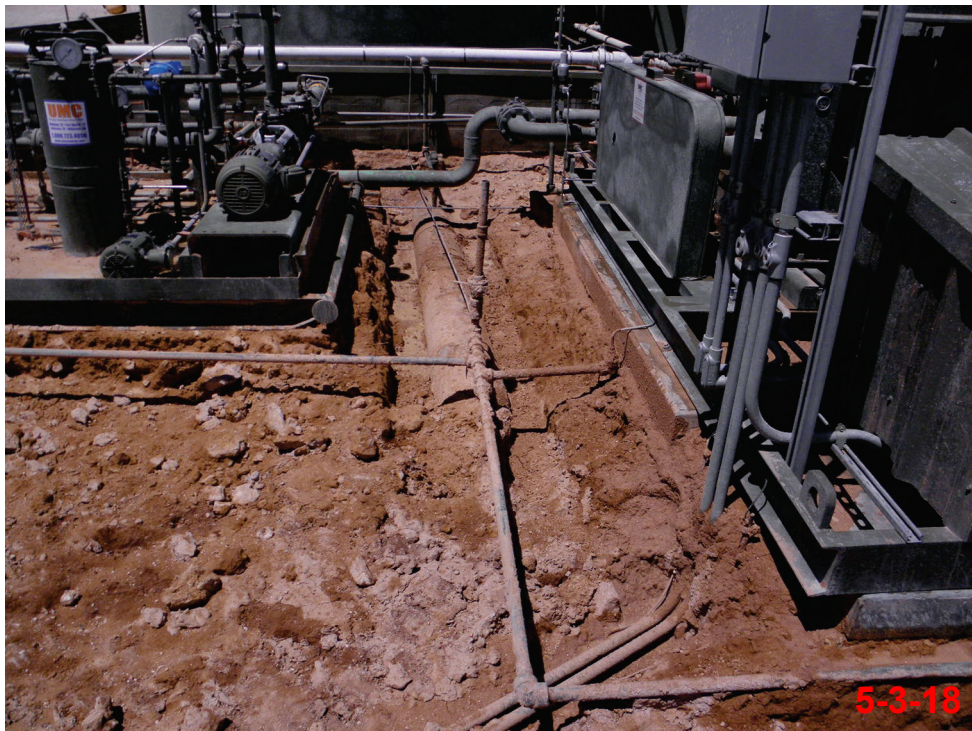
Photo 12 – View of hydrovac activity around LACT Unit equipment facing north

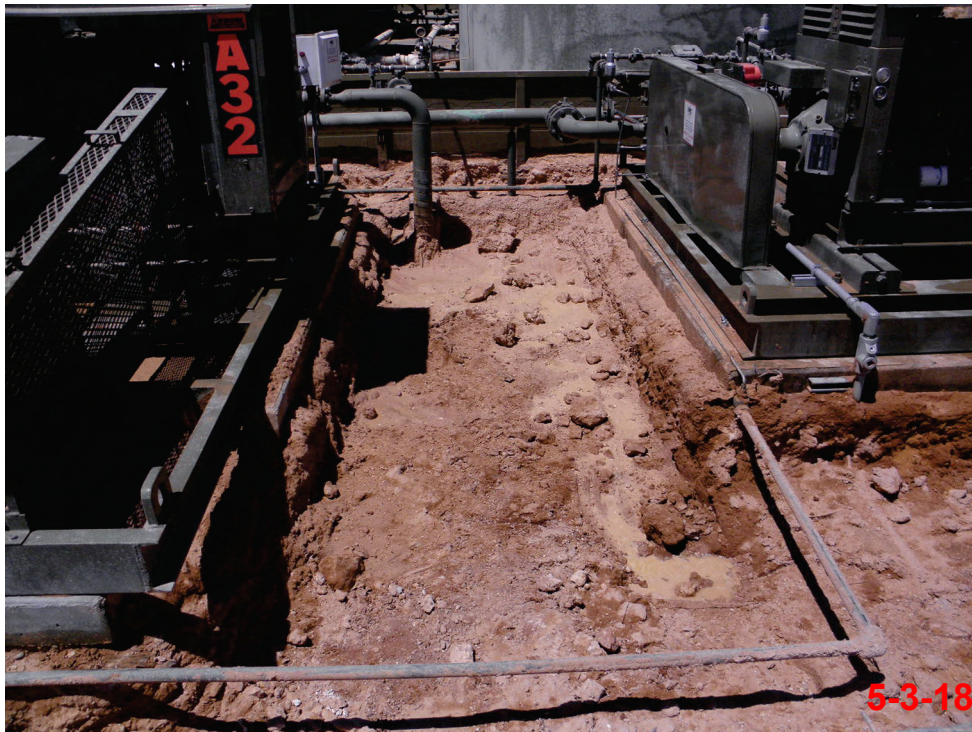
Photo 13 – View of hydrovac activity around LACT unit equipment facing north

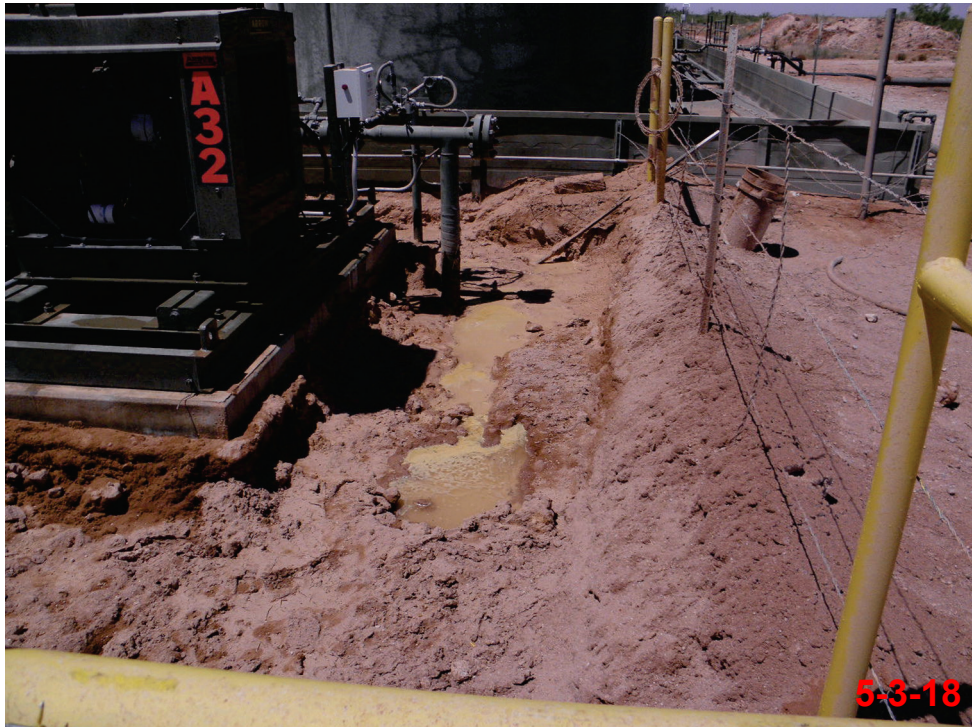
Photo 14 – View of hydrovac activity around eastern edge of LACT Unit facing north

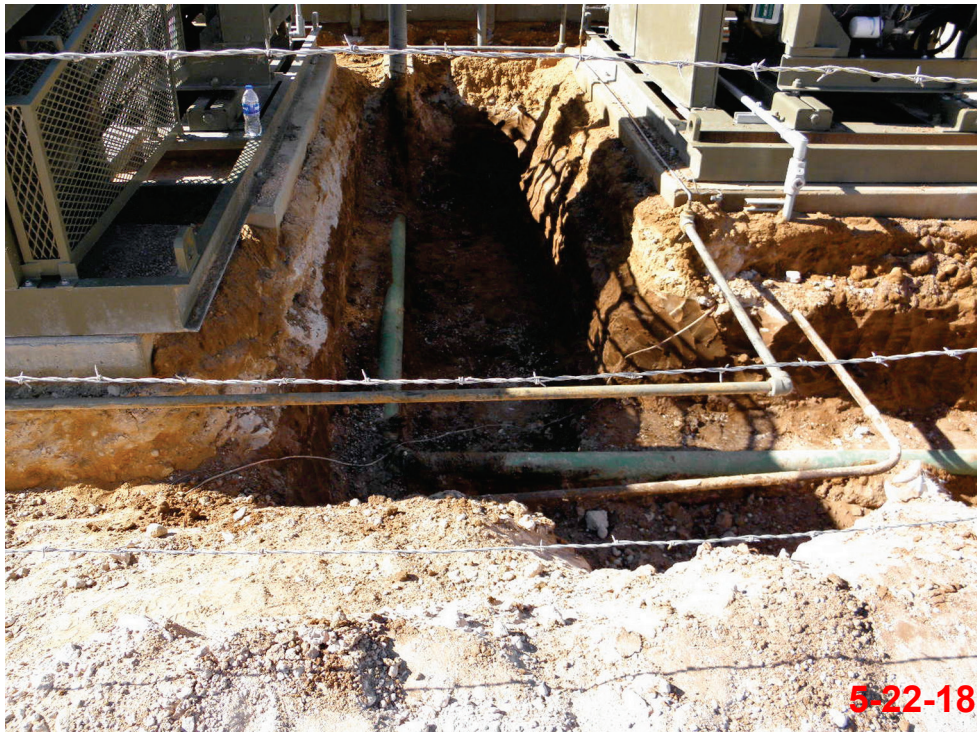
Photo 15 – View of hand digging activity around LACT Unit equipment facing north

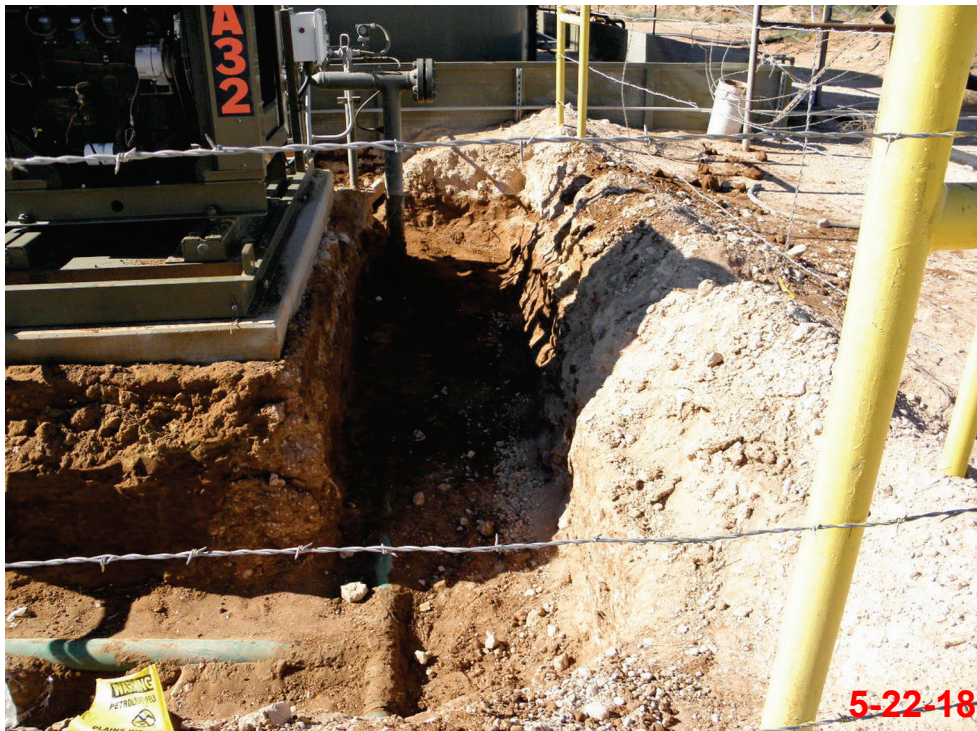
Photo 16 – View of hand digging activity along eastern edge facing north

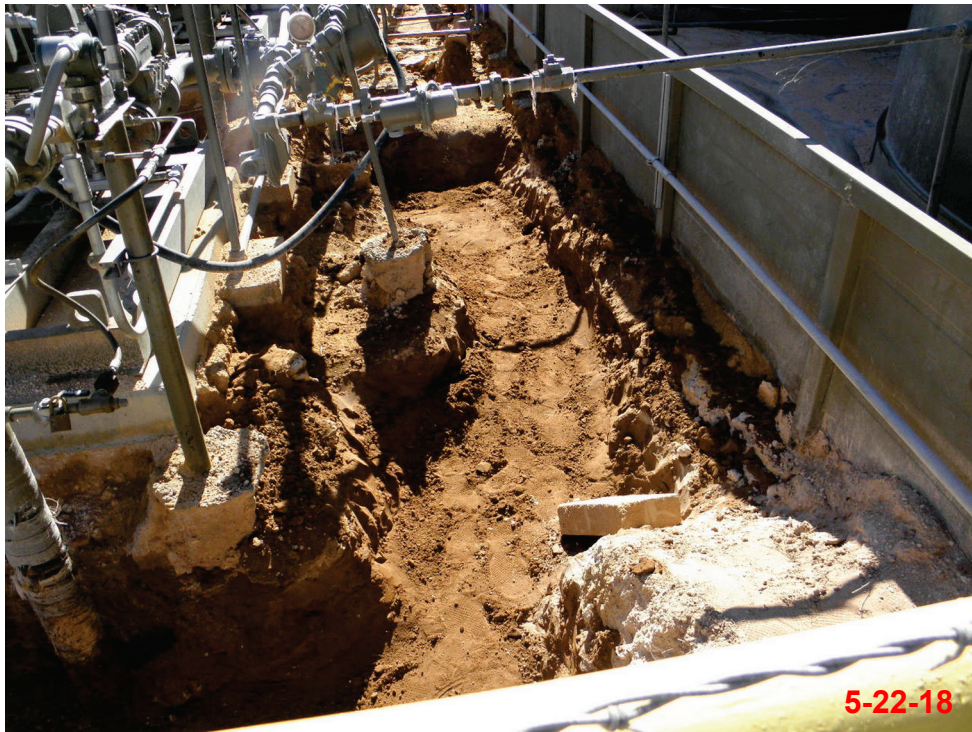
Photo 17 – View of hand digging activity along northern edge facing west

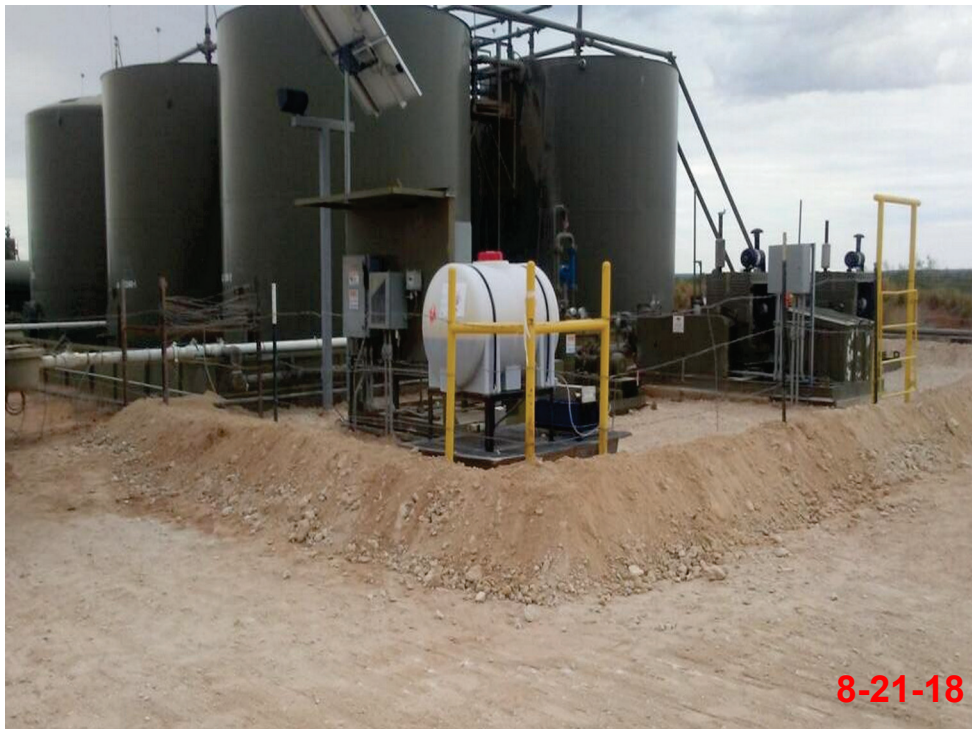
Photo 18 – View of backfilled and restored LACT Unit area

Backfilling activities at the Site began on August 11, 2018, with the transportation of clean soil materials from an off-Site source; which was provided by Gandy. Approximately 52-cy of clean screened caliche material was emplaced into the remedial excavation. Gandy utilized heavy equipment and hand tools to backfill the construction affected areas within the bermed containment. Remedial activities were concluded on August 12, 2018. Site photographs documenting work activities are presented in Appendix B.
