R. T. HICKS CONSULTANTS, LTD.

RE: 1RP-4624, Pride Energy Company
NM 87 State #001 (Wellhead), API#: 30-025-23655
Section 33-14S-34E: Unit K, Lea County, New Mexico
Site Characterization Report and Remediation Plan

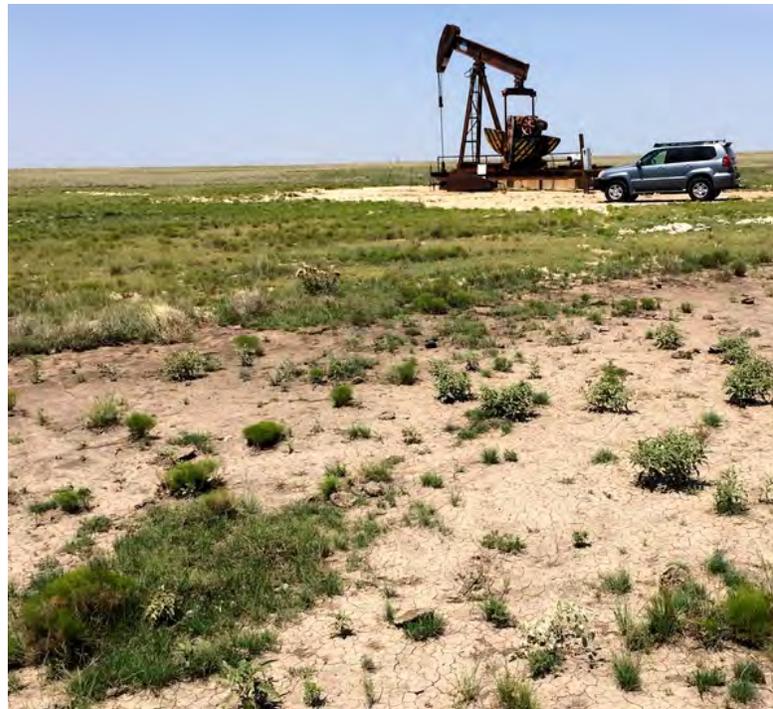
- SE Pasture
Chloride, Benzene, BTEX, and TPH concentrations are below Closure Criteria.
No reclamation is necessary.

Photo 1: SE Pasture viewing northeast toward wellhead. Area shows vegetation and evidence of cattle wallows where water collects. Aug. 15 2018.

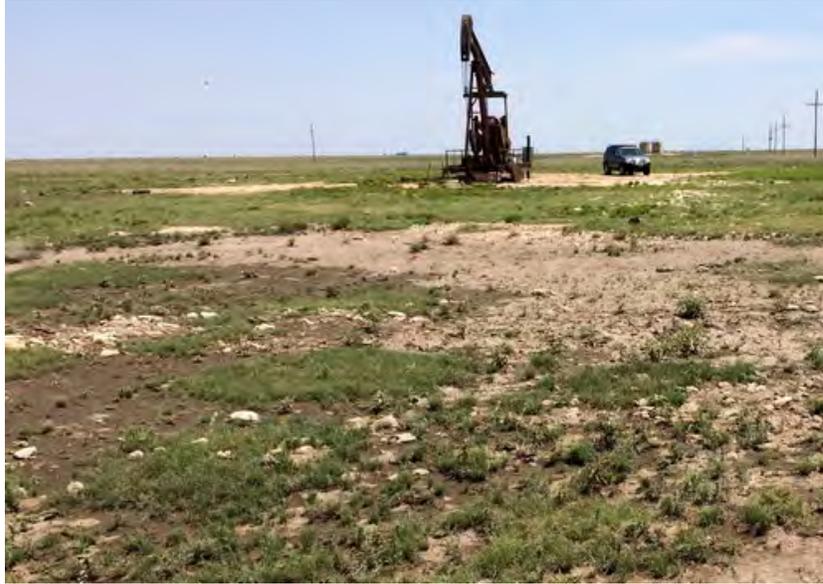
- SW Pasture
Chloride, Benzene, BTEX, and TPH concentrations are below Closure Criteria.
No reclamation is necessary.

Photo 2: SW Pasture viewing east toward wellhead. Area shows vegetation and evidence of cattle wallows where water collects. Aug. 15, 2018

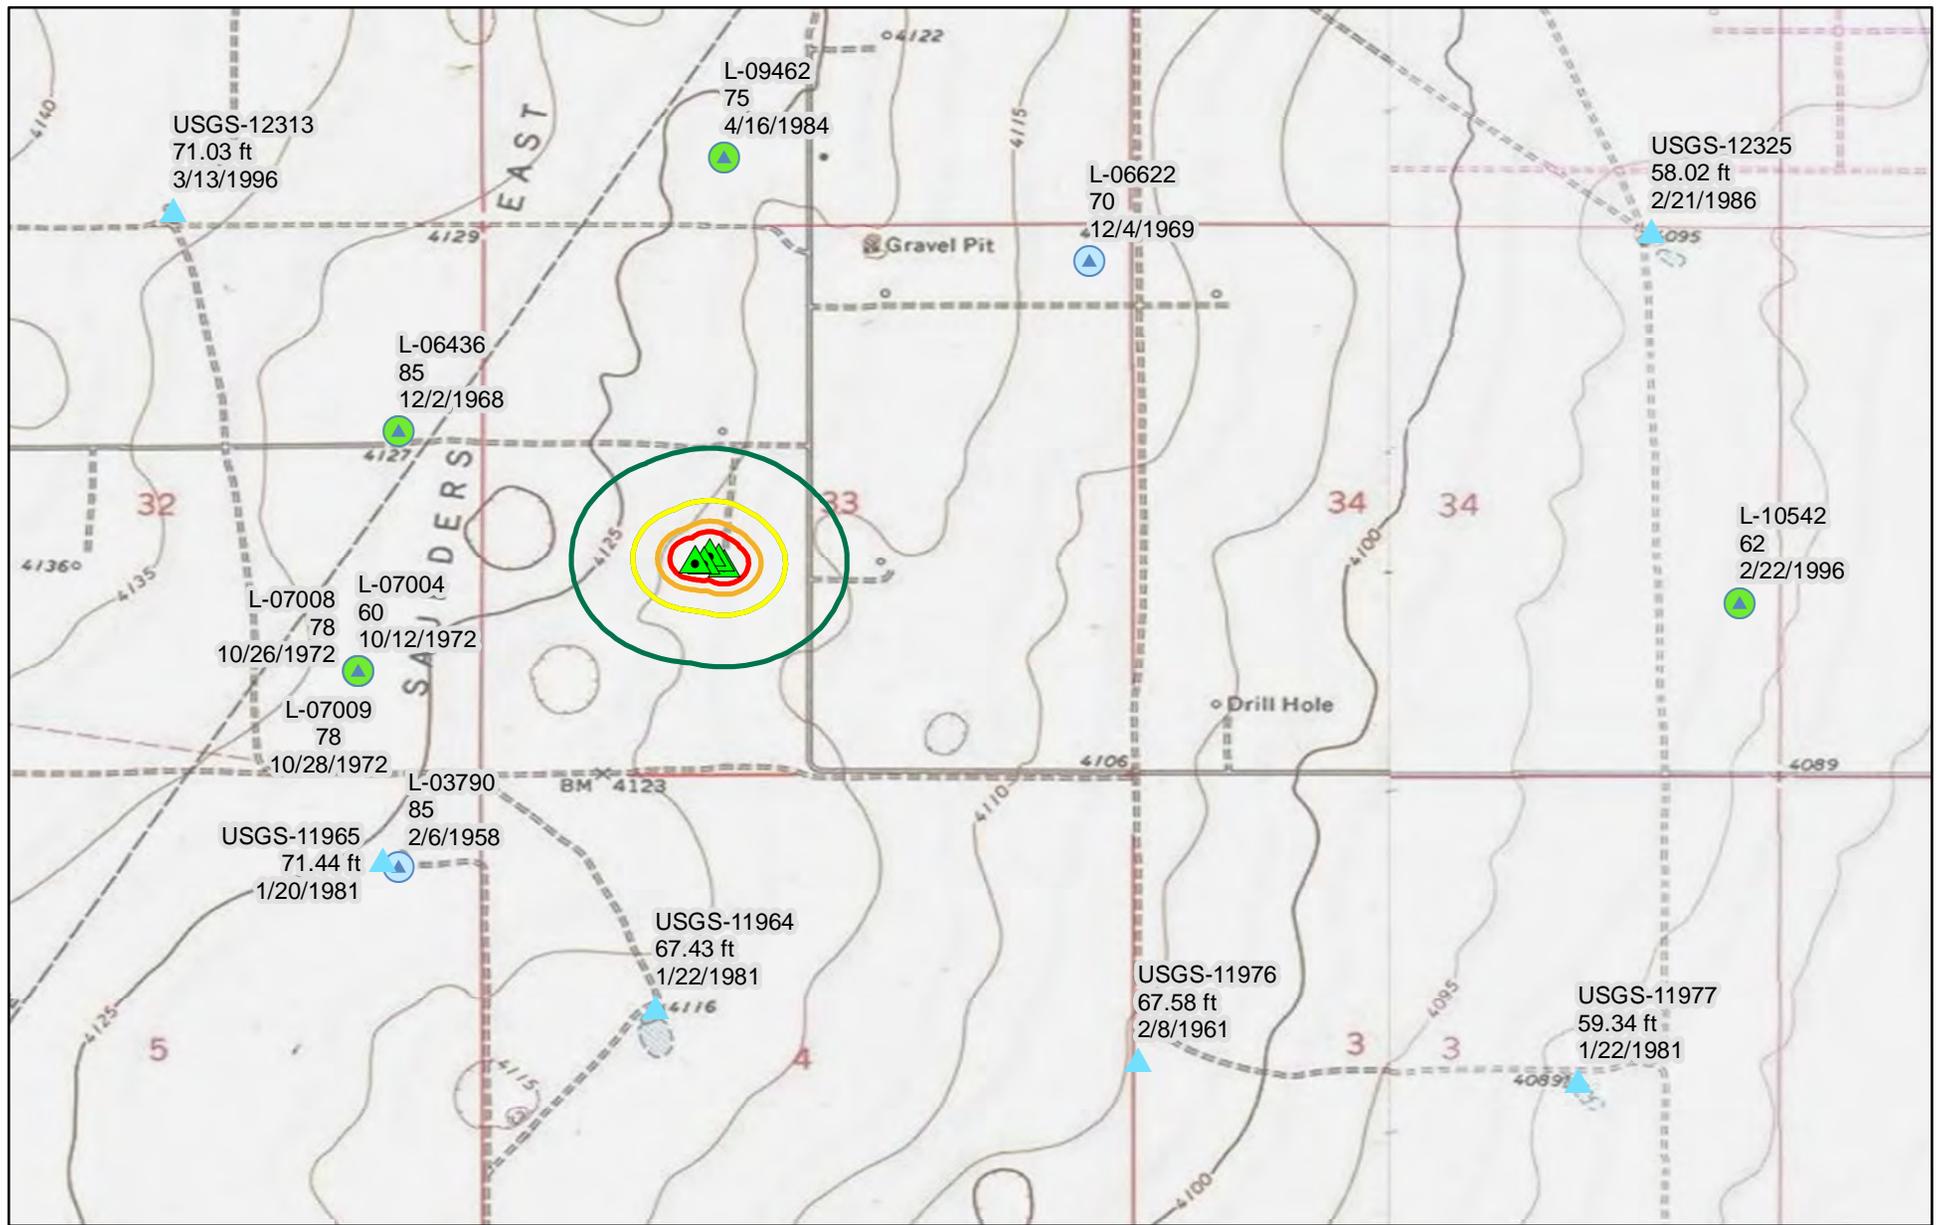
Plate 1
March 2018

Depth To Water
Pride Energy Company
NM 87 State #001 (Wellhead)

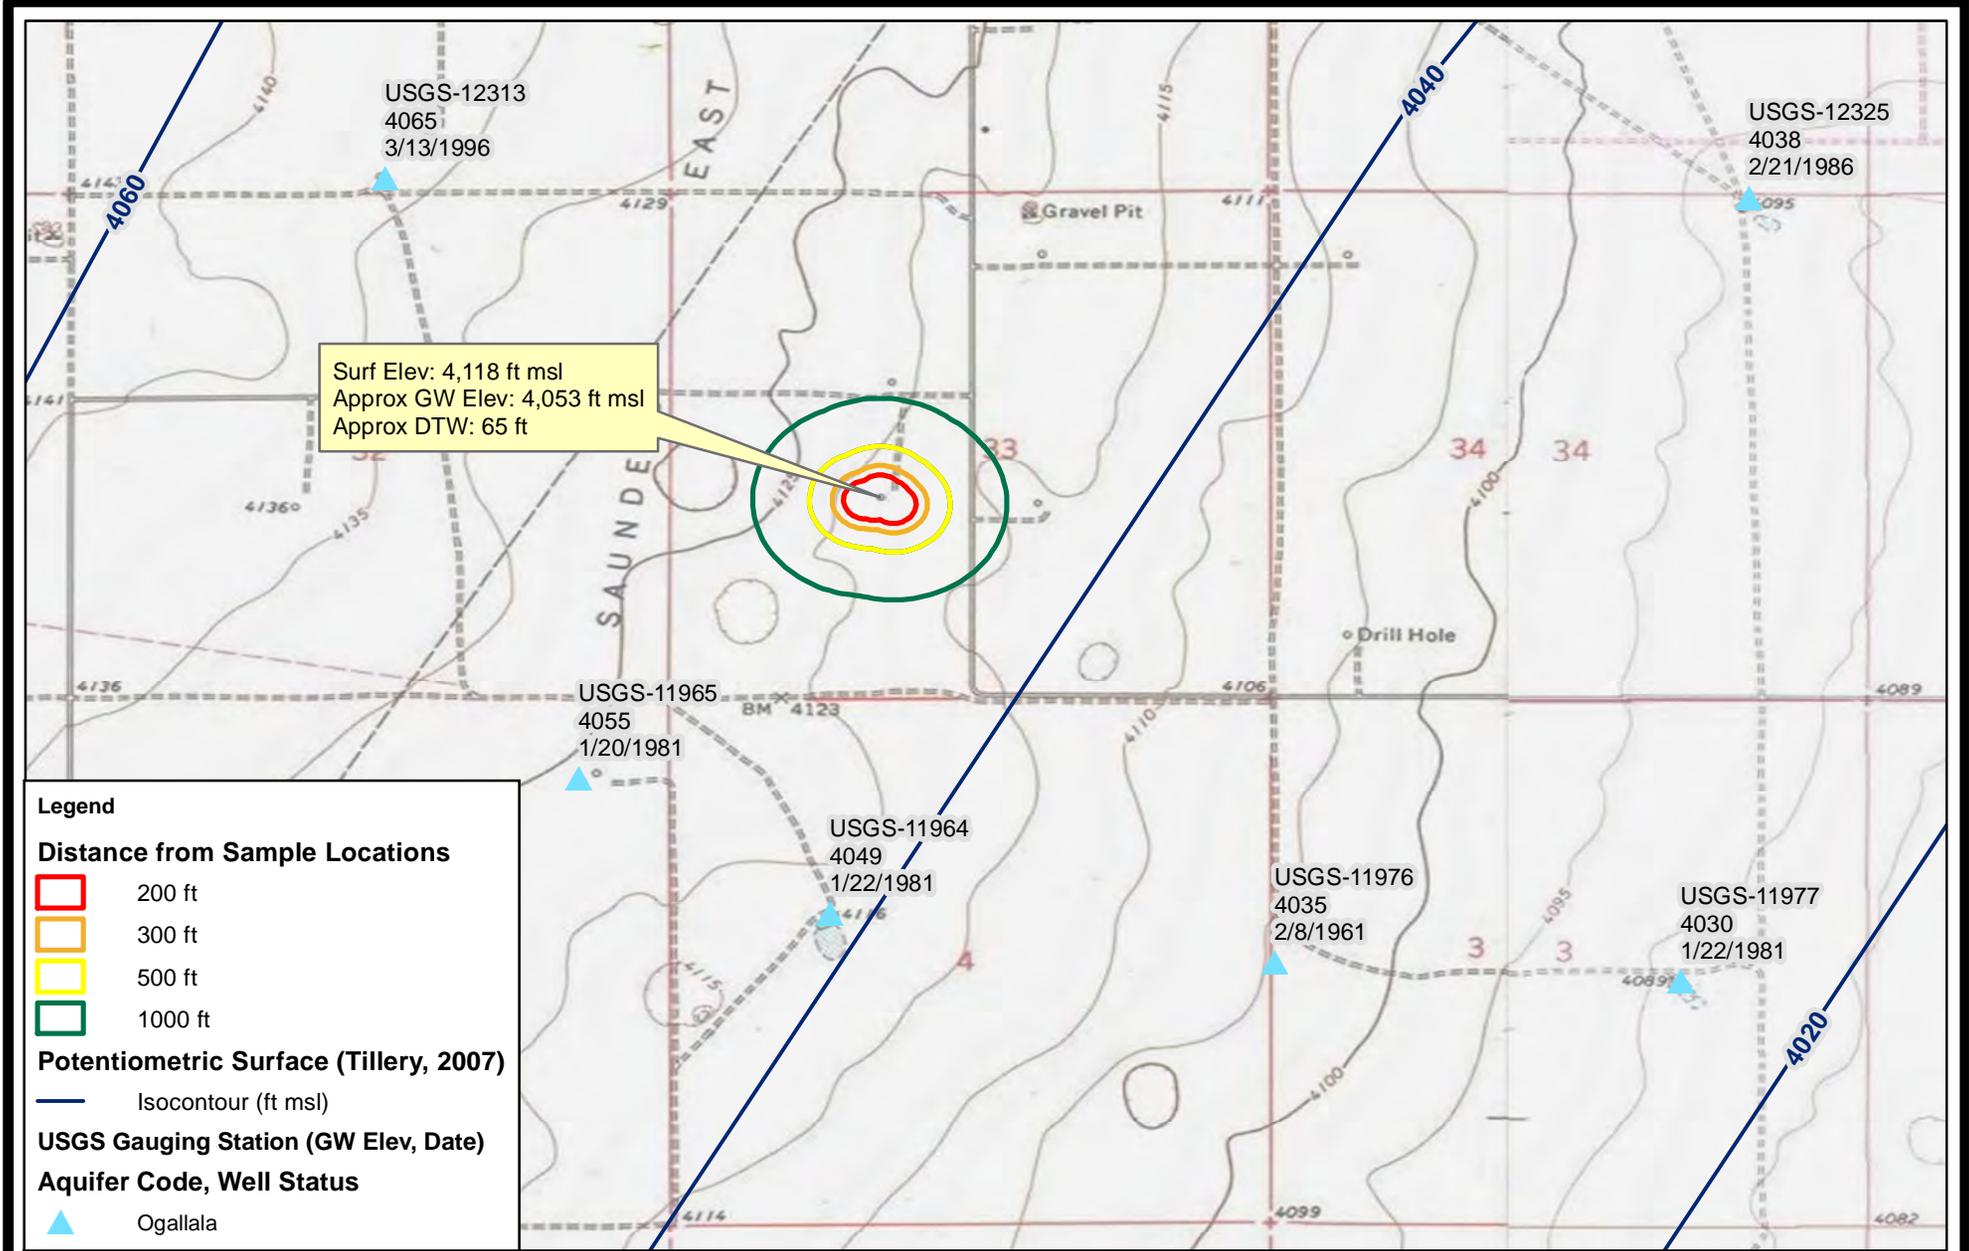
Plate 2
 March 2018

19.15.29.11.A.1-4. Plate 2 shows the depth to groundwater at the location is approximately 65-feet below ground surface; calculated from USGS 2007 potentiometric surface¹.

Potentiometric Surface and Groundwater Elevation
 Pride Energy Company
 NM 87 State #001 (Wellhead)

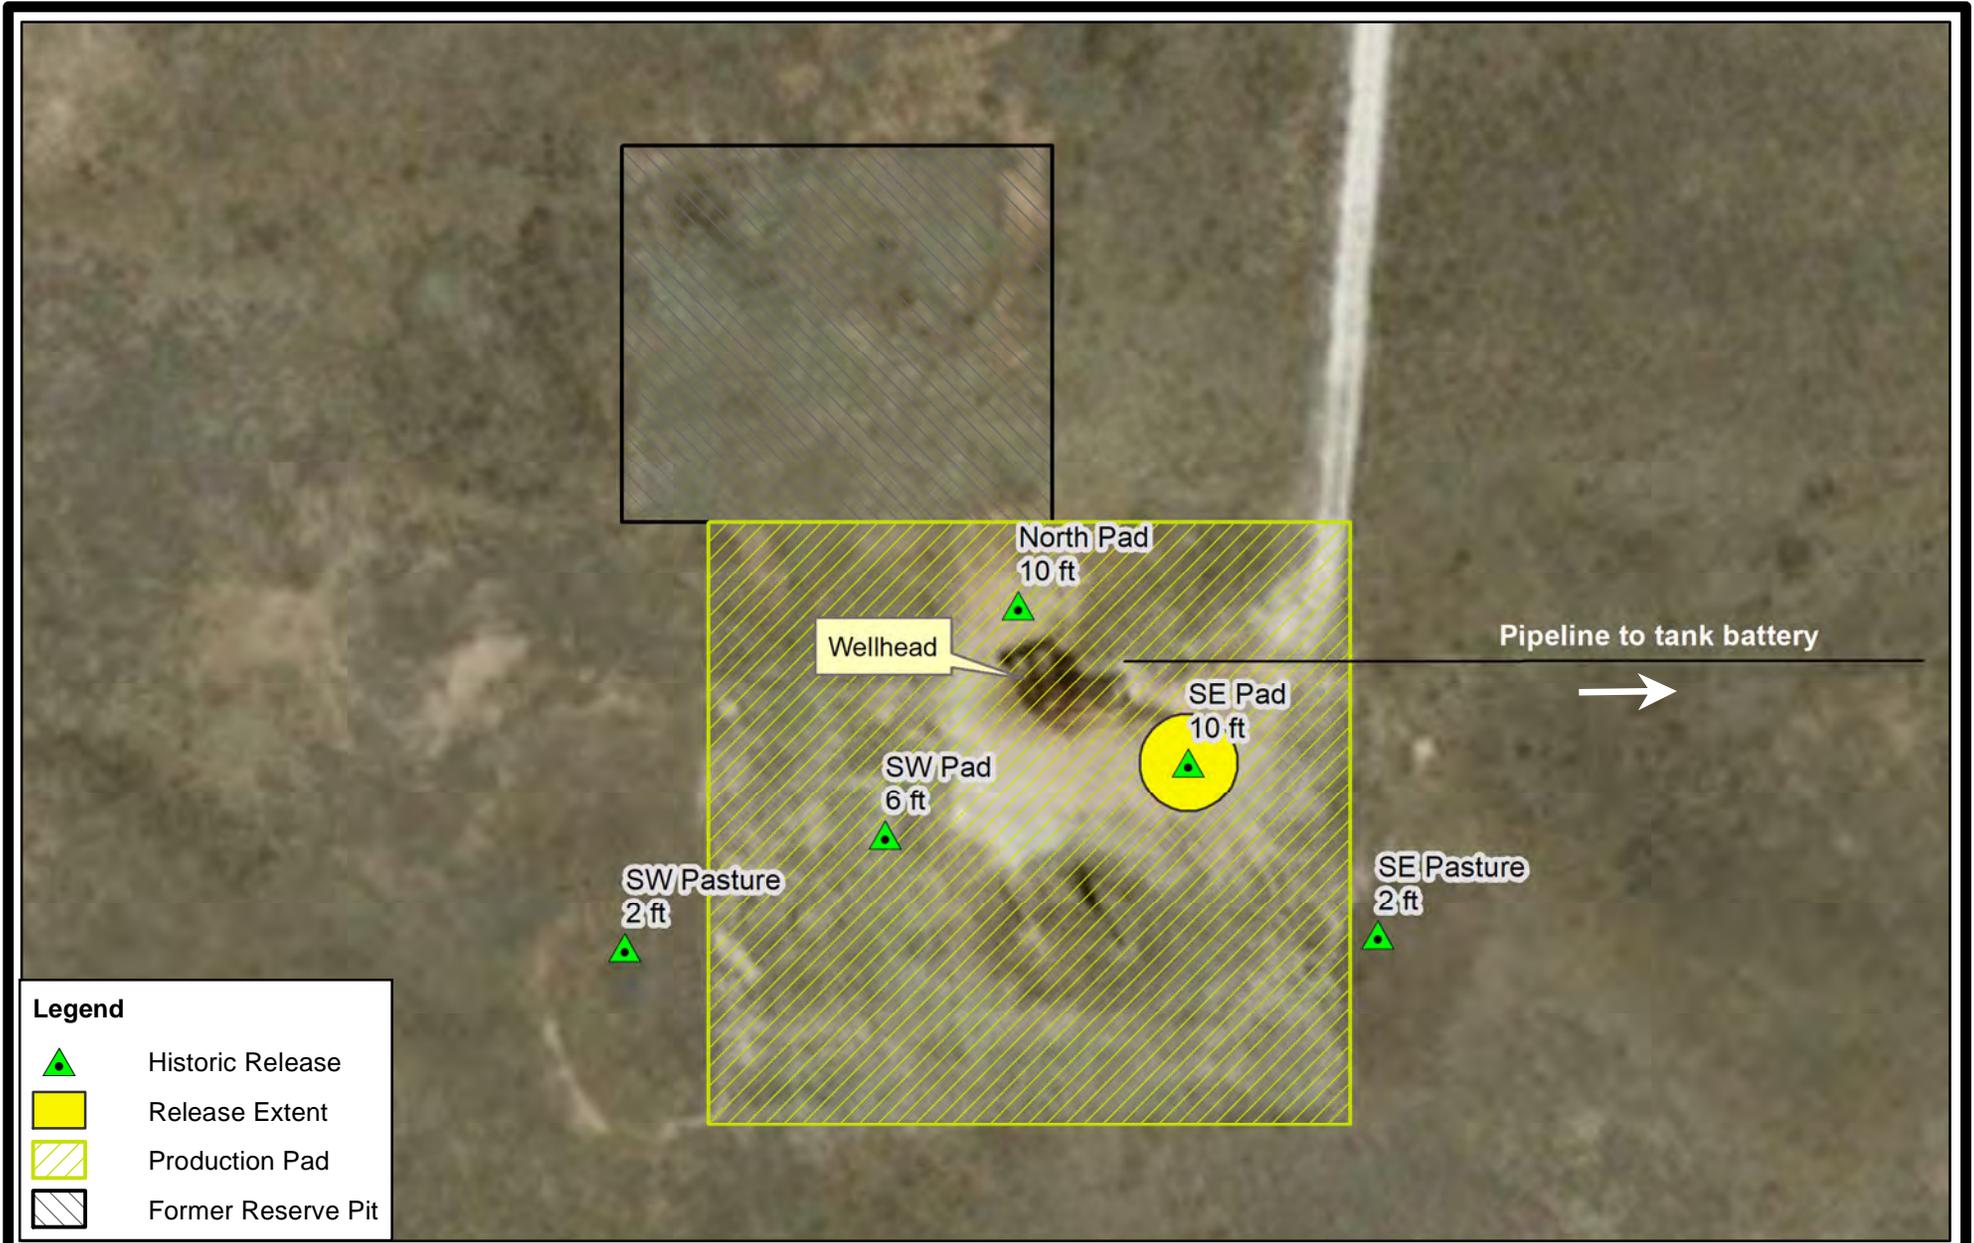
Plate 10 shows the locations of the trench and soil boring locations relative to the production pad. Plate 11 presents chloride concentration at depths between zero and 4 feet at each location during the January and April 2018 characterization activities. Appendix B discusses our January and April 2018 characterization activities.

| R.T. Hicks Consultants, Ltd 901 Rio Grande Blvd NW Suite F-142 Albuquerque, NM 87104 Ph: 505.266.5004 | Sample Locations with Total Depth (ft) (Jan & April 2018) | Plate 10 |

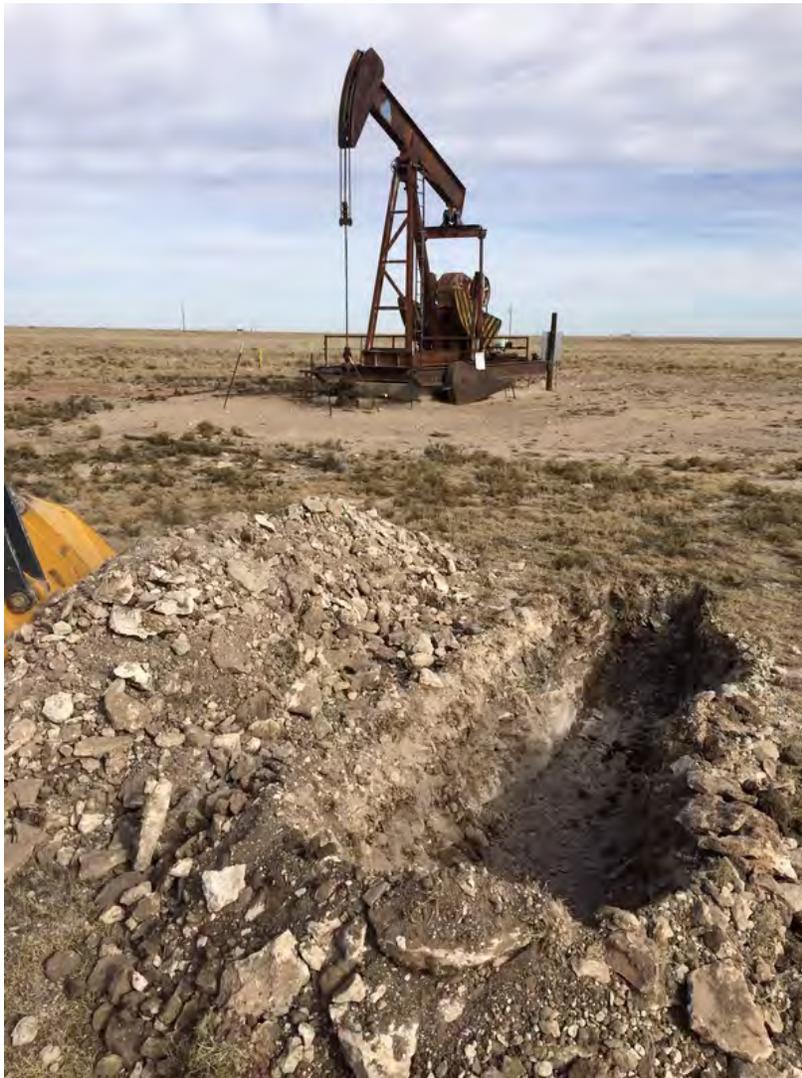
Exhibit B: Trench sample at SW Pad. Hard caliche encountered at 1-foot below ground surface. Total depth was 2-feet below ground surface. Land surface is undergoing natural restoration/re-vegetation.

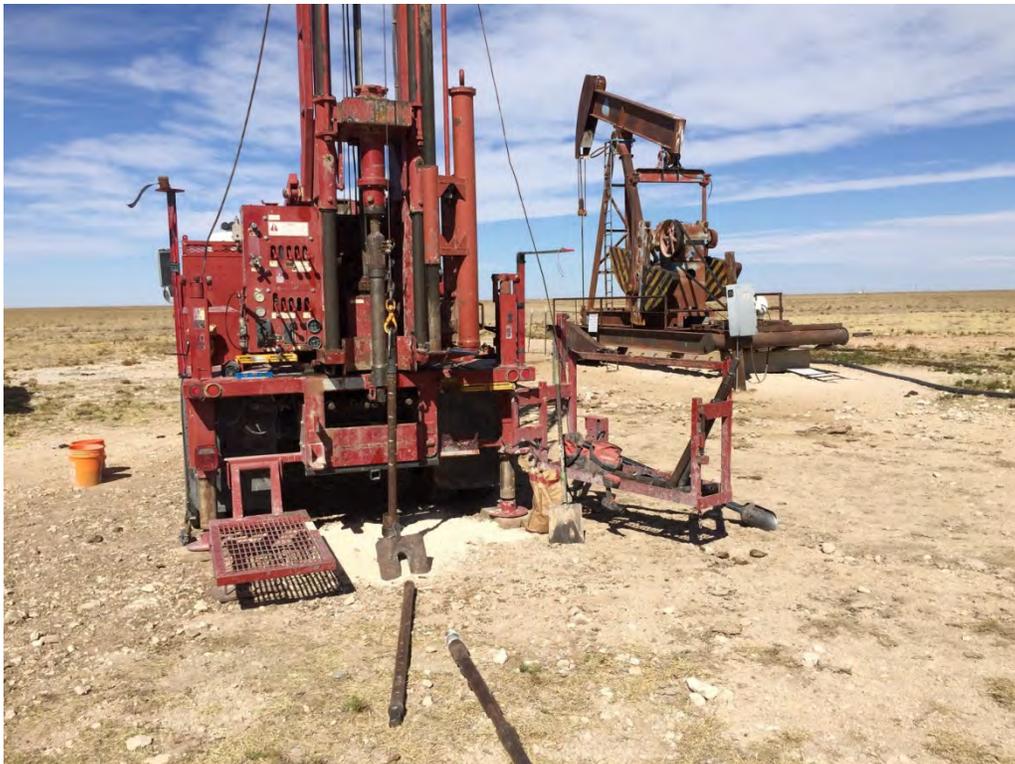
Exhibit D: Drilling SE Pad. The production pad is beginning to revegetate (foreground center).

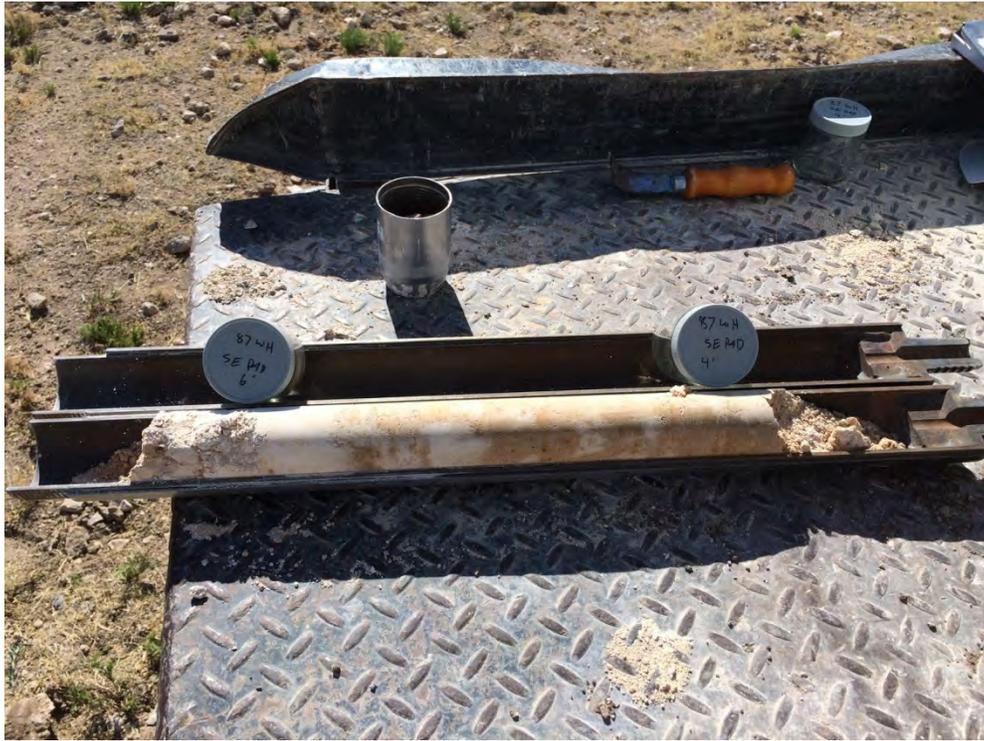
Exhibit E: Split-spoon core from 4-feet (right) to 6-feet (left) at SE Pad. Caliche dominates the core sample.

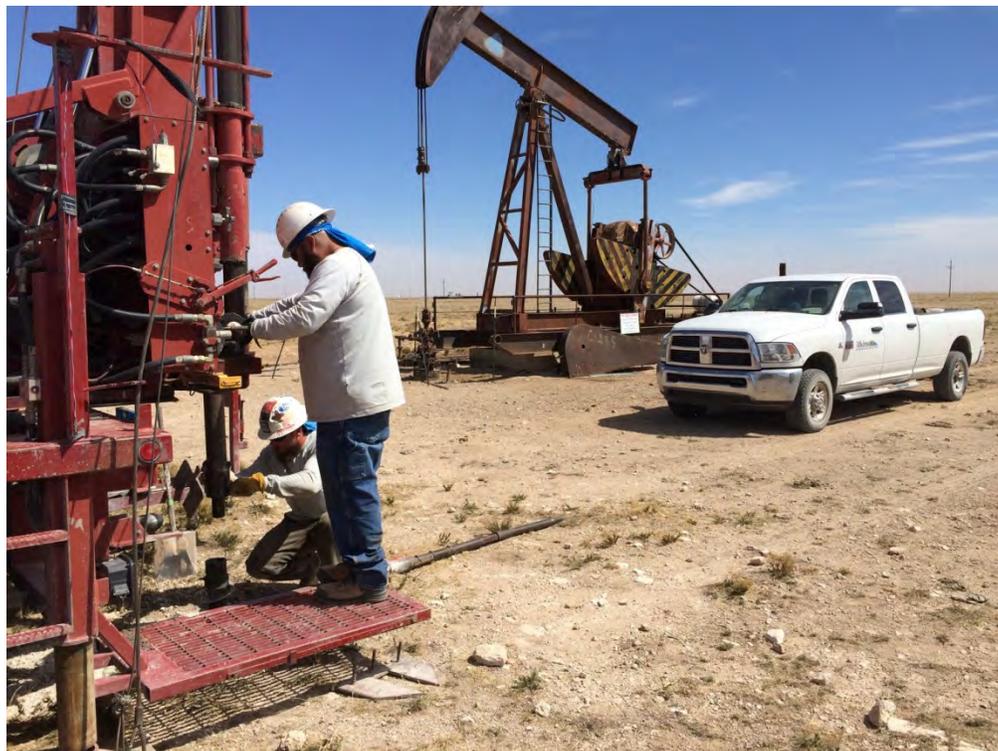
Exhibit F: Drilling SW Pad. The production pad is beginning to revegetate (foreground center).

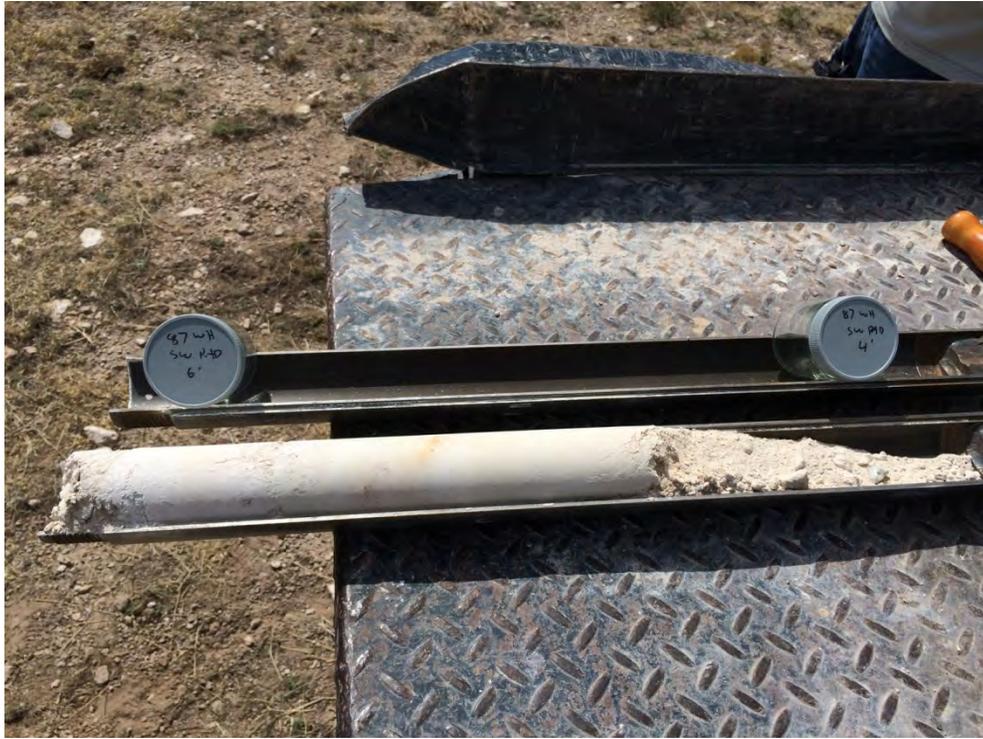
Exhibit G: Split-spoon core from 4-feet (right) to 6-feet (left) at SW Pad. Caliche dominates the core sample.
