1RP-4787
DELINEATION AND REMEDIATION REPORT
NGL Release

Lea County, New Mexico

LAI Project No. 17-0177-01

August 30, 2018

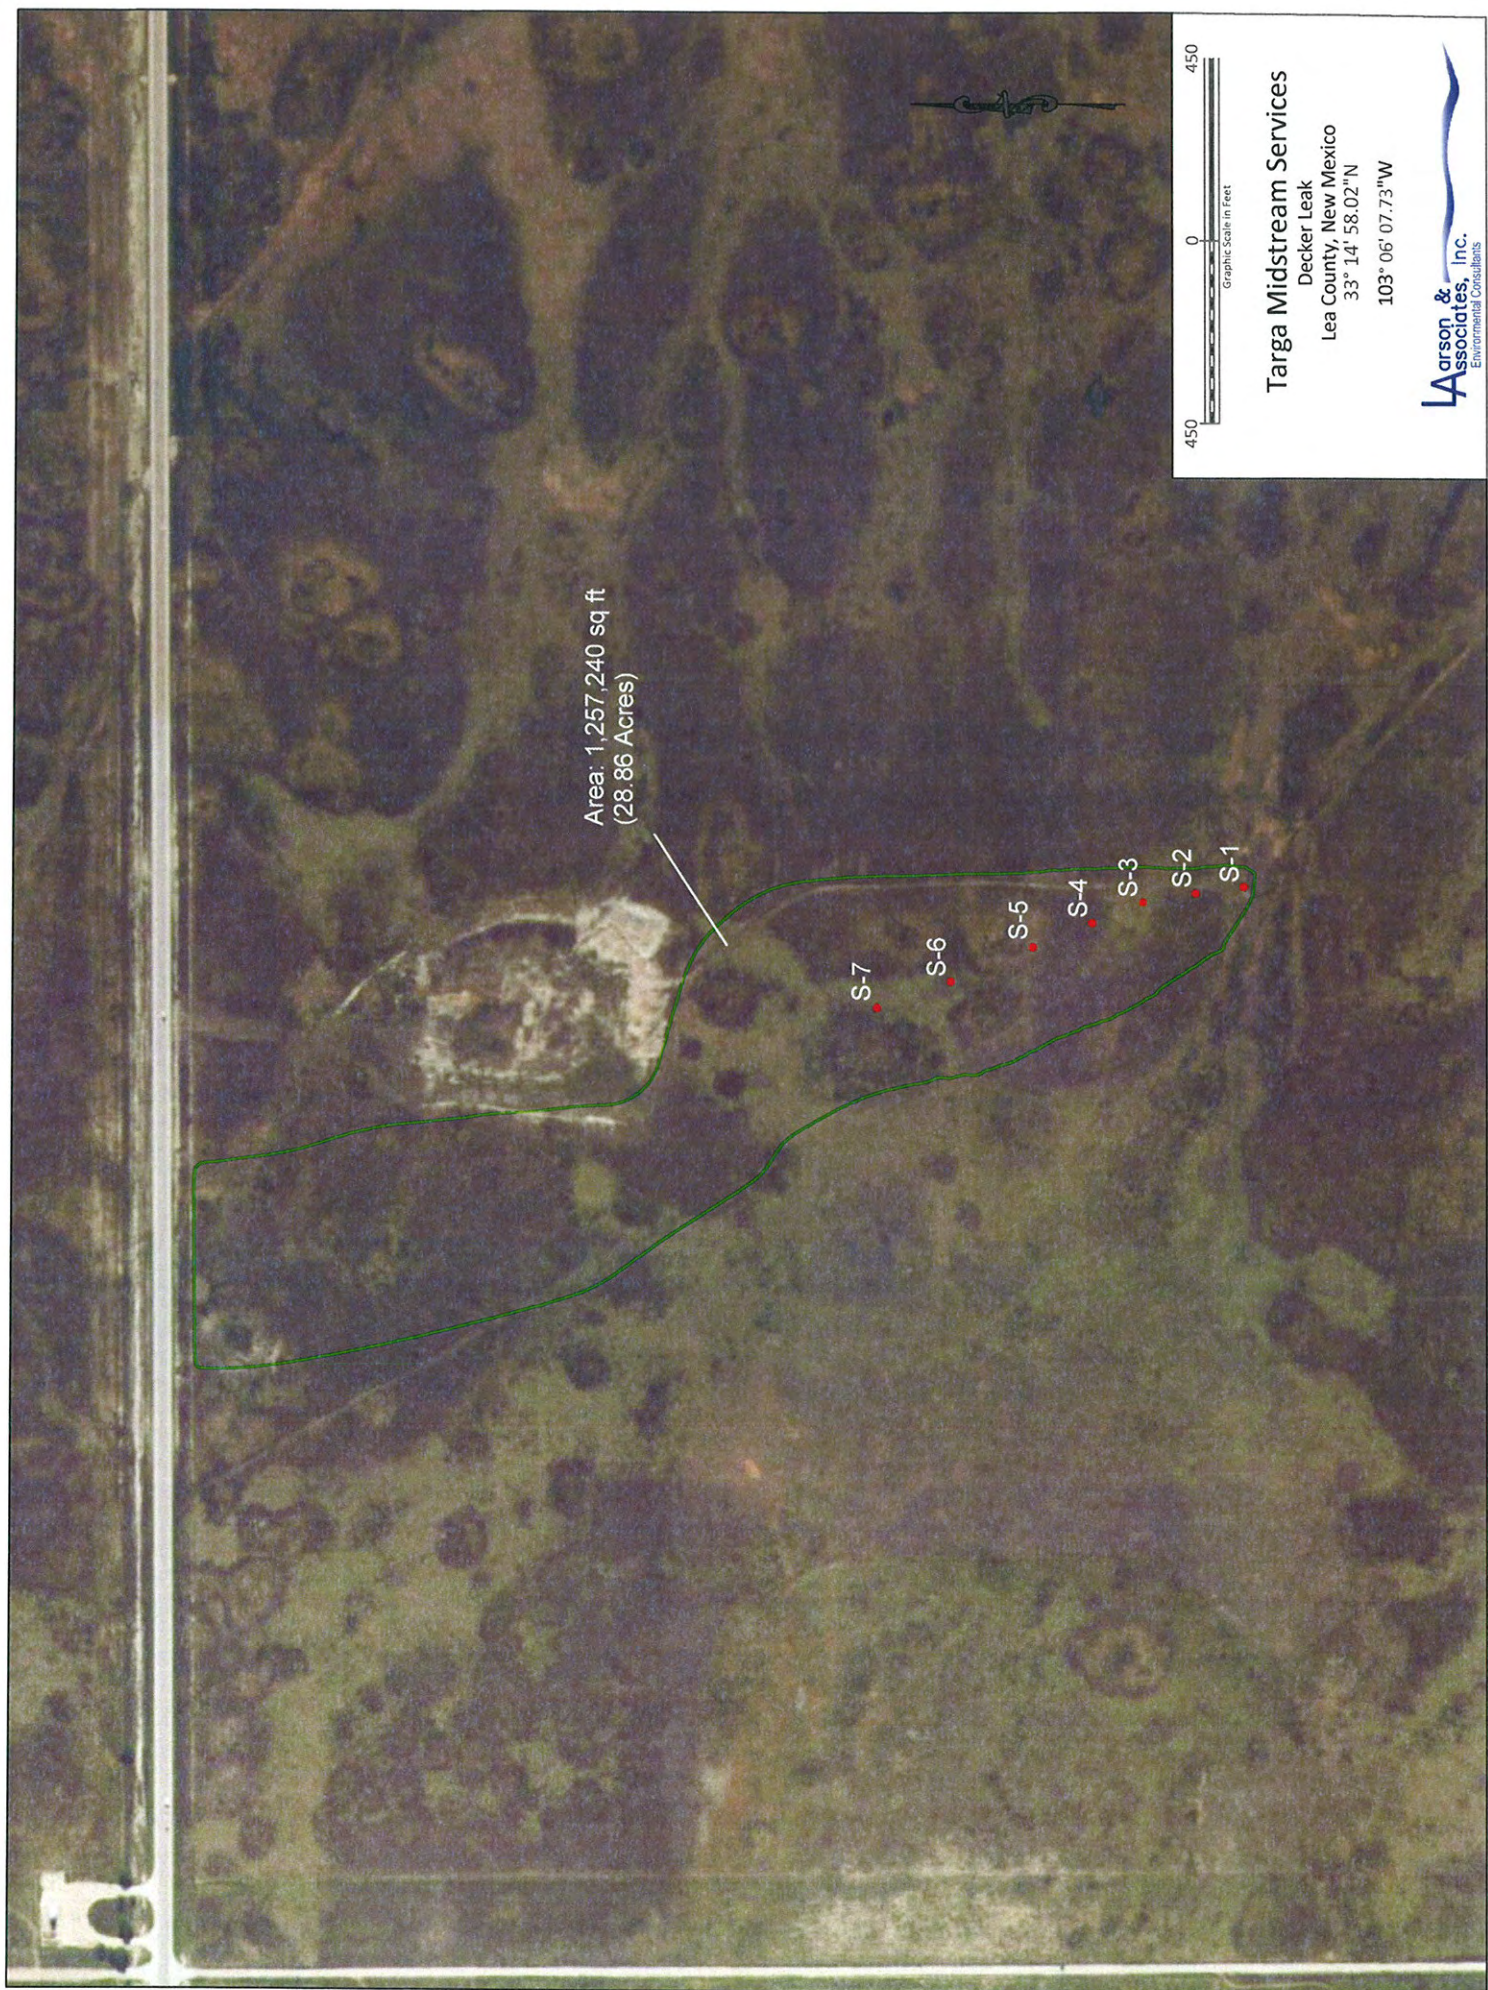
Figure 2 - Aerial Map Showing Release Area and Initial Soil Sample Locations

August 7, 2017, personnel from Larson & Associates, Inc. (LAI) met at the Site with Targa personnel and the landowner (Jeff Decker) to discuss the release. LAI personnel used a hand trowel to collect surface soil samples at seven (7) locations (S-1 through S-7) beginning near the source (S-1) and terminating about 1,000 feet north and northwest of the source (S-7). The soil samples were collected between ground surface and about 6 inches below ground surface (bgs). The samples were collected in laboratory containers and delivered under preservation and chain of custody to Permian Basin Environmental Lab (PBEL) in Midland, Texas. The laboratory analyzed the samples for BTEX (sum of benzene, toluene, ethylbenzene and xylenes) by EPA SW-846 Method 8021B, total petroleum hydrocarbons (TPH) by Method 8015M including gasoline range organics (GRO), diesel range organics (DRO) and oil range organics (ORO), and chloride by Method 300. Table 1 presents the initial soil sample analytical data summary. Figure 2 presents an aerial map showing the initial soil sample locations.

Benzene and BTEX were below the RRAL in samples S-1 through S-7. TPH exceeded the RRAL in samples of 100 milligrams per kilogram (mg/Kg) in samples S-1 (12,850 mg/Kg), S-2 (3,920 mg/Kg) and S-3 (411.3 mg/Kg). Chloride was above 250 mg/Kg in samples S-1 (2,680 mg/kg) and S-2 (1,640 mg/Kg).

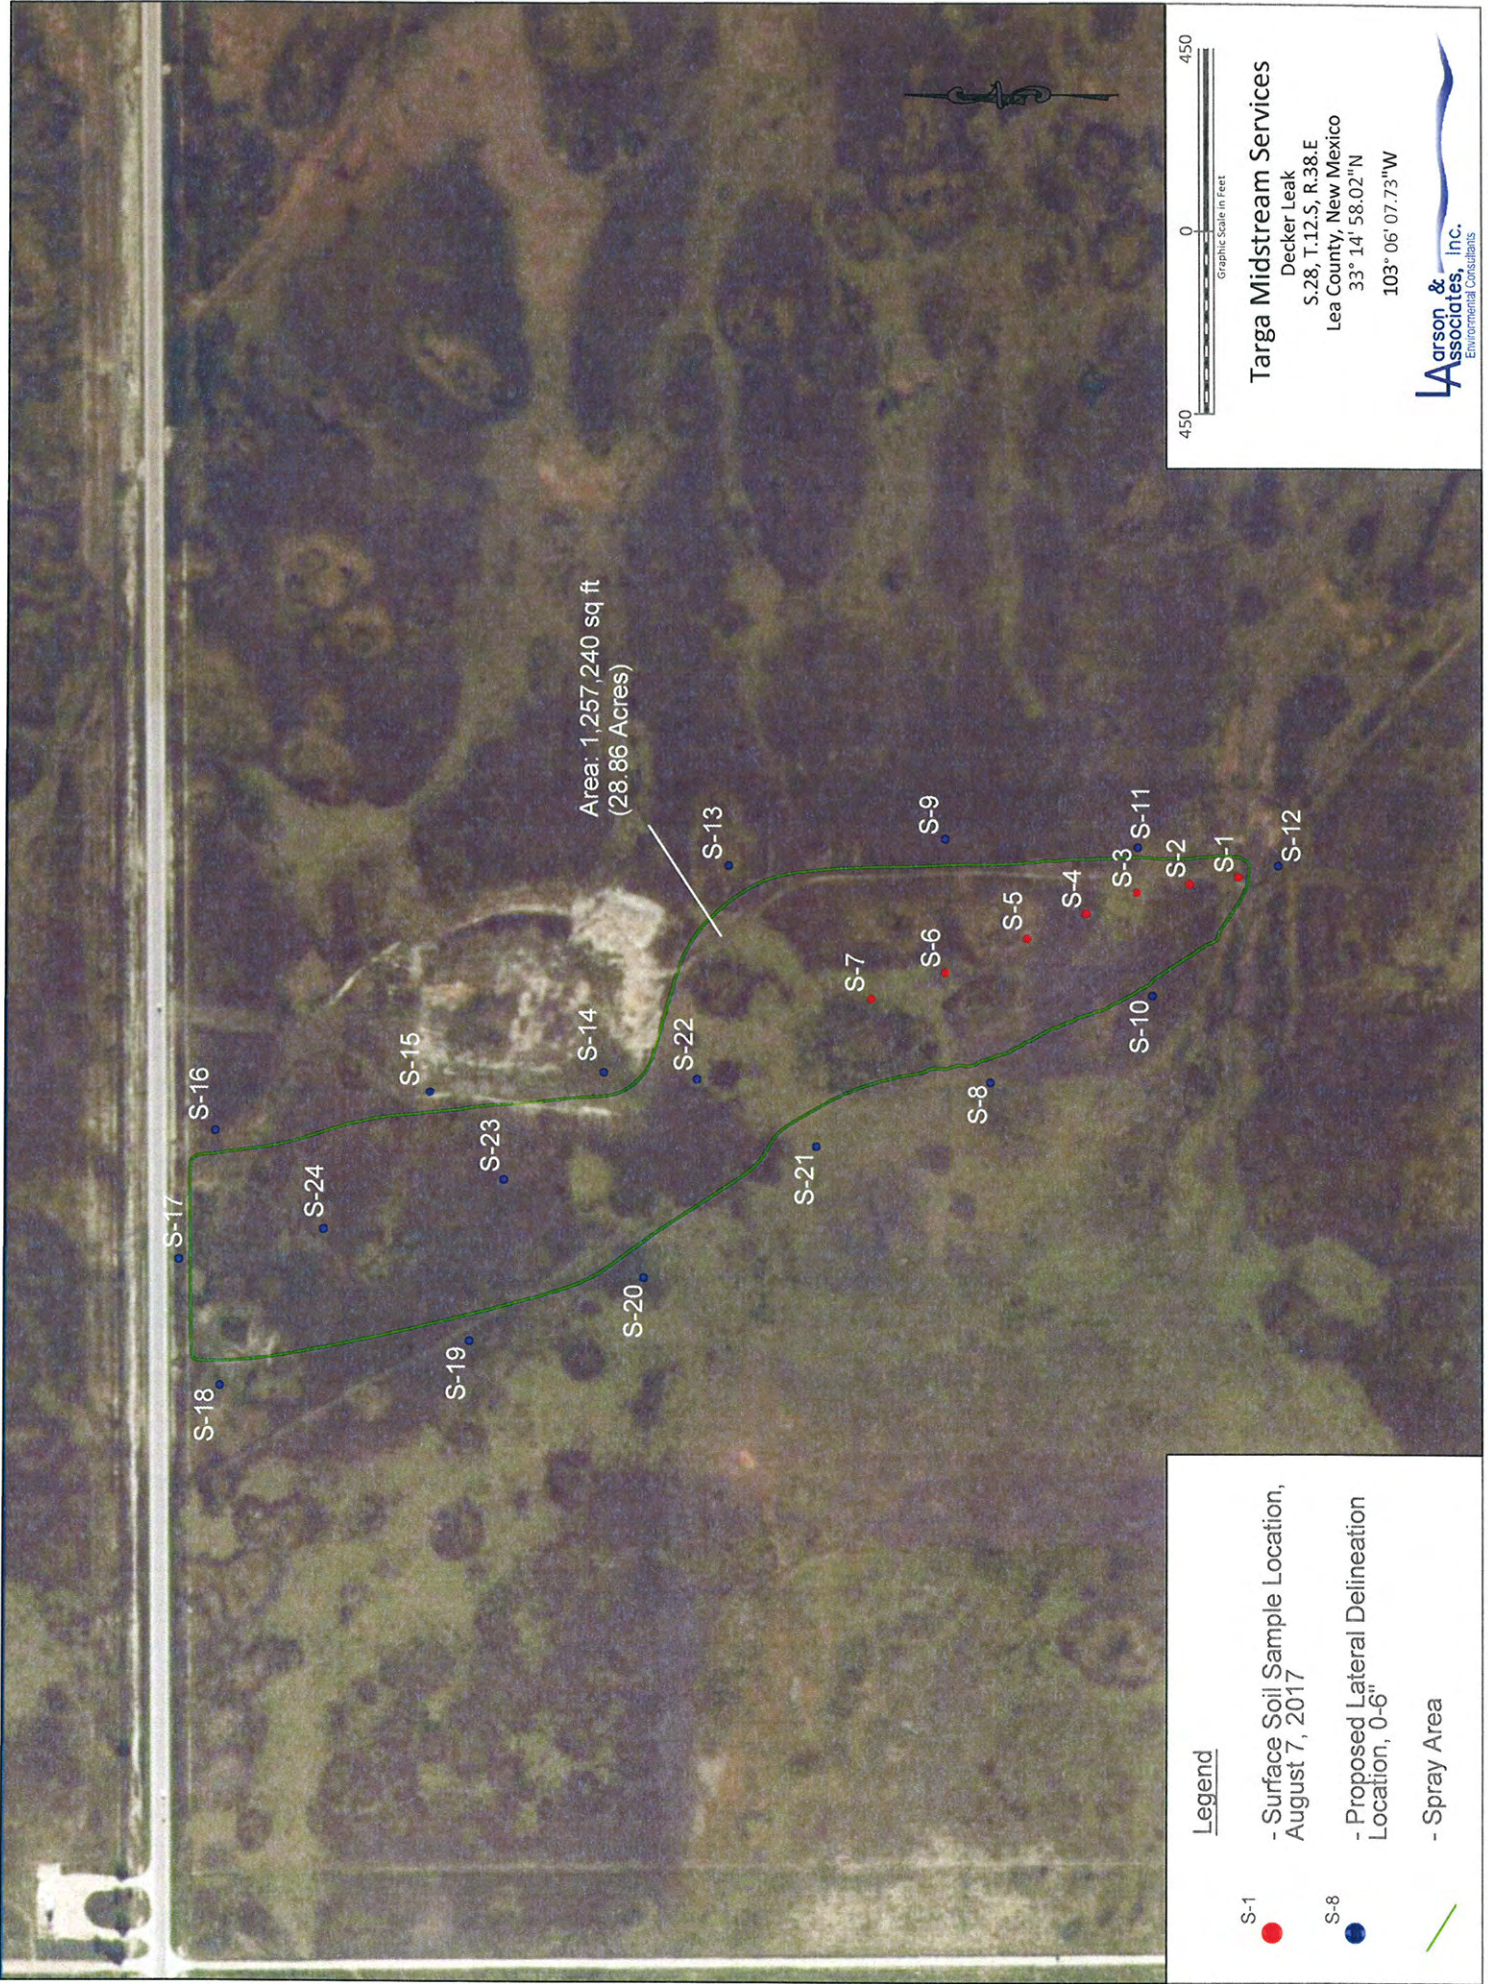
Figure 4 - Aerial Map Showing Delineation and Remediation Confirmation Soil Sample Locations

Between October 17, 2017 and December 5, 2017, LAI personnel collected delineation and remediation confirmation soil samples with direct push technology (DPT) at locations S-1 through S-4 and S-6. Soil samples were collected from ground surface to approximately 6 inches bgs to assess bioremediation of hydrocarbons with Microblaze®, from 6 inches to 1 foot bgs and every 1 foot thereafter (i.e., 1 to 2, 2 to 3 feet) until refusal on caliche which occurred between approximately 2 and 3 feet bgs. The DPT core barrel was equipped with dedicated polyethylene liners to minimize sample cross contamination. Soil samples were collected at locations S-7 through S-24 from ground surface to approximately 6 inches bgs with a stainless steel hand auger. The auger bucket was thoroughly cleaned between samples with a solution of potable water and laboratory grade detergent (Alkonox®) and rinsed with distilled water.

On December 5, 2017, Scarborough Drilling, Inc. (SDI) used an air rotary rig and jam tube sampler to collect deeper soil samples at locations S-1 and S-2 for chloride delineation. Soil samples were collected from S-1 at 5 to 6 feet, 10 to 11 feet, 15 to 16 feet and 20 to 21 feet. Soil samples were collected from S-2 at 5 to 6 feet, 10 to 11 feet and 15 to 16 feet. The borings were plugged with bentonite. The samples were collected in laboratory supplied sample jars that were labeled, preserved and delivered under chain of custody to Permian Basin Environmental Laboratory (PBEL) in Midland, Texas. The laboratory analyzed the samples for TPH by EPA SW-846 Method 8015M, including GRO, DRO and ORO, and chloride by EPA Method 300. Table 2 presents the delineation and remediation confirmation soil sample analytical data summary. Figure 4 presents an aerial map showing the delineation and remediation confirmation sample locations. Appendix C presents the laboratory report.

The laboratory reported TPH above the reporting limit (RL) initially in the following samples:

- S-1, 0.0 – 0.5' (127 mg/Kg)
- S-2, 0.0 – 0.5' (194.9 mg/Kg)
- S-20, 0.0 – 0.5' (111 mg/Kg)
- S-21, 0.0 – 0.5' (107.3 mg/Kg)

Based on the reduction in TPH concentrations at S-1 (99.01%) and S-2 (95.03%) and TPH concentrations marginally above the RRAL (100 mg/Kg) in samples S-20 (111 mg/Kg) and S-21 (107.3 mg/Kg), located outside the spray area, Targa recommends no further action for TPH. Chloride was delineated within the release area to 250 mg/Kg plus 10 feet further in depth with concentrations below 250 mg/Kg. Chloride was 489 mg/Kg in the background sample (S-12) located upwind (south) of the release. Targa therefore recommends no further action for chlorides. For these reasons, Targa requests closure for remediation permit number 1RP-4787. Appendix E presents the final C-141.

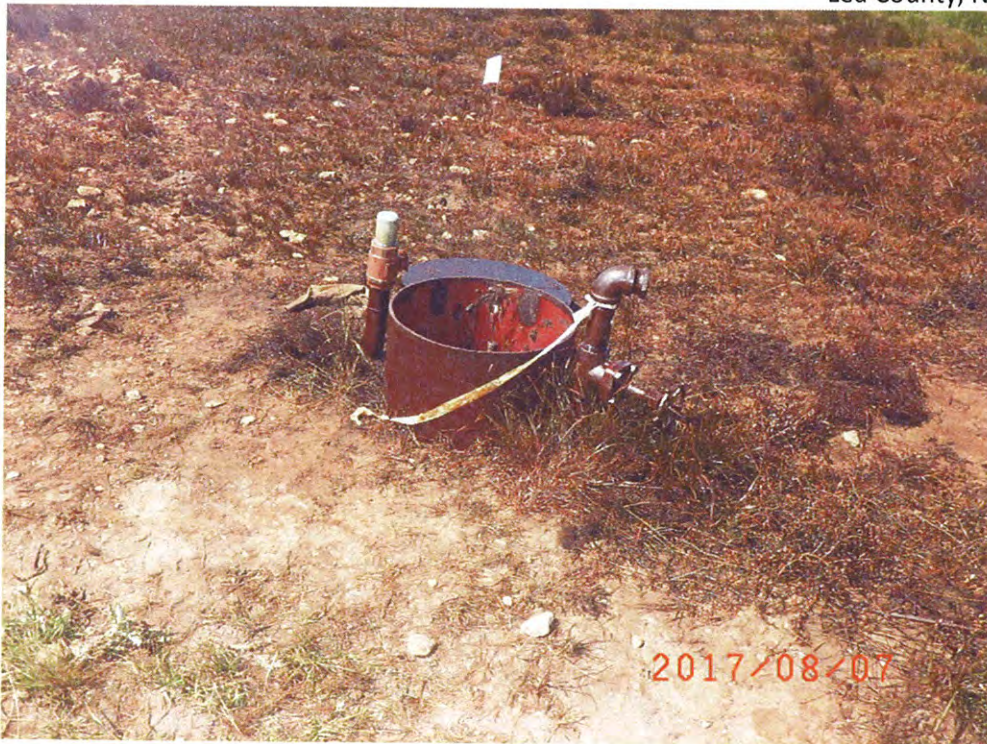
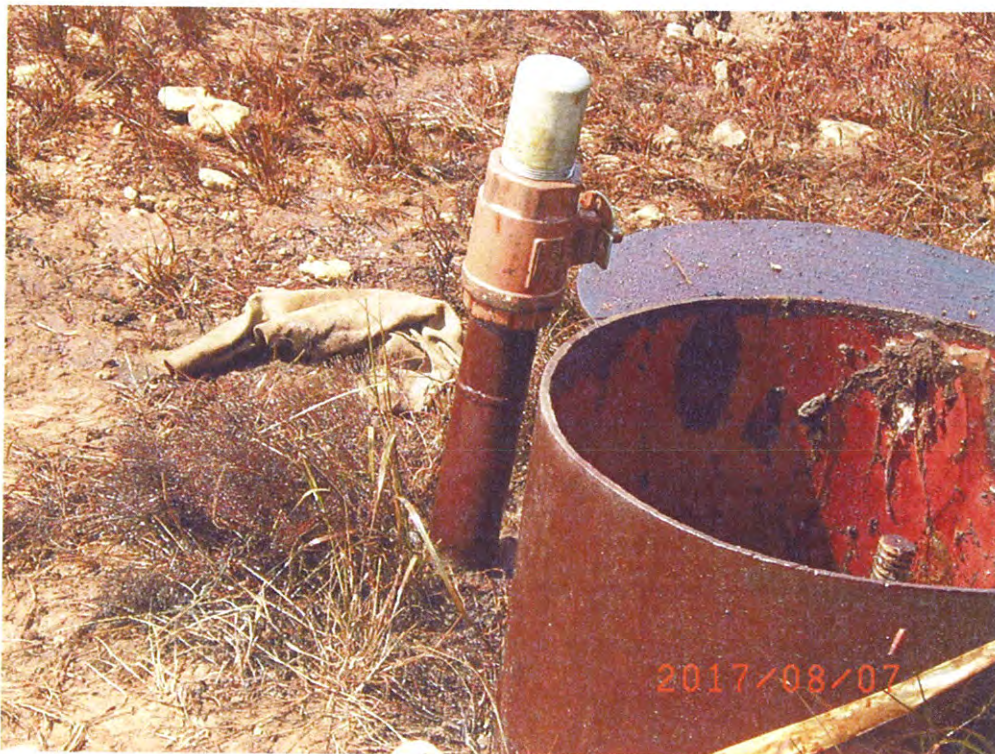
On August 5, 2017, Targa was notified of the release which was due to valve failure from corrosion on a 6 inch poly line. The line was isolated, blown down and the valve was removed. Targa estimated approximately 7 barrels (bbl) of NGL and 425 thousand cubic feet (Mcf) of gas was released. Wind dispersed NGL as a mist approximately 2,900 feet north and northwest from the source. NGL was dispersed over an area measuring approximately 1,257,240 square feet or about 28.86 acres. No liquid was recovered. Targa representatives submitted the initial C-141 to the OCD District 1 on August 11, 2017. The OCD assigned the release remediation permit number 1RP-4787 with conditions. Appendix A presents the OCD approved initial C-141.

Source of Release Viewing North

Source of Release

Targa's 6" poly pipeline was discovered leaking as the result of external corrosion on a 2" valve. The line was isolated, blown down and a new valve was installed.
