**Devon Energy Production Co LP
Bell Lake 24 Federal 1H**

Closure Report

**Unit Letter M, Section 24, T24S, R32E
Lea County, New Mexico**

March 20, 2017

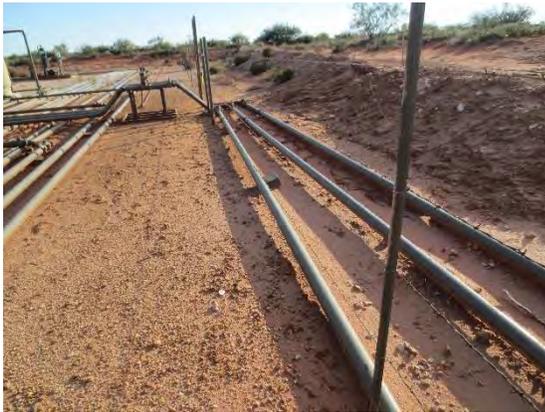
West side of the release area

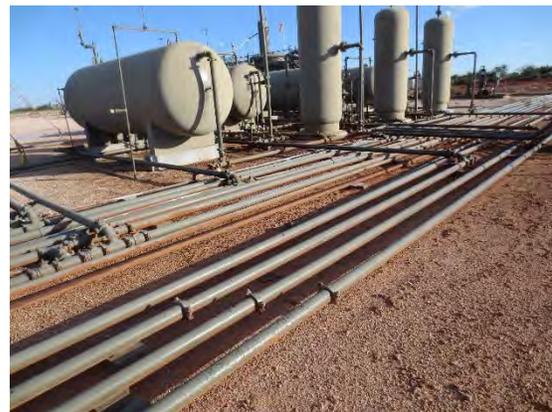
West side of the release area

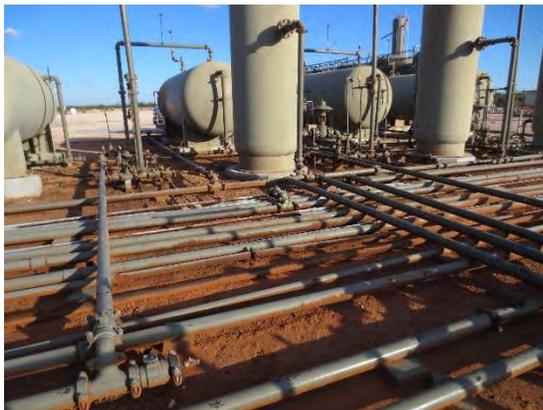
Interior of release area-looking East

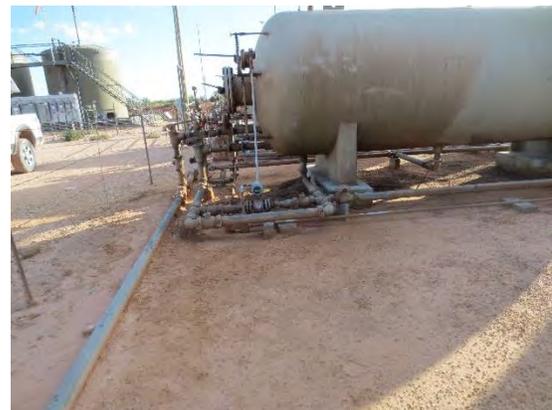
East side-looking South

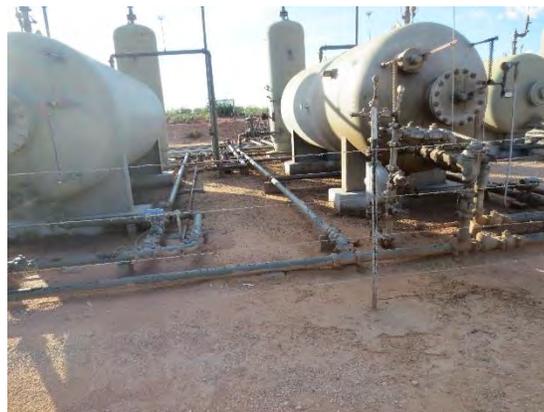
East Side Release Point

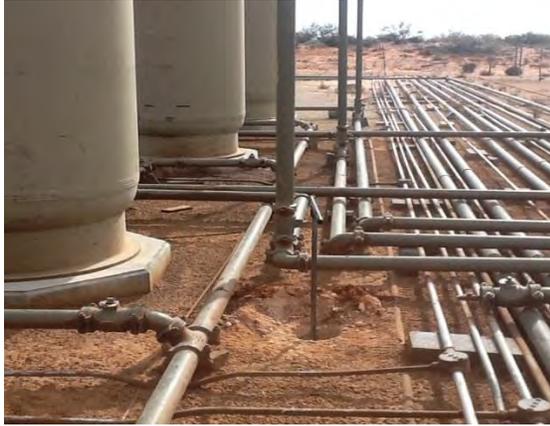
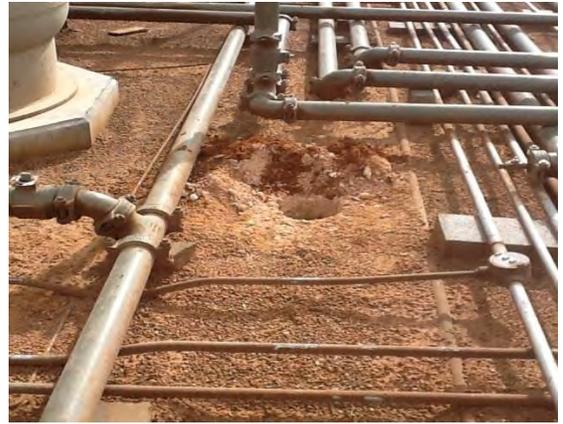
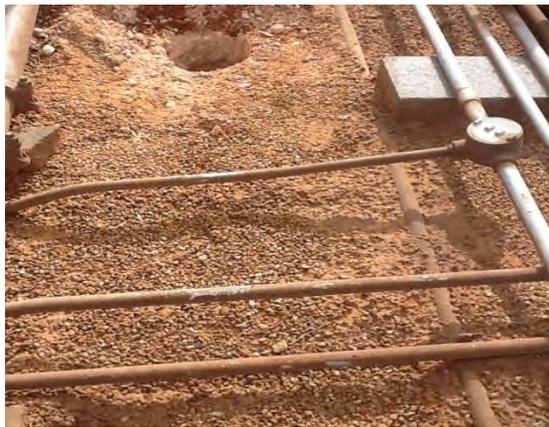
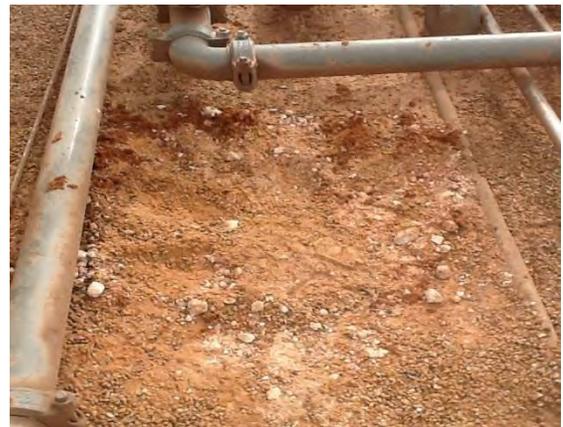
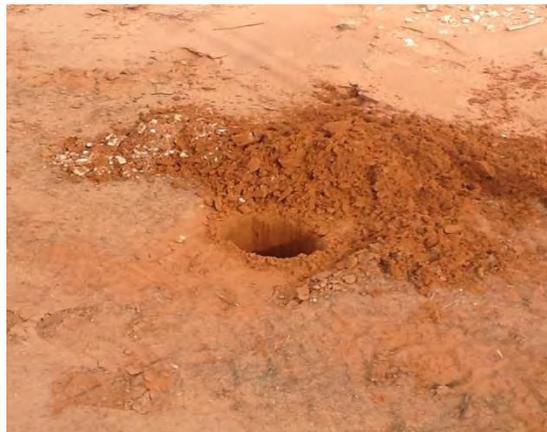
Devon Bell Lake
Microblaze Installed

On February 22, 2017, Jerry SESI is onsite with Gabriel Tarin (Devon) and advised him the purpose of SESI being onsite. Set up equipment, pump and hoses. Looked over the location for the hydro carbon staining. Started the pump and began saturating the hydro carbon staining with the mixture of water and micro blaze. Cleaned up and and rigged down.
