1RP-4647

SUBJECT: SOIL REMEDIATION PLAN FOR THE INCIDENT AT THE Sanmal Queen Unit, LEA COUNTY, NEW MEXICO

Smith&Marrs | Sanmal Queen Unit | 10/22/2018

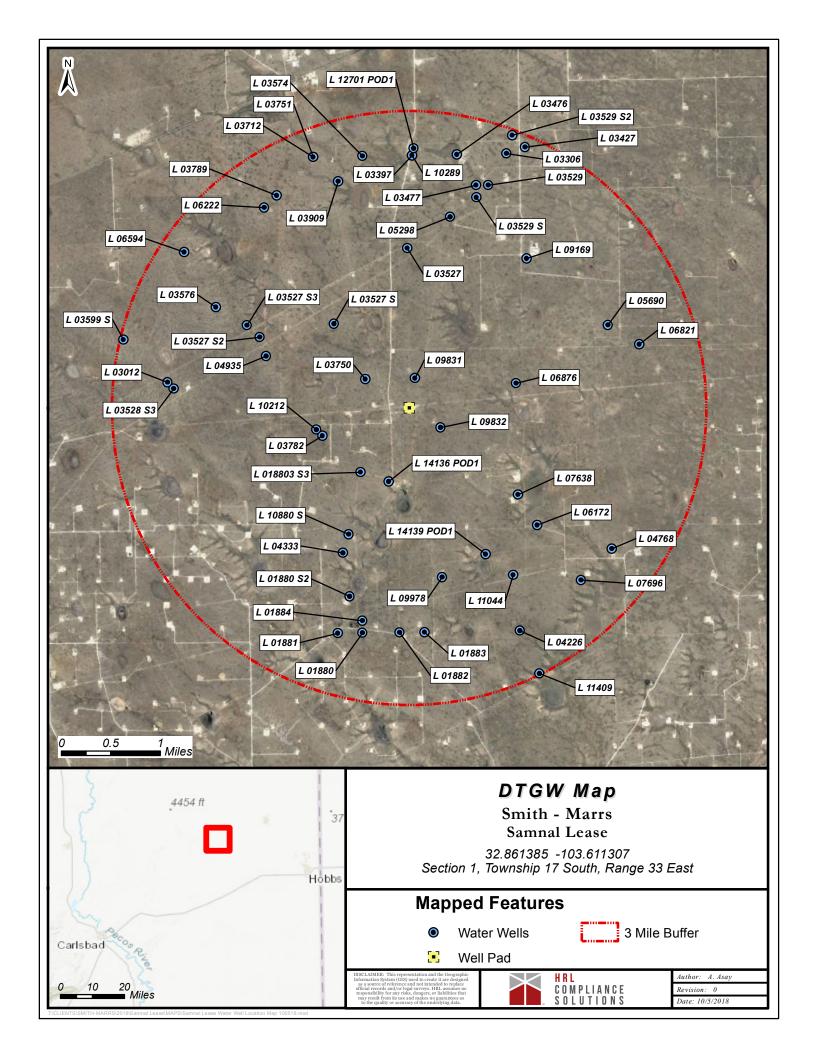
NMOSE Depth to Water Map and Report

An assessment of surrounding water well information identifies 55 water wells thin a 3-mile buffer. Average depth to water is over 100 feet bgs. This information is illustrated in Attachment A.

Average Depth to Water: 135 feet

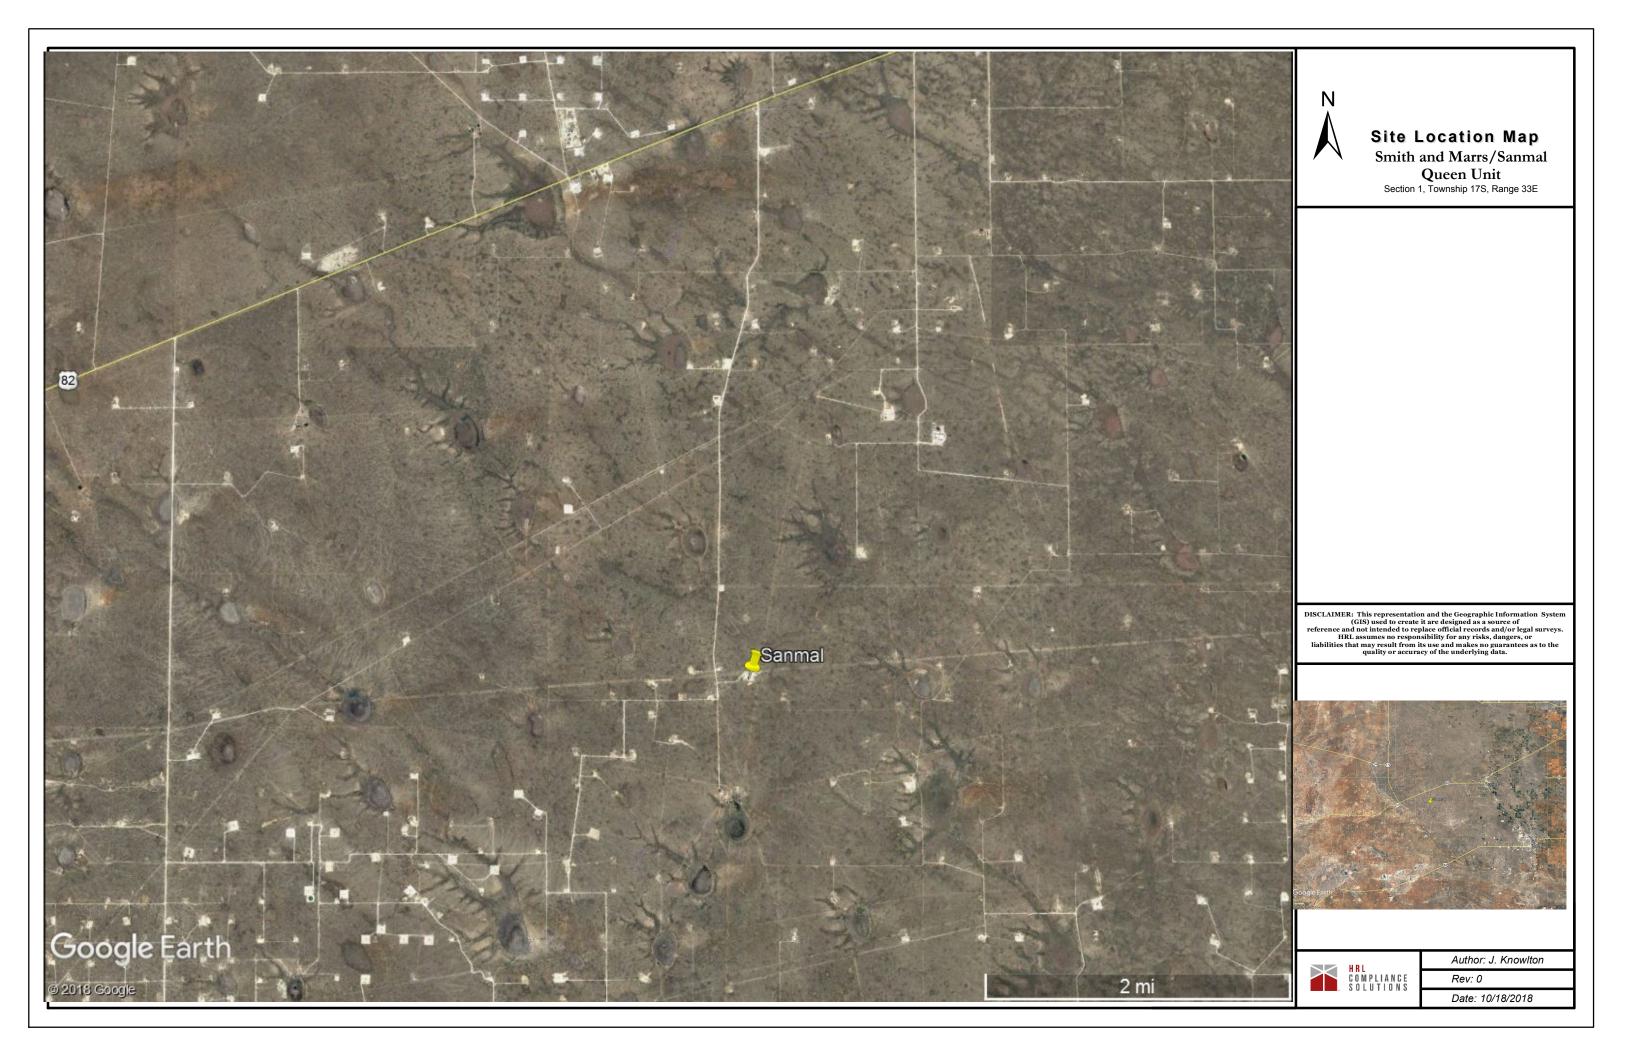
U.S. Fish and Wildlife Service **National Wetlands Inventory**

Sanmal Queen Unit

An assessment of wetlands and springs was performed using USGS National Water Information System and re-verified utilizing a 7.5-minute topographical map There are no wetlands with 300 feet of this location. There are no springs within 1000 feet of this location. This map is in Attachment B.

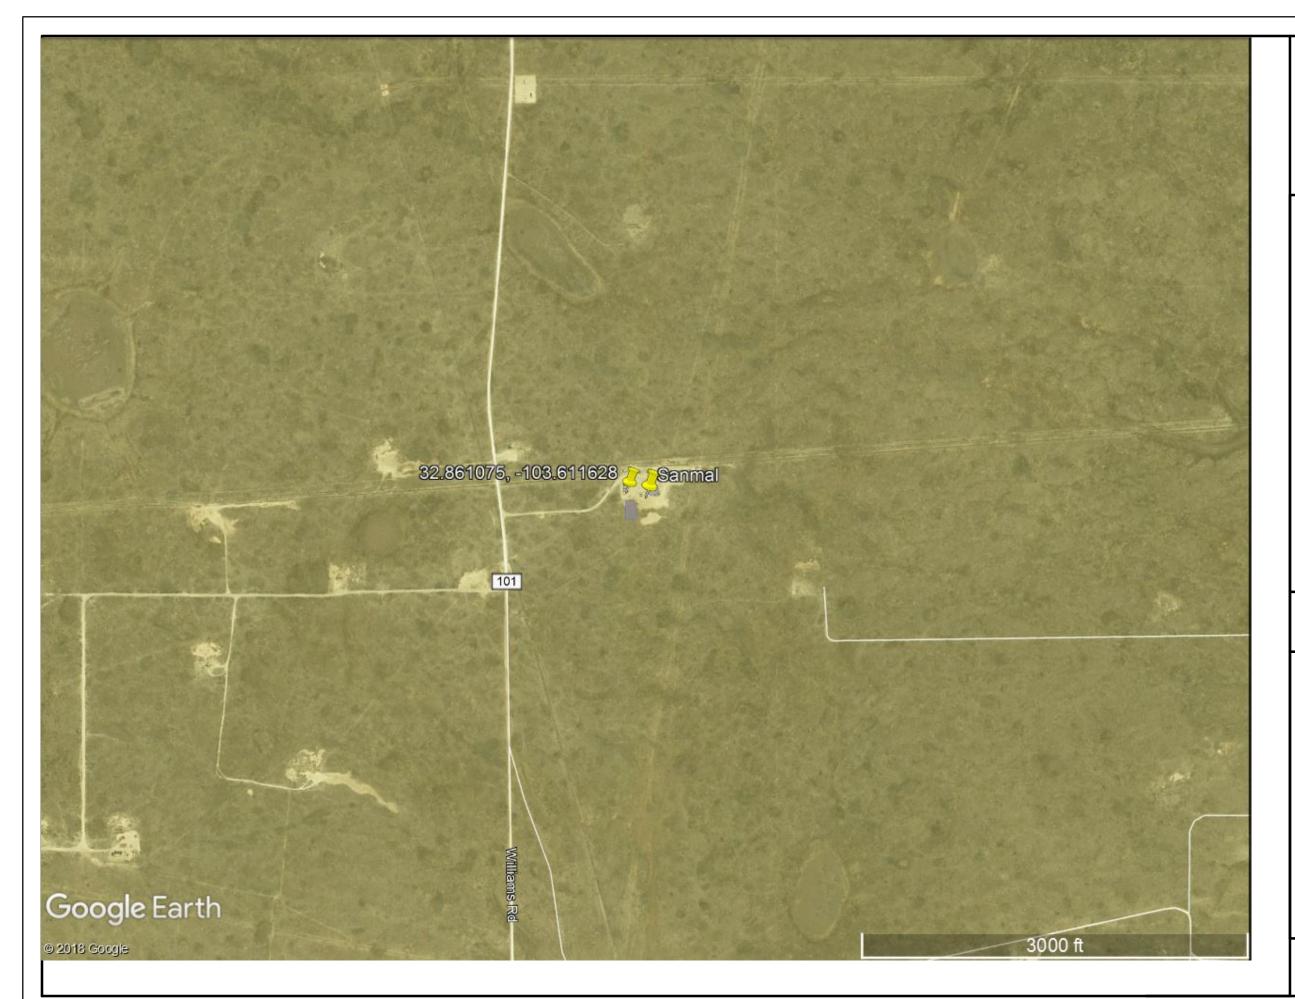
Site Location Map Smith and Marrs/Sanmal Queen Unit

There are no features of concern identified within proximity of the site. There is no flowing watercourse or significant watercourse within 300 feet of this location. There is no lakebed, sinkhole, or playa lake within 200 feet for this location. This location is not within 300 feet of an occupied permanent residence, school, hospital, institution, or church. This location is not with 500 feet for a spring or domestic freshwater well. This facility is not within incorporated municipal boundaries or within a defined municipal freshwater well field. This is illustrated in Attachment B.

Section 1, Township 17S, Range 33E

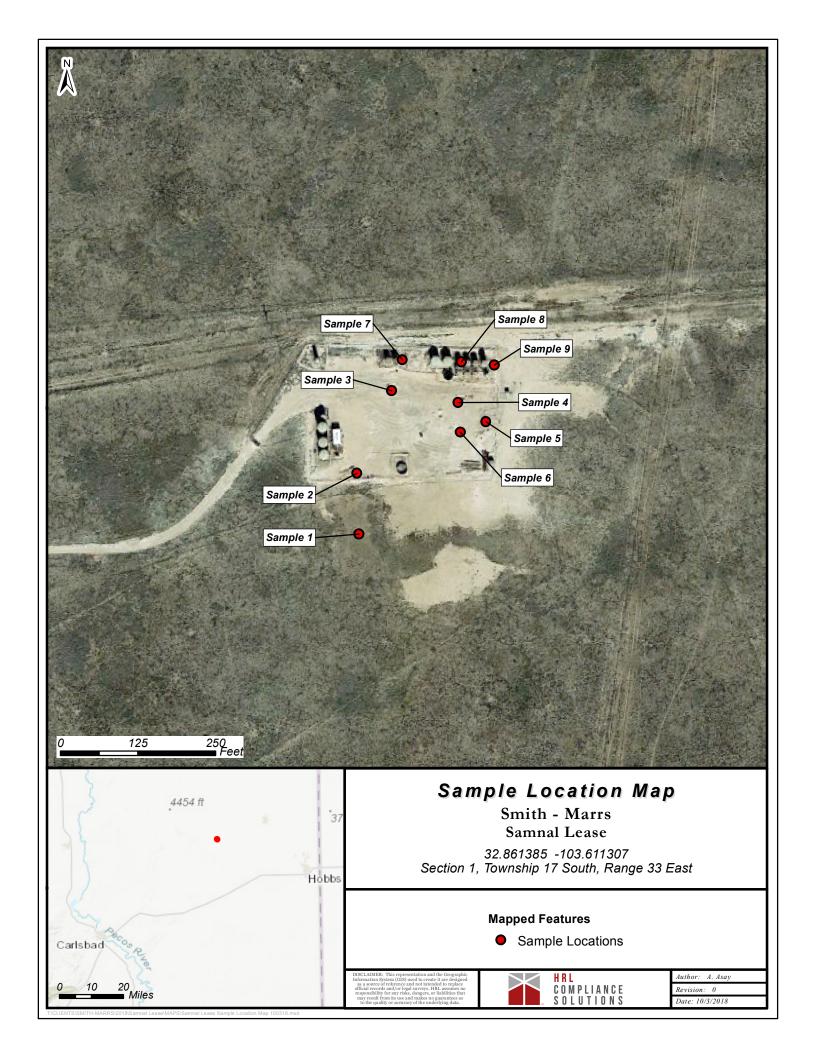
Sample Location Map

Upon receiving clearance from the underground utility locate (811) on September 25, 2018, HRL field personnel assessed the impacted area. Samples were collected on 9/25/2018 to characterize the extent of impacts and calculate a volume of soil to be excavated for disposal with a backhoe. All samples were collected and analyzed at a National Environmental Laboratory Accreditation Program (NELAP) laboratory and in accordance with NMOCD soil sampling procedures. The samples were submitted to Cardinal Laboratory for analyses including chlorides by Method 4500, volatile organics (BTEX) by Method 8021B, and MRO, DRO, and GRO by EPA Method 8015B. Sample locations are depicted in Attachment C. All laboratory results are summarized in Table 1 with raw analytical reports included in Attachment D.

The area around Sample Point 6 will be excavated to an approximate depth of 1 foot. Per the direction of the State Land Office (see email in Attachment E), a liner is required at SP6 prior to backfill. In addition, the State Land Office is requiring an excavation around SP1 to a depth of 2 feet with a liner and appropriate top soil replaced. A total of 980 cubic yards is estimated to be removed. Confirmation samples will be taken from both excavation areas prior to backfill.

SP6 is on an active pad and will be returned to use as such. The area around SP1 will be seeded as per SLO guidelines.
