REMEDICATION SUMMARY AND RISK-BASED SITE CLOSURE REQUEST

**COG Operating, LLC
Phillips State #001
Lea County, New Mexico
Unit Letter "O", Section 17, Township 21 South, Range 35 East
Latitude 32.4744949° North, Longitude 103.3875351° West
NMOCD Reference No. 1RP-4883**

September 2018

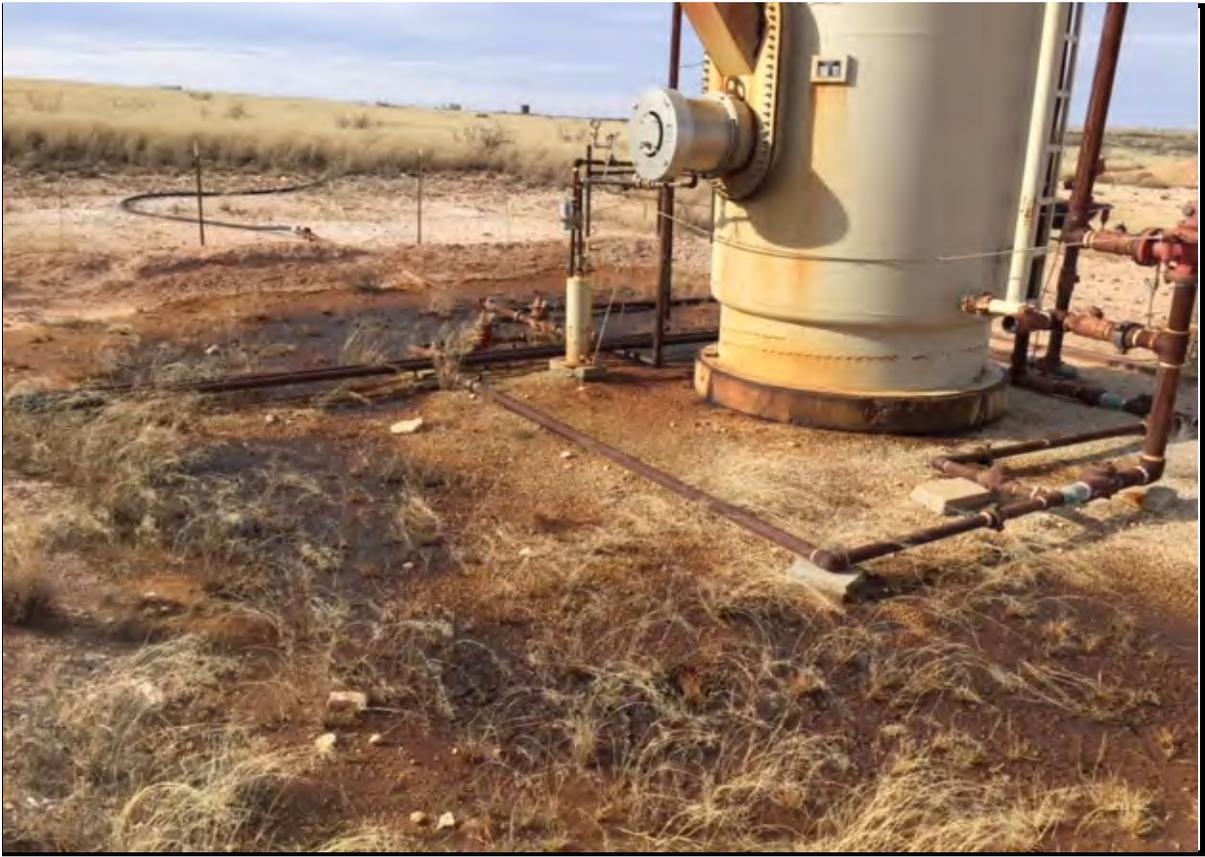
Figure 1 - View of the affected area, facing northwest.

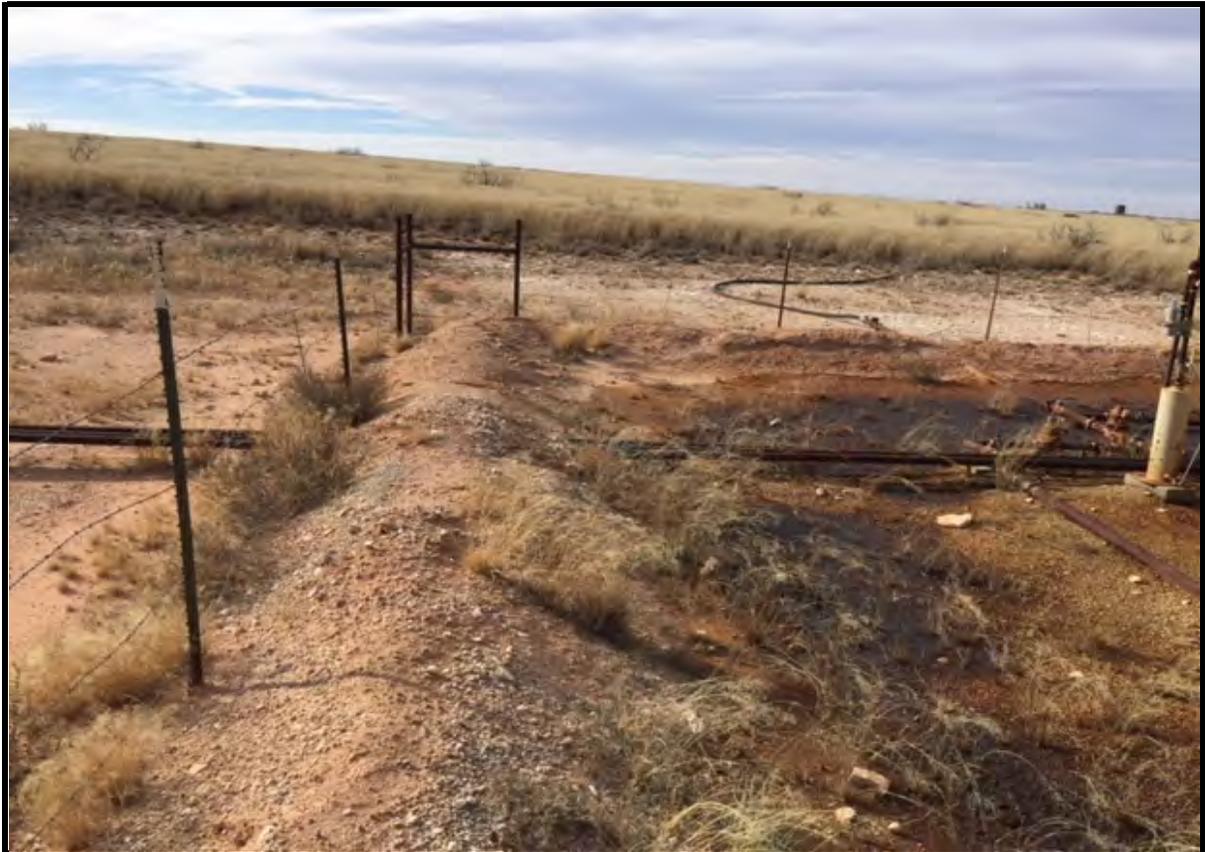
Figure 2 - View of the affected area, facing west.

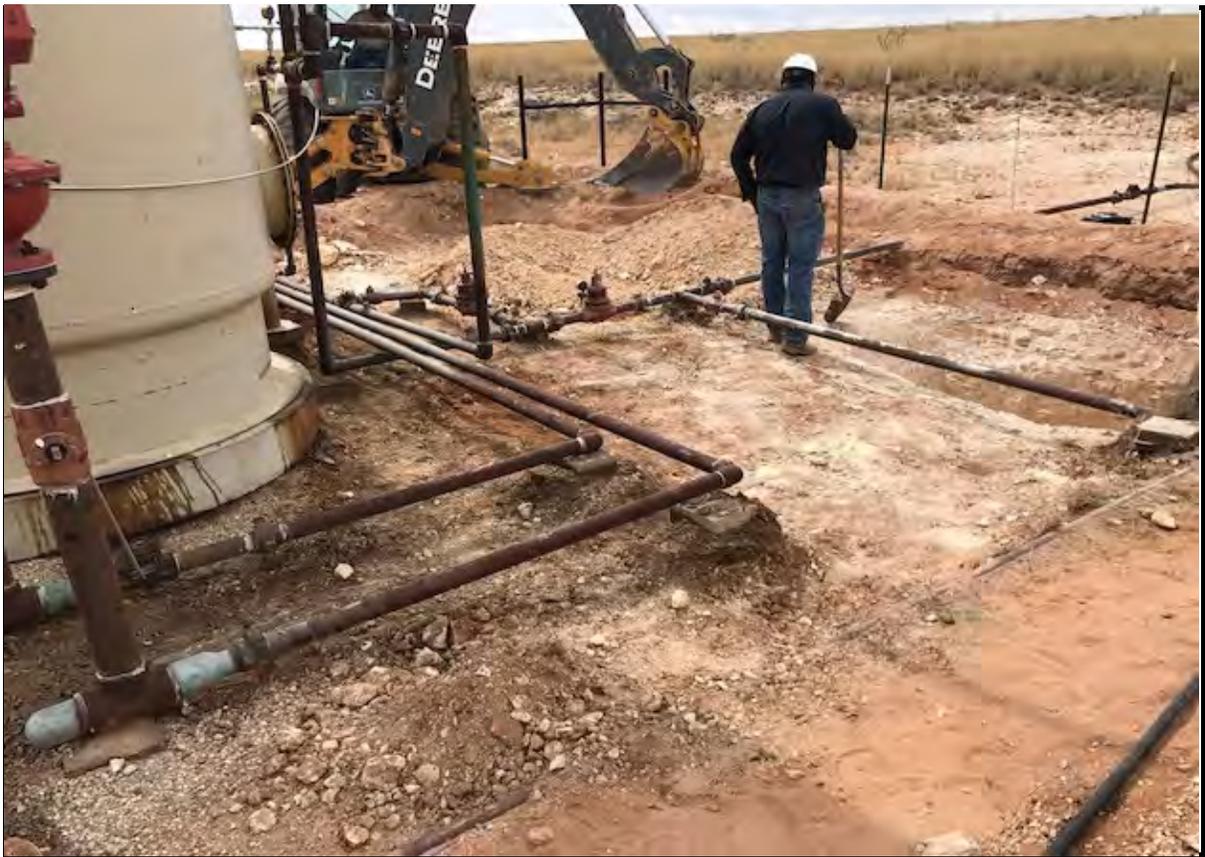
Figure 3 - View of portion of the excavated area, facing southwest.

On April 26 and 27, 2018, TRC revisited the Release Site with a backhoe equipped with a different set of “rock teeth”. Excavation sidewalls were advanced until chloride field test results indicated concentrations of chloride were below the NMOCD RRAL. Attempts to advance the floor of the excavation resulted in broken backhoe teeth and risked destabilizing the heater treater. Upon advancing the excavation sidewalls, four (4) soil samples (NSWb, ESWb, SSWb and WSWb) were collected and submitted to the laboratory for analysis of chloride concentrations. Laboratory analytical results indicated chloride concentrations range from 121 mg/kg in soil sample NSWb to 524 mg/kg in soil sample WSWb. Soil sample ESWb was also analyzed for concentrations of TPH, which were determined to be 3,890 mg/kg.

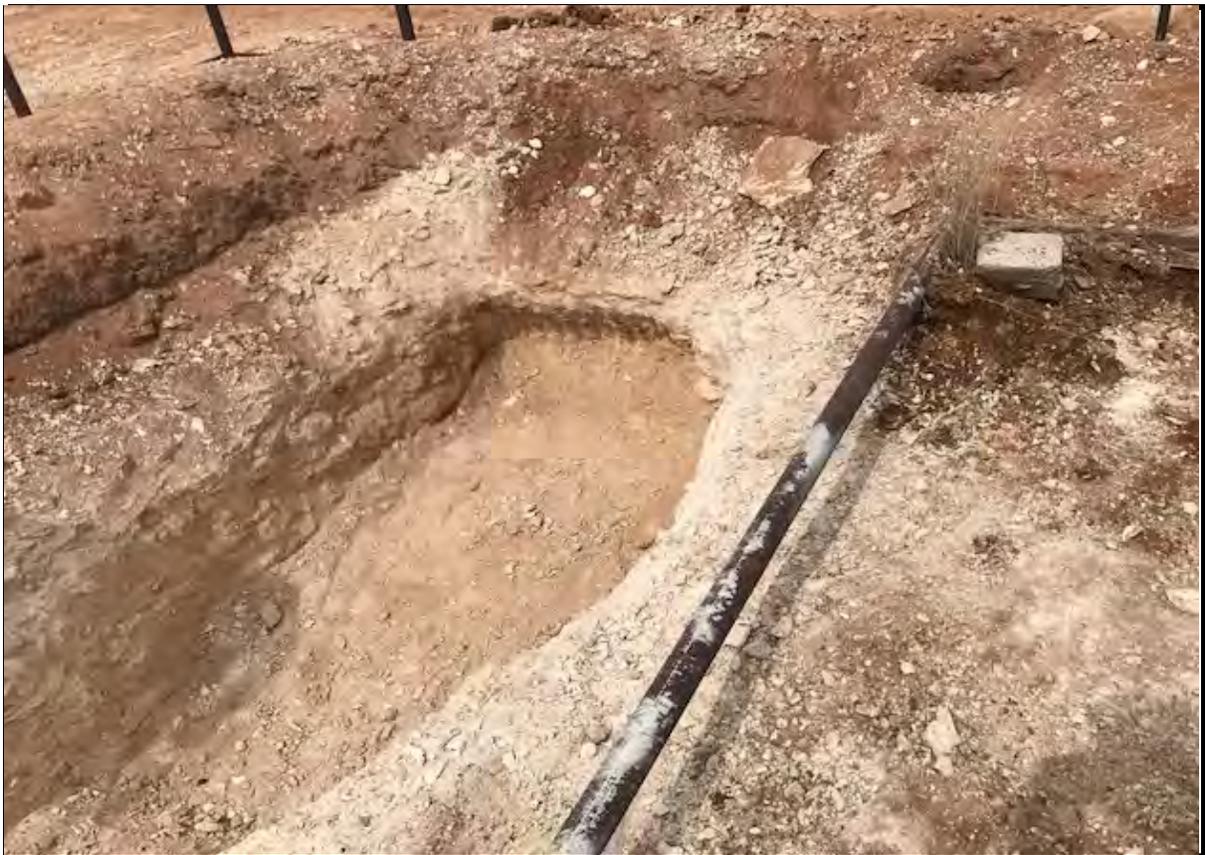
Figure 4 - View of portion of the excavated area, facing north.

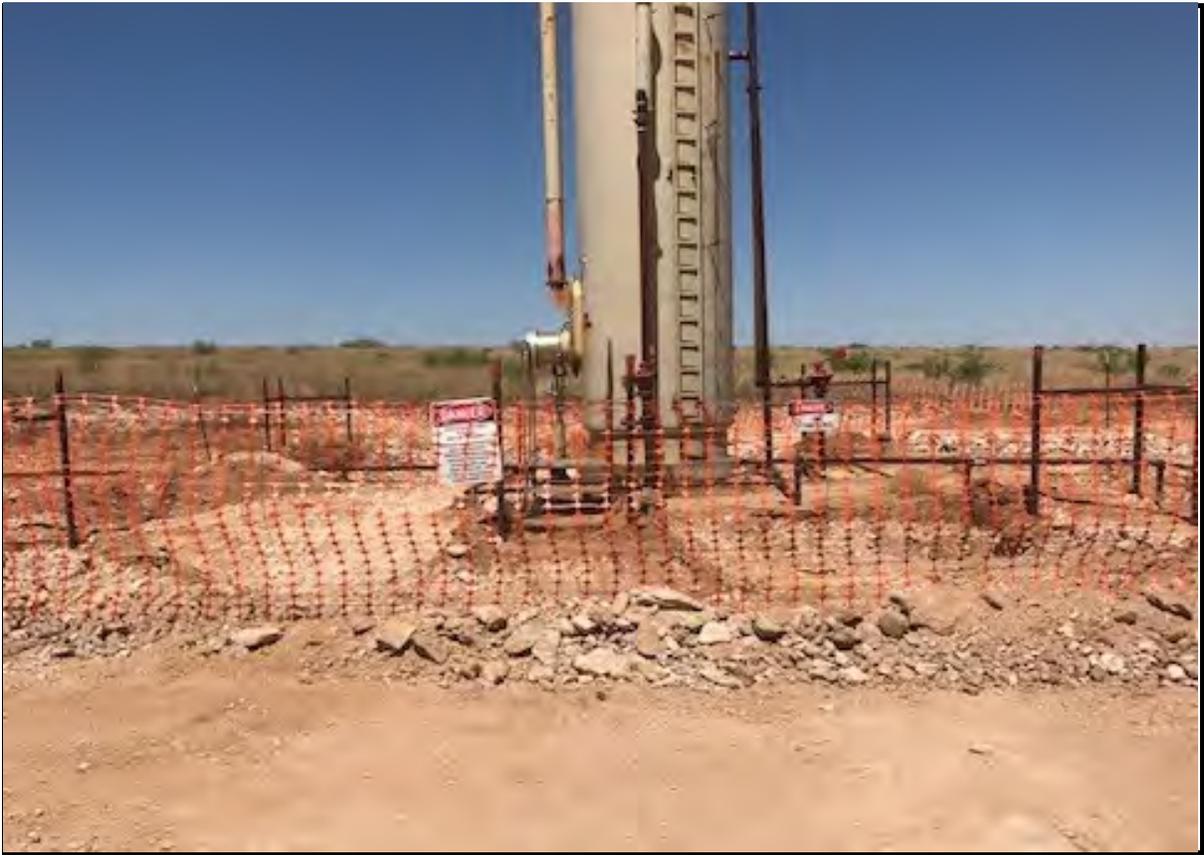
Figure 5 - View of portion of the excavated area, facing west.

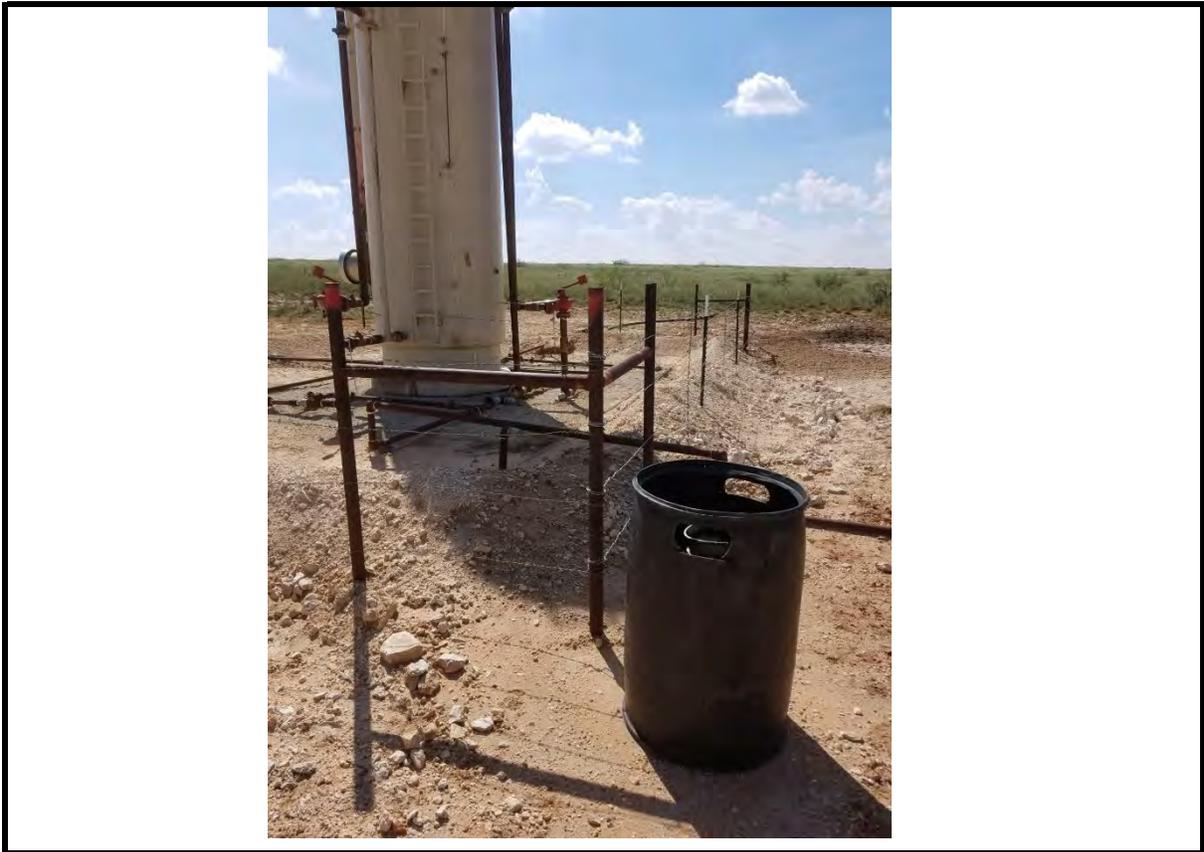
Figure 6 - View of affected area after remediation activities, facing northwest.

Remediation activities were conducted in accordance with the NMOCD. Impacted soil within the release margins was excavated and transported to an NMOCD-approved disposal facility. Impacted soil remaining in-situ in the floor of the excavated area and adjacent to the heater treater affected above the NMOCD RRAL for TPH and chloride will be further investigated and/or remediated at time of abandonment (TOA). Based on laboratory analytical results and field activities conducted to date, TRC recommends COG provide copies of this *Remediation Summary and Risk-Based Soil Closure Request* to the NMOCD and BLM and request closure status to the Phillips State #001.

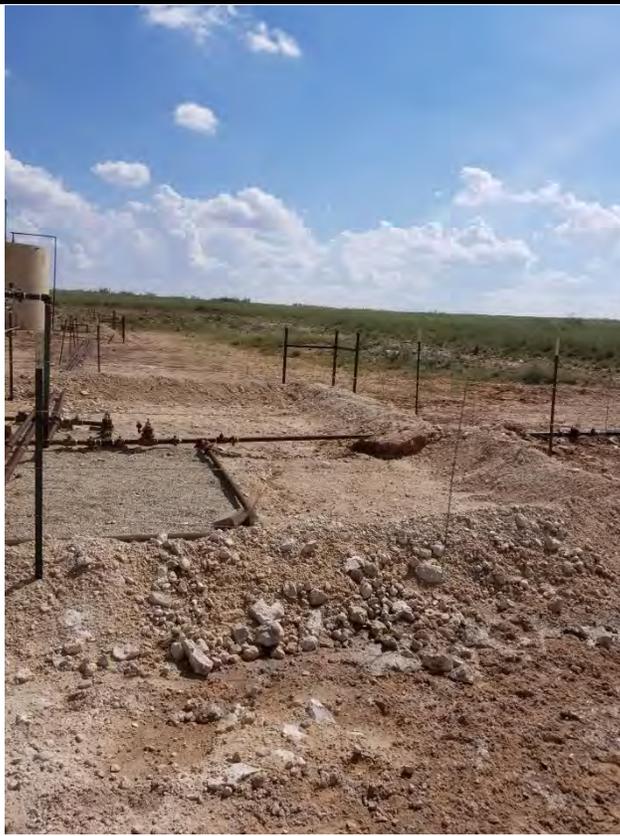
Figure 7 - View of affected area after remediation activities, facing south.
