**1RP-4787**  
**FINAL**  
**DELINEATION AND REMEDIATION REPORT**  
**NGL Release**

Lea County, New Mexico

LAI Project No. 17-0177-01

November 9, 2018

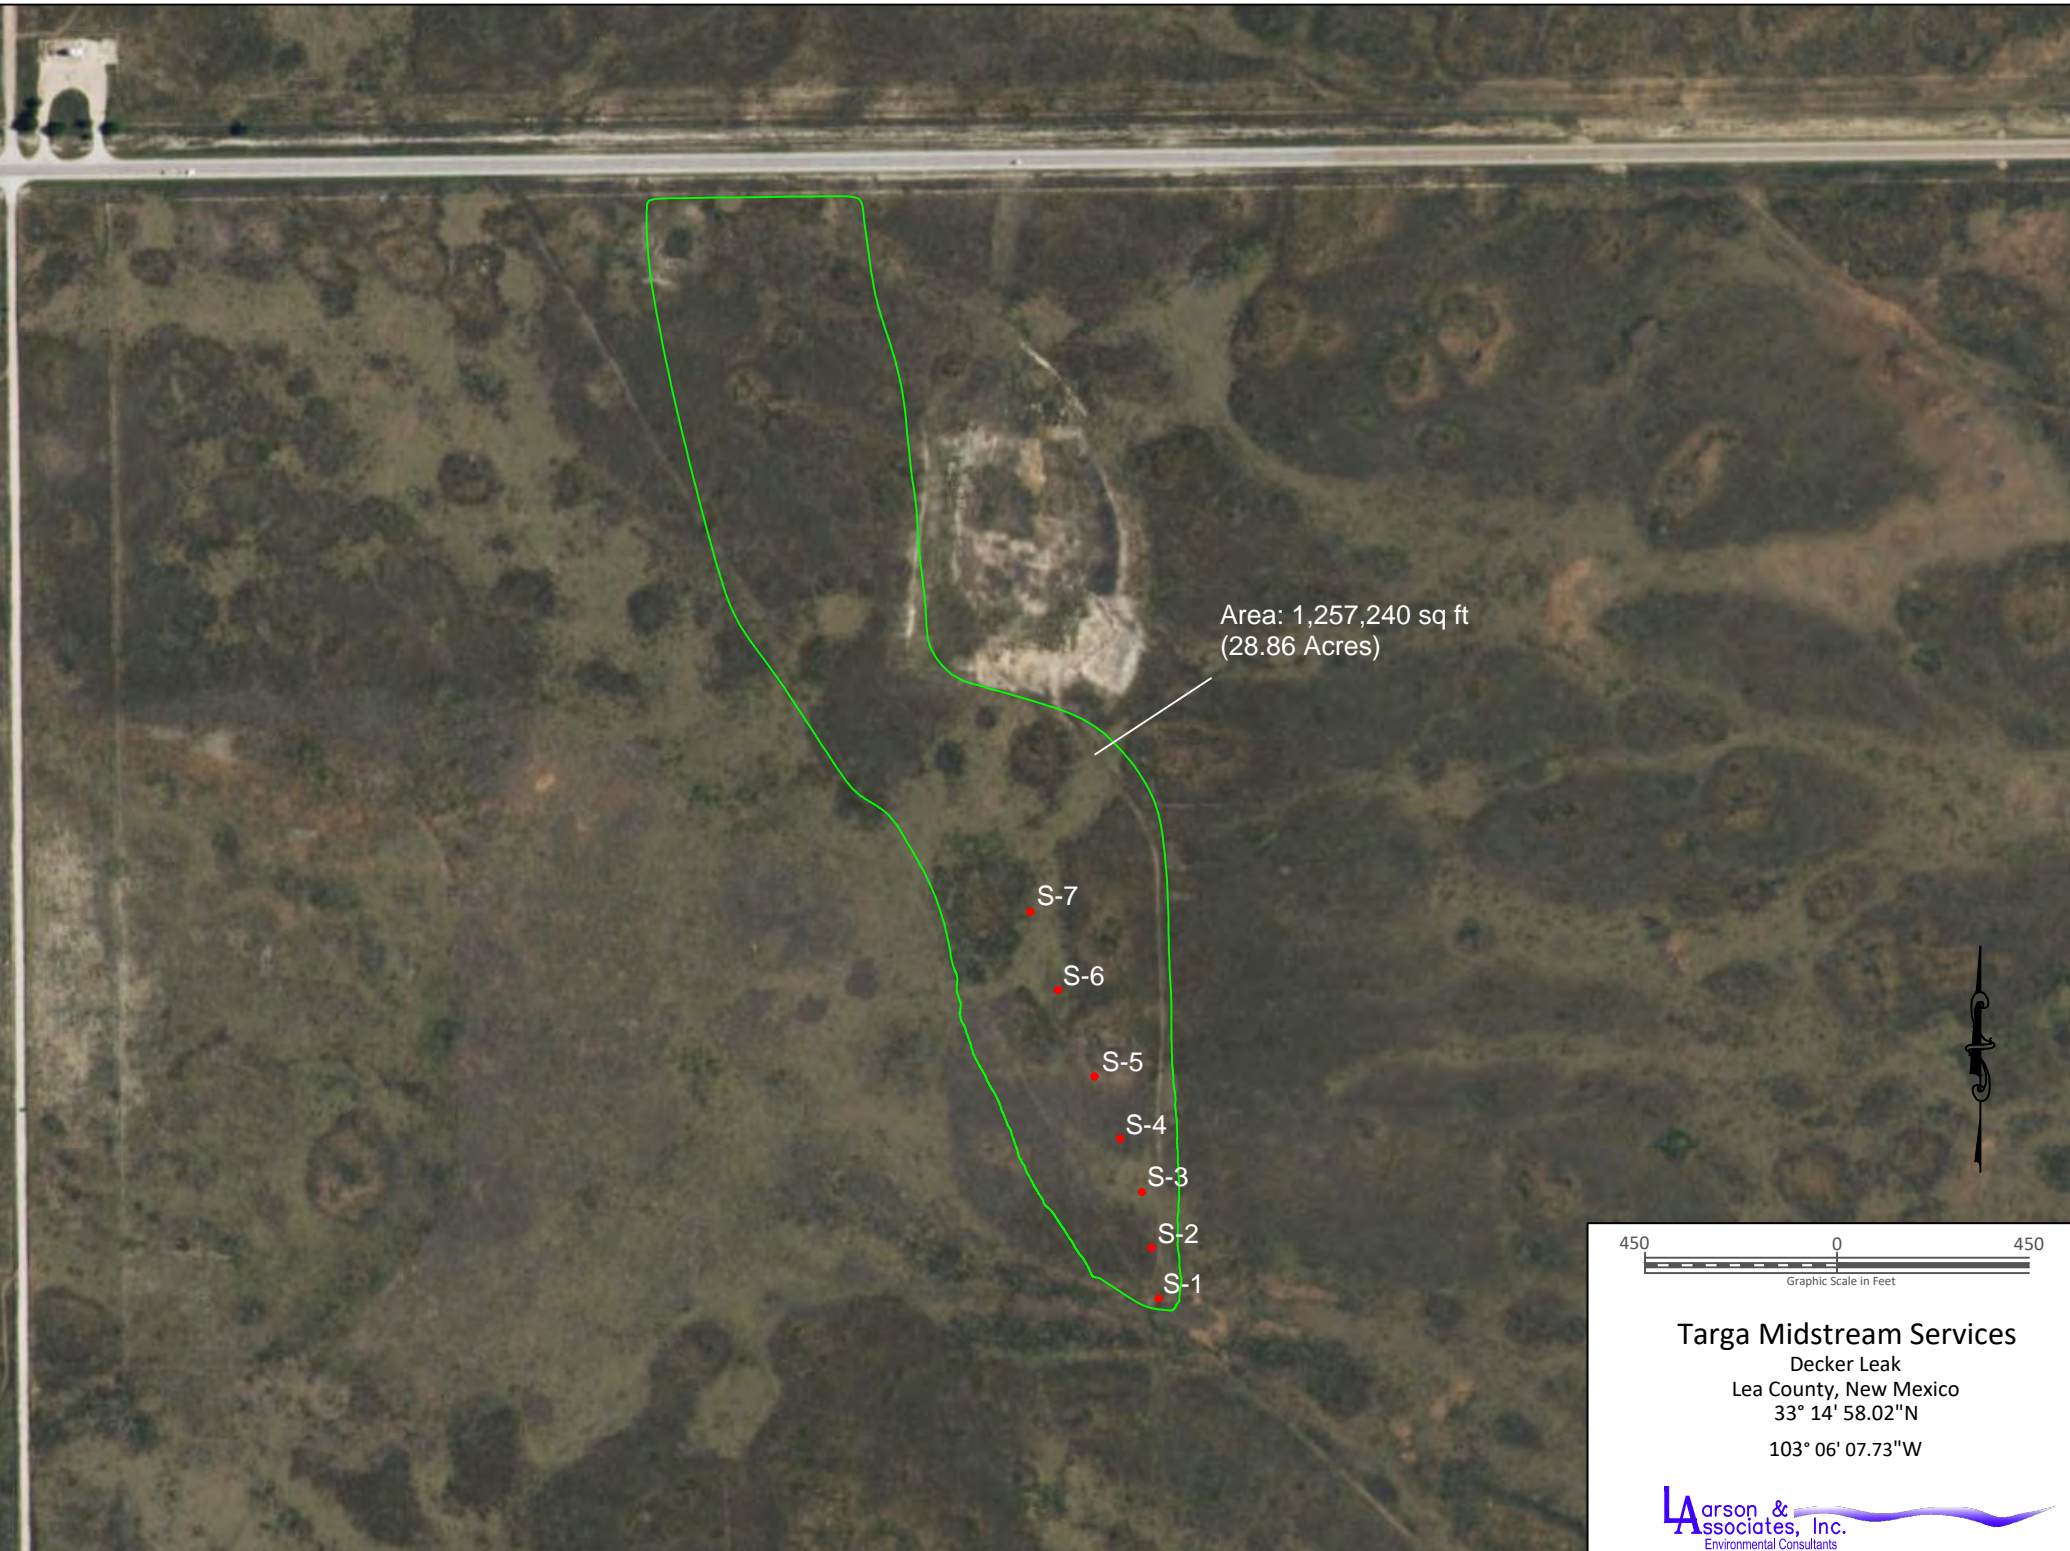
Figure 2 - Aerial Map Showing Release Area and Initial Soil Sample Locations

August 7, 2017, personnel from Larson & Associates, Inc. (LAI) met at the Site with Targa personnel and the landowner (Jeff Decker) to discuss the release. LAI personnel used a hand trowel to collect surface soil samples at seven (7) locations (S-1 through S-7) beginning near the source (S-1) and terminating about 1,000 feet north and northwest of the source (S-7). The soil samples were collected between ground surface and about 6 inches below ground surface (bgs). The samples were collected in laboratory containers and delivered under preservation and chain of custody to Permian Basin Environmental Lab (PBEL) in Midland, Texas. The laboratory analyzed the samples for BTEX (sum of benzene, toluene, ethylbenzene and xylenes) by EPA SW-846 Method 8021B, total petroleum hydrocarbons (TPH) by Method 8015M including gasoline range organics (GRO), diesel range organics (DRO) and oil range organics (ORO), and chloride by Method 300. Table 1 presents the initial soil sample analytical data summary. Figure 2 presents an aerial map showing the initial soil sample locations.

Benzene and BTEX were below the RRAL in samples S-1 through S-7. TPH exceeded the RRAL in samples of 100 milligrams per kilogram (mg/Kg) in samples S-1 (12,850 mg/Kg), S-2 (3,920 mg/Kg) and S-3 (411.3 mg/Kg). Chloride was above 250 mg/Kg in samples S-1 (2,680 mg/kg) and S-2 (1,640 mg/Kg).

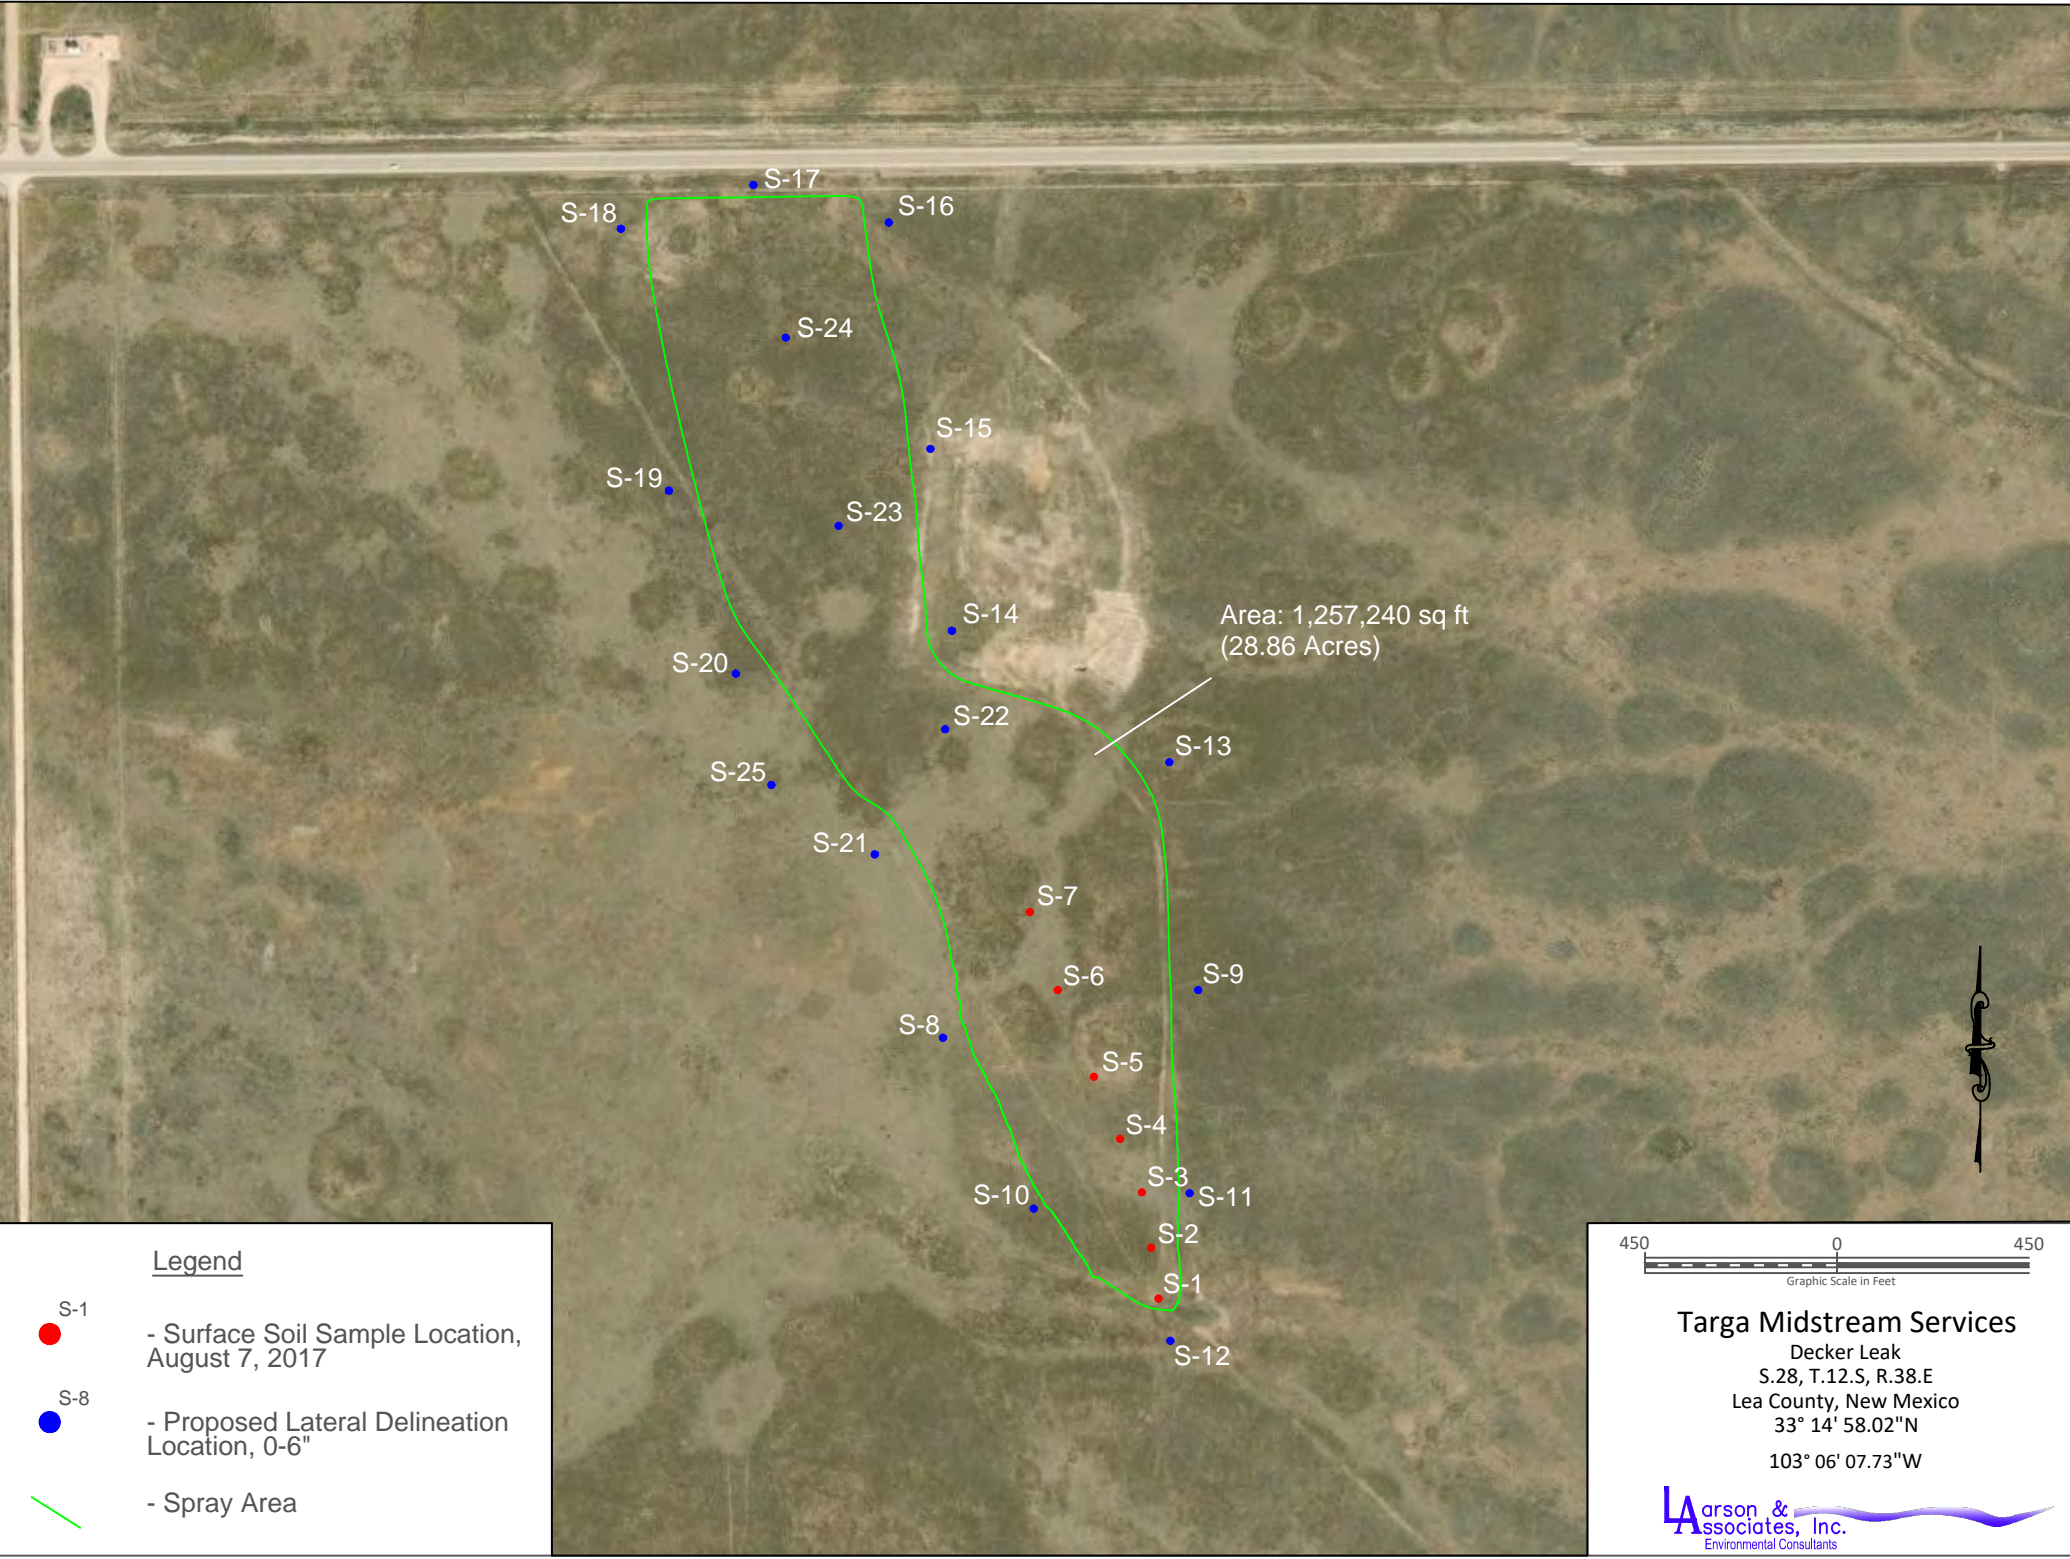
Figure 2 - Aerial Map Showing Spray Area and Surface Soil Sample Location, August 7, 2017

Between August 8 and 25, 2017, LAI personnel treated the spill area with Microblaze microbial amendment. An 8% solution of Microblaze amendment and water was applied to soil and vegetation between the source and sample location S-4. A 6% solution of Microblaze amendment and water was applied to soil and vegetation between sample locations S-4 and S-7. A 3% solution of Microblaze

amendment and water was applied to soil and vegetation over the remaining release area beyond sample location S-7. Figure 3 presents an aerial map of the Microblaze application area.

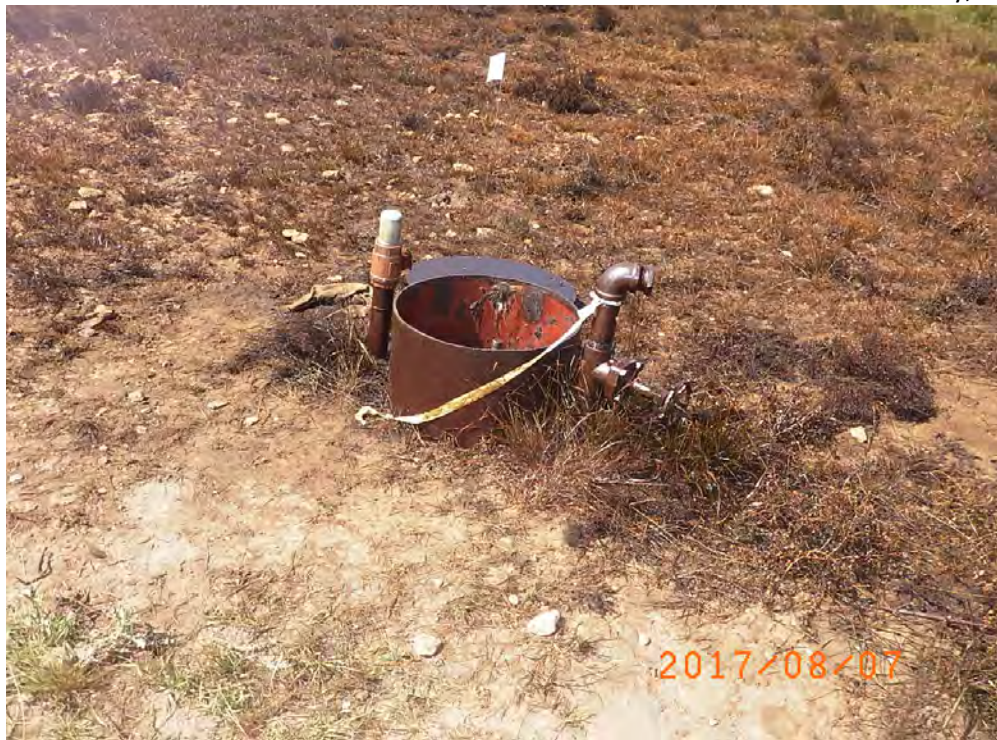
Source of Release Viewing North

On August 5, 2017, Targa was notified of the release which was due to valve failure from corrosion on a 6 inch poly line. The line was isolated, blown down and the valve was removed. Targa estimated approximately 7 barrels (bbl) of NGL and 425 thousand cubic feet (Mcf) of gas was released. Wind dispersed NGL as a mist approximately 2,900 feet north and northwest from the source. NGL was dispersed over an area measuring approximately 1,257,240 square feet or about 28.86 acres. No liquid was recovered. Targa representatives submitted the initial C-141 to the OCD District 1 on August 11, 2017. The OCD assigned the release remediation permit number 1RP-4787 with conditions. Appendix A presents the OCD approved initial C-141.

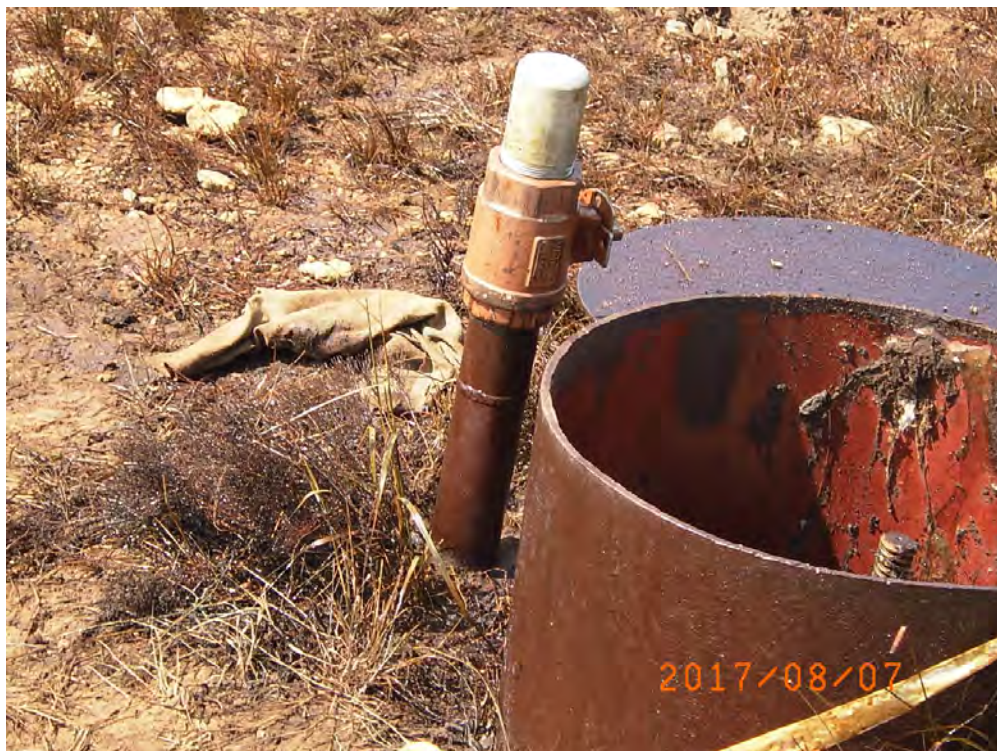
Source of Release

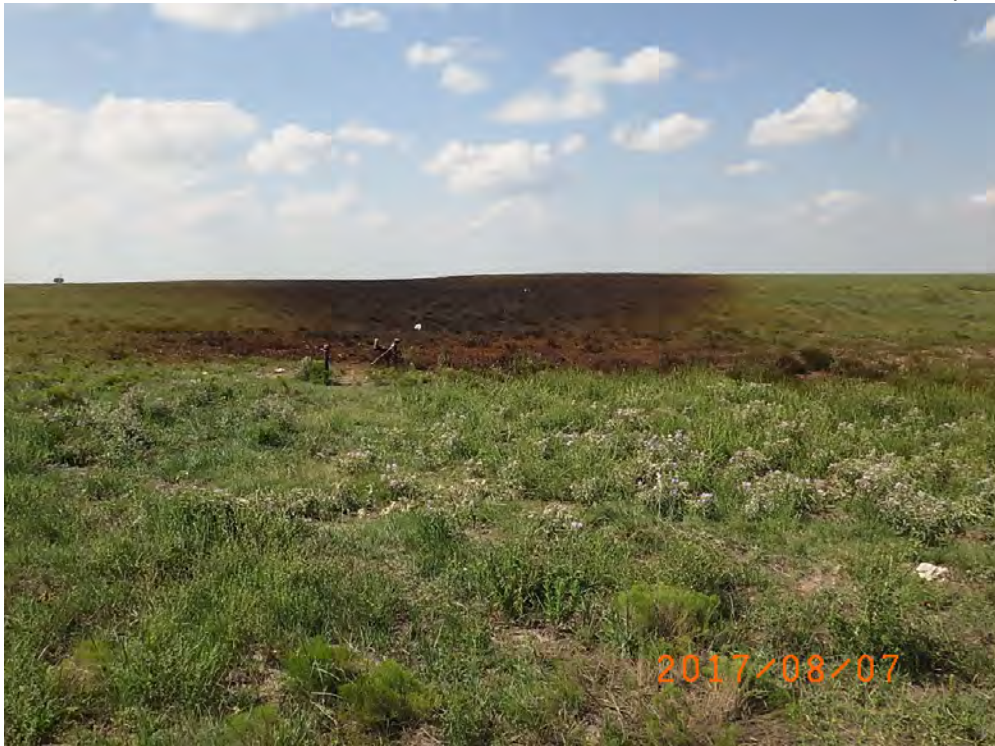
Release Area Viewing from South to North

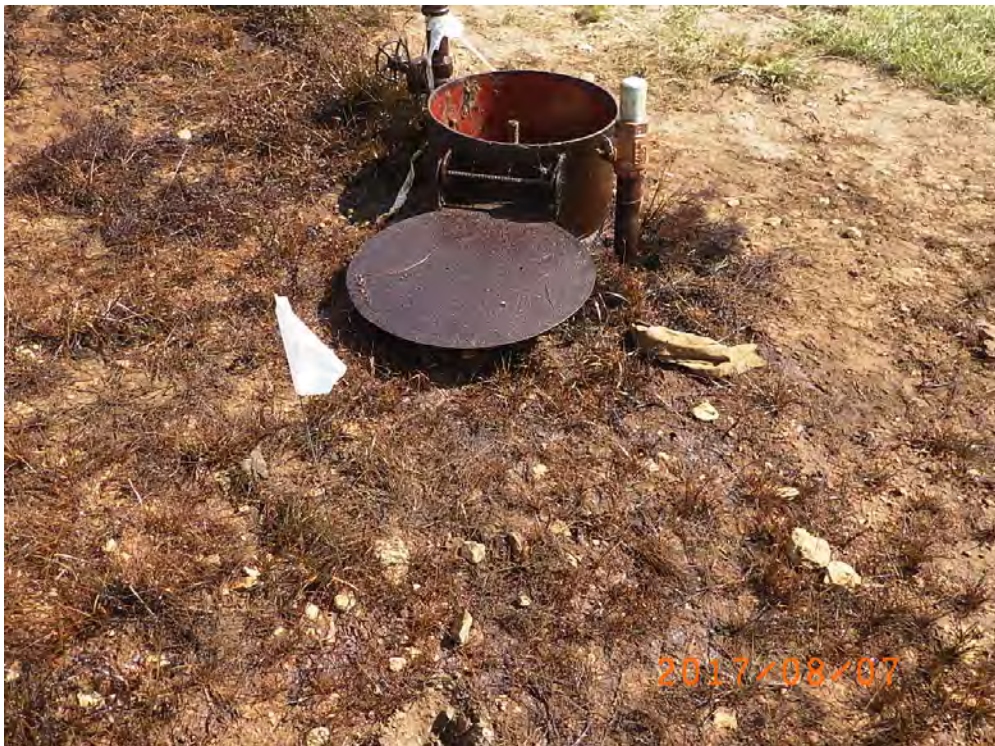
Soil Sample Location S-1 Viewing South

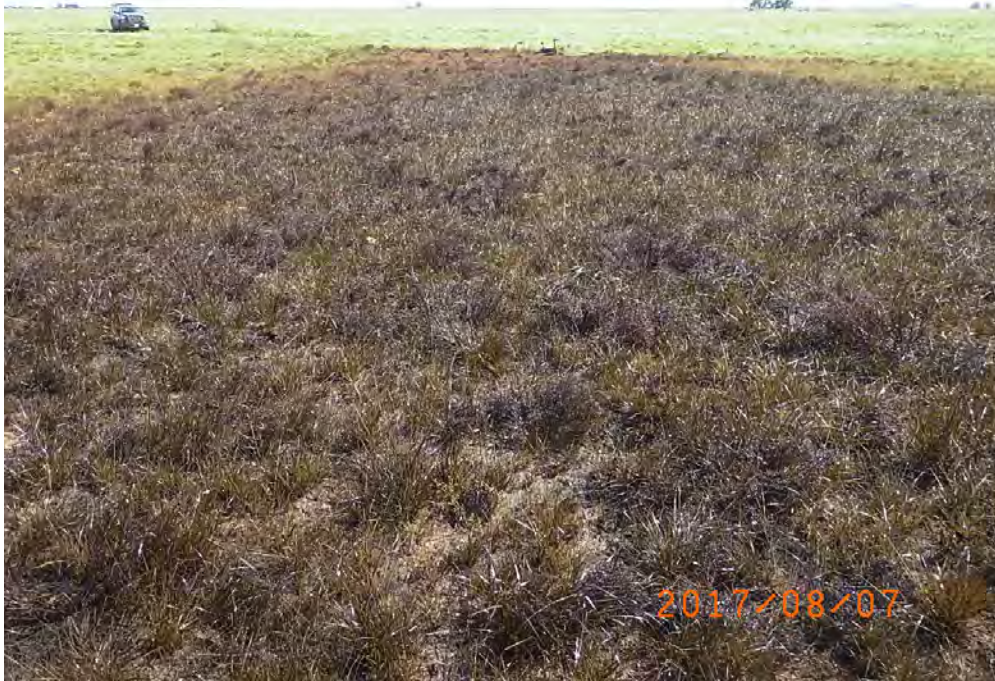
Release Area Viewing South from Soil Sample Location S-2

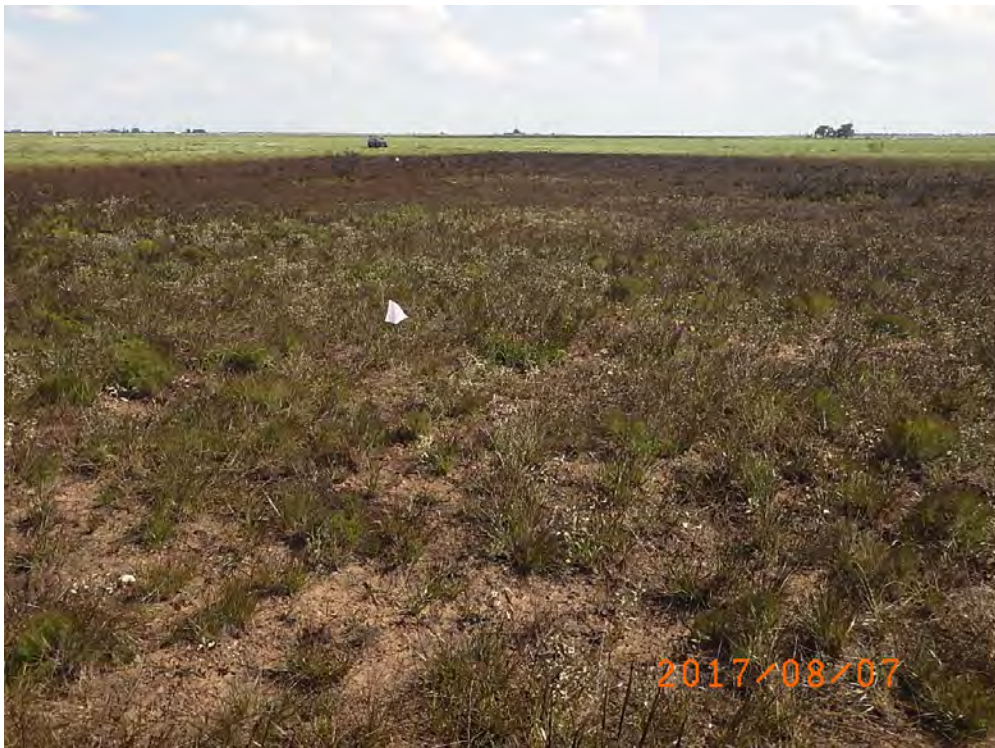
Release Area Viewing South from Soil Sample Location S-3

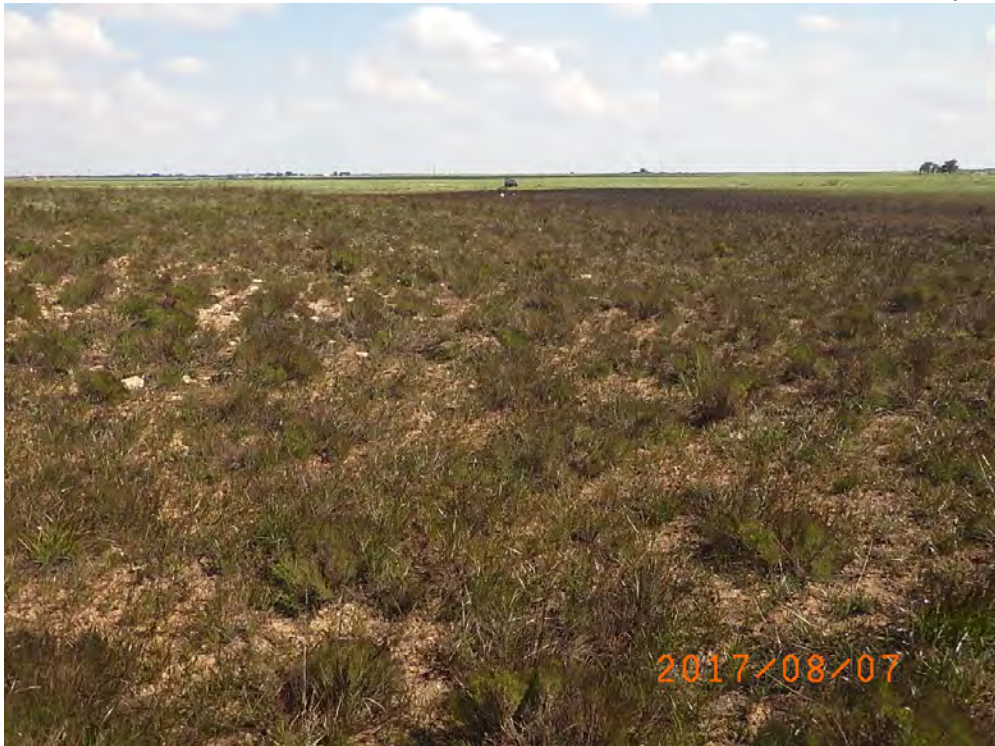
Release Area Viewing South from Soil Sample Location S-5

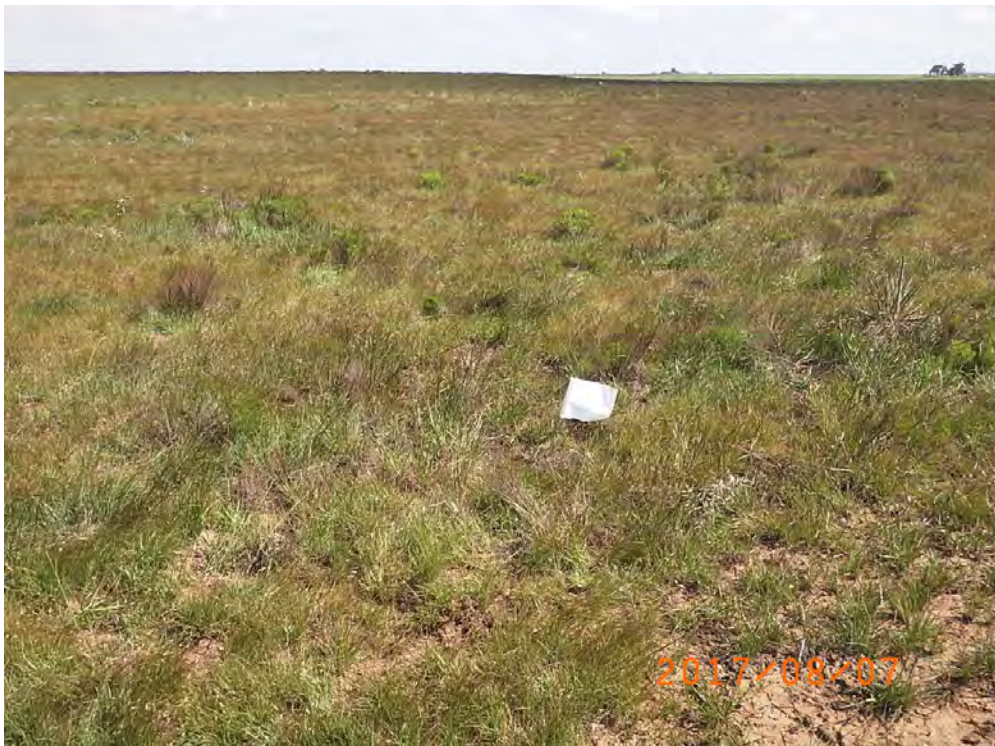
Release Area Viewing South from Soil Sample Location S-7

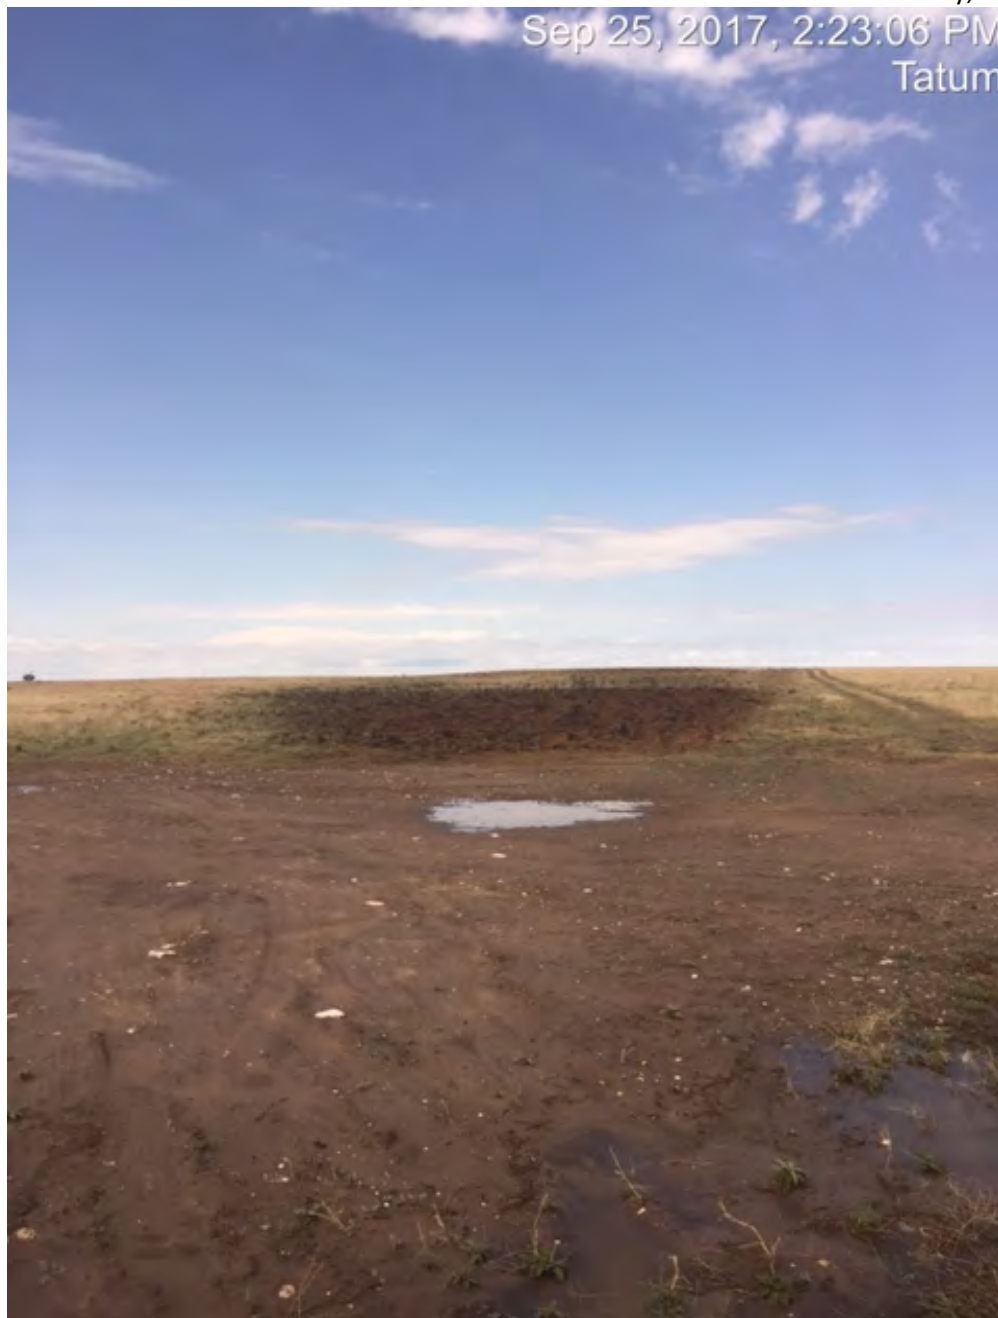
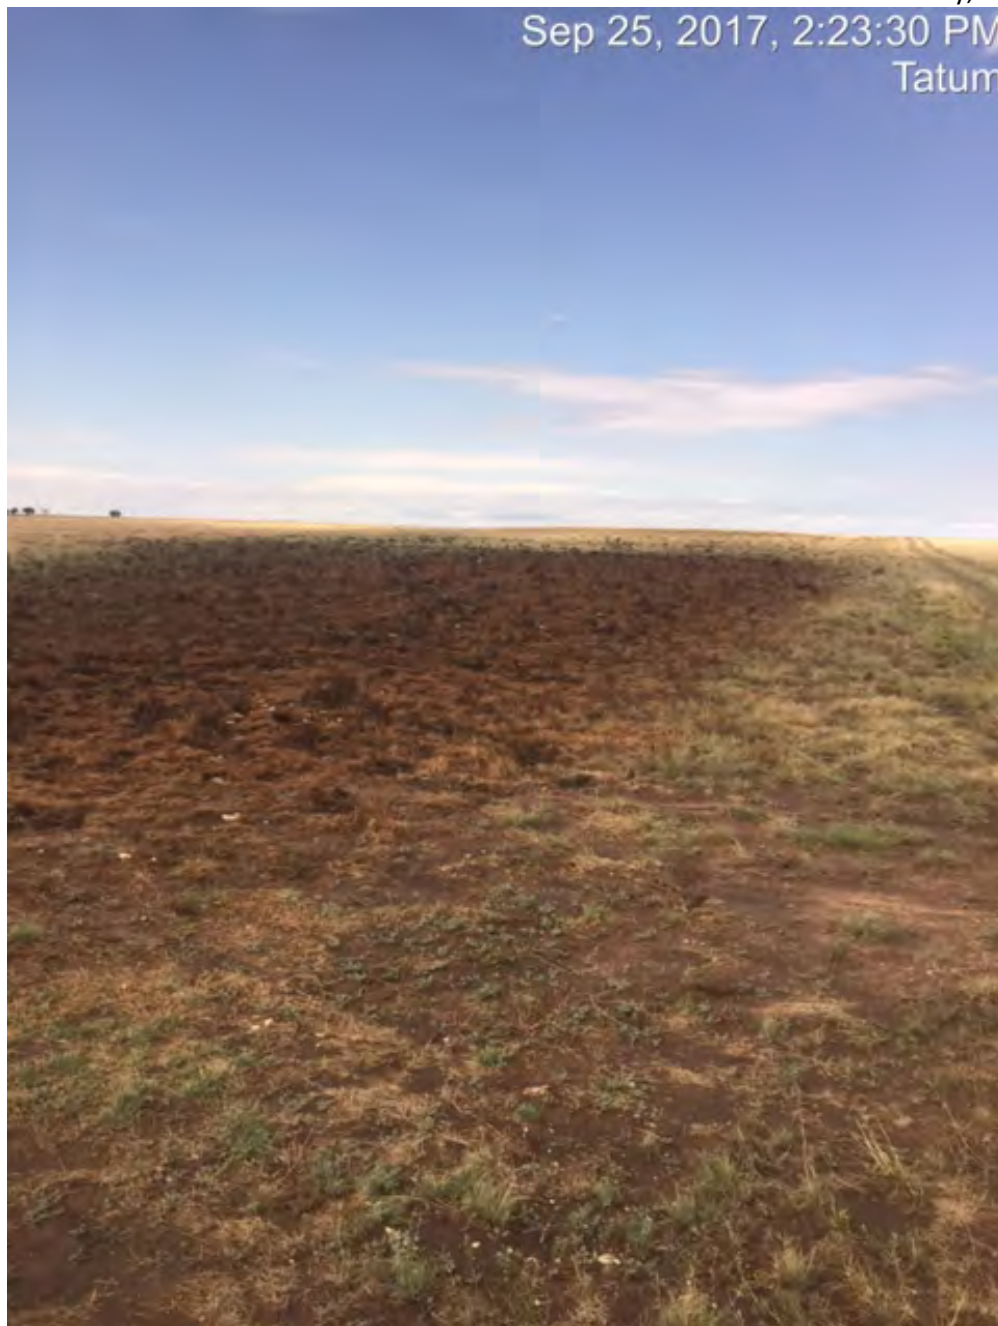
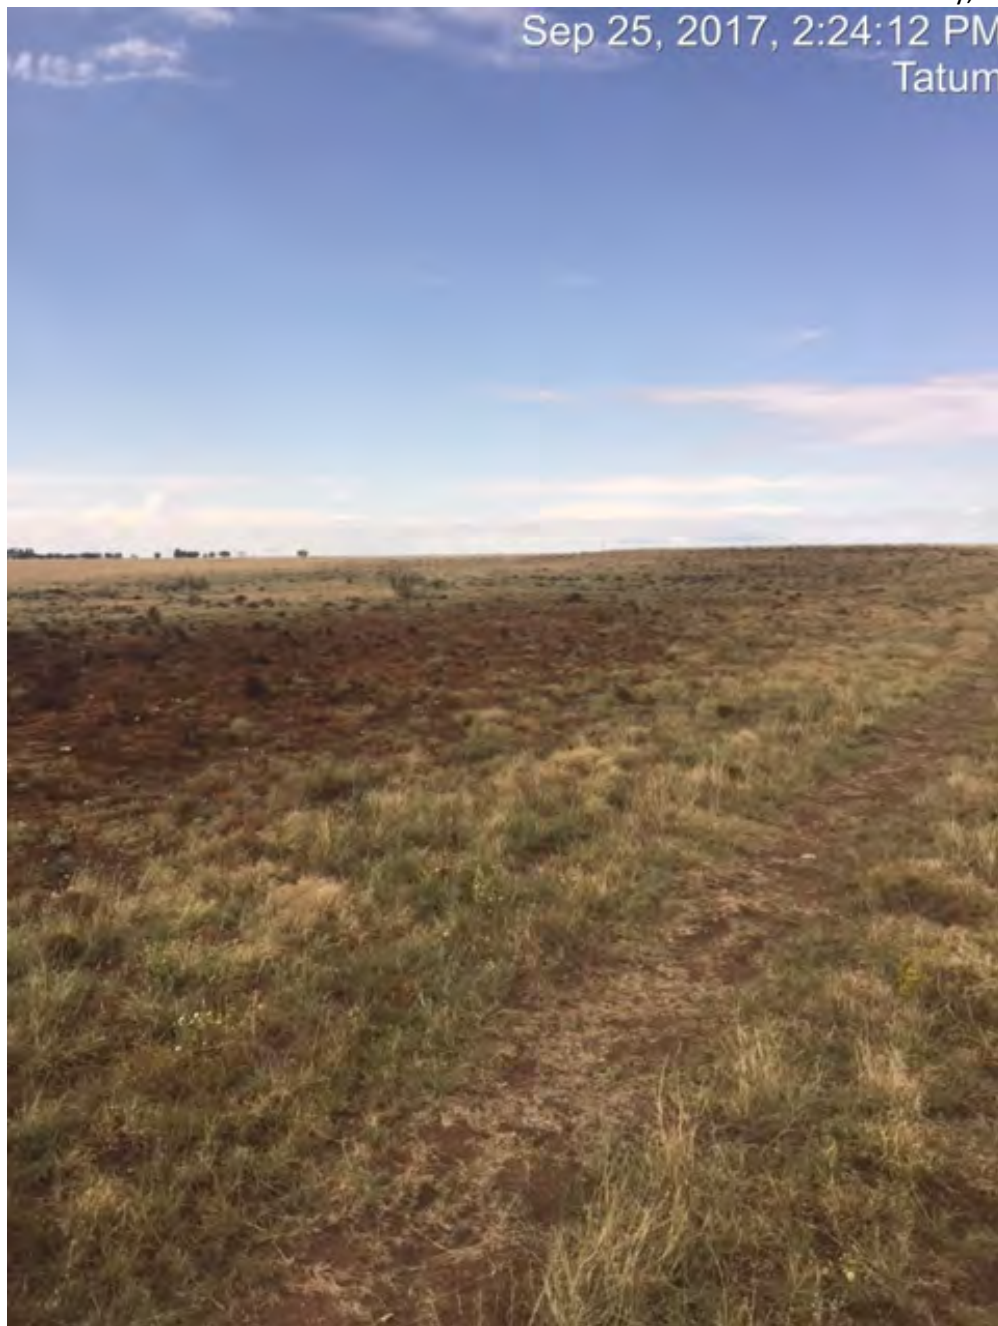
Release Area after Microblaze<sup>®</sup> Application Viewing North, September 25, 2017

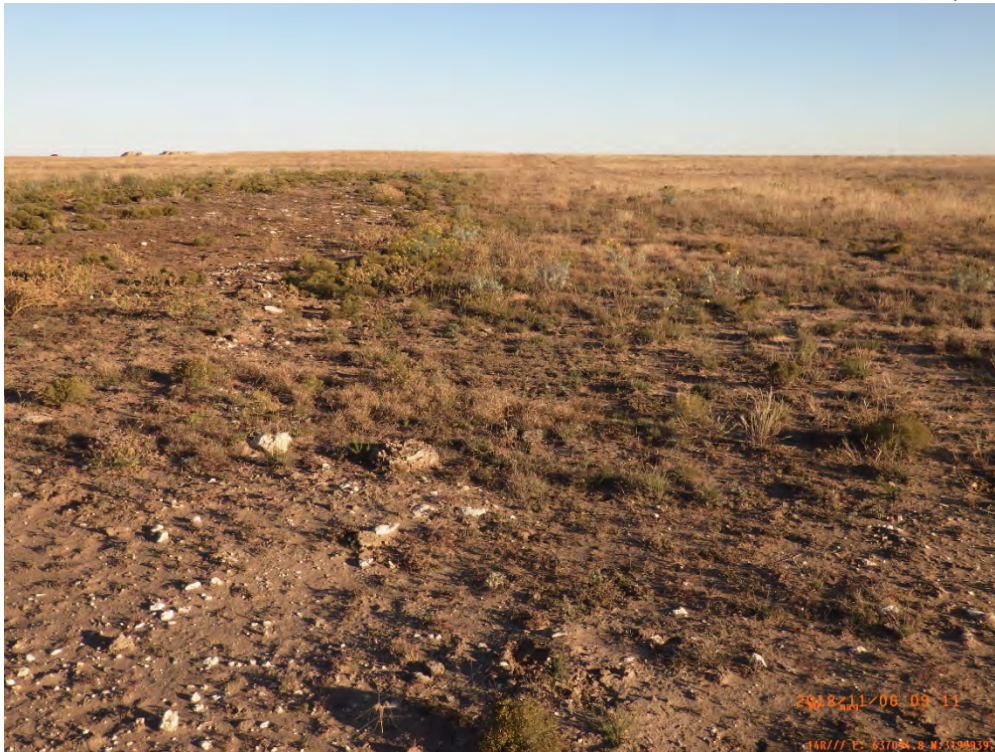
Release Point Viewing Northeast, November 7, 2018

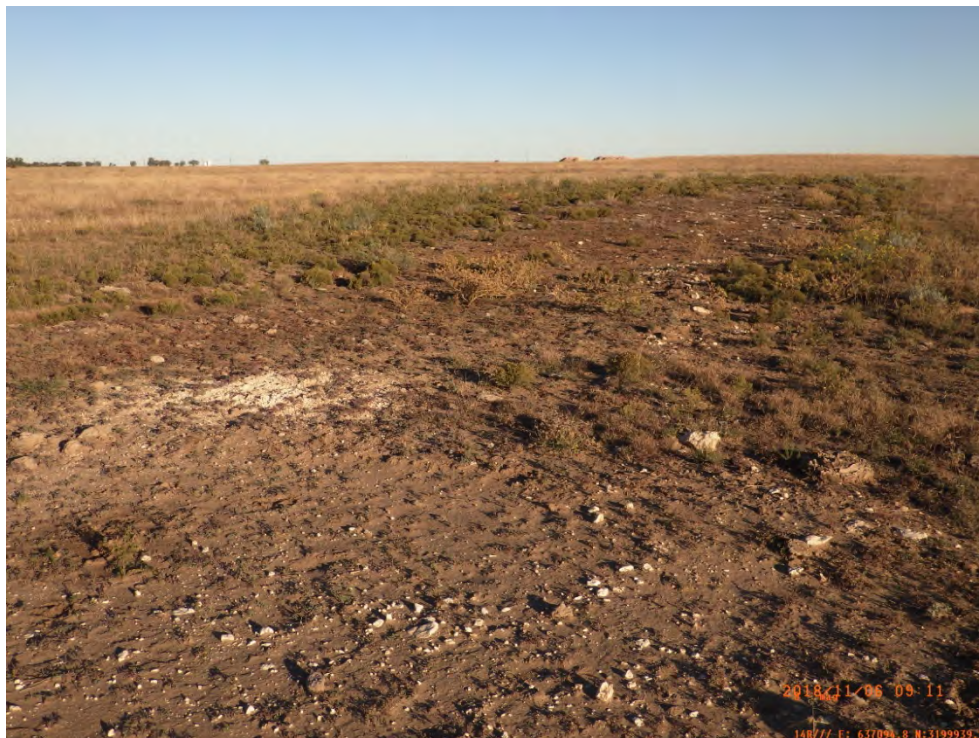
Release Point Viewing North, November 7, 2018

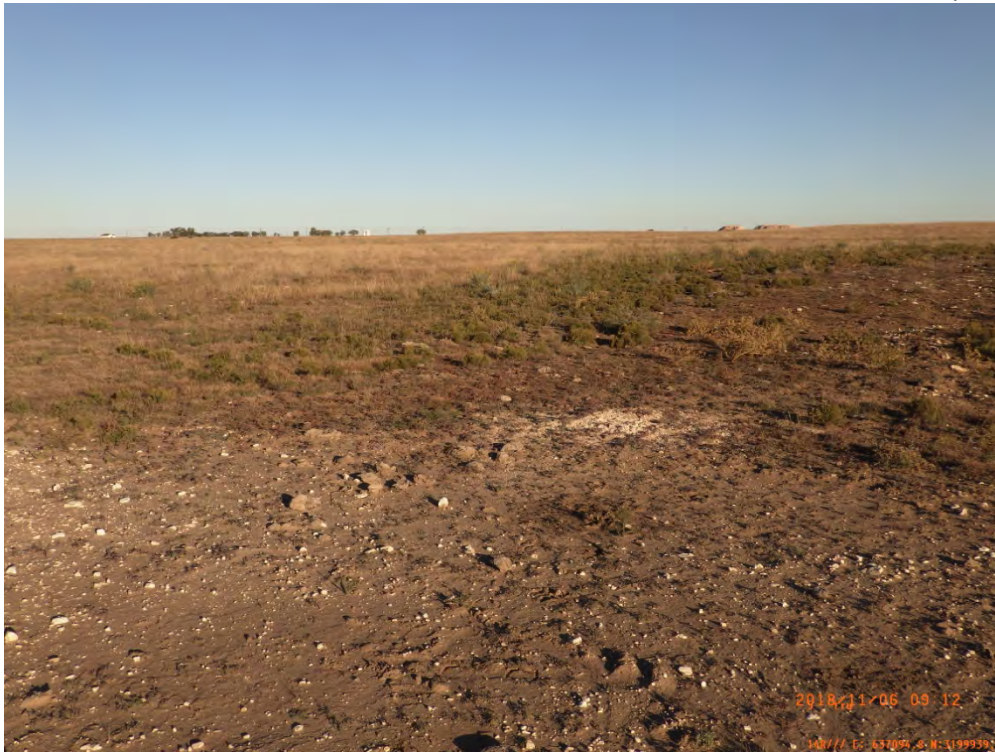
Release Point Viewing Northwest, November 7, 2018

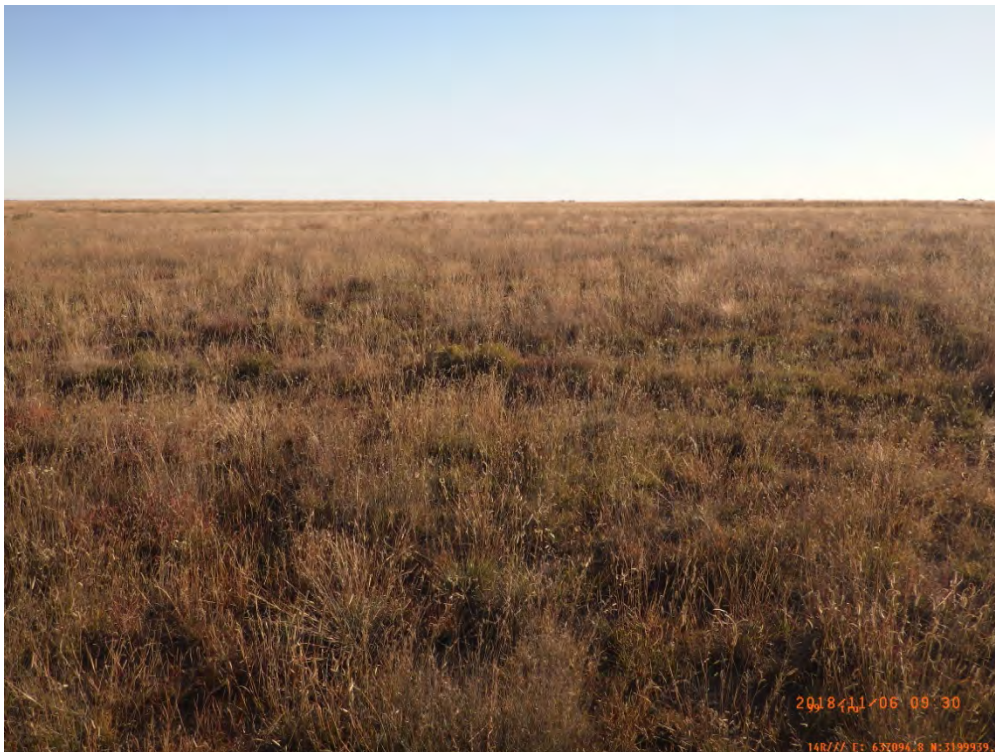
Central Release Area Viewing East, November 7, 2018

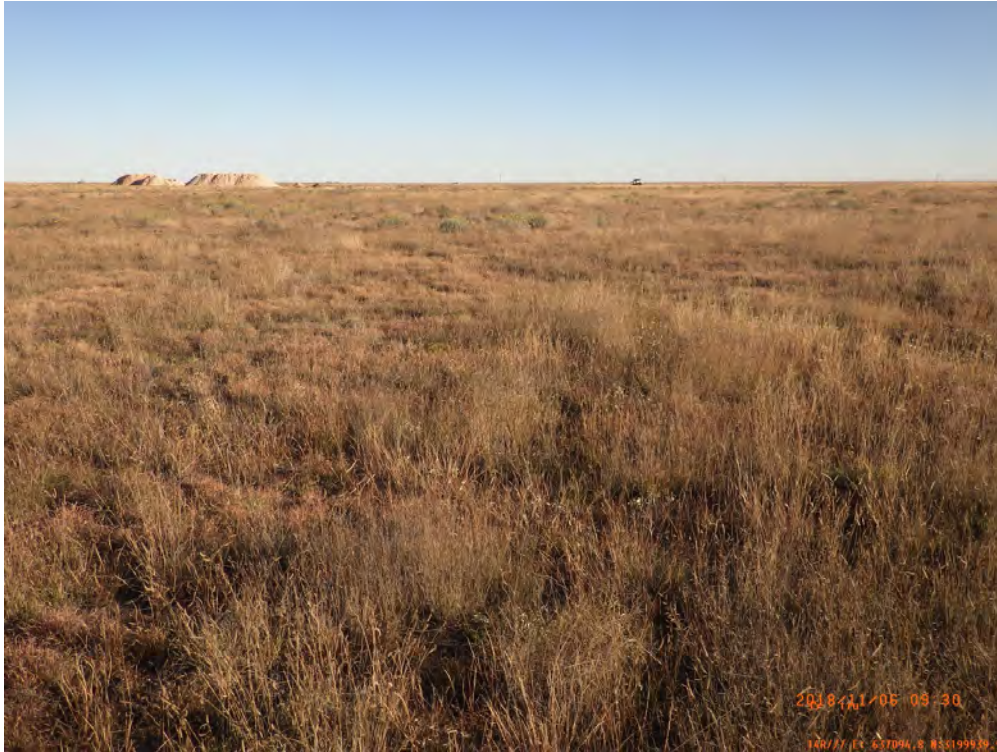
Central Release Area Viewing Northeast, November 7, 2018

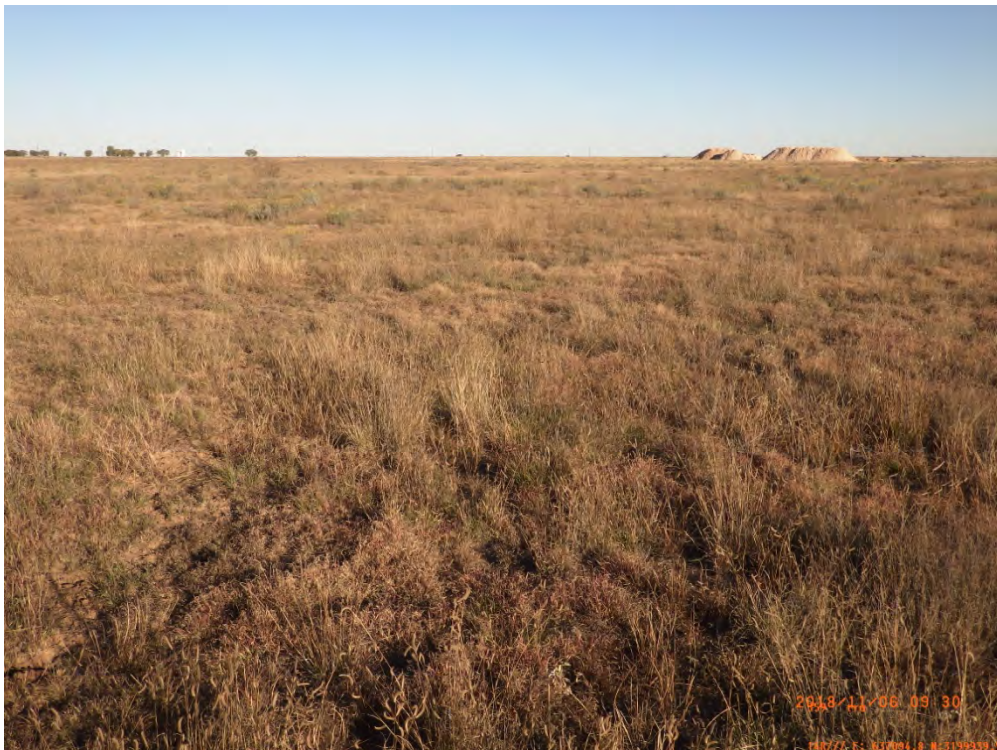
Central Release Area Viewing North, November 7, 2018
