Re: XTO Energy Inc. New Mexico State C NCT2 #10 Final C-141 and closure documentation  
UL H (SE¼ of the NE¼) of Section 19, T20S, R37E  
Latitude: 32°33'39.391"N and Longitude: 103°17'03.887"W  
Landowner: State of New Mexico  
Driving Directions: From the intersection of NMSR 8 and NMSR 322 in Monument, NM, go south on NMSR 8 for 6.4 miles. Then right on Maddox Road 4 miles, then right 1.0 miles, then right 0.15 miles, then right 0.15 miles to the NM State C NCT2 #10 work location.

# Site Information and Metrics

## Release Notification and Corrective Action

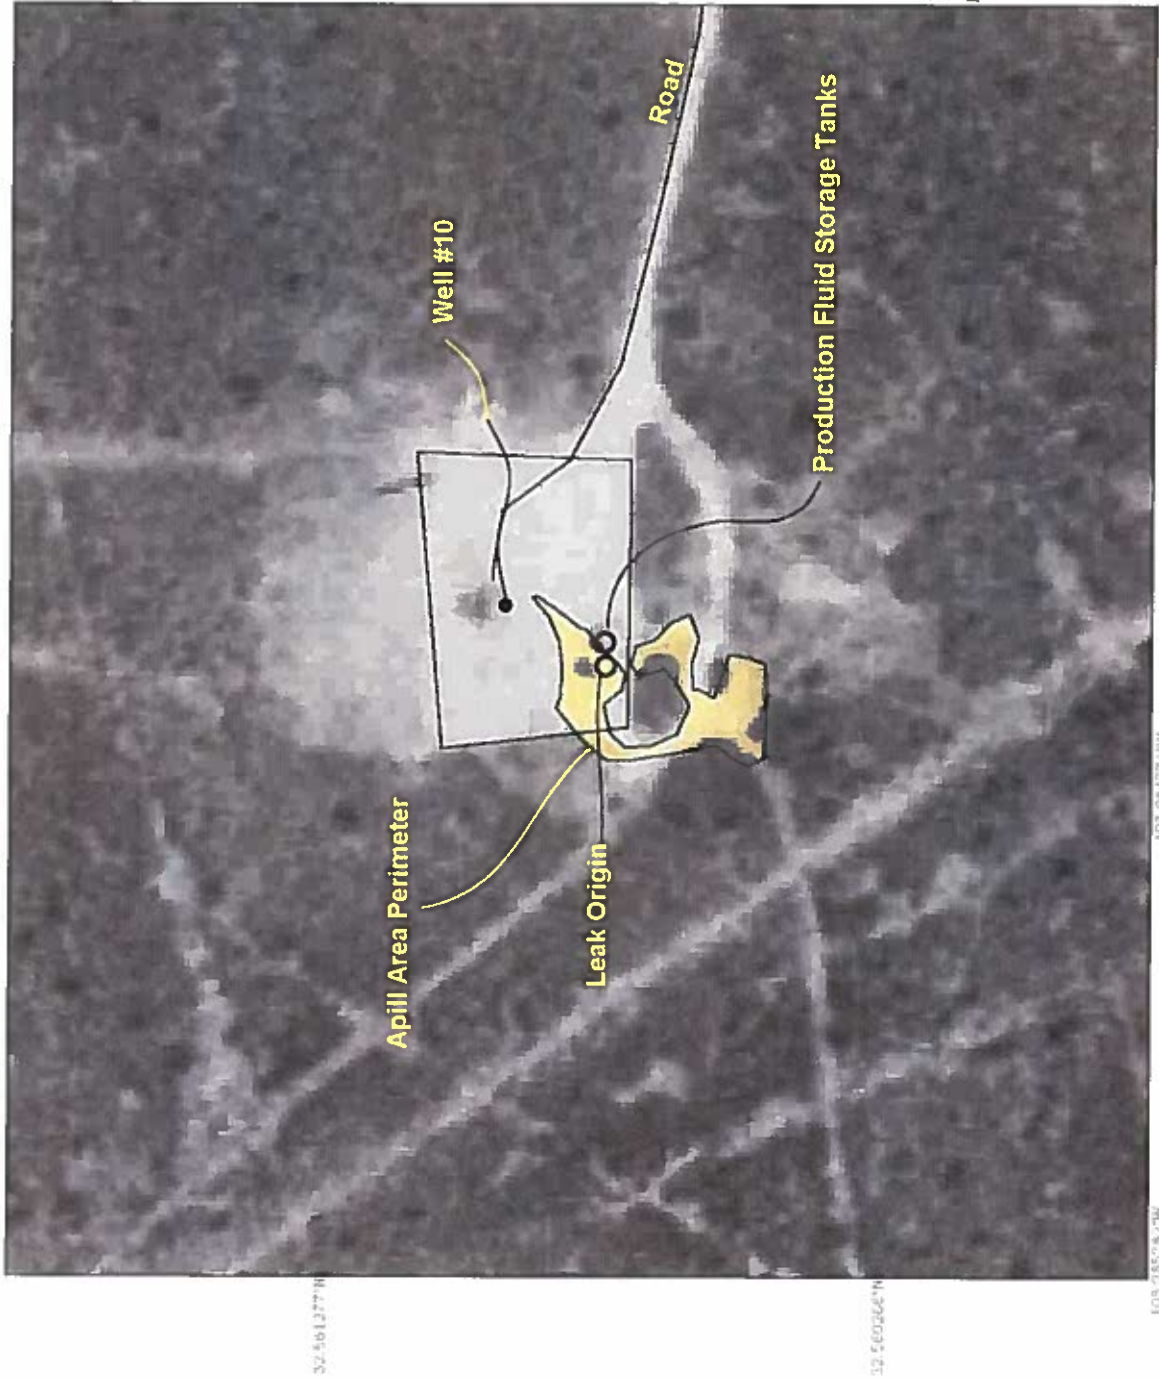
XTO Energy  
New Mexico  
State C  
NCT2 #10  
UL-H Sec 19  
T20S R37E  
Lea Co NM  
Affected Area  
~7,260 sqft
