**Breitbart Operating LP**  
**Jalmat Sands Unit Water Injection Unit Battery**  
**Work Plan**

**Section 14, Township 22S, Range 35E**  
**Lea County, New Mexico**

**September 16, 2019**

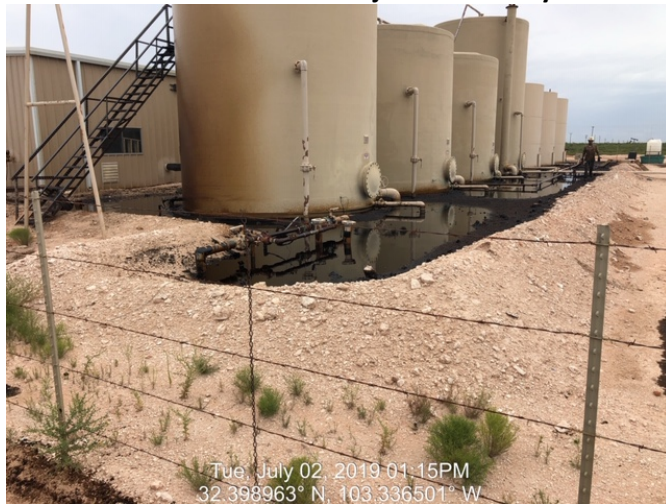
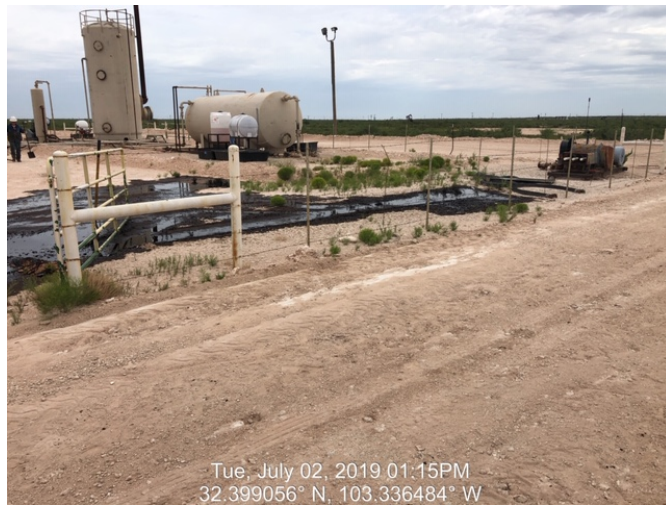
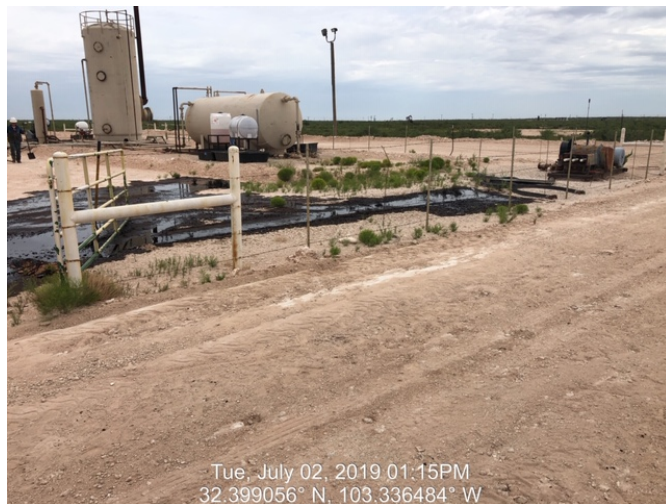
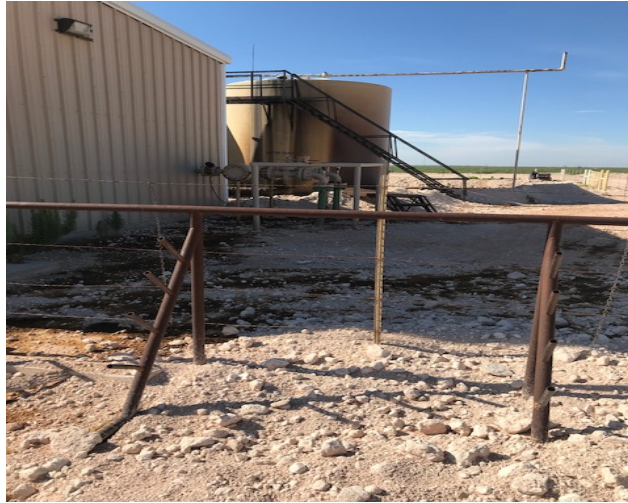
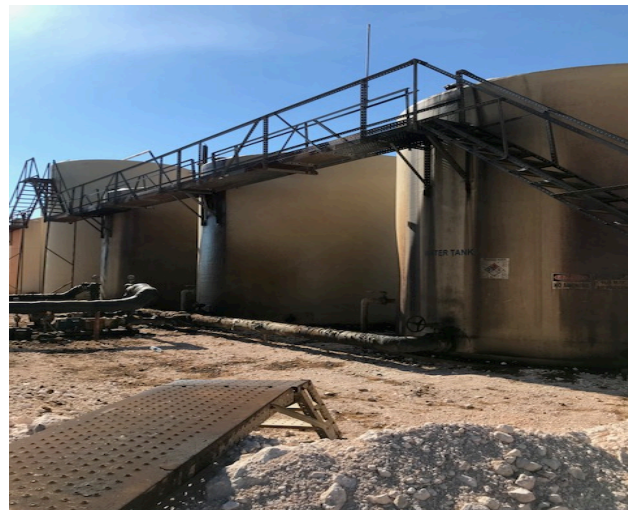
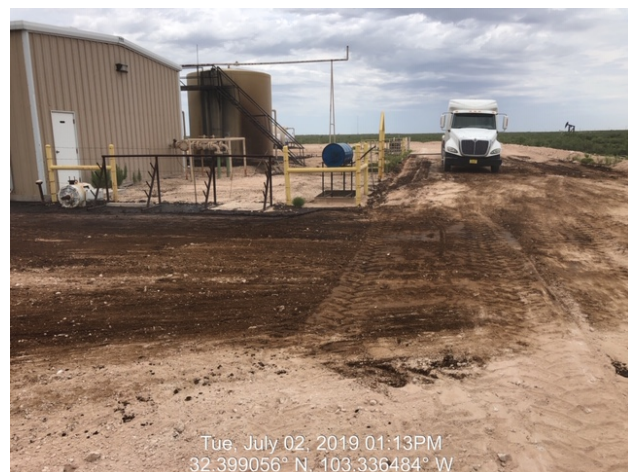
### **Site Photos**

Safety and Environmental Solutions, Inc., hereinafter referred to as (SESI) was engaged by Maverick Resources to assess a spill at the Jalmat Sands Unit Water Injection Tank Battery. The spill area was mapped using a handheld Juno 3B. According to the mapped area the spill impacted approximately 514 square yards of pad area. This site is situated in Section 14, Township 22S, and Range 35E.

According to the C-141: A pump malfunctioned, not allowing the movement of water to the injection well. This caused the tanks to overflow. 90% of the fluid was captured inside the containment area. Maverick took proactive measures by dispatching a vac truck to recover the fluid. Some fluid overflowed the containment traversing the lease road. There was no impact to pasture areas.

The results of the samples listed above indicate no BTEX present in any of the samples. SESI proposes to excavate the pad area, and interior of the berm to the extent that Recommended Remediation Levels are < 20,000 ppm for the Chloride Constituency, and < 2,500 ppm for Total Petroleum Hydrocarbons.

The horizontal extent of contamination will be determined by side wall samples to be taken at the time of excavation. Vertical remediation will be documented with bottom soil grab sample laboratory confirmation of RL's. It is estimated that a 1' bgs excavation will be necessary for the removal of impacted caliche. All contaminated soil will be transported to an NMOCD approved facility and documented via disposal manifests. The pad and interior bermed area will be backfilled with like material and returned to grade. Upon completion of approved remediation activity; all necessary closure documentation will be submitted to the appropriate regulatory agencies, and parties of concern.
