RE: Temporary Pit Closure Report
HeartThrob BSX State No.1H 30-025-41056
Ut.D sec.17-T24S-R33E

On behalf of Yates Petroleum Corporation, R.T. Hicks Consultants submits this closure report for the above-referenced temporary pit in accordance with the approved C-144 closure plan. This report includes the following information listed in Part 21 of the C-144 form:

Waste Material Sampling Analytical Results

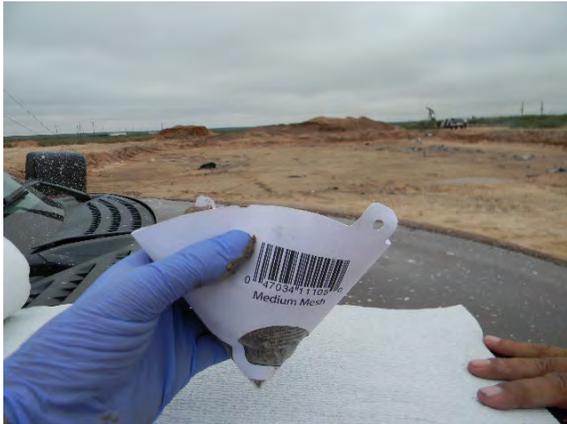
Paint Filter test on 9/15/2014

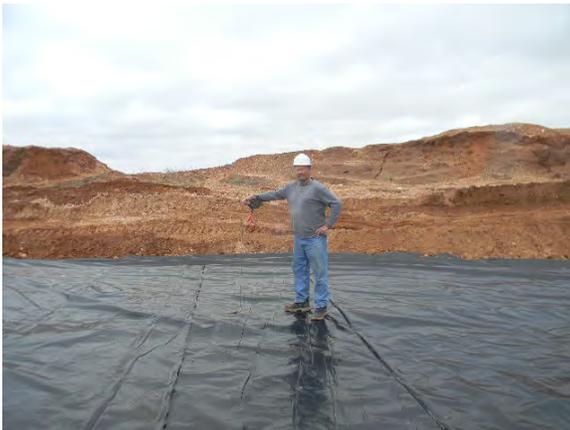
Liner Installation completed on 9/15/2014

5. Following the September 15, 2014 inspection, having achieved all applicable stabilization requirements associated with in-place burial, a 20 Mil. geomembrane liner was installed to completely cover the stabilized cuttings on September 15, 2014. The pit contents and liner were shaped to shed infiltrating water, sloping from north to south.

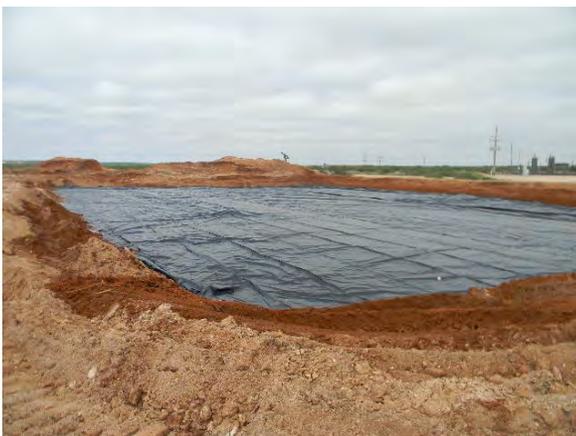
20 Mil. Liner installed on 9/15/2014

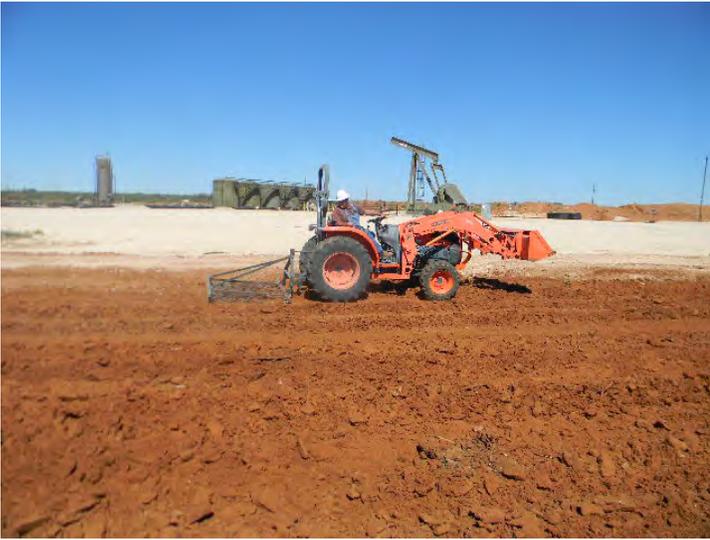
Tractor pulling seed drill across site on 10-13-2014
