R. T. HICKS CONSULTANTS, LTD.

RE: Temporary Pit Closure Report
Murchison - Mogi 9 State Com #3H, API #30-025-41070
Unit N, Section 9, T24S, R33E, Lea County

On behalf of Murchison Oil and Gas, R.T. Hicks Consultants submits this closure report for the above-referenced temporary pit in accordance with the approved C-144 closure plan. This report includes the following information listed in Part 21 of the C-144 form:

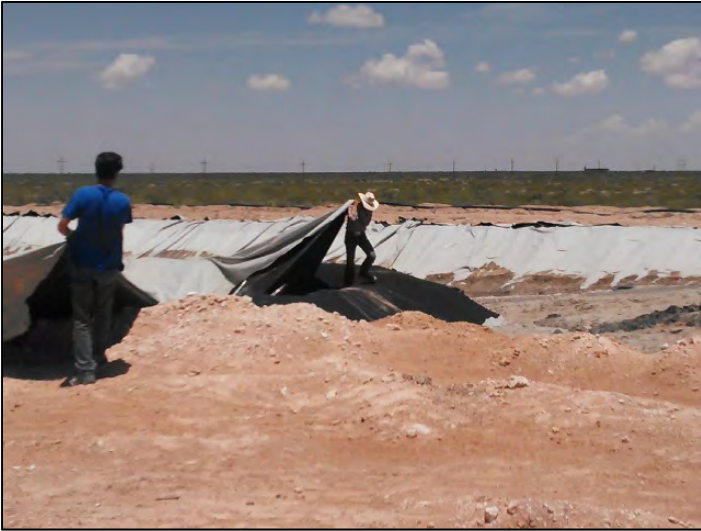
Removing liner 7/14/2014

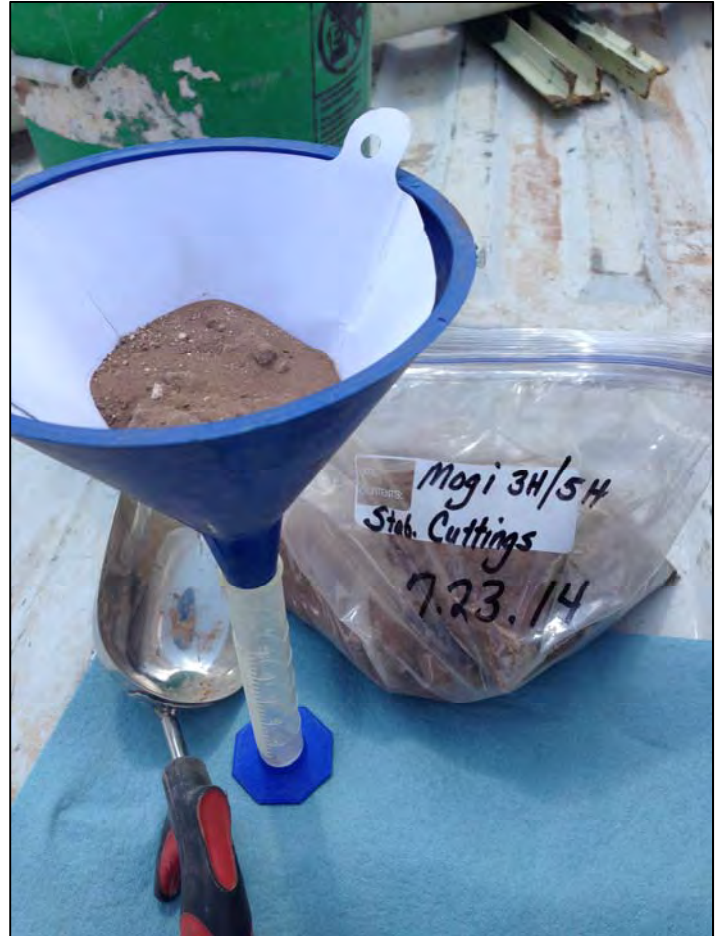
Paint filter test on stabilized cuttings 7/23/2014

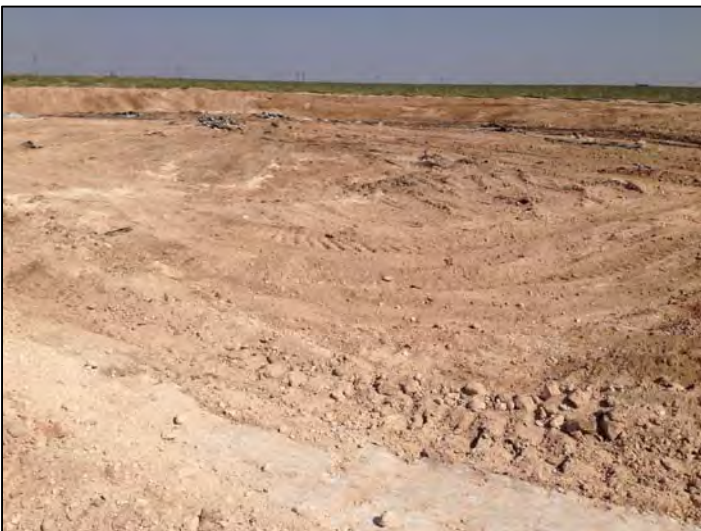
Stabilized cuttings 4 feet below surrounding grade
7/24/2014

7. Once the geomembrane cover was in place, approximately 4 feet or more of non-waste containing, uncontaminated, earthen material and the reserved topsoil were replaced to their relative positions in accordance with Subsection (3) of Paragraph H of 19.15.17.13 NMAC. The soil cover consists of at least four feet of compacted, non-waste containing, earthen material. The uppermost topsoil is equal to the background thickness at least one foot. The surface was contoured to blend with the surrounding topography and to prevent erosion and the ponding of water over the on-site closure. This work was completed on August 6, 2014.

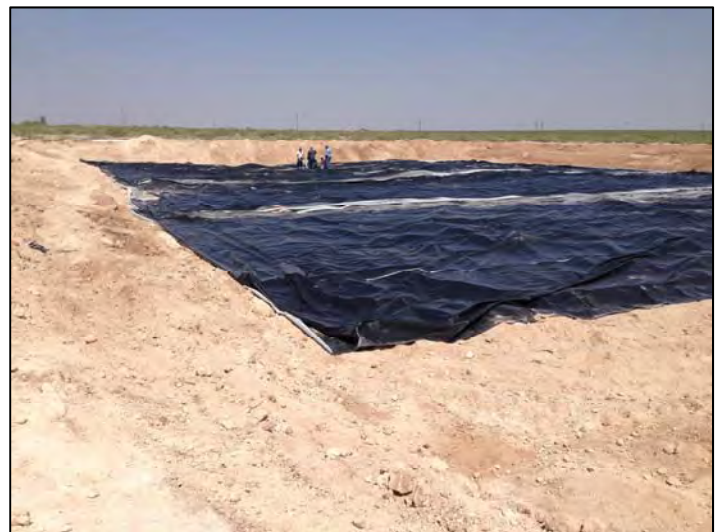
Installing geomembrane cover 7/24/2014

6. Having achieved all applicable stabilization requirements associated with in-place burial, a geomembrane liner was installed to completely cover the stabilized cuttings on July 24, 2014. The pit contents and liner were shaped to shed infiltrating water, slightly higher in the center.
