RE: Temporary Pit Closure Report  
Jackson Jackson Unit #22H, API #30-025-41228, Pit Permit #P1-06386  
Unit M, Section 22, T24S, R33E, Lea County

**On-site Burial Location of Temporary Pit**  
in relation to well pad  
Murchison Oil and Gas, Inc.  
Jackson Unit #22H

**Closure Letter Attachment 4**  
**Murchison – Jackson Unit #22H**  
**API #30-025-41228**

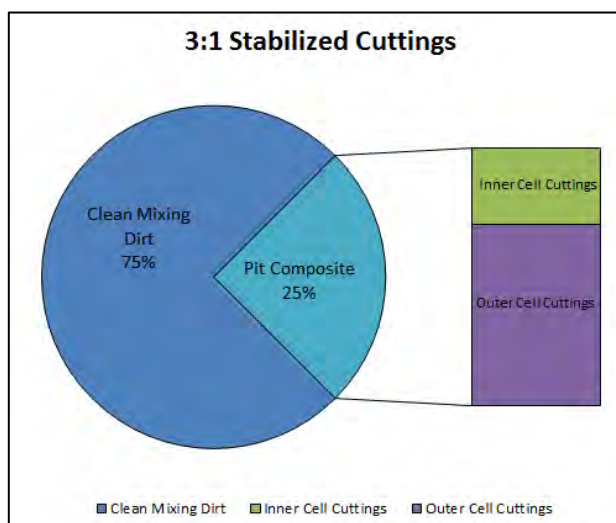
Composition of "3:1 Stabilized Cuttings" Calculation

on the coarser-grained discharge side was 33 inches and the thickness of solids on the finer-grained suction side was 4 inches, we used the following formula to determine the chemical characteristics of the outer cell of the pit:

$$\text{Outer cell concentrations} = \frac{(AB*33)+(CD*4)}{33+4}$$

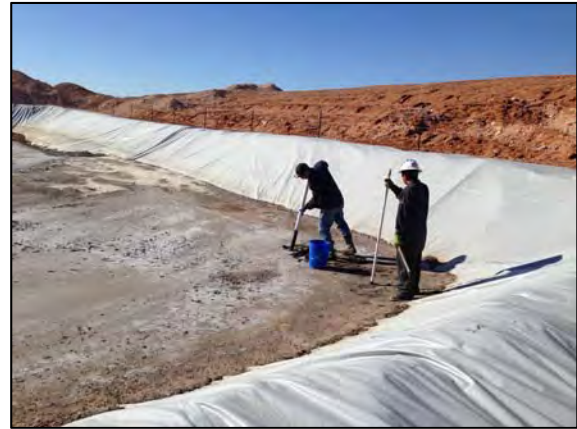
Sampling Pit Contents 10/28/2014

On October 28, 2014, four-point composite samples of the pit solids from the inner and outer cells respectively and from the berms of the pit (below the liner) were collected in accordance with the Pit Rule. Hall Environmental Analysis Laboratory of Albuquerque provided BTEX (8260B), GRO/DRO (8015B), TPH (418.1), and Chloride (SM4500) analyses for each component sample. When “3:1 stabilized cuttings” was calculated by mathematically mixing 1 part weighted pit composite with 3 parts non-waste mixing material, the resultant DRO+GRO concentration did not meet Table II limits.

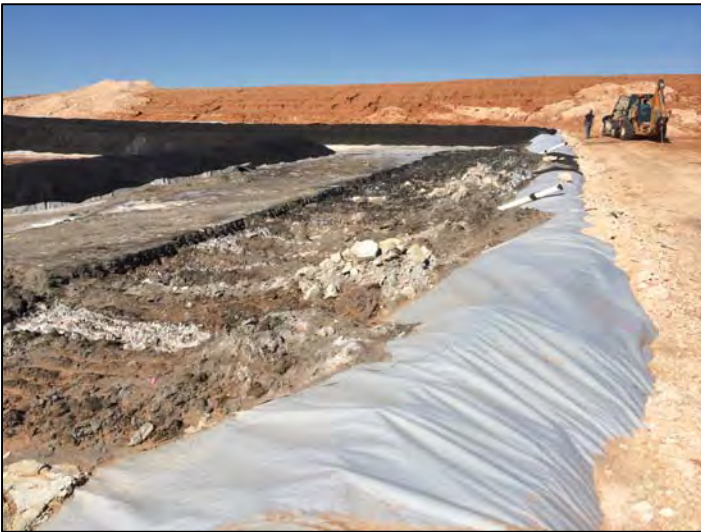
Cutting liner at mud line 2/13/2015

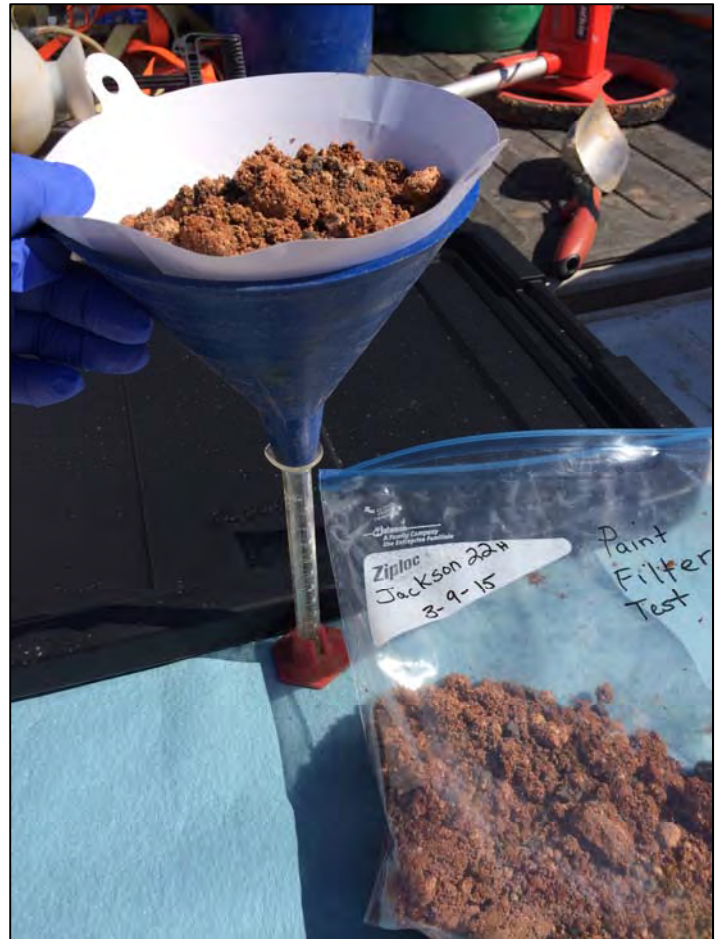
Paint Filter Test on Stabilized Cuttings 3/9/2015

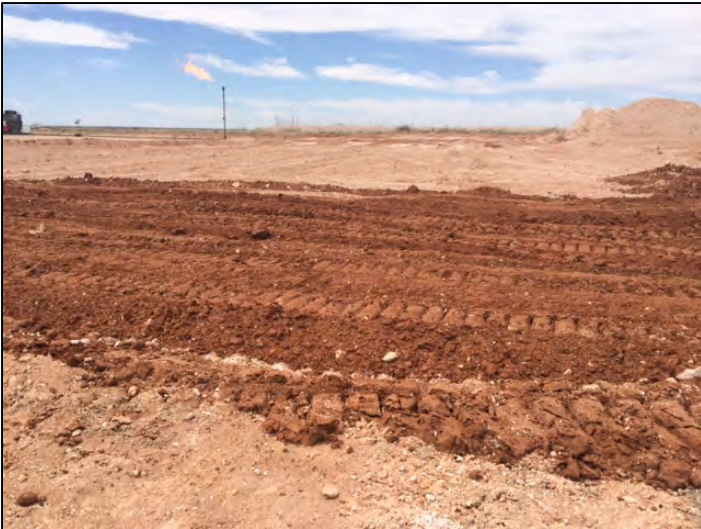
Spreading topsoil on surface 3/25/2015

their relative positions in accordance with Subsection (3) of Paragraph H of 19.15.17.13 NMAC. The soil cover consists of at least four feet of compacted, non-waste containing, earthen material. The uppermost topsoil is equal to the background thickness at least one foot. The surface was contoured to blend with the surrounding topography and to prevent erosion and the ponding of water over the on-site closure. This work was completed on March 25, 2015.

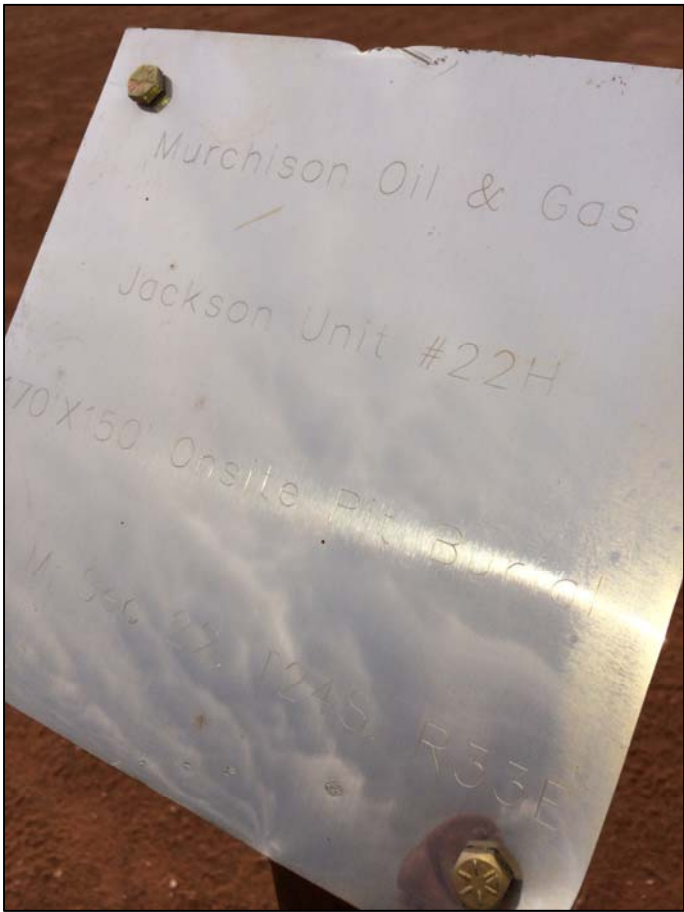
Steel plate installed on surface marking on-site closure

3. A steel plate marking the site as an in-place pit closure has been placed on the surface at the center of the former pit location in accordance with Subsection (3) of Paragraph F of 19.15.17.13 NMAC.
4. The seeded area will be monitored for growth and the operator will repeat seeding until a successful vegetative cover is achieved as outlined in Subsection (5) of Paragraph H of 19.15.17.13 NMAC.
5. If conditions are not favorable for the establishment of vegetation, such as periods of drought, the operator may request that the division allow a delay in additional seeding until soil moisture conditions become favorable. The operator will notify the division and provide photo-documentation when it successful re-vegetation is achieved.
