# R. T. HICKS CONSULTANTS, LTD.

RE: Temporary Pit Closure Report  
Murchison – Mogi 9 St Com #10H, API #30-025-41973, Pit Permit #P1-06561  
Unit O, Section 9, T24S, R33E, Lea County

**Closure Letter Attachment 4**  
**Murchison – Mogi 9 St Com #10H (Jackson Unit #33H)**  
**API #30-025-41973**

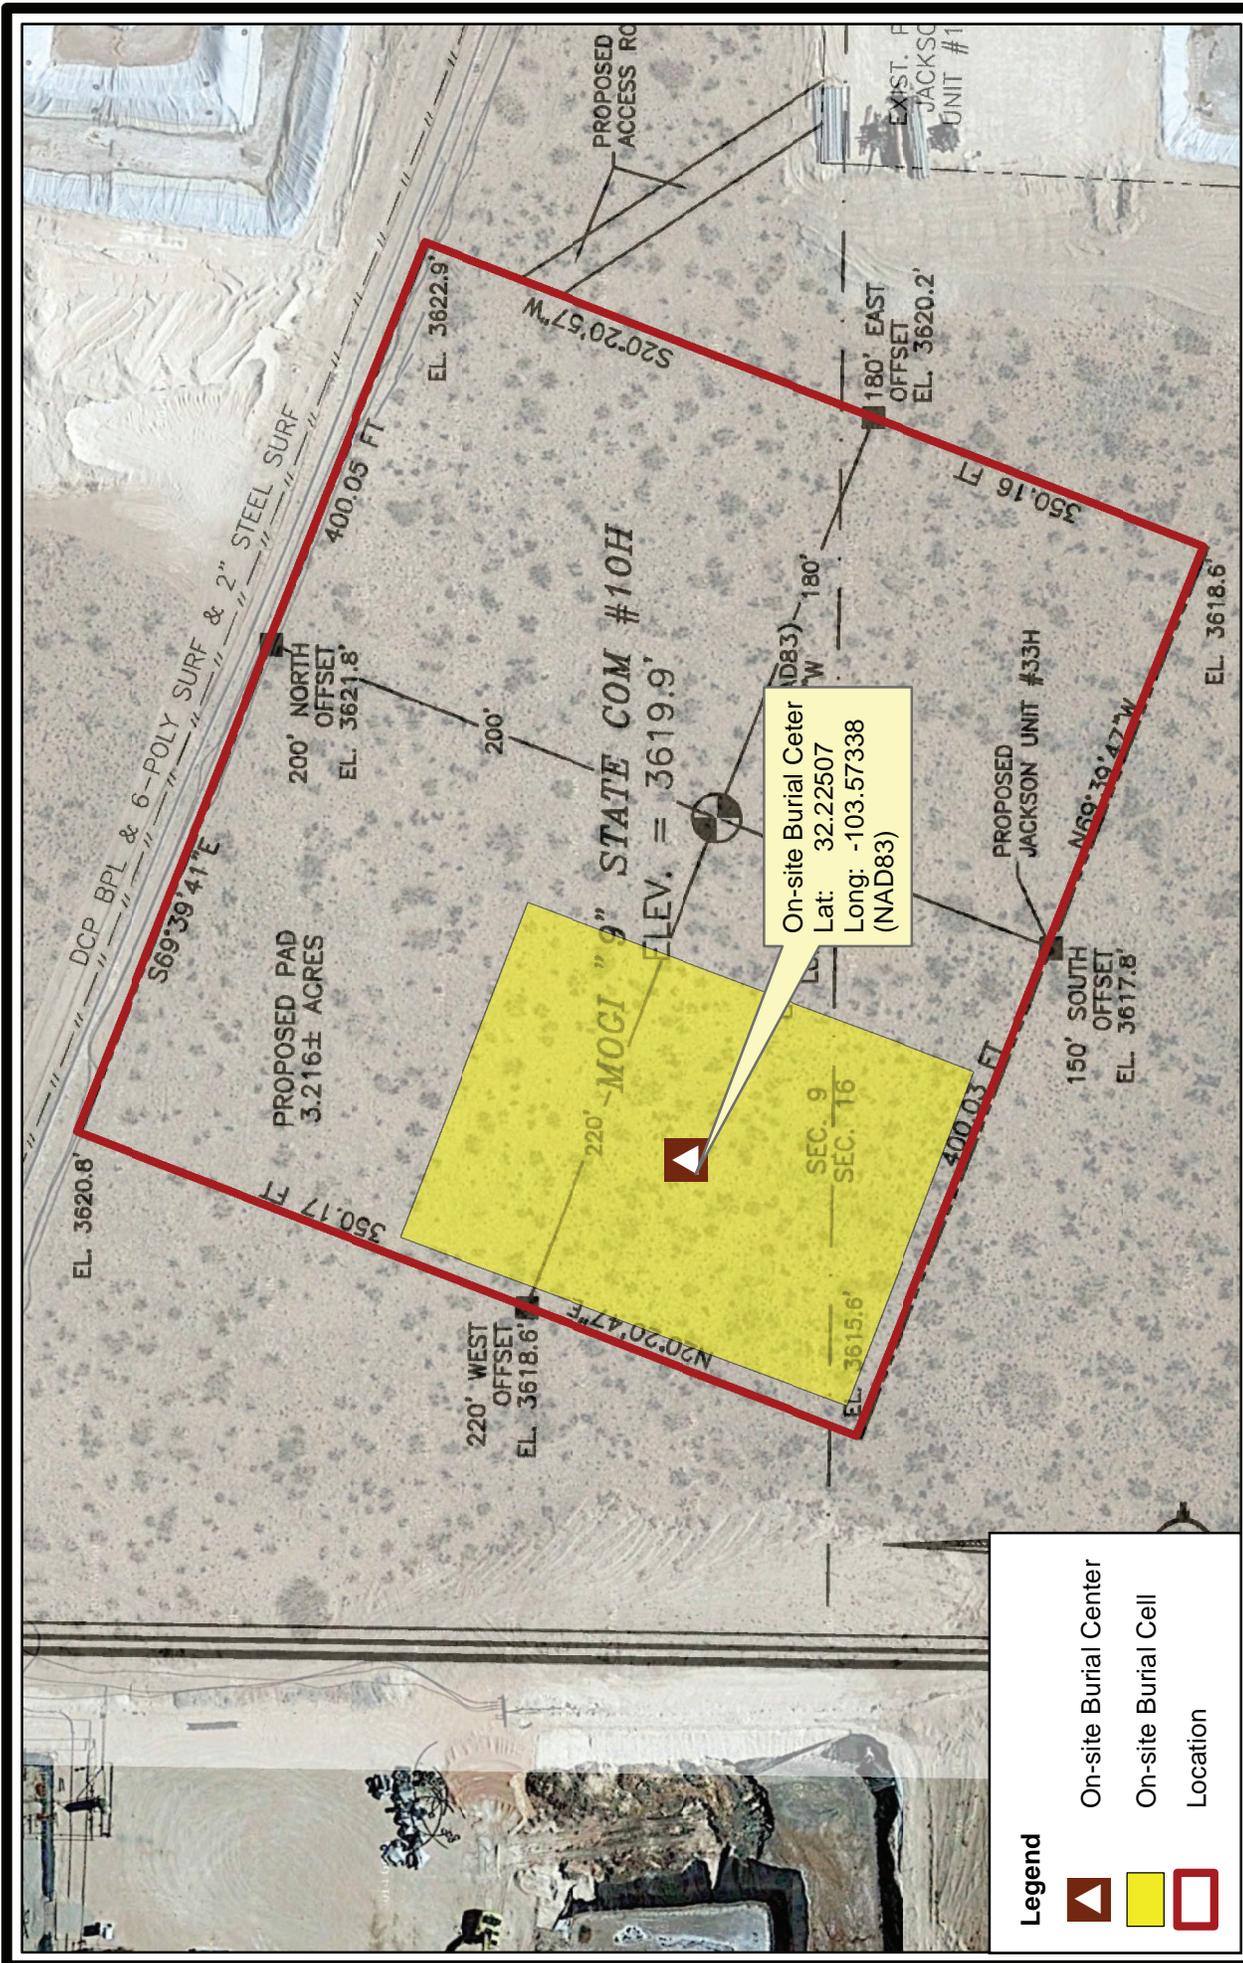
Plate 1  
 C-105 form  
 Sept 2015

**On-Site Burial Location of Temporary Pit**  
 in relation to well pad  
 Murchison Oil and Gas, Inc.  
 Mogi 9 State Com 10H

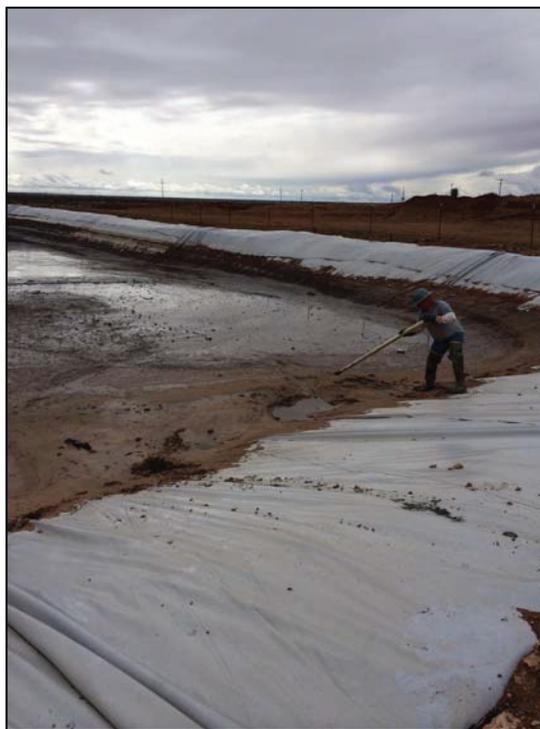
**Sampling Pit Contents 3/4/2015**

The Mogi 9 State Com #10H temporary pit held cuttings from both the #10H well and the Jackson Unit #33H well. After the #33H was completed, four-point composite samples of the pit solids from the inner and outer cells respectively and from the berms of the pit below the liner were collected in accordance with the Pit Rule on March 4, 2015. Hall Environmental Analysis Laboratory in Albuquerque provided analyses of BTEX (8021B), GRO+DRO (8015D), TPH (8015D), and Chloride (300.0) for each component sample.

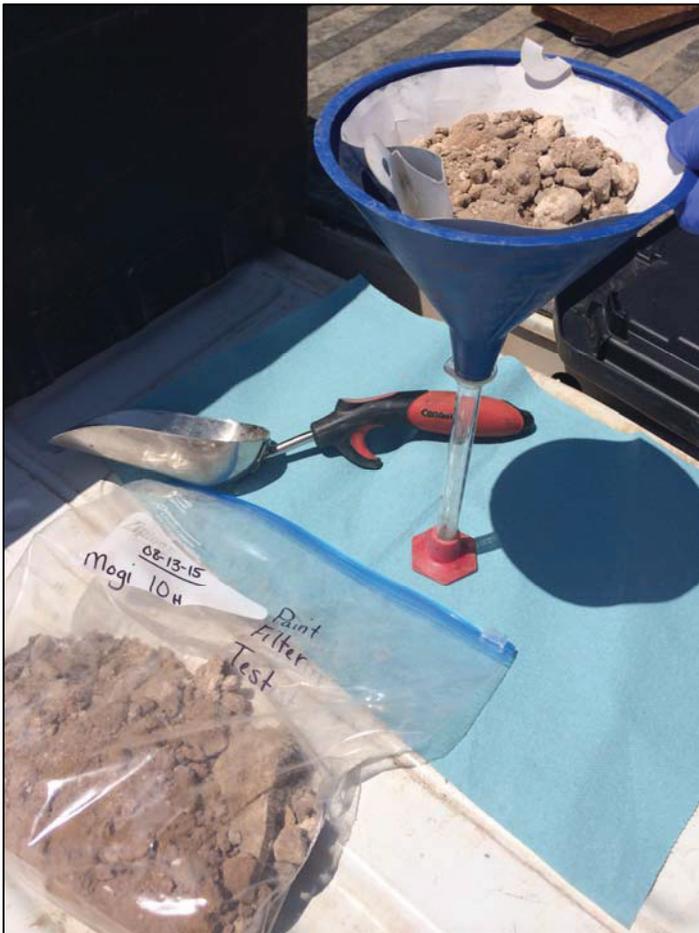
Paint Filter Test on Stabilized Cuttings 8/13/2015

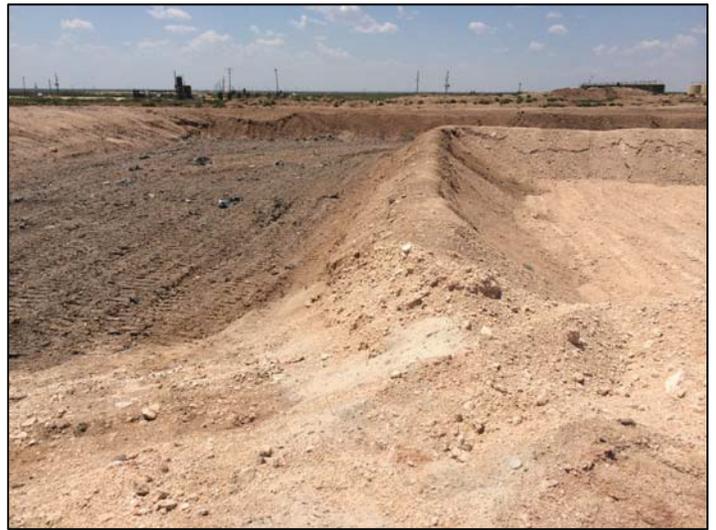
Stabilized cuttings staged for cap liner 8/13/2015

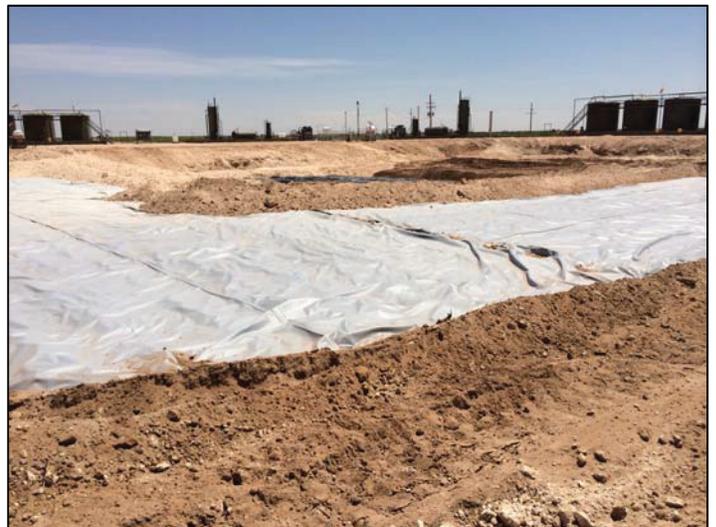
Geomembrane liner over stabilized cuttings 8/18/2015

5. Following inspection, having achieved all applicable stabilization requirements associated with in-place burial, a geomembrane liner was installed to completely cover the stabilized cuttings on August 18, 2015. The pit contents and liner were shaped to shed infiltrating water, slightly higher in the center.
