**Field Activity Report**

**Drill Pad Remediation and H<sub>2</sub>S Sign Installation  
Frontier AGI #1, Maljamar, NM**

**November 20, 2012**

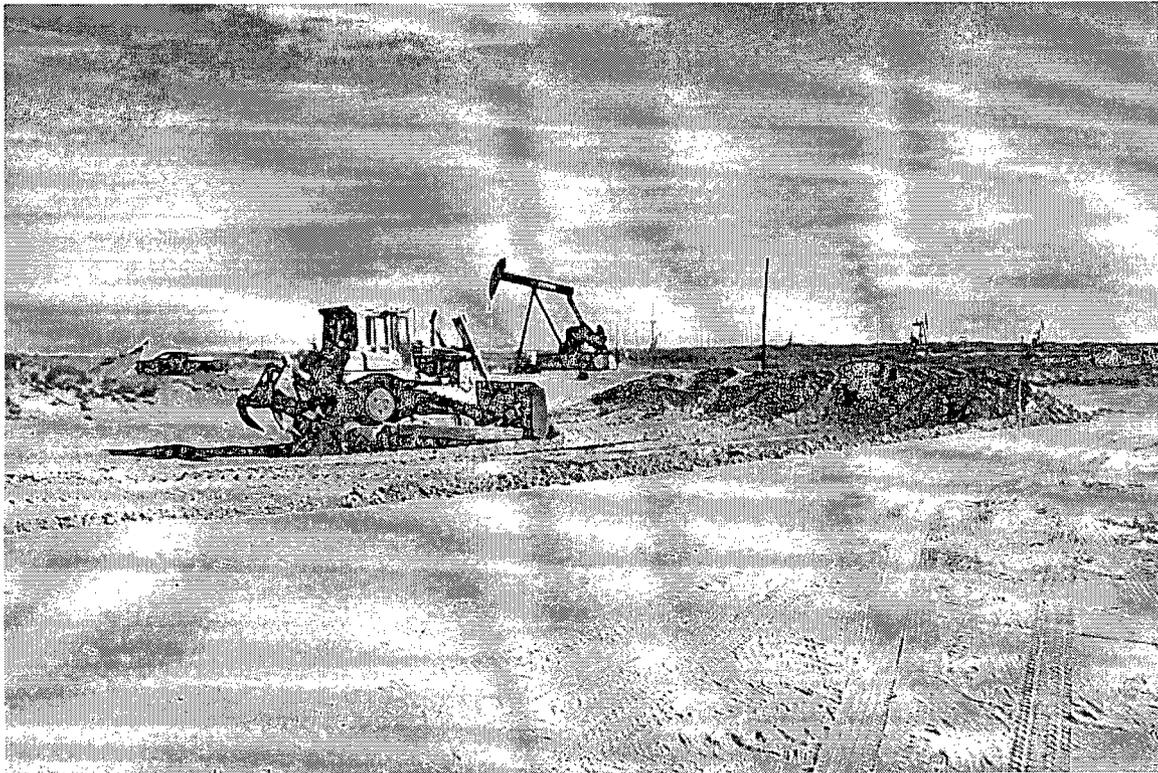
Removing surface caliche layer from the north side of the drill pad

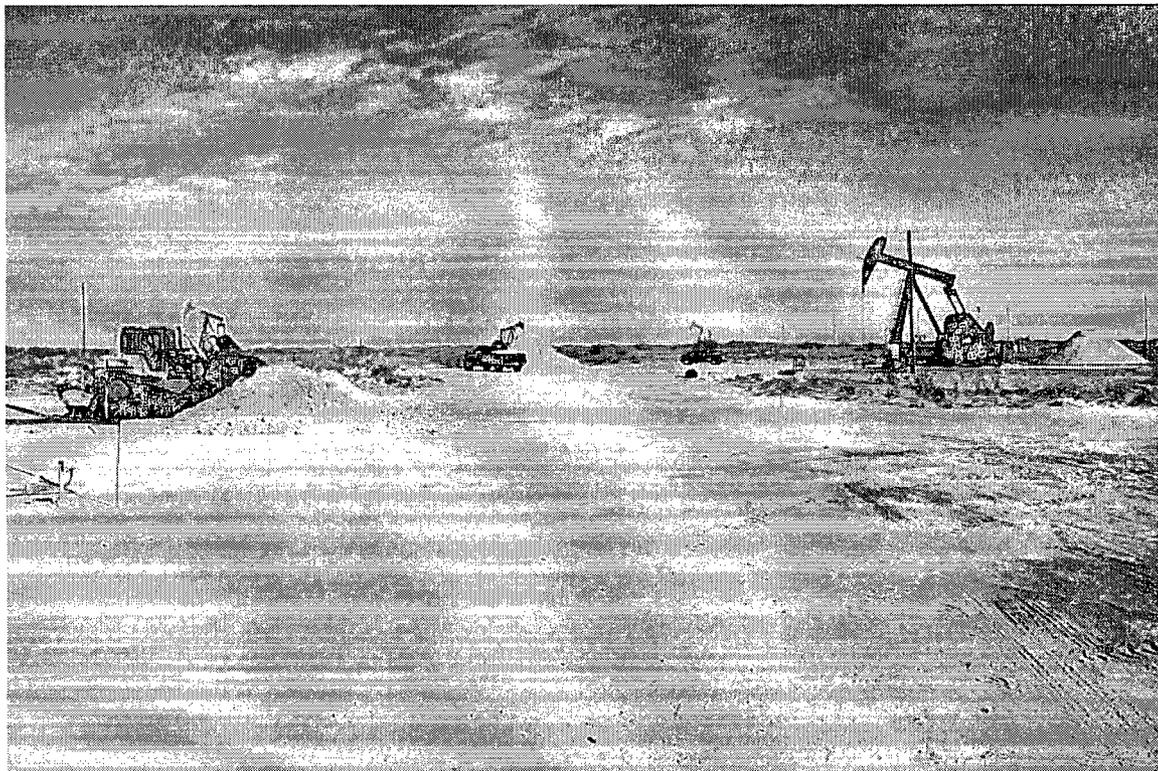
Stockpiling caliche next to the access road

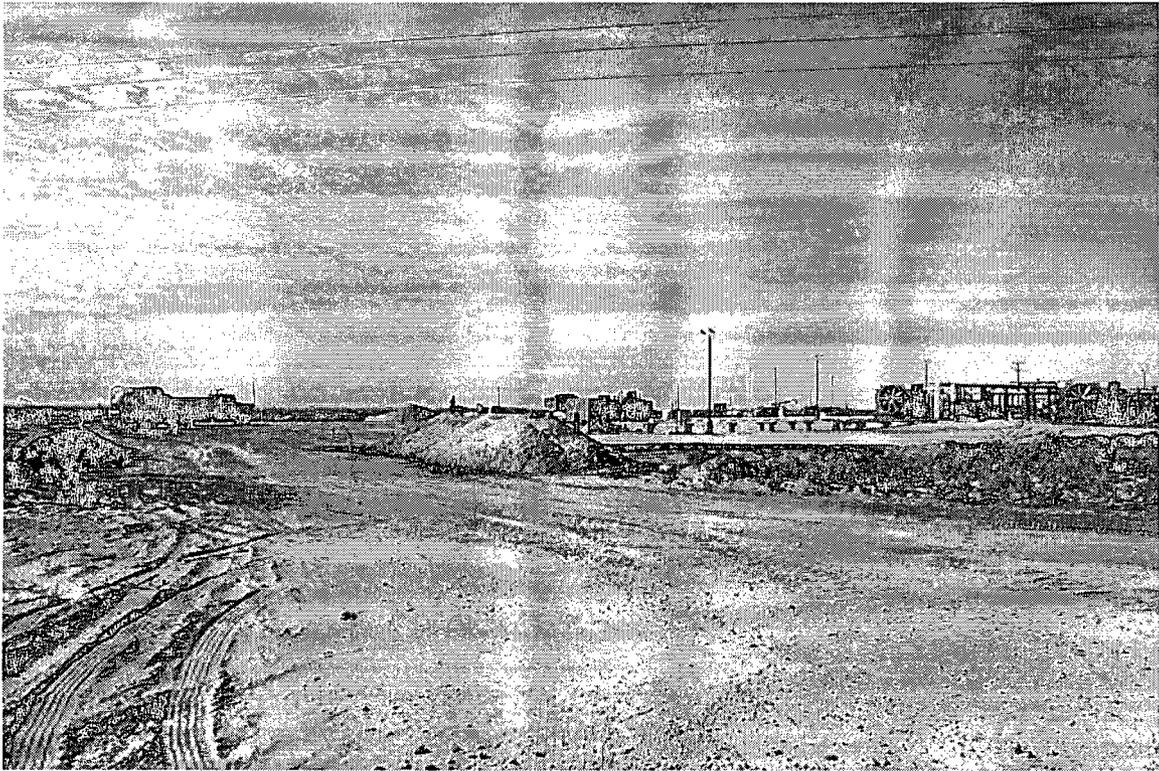
Stockpiled caliche for transport to the new parking lot area

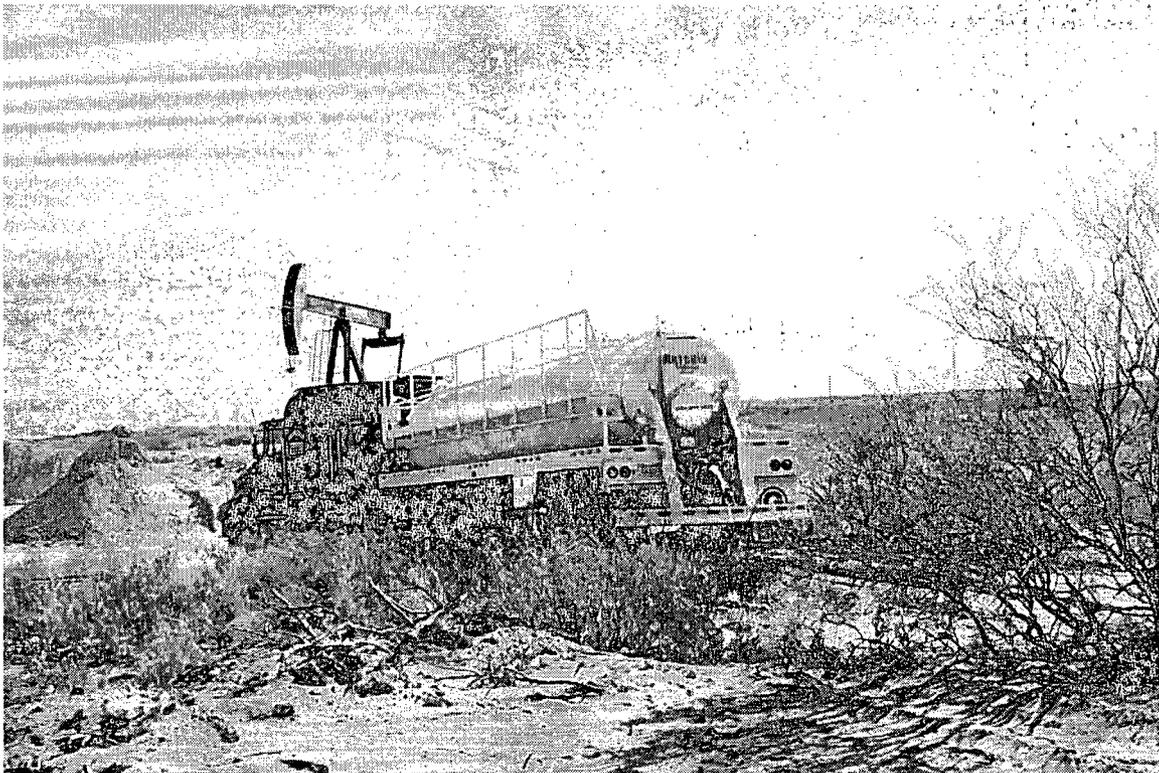
Water truck watering and compacting temporary access along flare fence

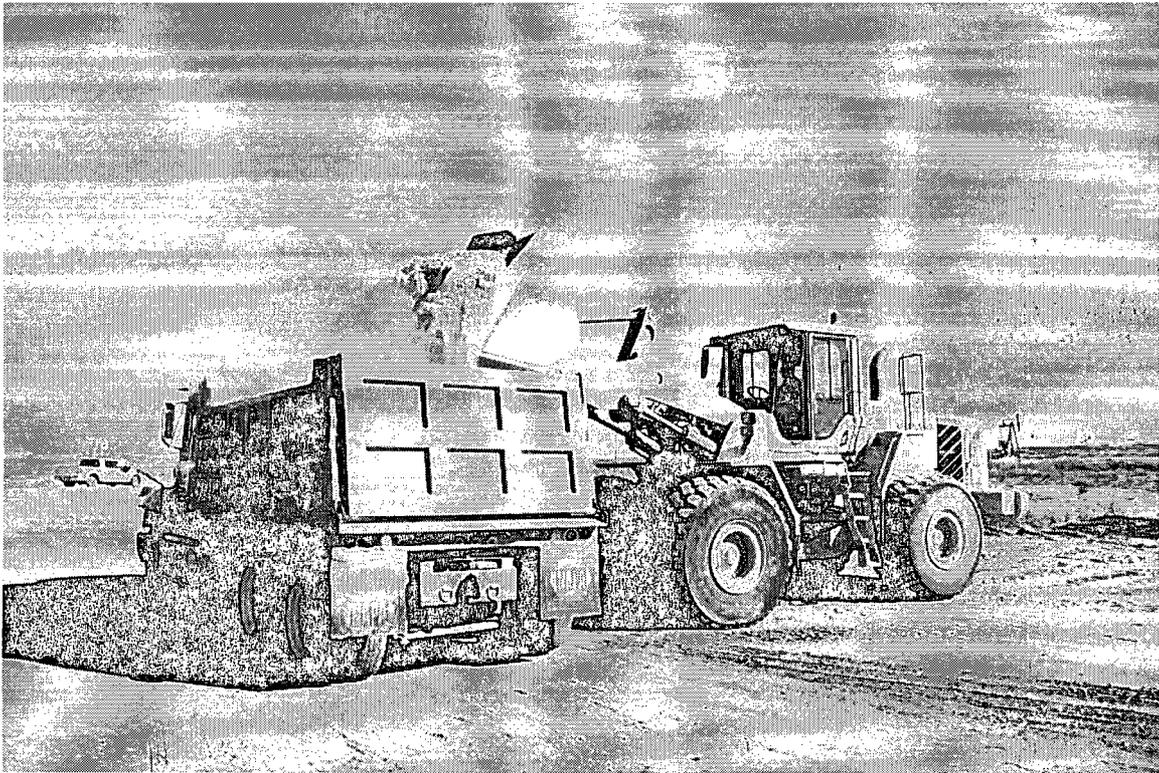
Frontend Loader loading caliche into dump truck

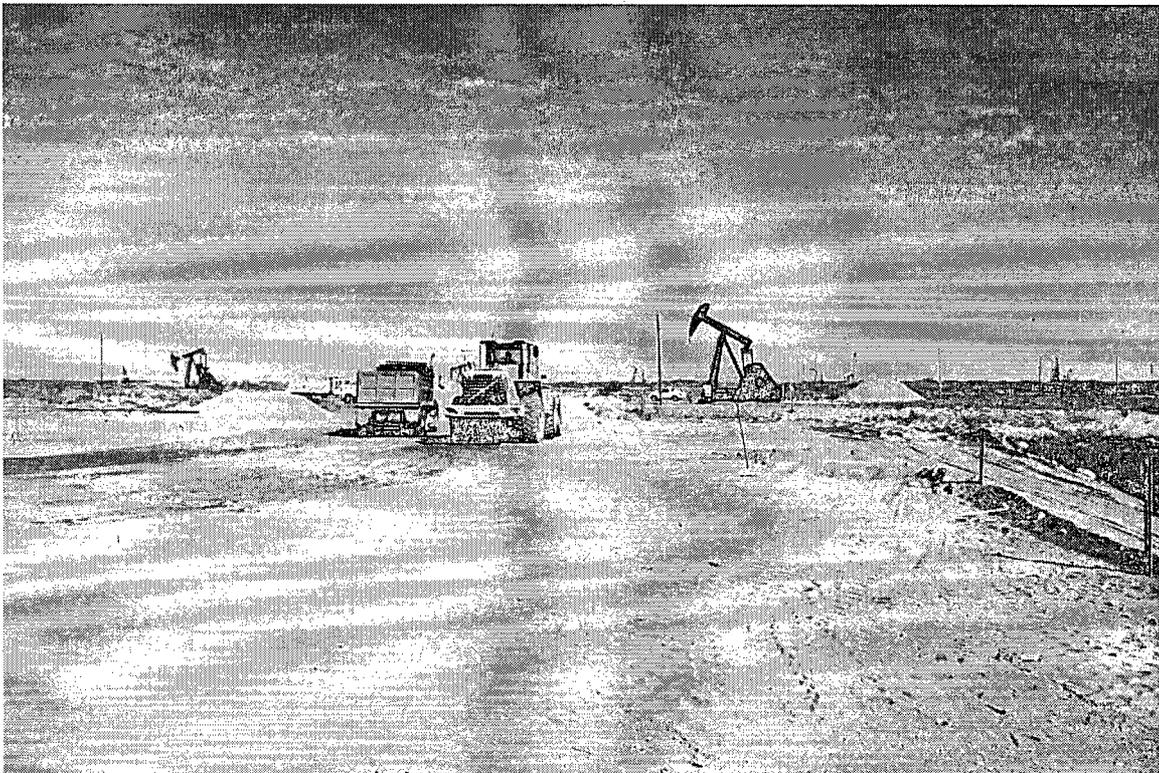
View of area while transporting caliche

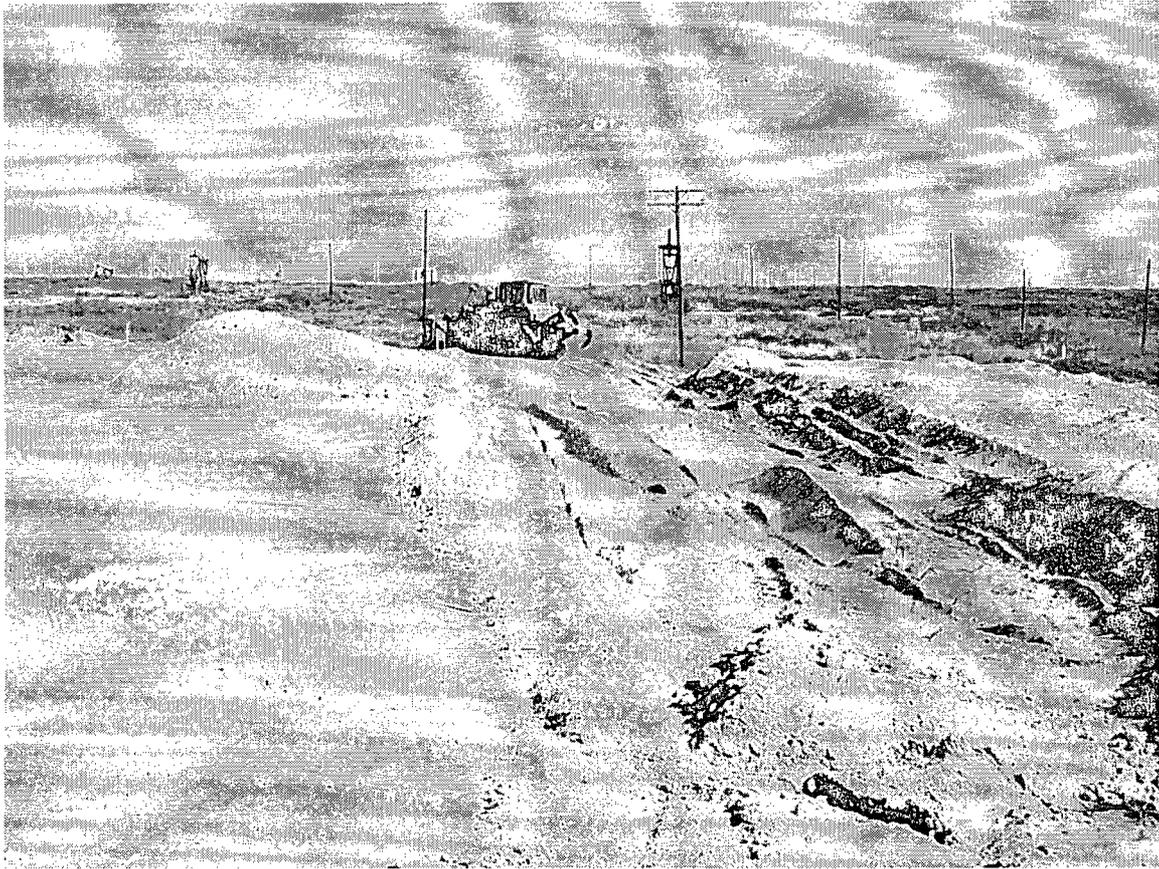
View of south side of drill pad after caliche was stripped off.

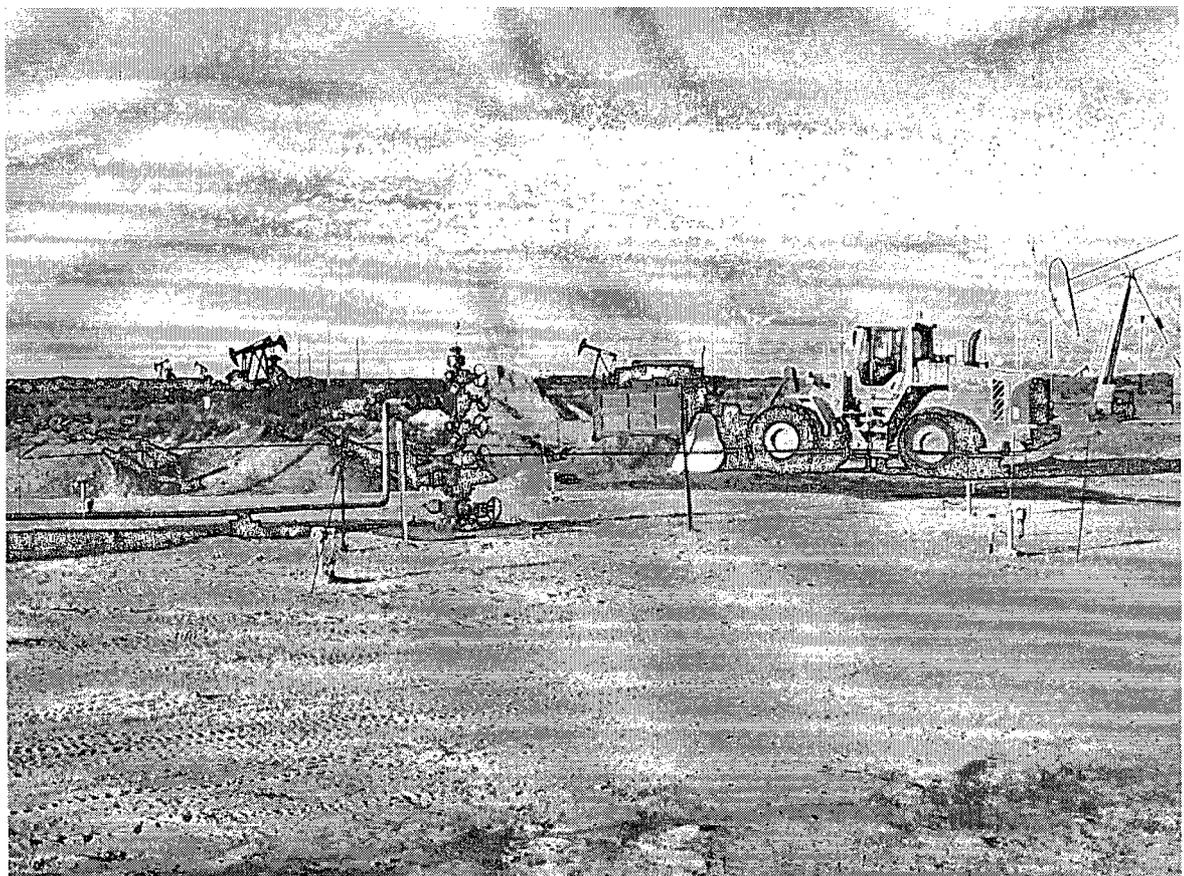
View of north fill area after caliche was remove and native sand deposited

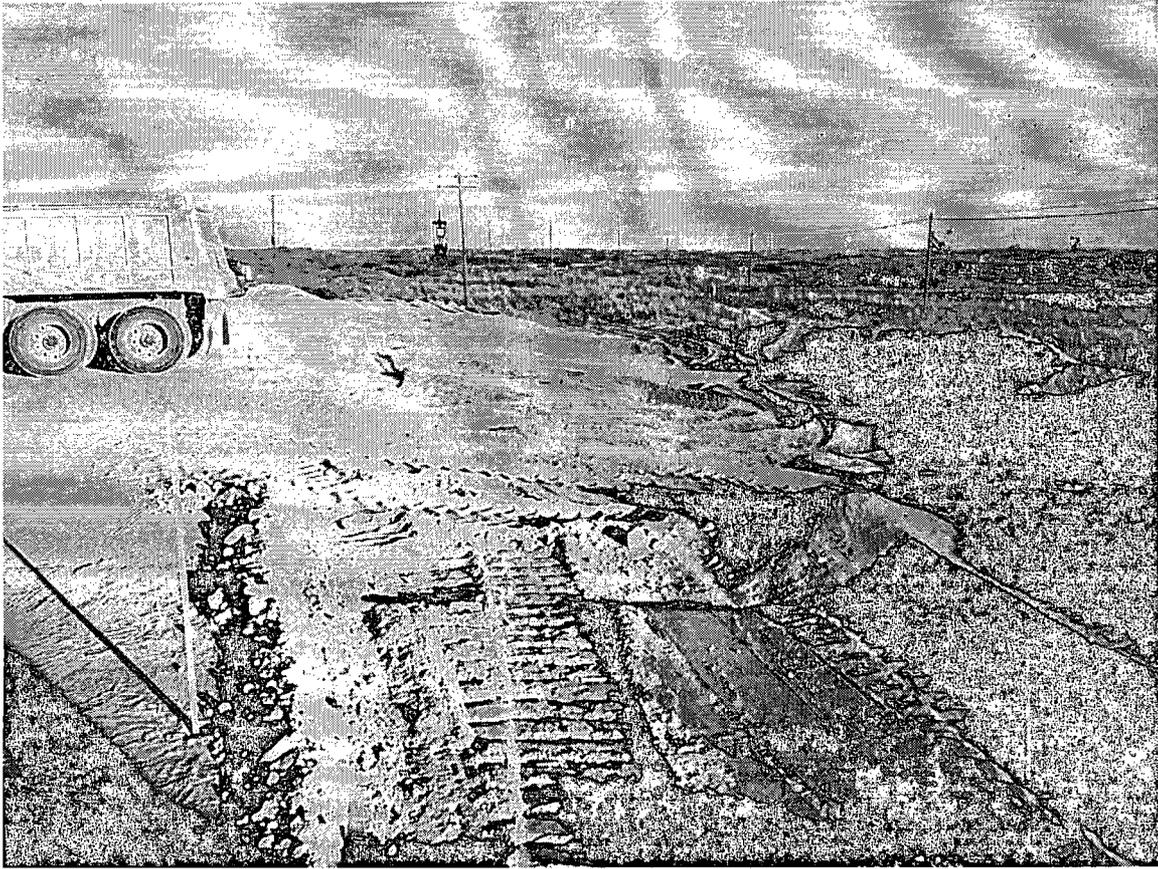
South cut area after removing stockpiled sand

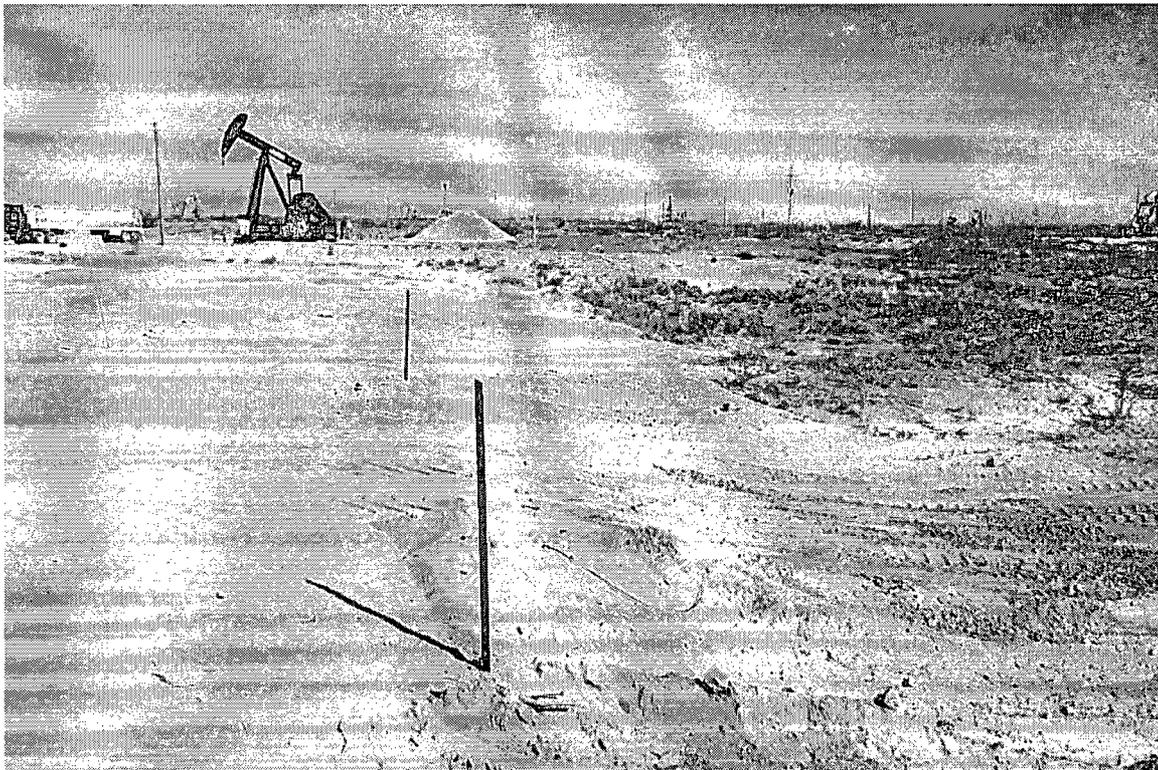
View looking north of newly constructed east slope to native desert.

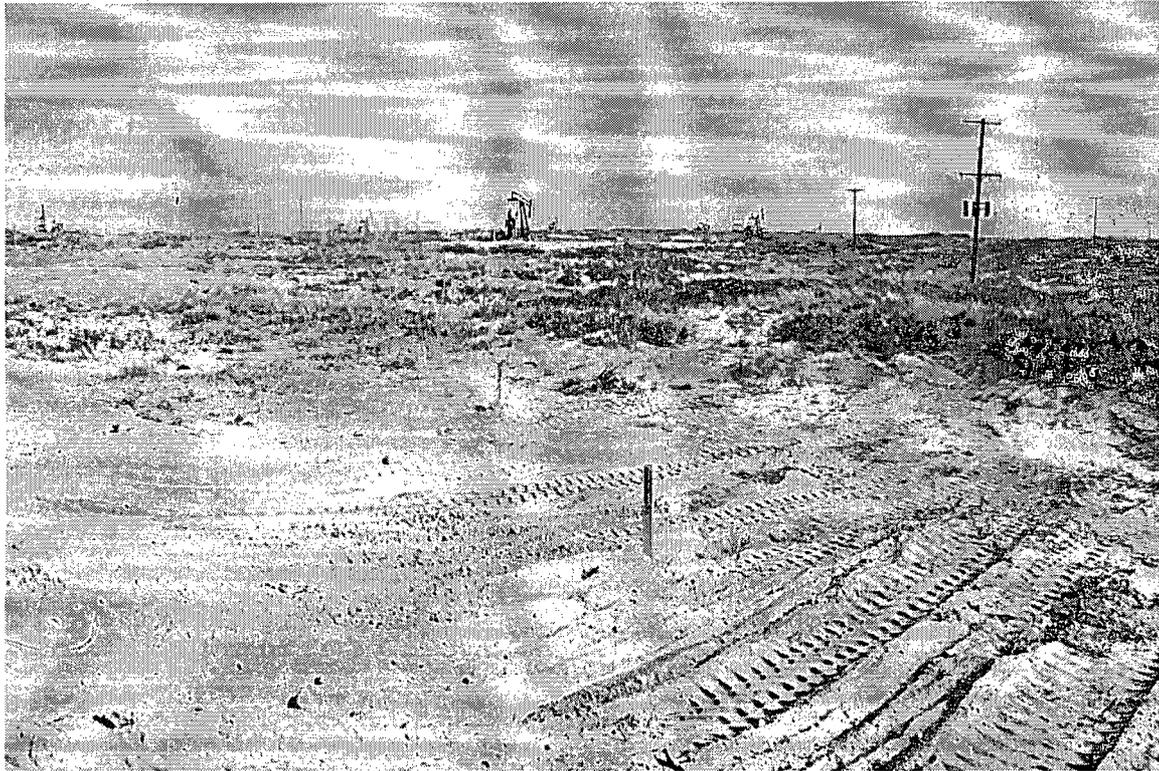
View of east slope pipeline marker

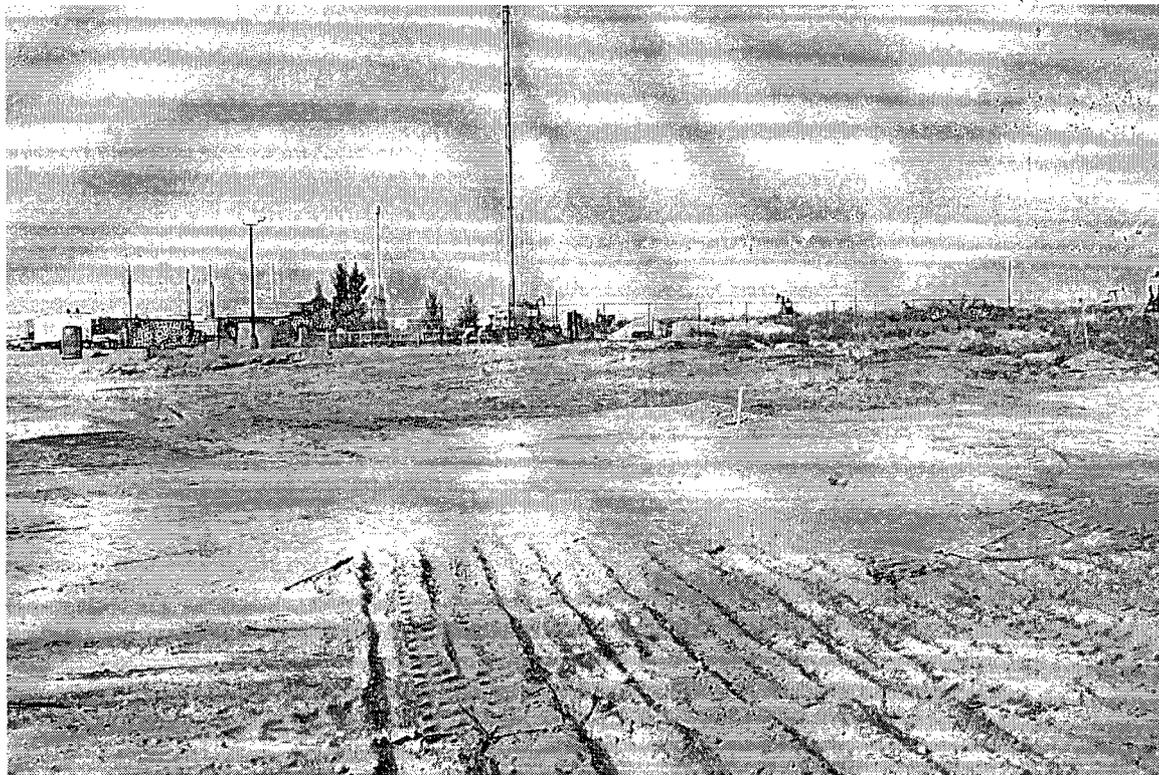
View of north remediated area with access road

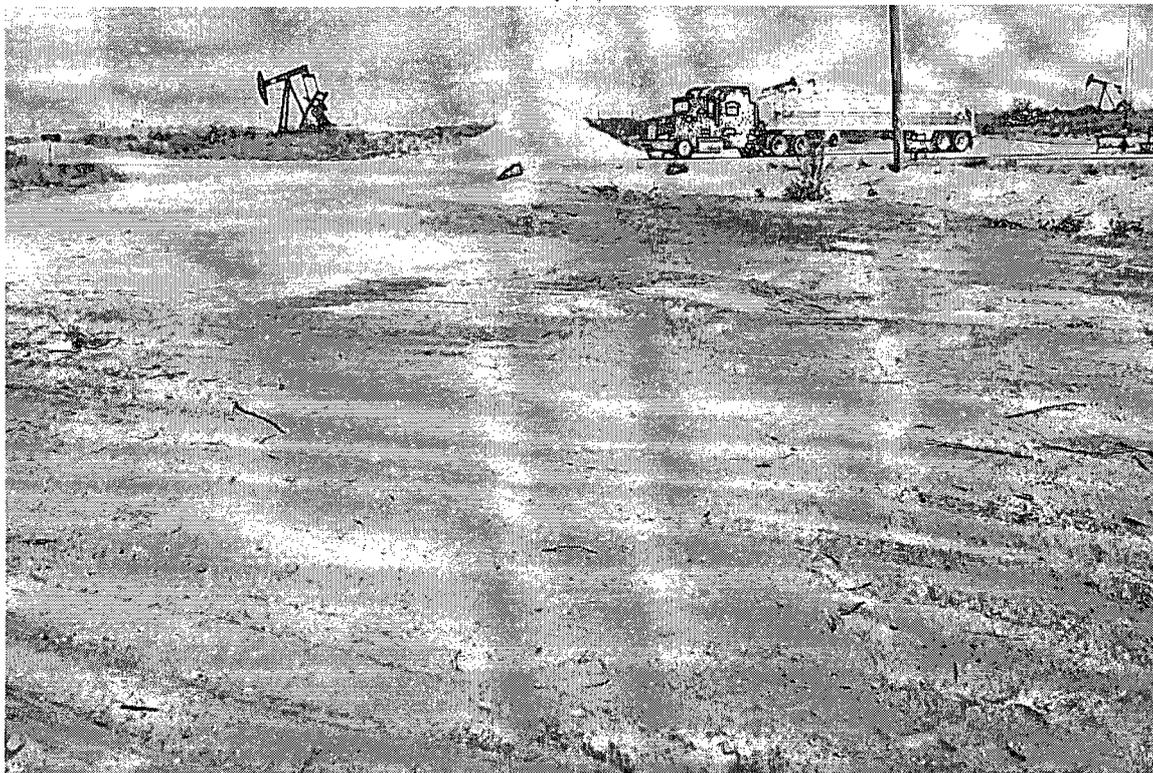
View of northeast corner after remediation

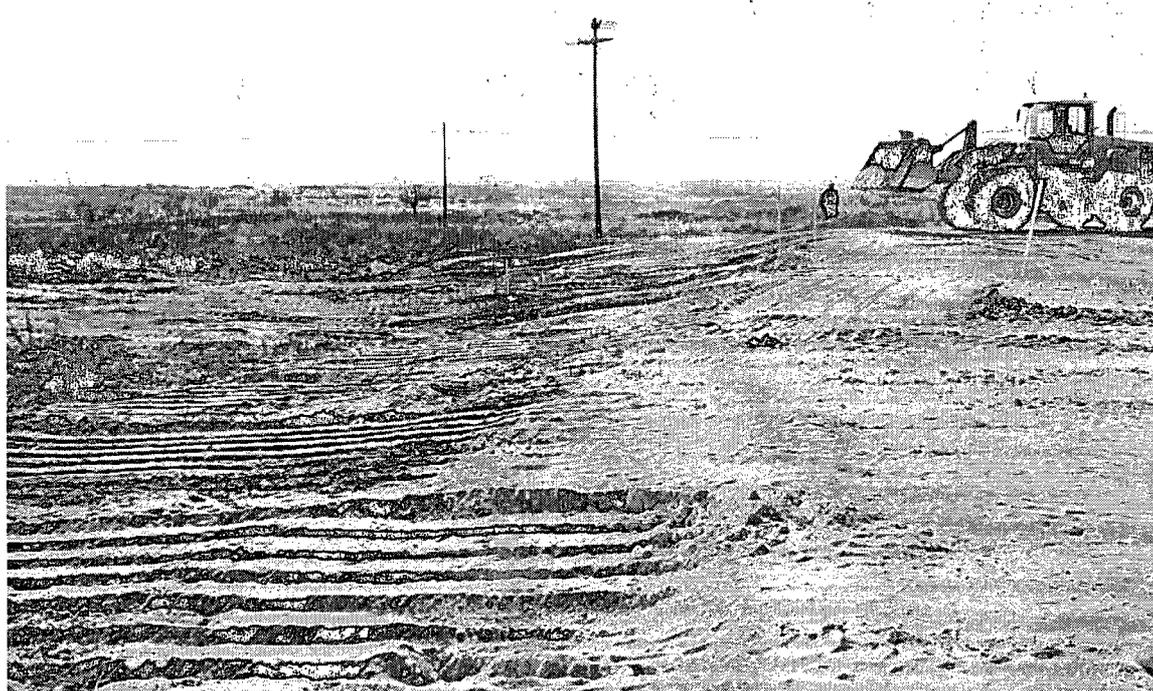
View looking south along the east side of the well pad after remediation

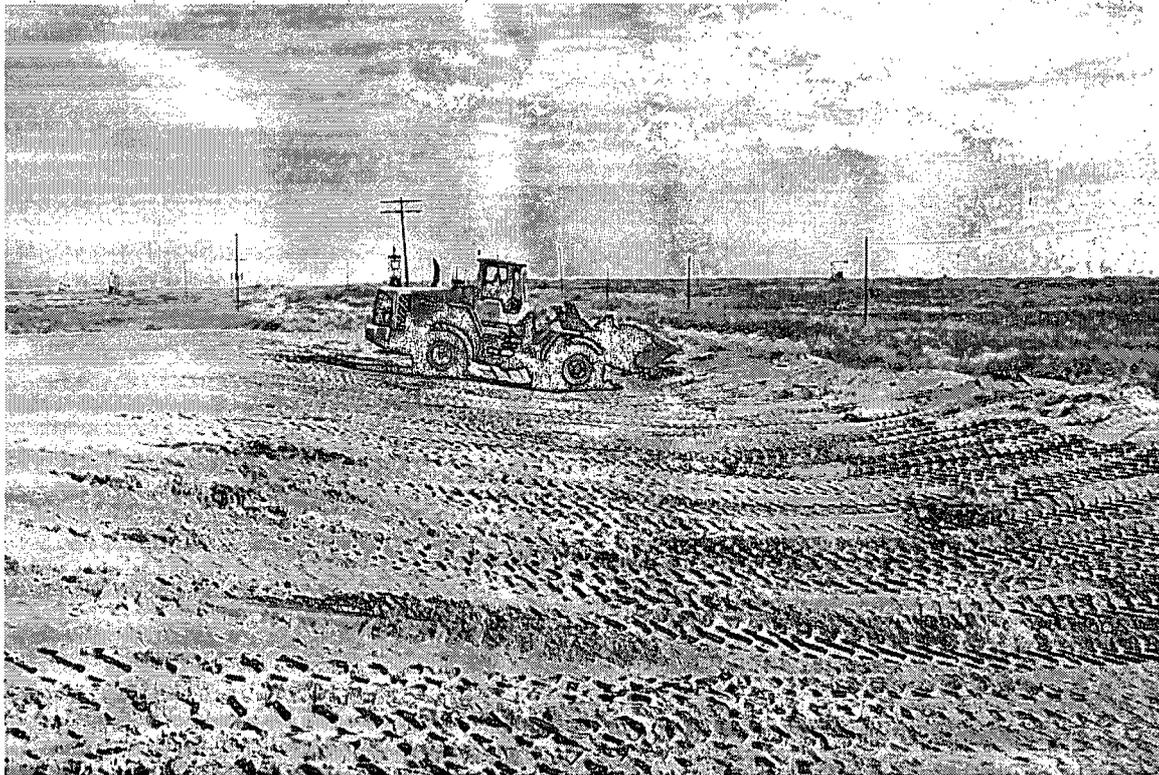
View of the south side of the pad (the cut side) newly constructed slope and dunes

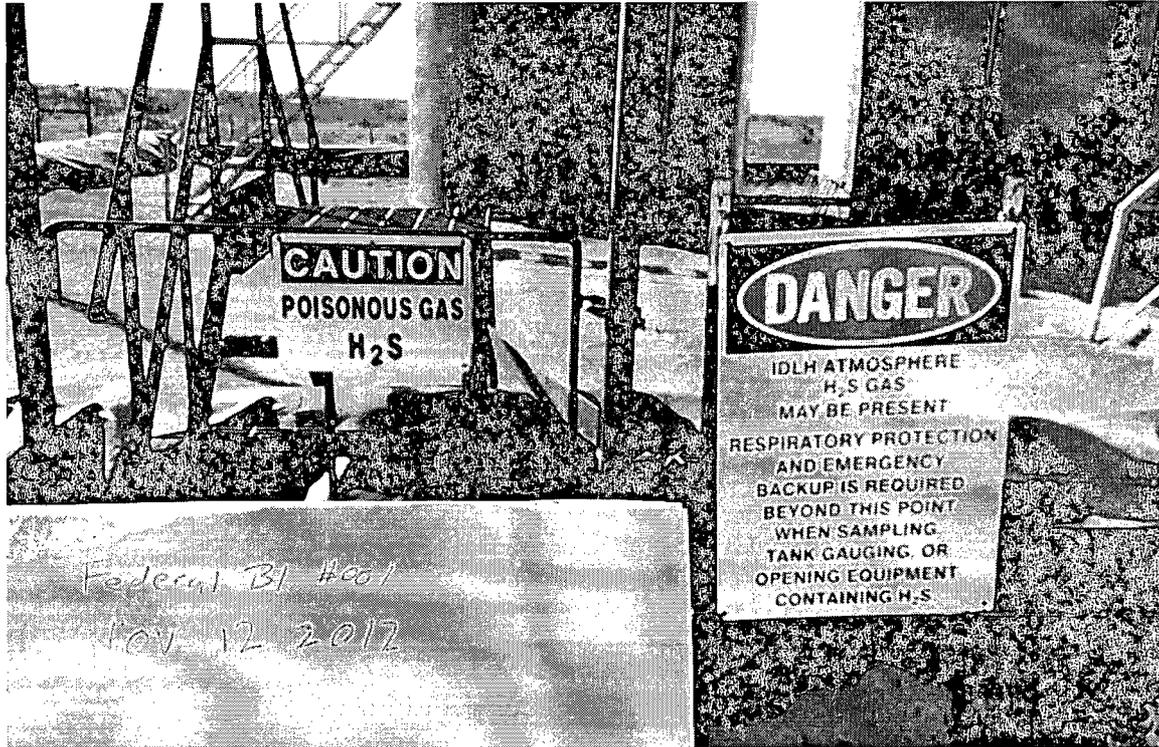
The first two wells on the list, Federal B1 #001 and SWD 29 #001, already had the required signs; therefore, no signs were installed at these two wells (see attached photos).

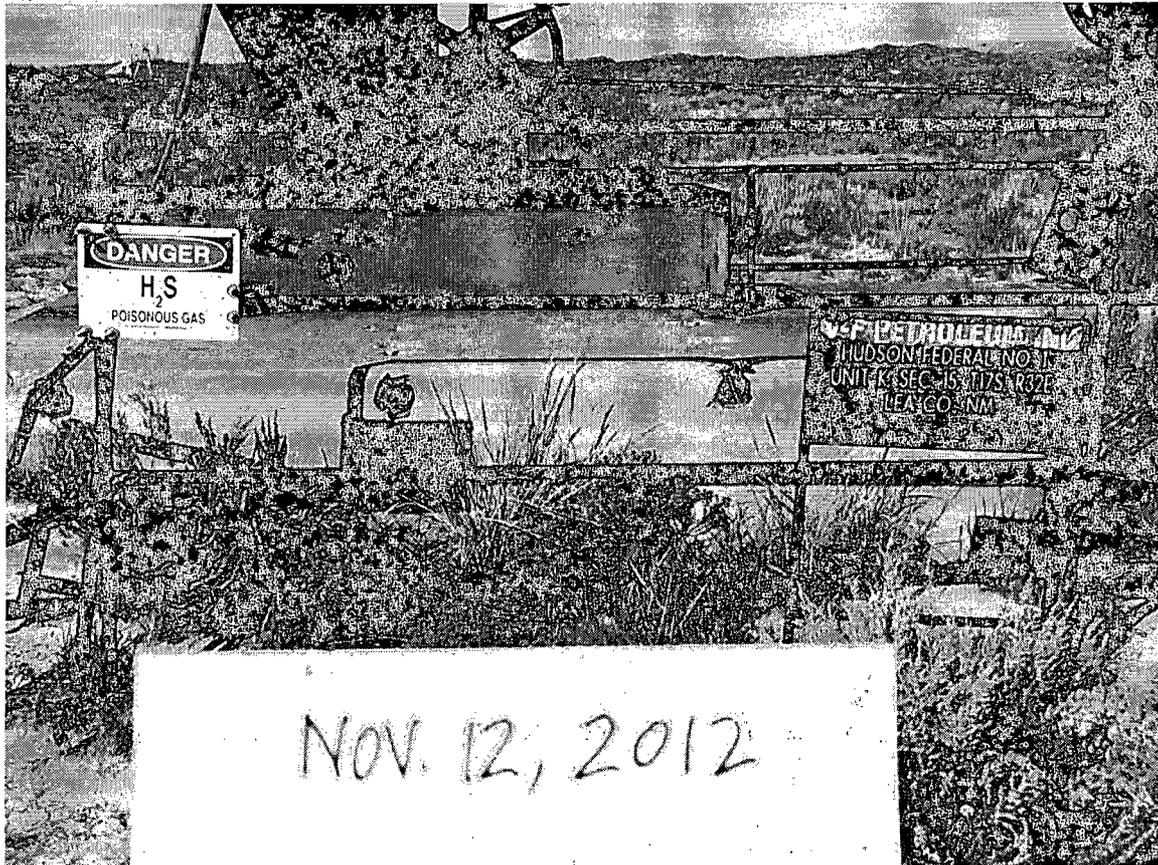
Hudson Federal #001

In addition to completing the drill pad remediation, Geolex posted H<sub>2</sub>S warning signs at the 8 wells within a half mile that penetrate the injection zone to satisfy the requirements of the NM OCD Order (Figure 2 and photos).
