Pit, Below-Grade Tank, or  
Proposed Alternative Method Permit or Closure Plan Application

1.  
Operator: Chevron, USA OGRID #: \_\_\_\_\_  
Address: 56 Texas Camp Road, Lovington, New Mexico 88260  
Facility or well name: New Mexico "O" State NCT-1 #40  
API Number: 30-025-38140 OCD Permit Number: \_\_\_\_\_  
U/L or Qtr/Qtr J Section 36 Township 17S Range 34E County: Lea  
Center of Proposed Design: Latitude N 32.7893° Longitude W 103.5123° NAD:  1927   
1983  
Surface Owner:  Federal  State  Private  Tribal Trust or Indian Allotment

CRA recommends no further action be required for the Site and requests closure of the New Mexico "O" State NCT-1 #40 Pit (RP #2673). Attached to the front of this closure report is a completed and signed Form C-144.

**SITE LOCATION MAP**  
**NEW MEXICO "O" STATE #40 PIT**  
**SECTION 36, T17S, R34E (RP#2673)**  
*Chevron Environmental Management Company*

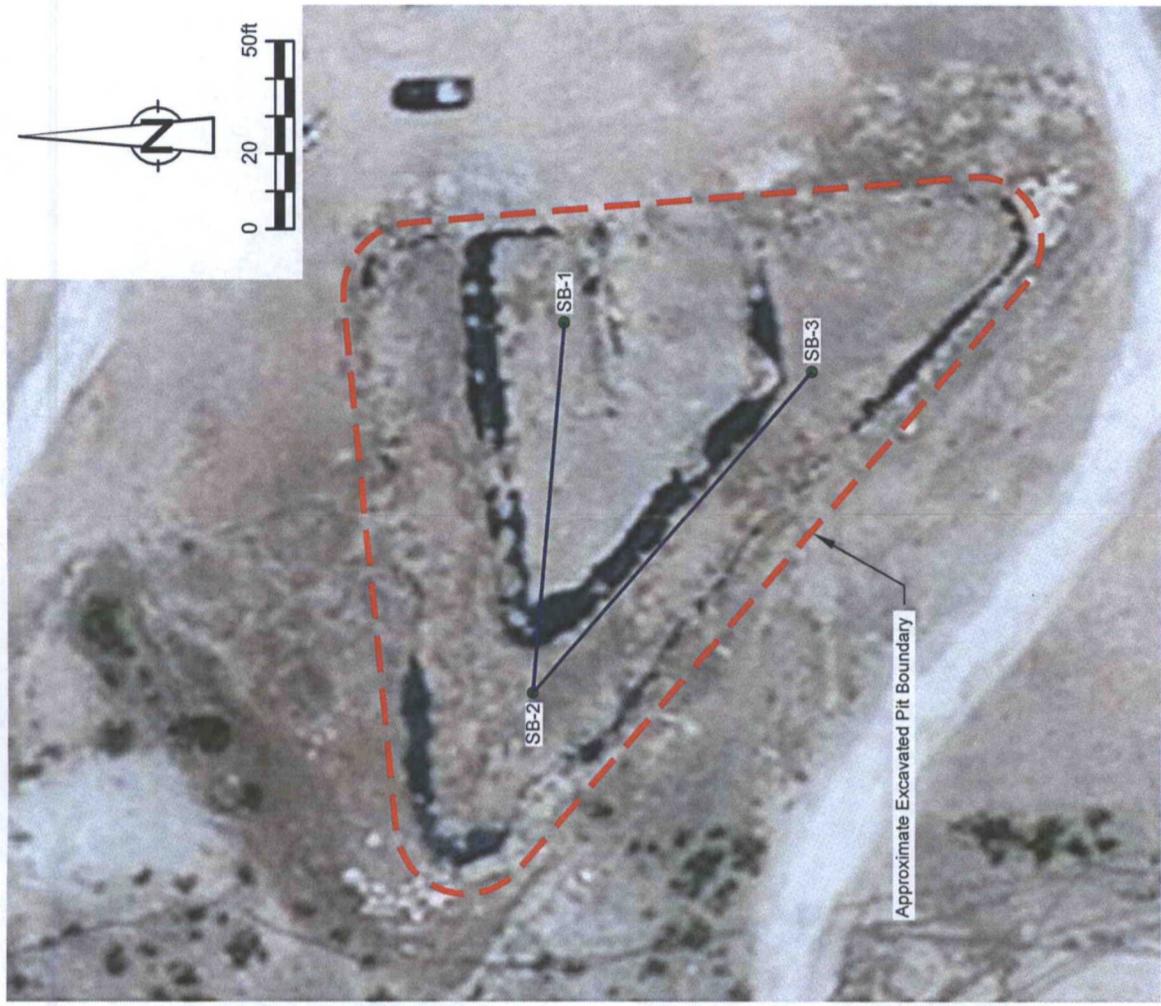
**SOIL CROSS-SECTION  
NEW MEXICO "O" STATE #40 PIT  
SECTION 36, T17S, R34E (RP#2673)**

1. Soil borings advanced May 7 and 8, 2013.
2. Samples evaluated using drill cuttings and split spoon sampler.
3. Boundaries between soil units are approximate.
4. Harrison & Cooper (Lubbock, Texas) drilling contractor. Six-inch borehole using Ingersol Rand 11RTH60 (2006) drill rig.
5. All borings plugged with drill cuttings and approximately 20 bags of bentonite.

In May 2013, after discussions and approval from the NMOCD Hobbs District I office, three soil borings (SB-1, SB-2 and SB-3) were installed within the existing remedial excavation to a depth of 100 feet below ground surface bgs. Soil samples were collected at 5 to 10 foot intervals in an effort to horizontally and vertically evaluate the extent of chloride impacts. All three soil borings SB-1 (70'-69.8 mg/kg), SB-2 (70'-108 mg/kg) and SB-3 (70'-29.8 mg/kg) demonstrated decreasing chloride levels with depth to well below recommended remediation and delineation levels. Analytical results are summarized in Table I. A soil cross section depicting subsurface conditions is provided in Figure 2. Certified Laboratory Reports for the 2013 soil boring sampling events are provided in Appendix D.

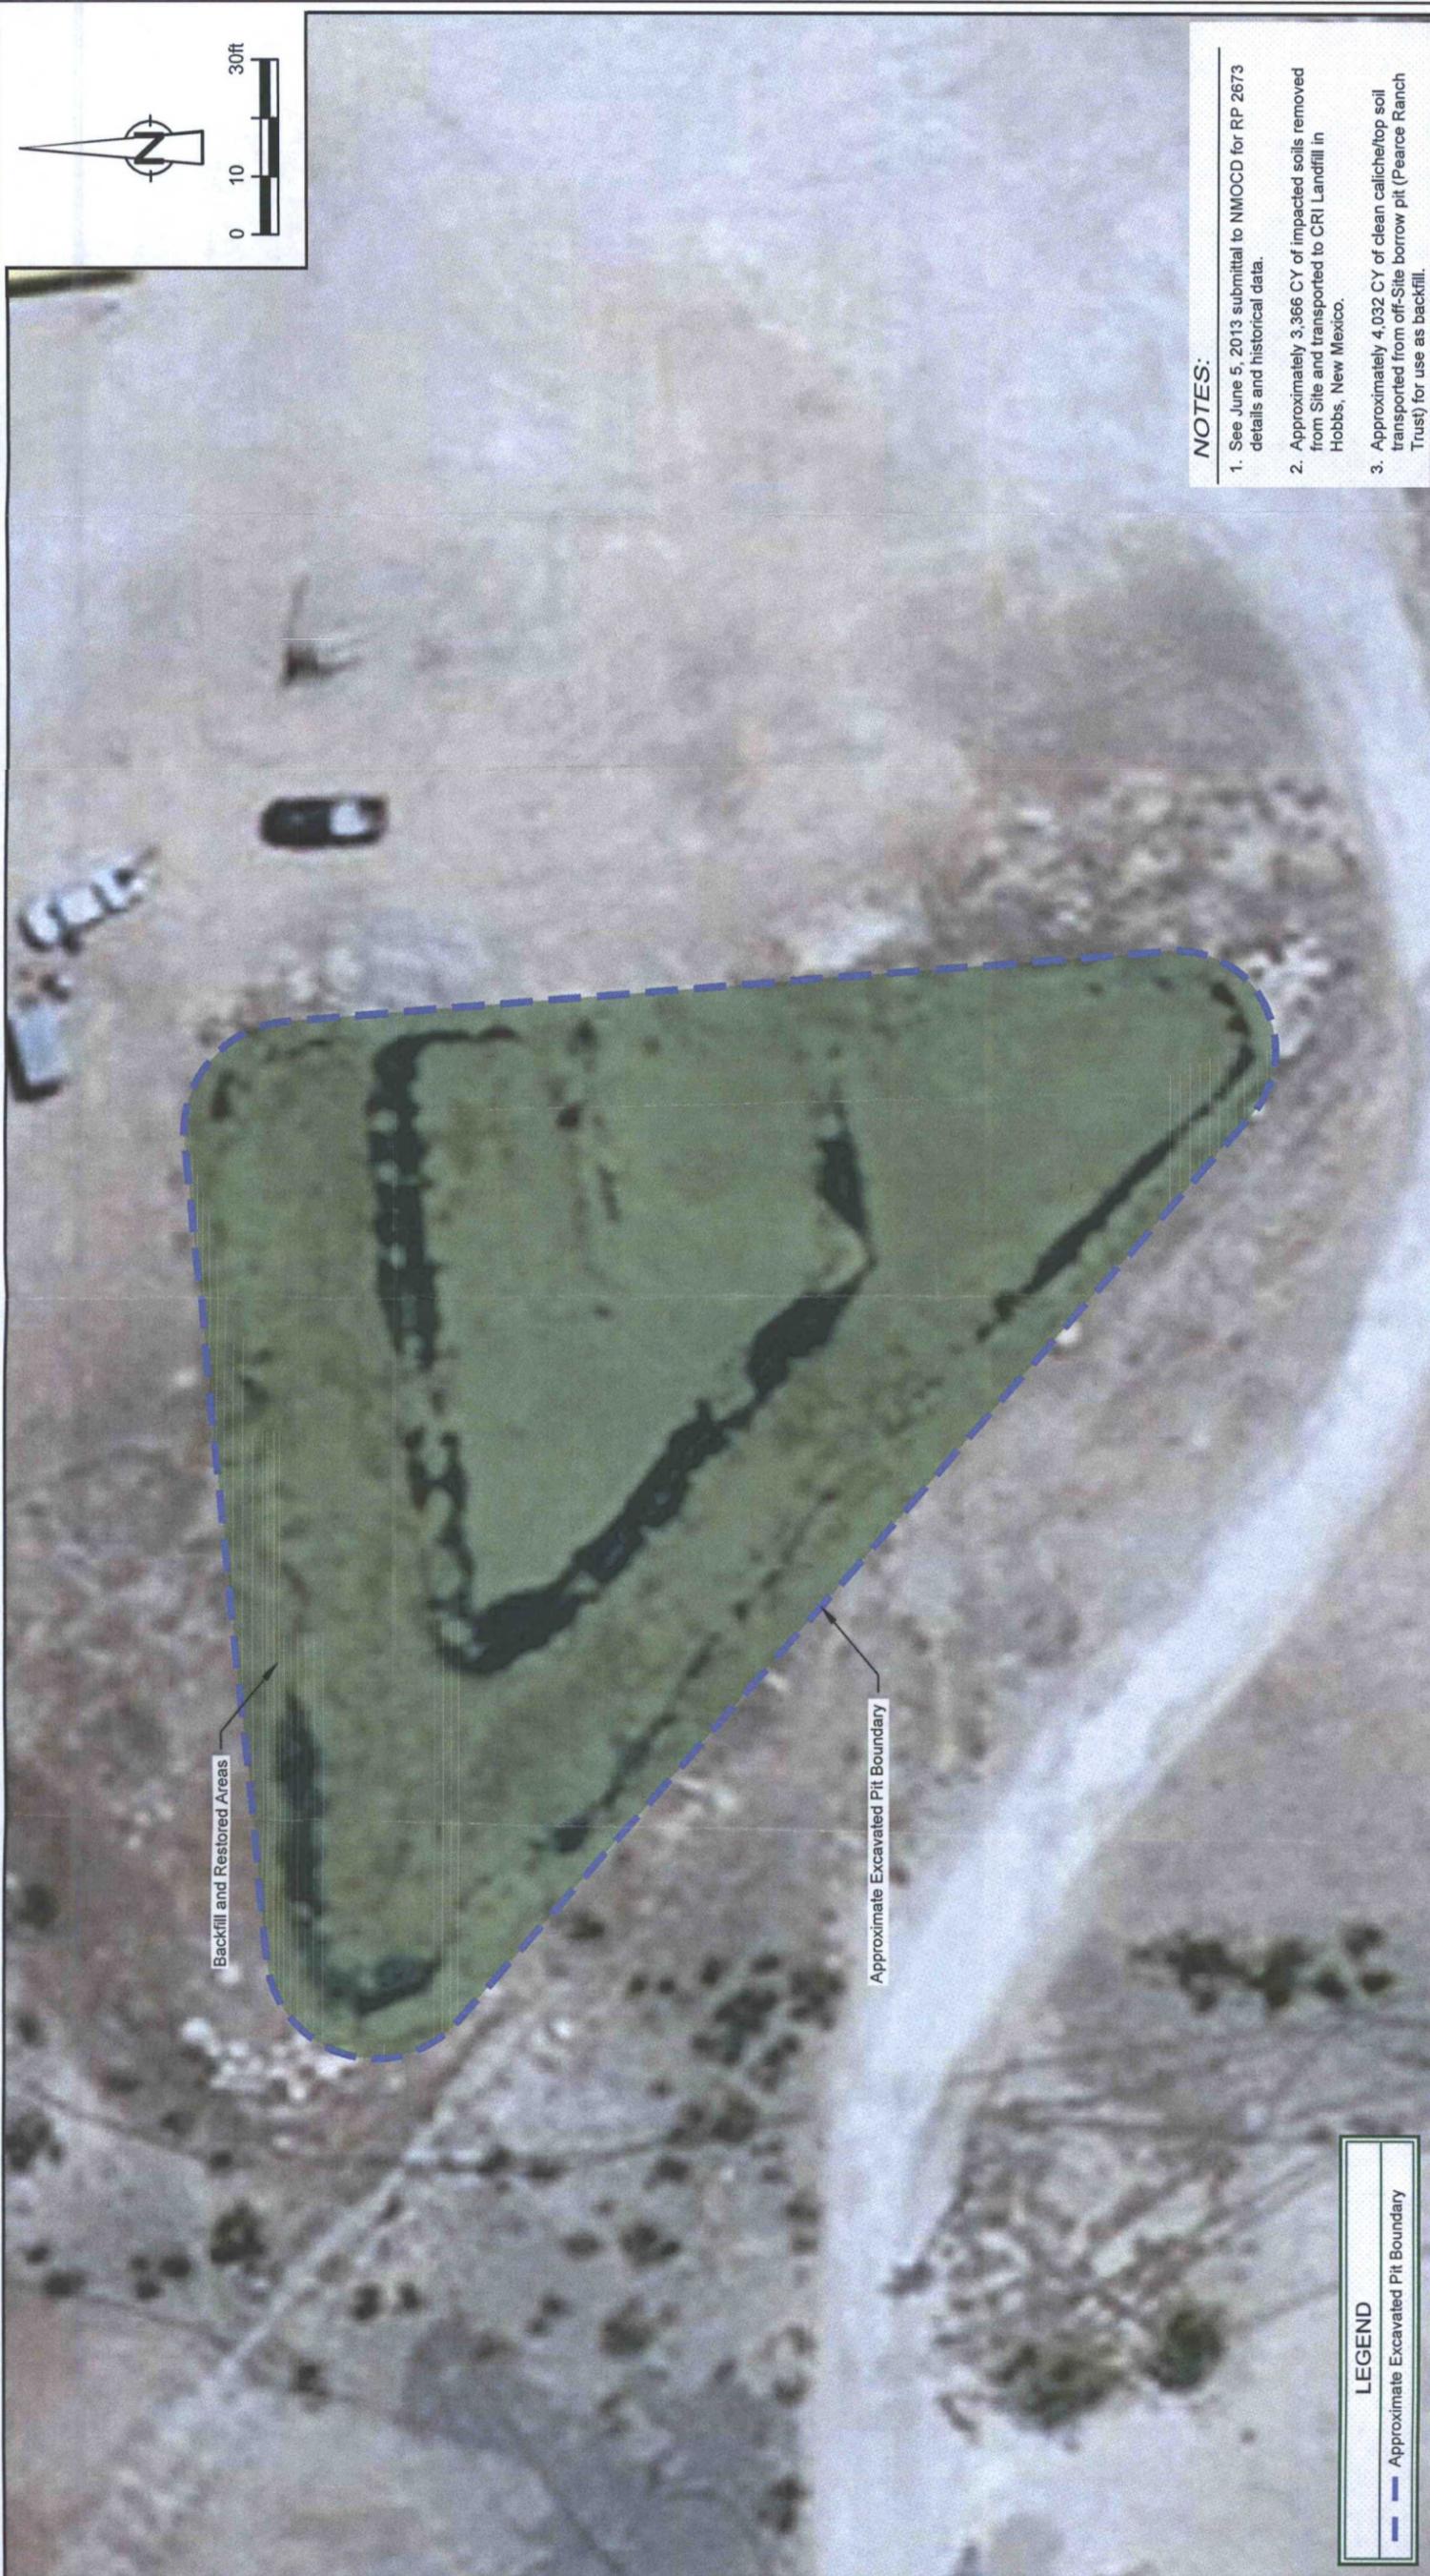
1. See June 5, 2013 submittal to NMOCDD for RP 2673 details and historical data.
2. Approximately 3,366 CY of impacted soils removed from Site and transported to CRI Landfill in Hobbs, New Mexico.
3. Approximately 4,032 CY of clean caliche/top soil transported from off-Site borrow pit (Pearce Ranch Trust) for use as backfill.

CRA was responsible for managing waste associated with the 2013 project activities (3,366 cy). Controlled Recovery, Inc. (CRI) of Hobbs, New Mexico was utilized as the disposal facility for impacted soils. The permit number for CRI is R9166. CRI is an NMOCD and Chevron approved facility. The material was loaded into trucks provided by RWI Construction, Inc. (RWI). Each truck leaving the Site was provided with a uniquely numbered non-hazardous waste manifest to accompany each load. The manifest was signed by the generator (CEMC's agent), the transporter and finally by the CRI landfill's representative. Waste manifests utilized between March 20, 2013 and March 27, 2013 were labeled incorrectly with Central Vacuum Unit #342 information. Correspondence between CRA and CRI landfill on March 27, 2013 identified the incorrectly labeled manifests and addressed the issue, ultimately being resolved with the assistance of CRI landfill agents. Table II indicates the waste manifests that were incorrectly labeled with the Central Vacuum Unit #342. Table II also provides disposal volumes (in cubic yards), as well as manifest and vehicle numbers for the waste material that was transported off of the Site. Copies of the Manifests are included in Appendix F in electronic form on a CD.

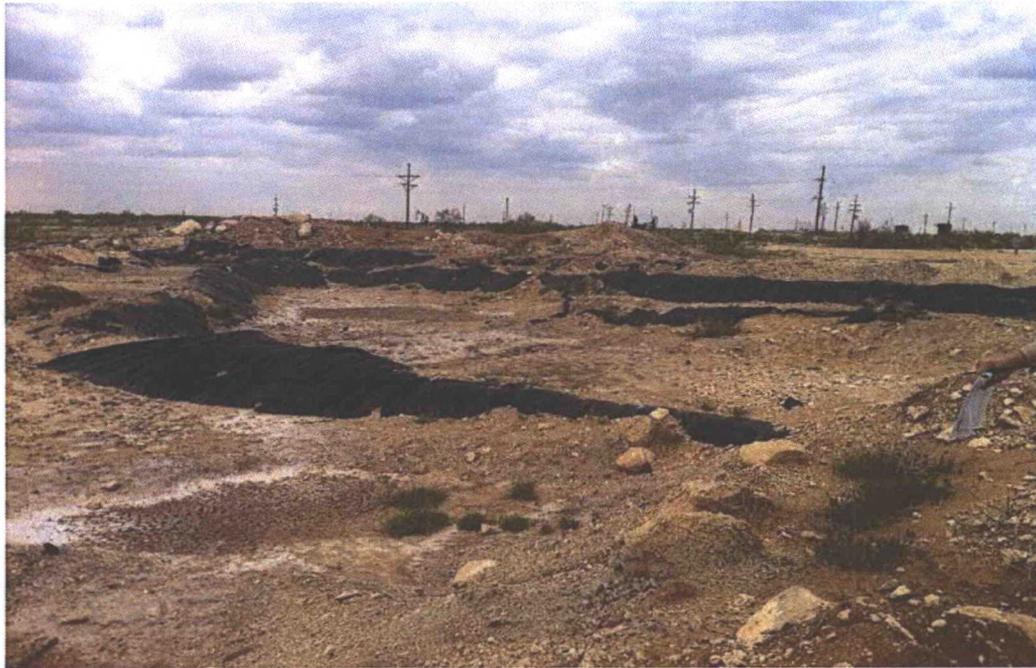
PHOTO 1: View of reserve pit facing north before any remedial work activities

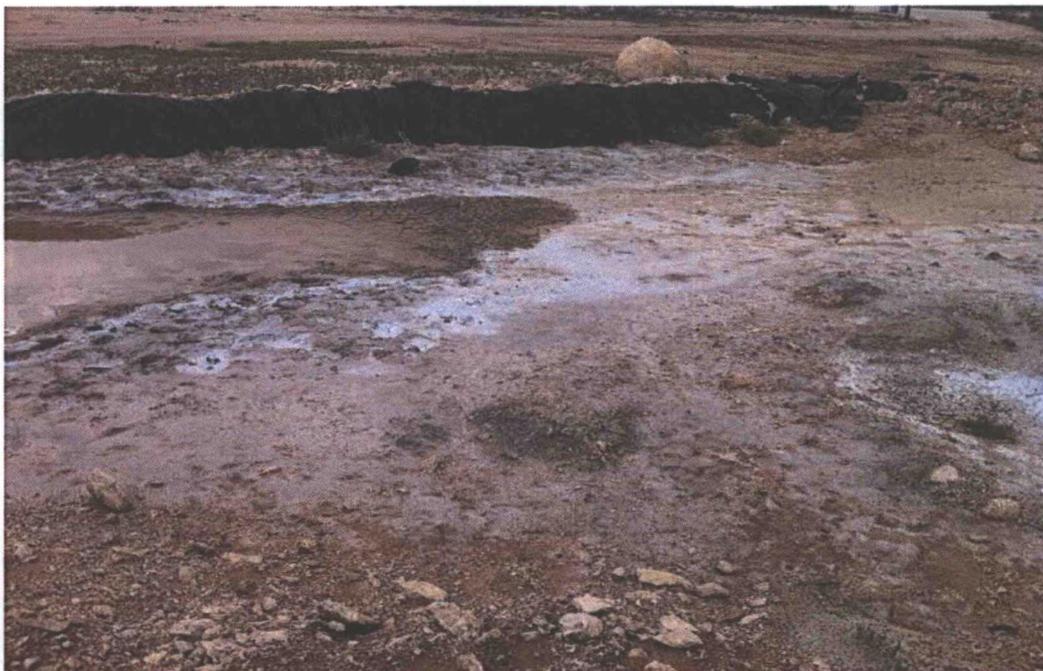
PHOTO 2: View of reserve pit facing south before any remedial work activities

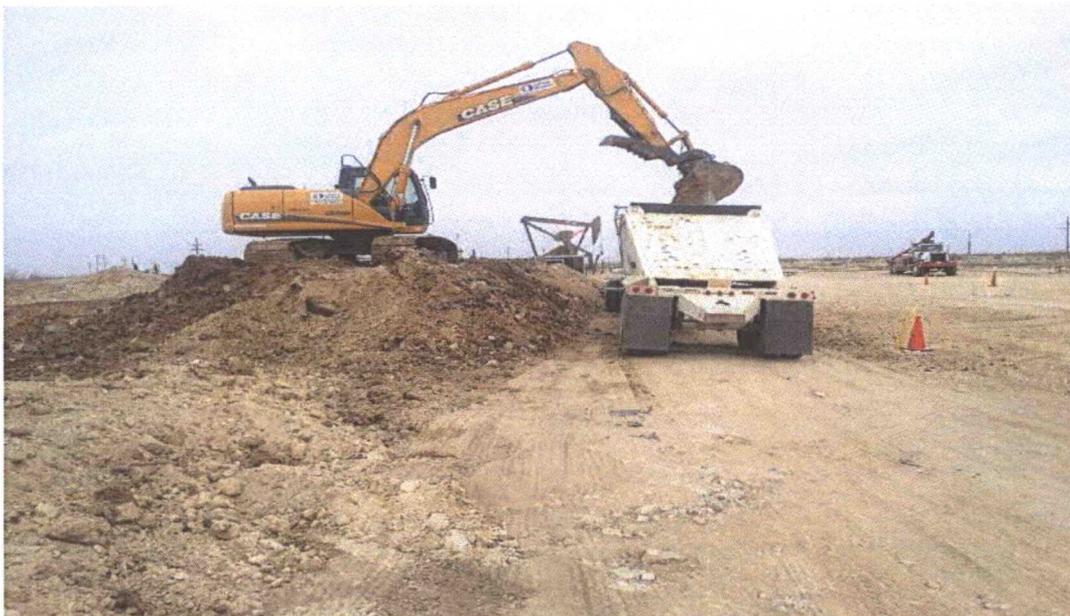
PHOTO 3: View of excavation/waste removal activities

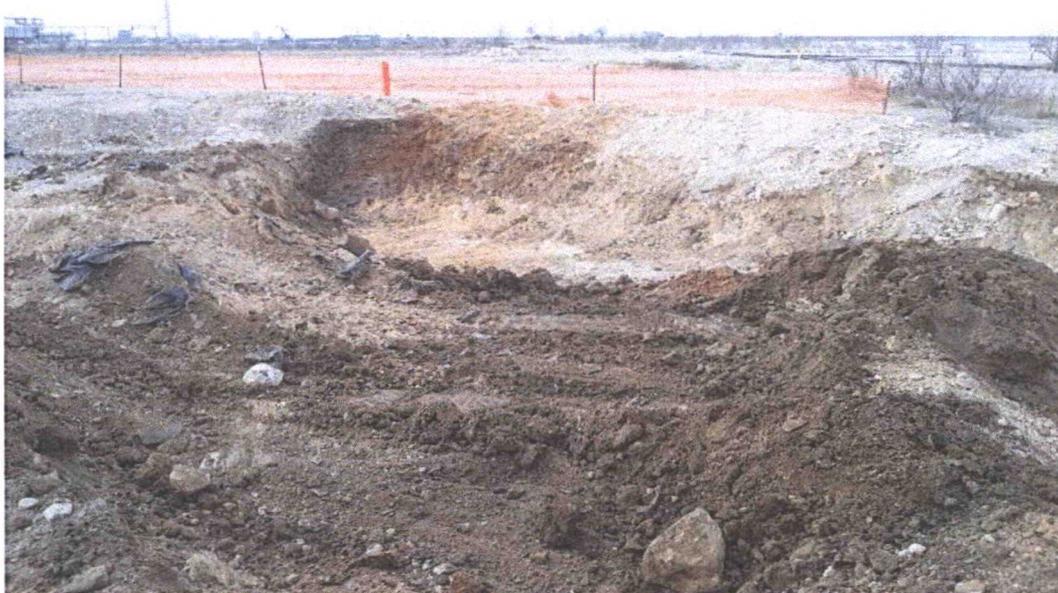
PHOTO 4: View of excavation/waste removal activities facing southwest

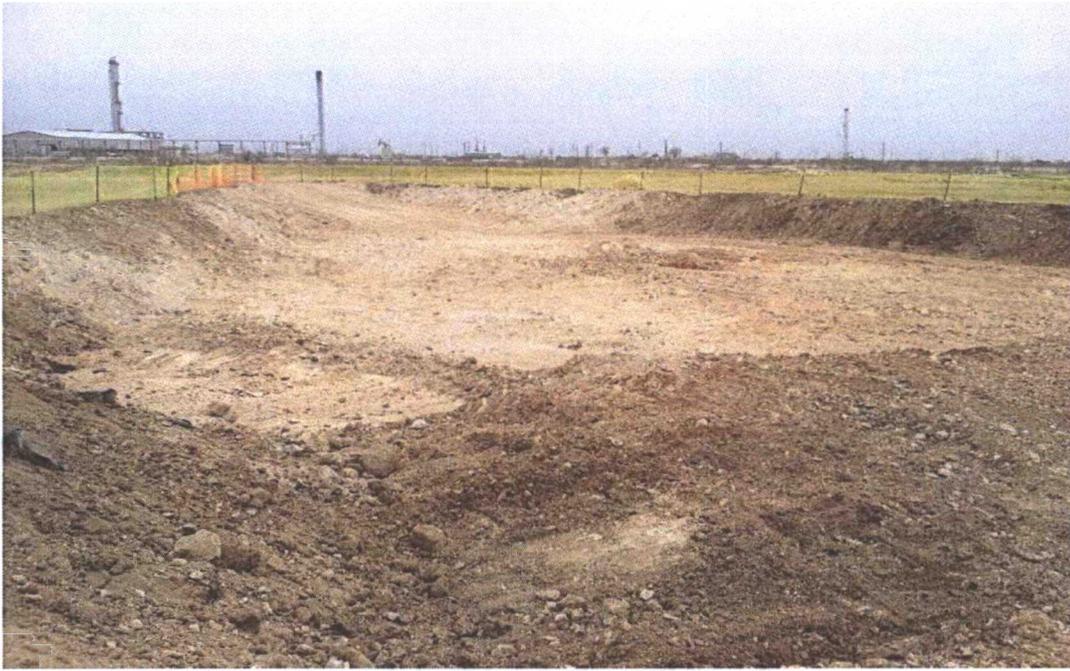
PHOTO 5: View of excavated reserve pit facing south

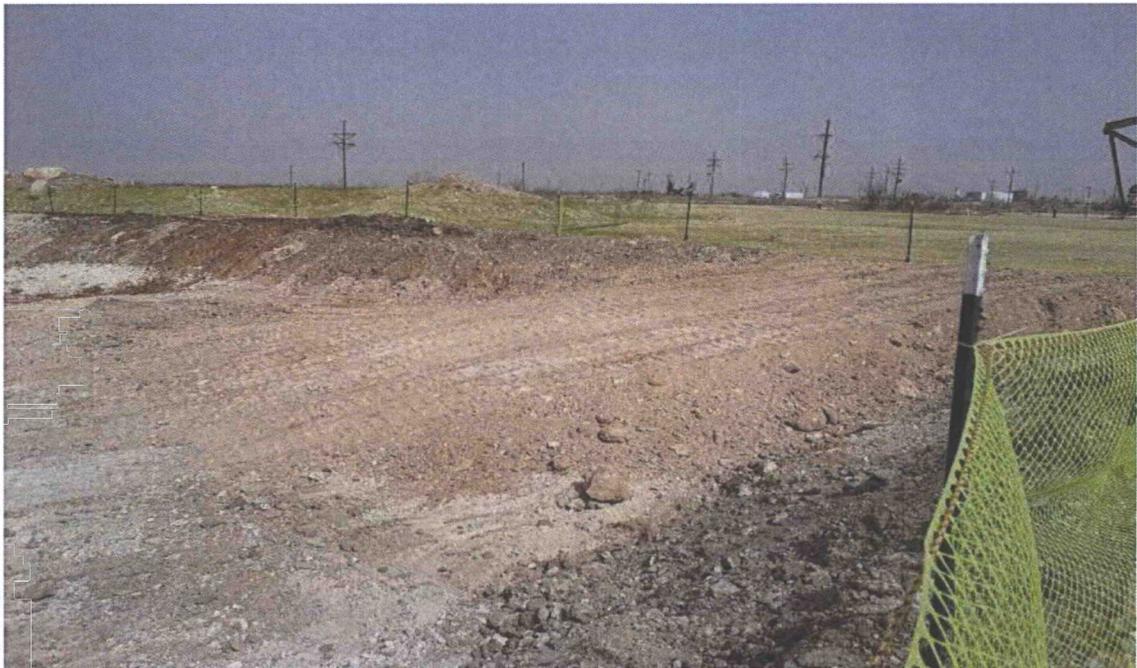
PHOTO 6: View of excavated pit and entrance ramp facing north

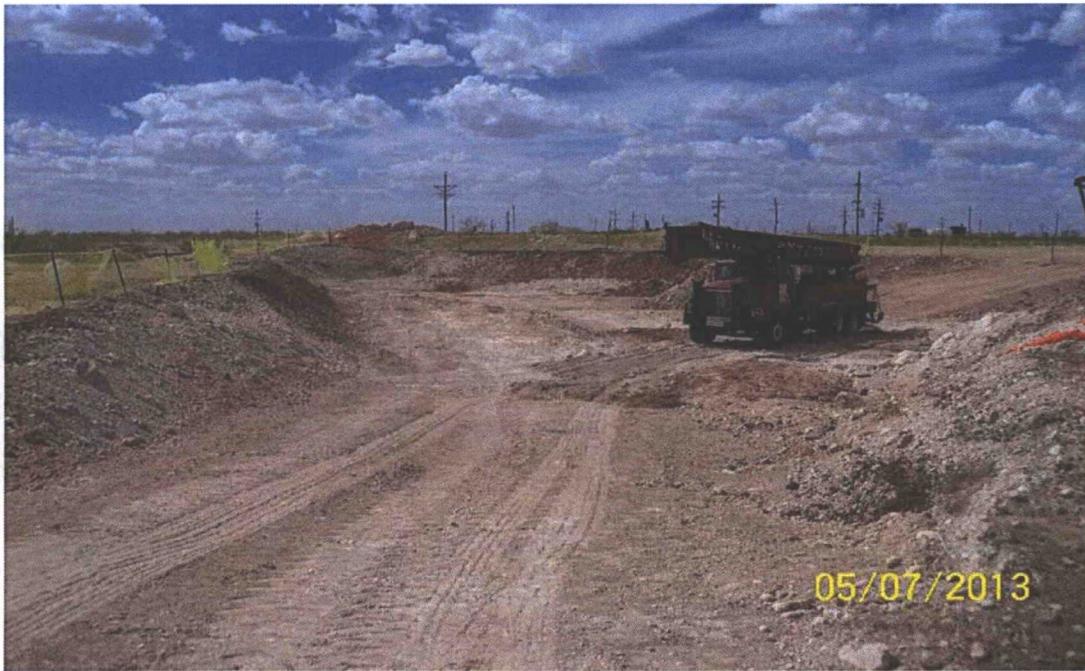
PHOTO 7: View of drill rig inside excavated reserve pit facing north

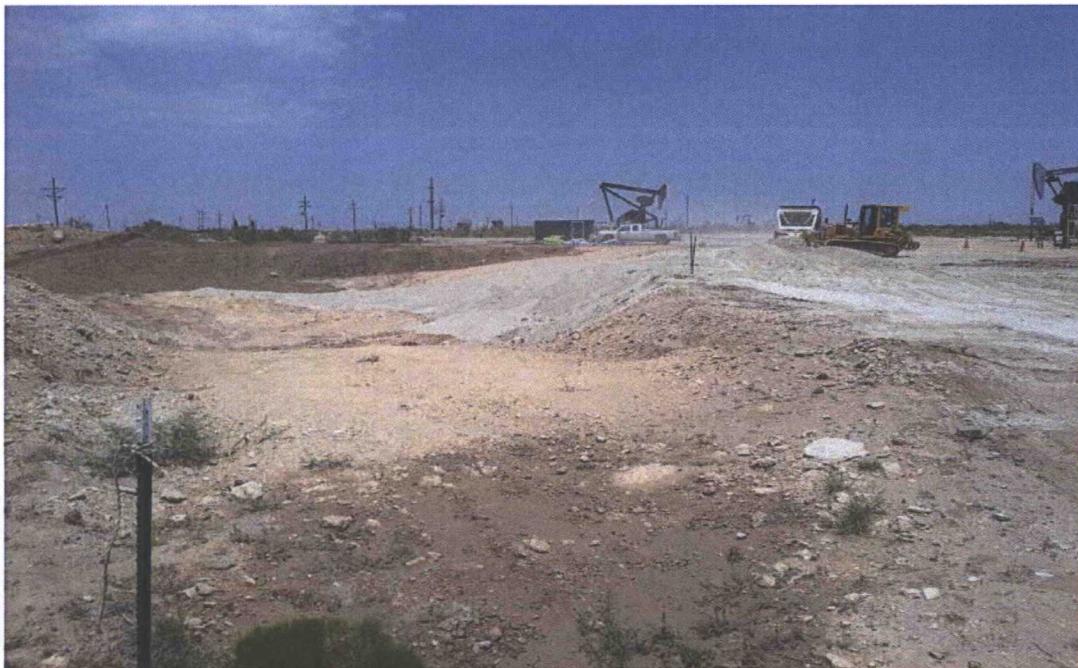
PHOTO 8: View of backfill activities facing north

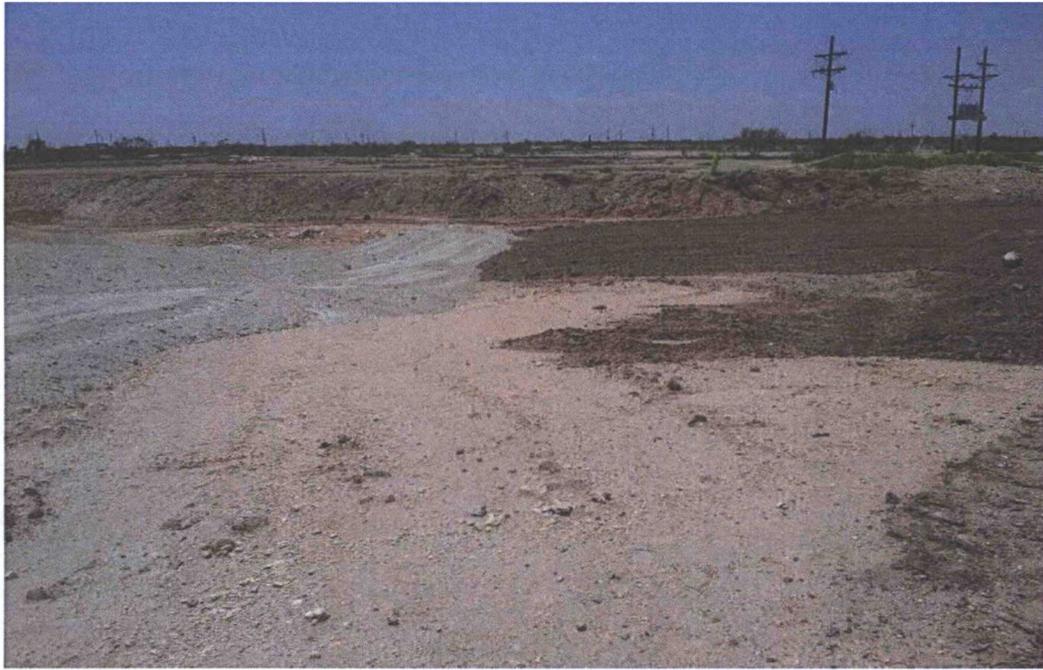
PHOTO 9: View of backfill activities facing west

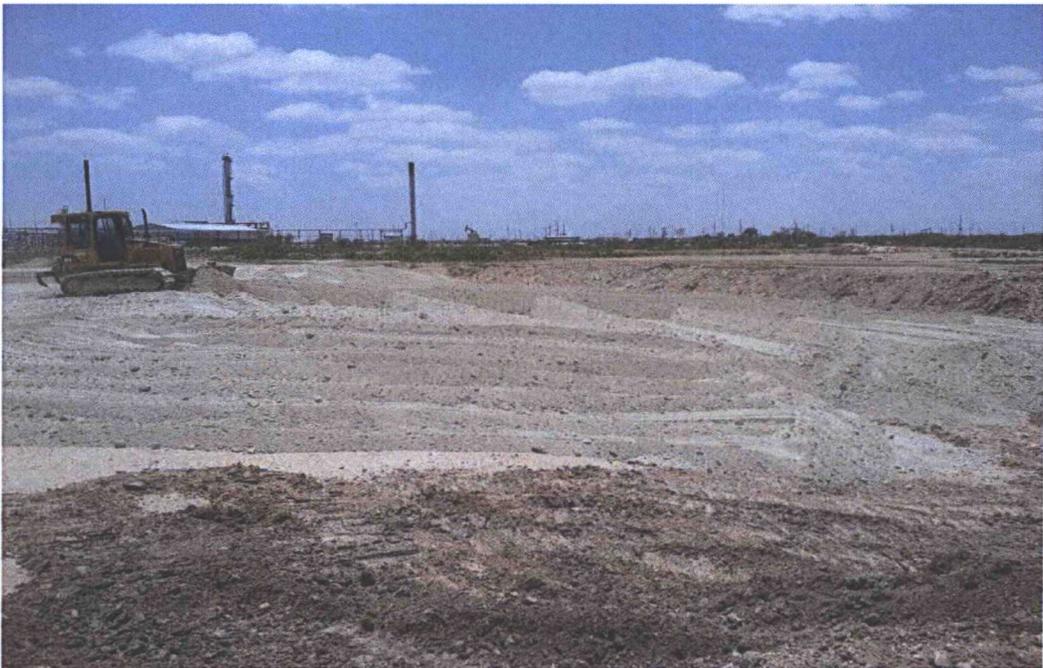
PHOTO 10: View of backfilling activities facing south

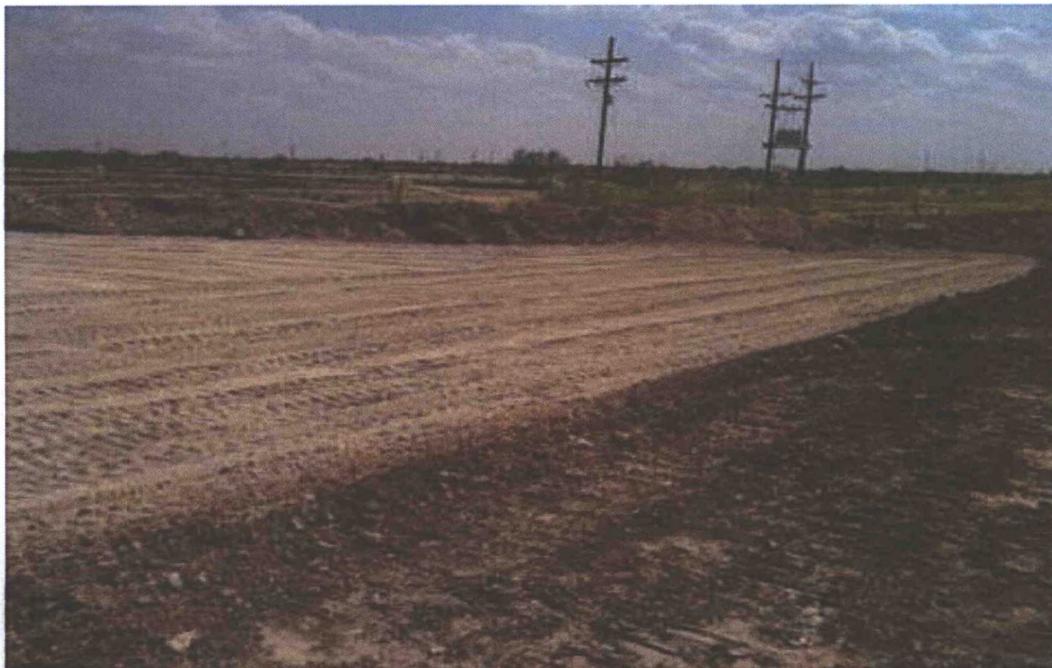
PHOTO 9: View of backfill ready for 20 mil poly liner installation facing northwest

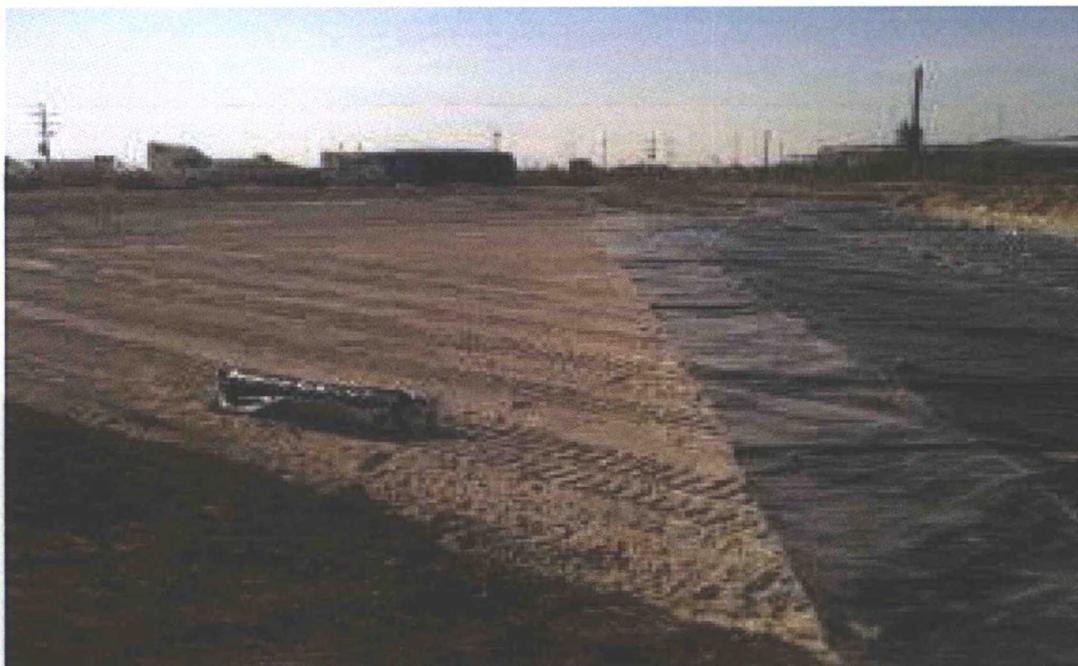
PHOTO 11: View of 20 mil poly liner installation facing southeast

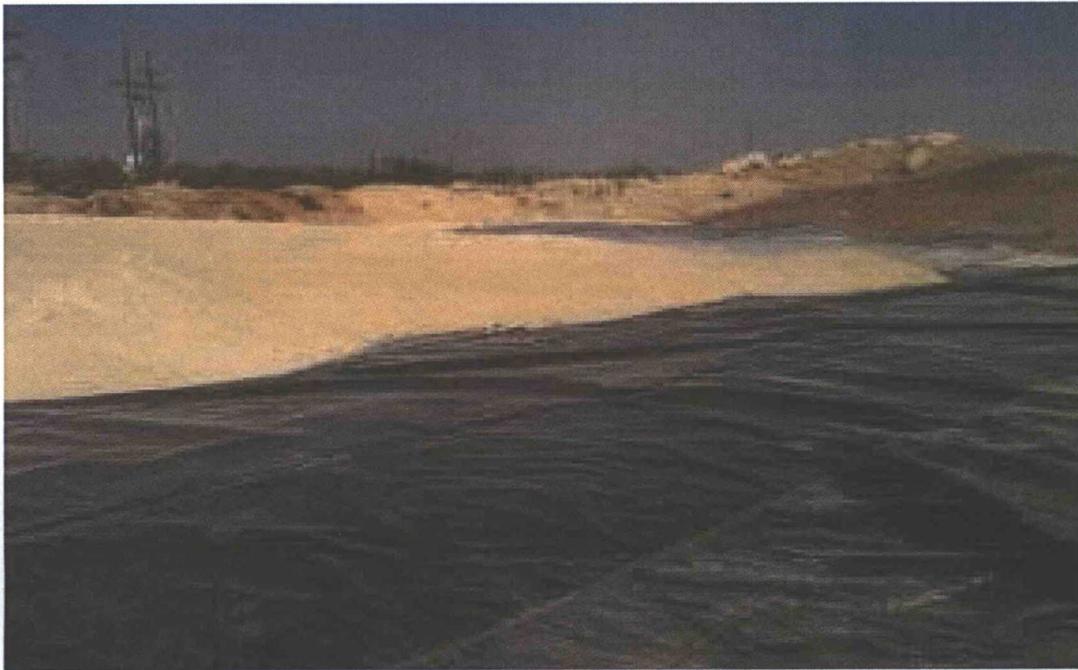
PHOTO 12: View of 20 mil poly liner installation/backfill facing northwest

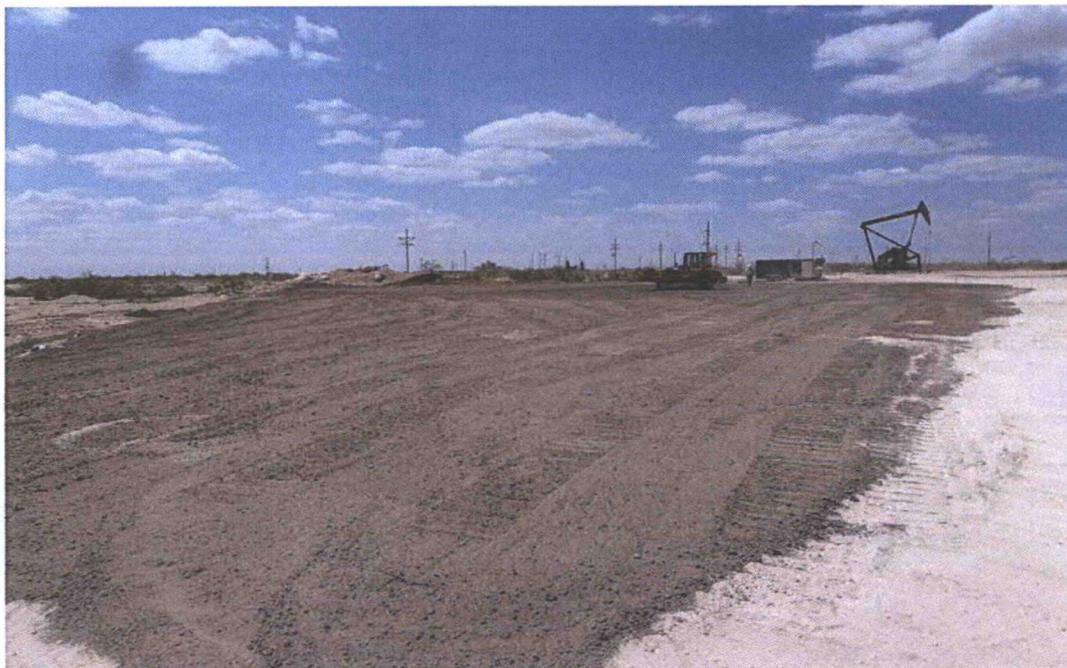
PHOTO 13: View of final grading and seeding activities facing north
