Pit or Below-Grade Tank Registration or Closure Is pit or below-grade tank covered by a "general plan"? Yes No

Re: Final C-144

> Chevron USA (O-Grid #4323) C. L. Hardy #7 (Ref. #200094)

API#30-025-37833

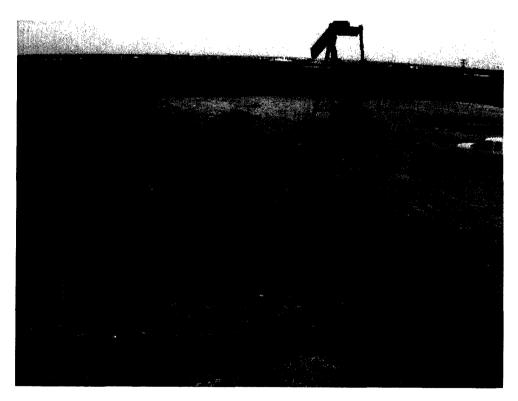
Photograph #2 - Pit and berm, looking easterly.
