**Pit or Below-Grade Tank Registration or Closure**

Operator: <u>Range Operating New Mexico, Inc</u> Telephone: <u>(505) 631-0926</u> e-mail address: <u>salmager@rangeresources.com</u>		
Address: <u>P.O. Box 2510 Hobbs, NM 88241</u>		
Facility or well name: <u>H.S. Turner Well #8</u> #: <u>30-025-37873</u> U/L or Qtr/Qtr <u>M</u> Sec <u>29</u> T <u>21S</u> R <u>32E</u>		
County: <u>Lea</u> Latitude <u>N 32° 26.678'</u> Longitude <u>W 103° 11.557'</u> N <input type="checkbox"/> 1927 <input checked="" type="checkbox"/> 1983 <input type="checkbox"/>		
Surface Owner: Federal <input type="checkbox"/> State <input type="checkbox"/> Private <input type="checkbox"/> Indian <input checked="" type="checkbox"/>		
<b>Pit</b> Type: Drilling <input checked="" type="checkbox"/> Production <input type="checkbox"/> Disposal <input type="checkbox"/> Workover <input type="checkbox"/> Emergency <input type="checkbox"/> Lined <input checked="" type="checkbox"/> Unlined <input type="checkbox"/> Liner type: Synthetic <input checked="" type="checkbox"/> Thickness <u>20</u> mil Clay <input type="checkbox"/> Pit Volume <u>    </u> bbl	<b>Below-grade tank</b> Volume: <u>    </u> bbl Type of fluid: <u>    </

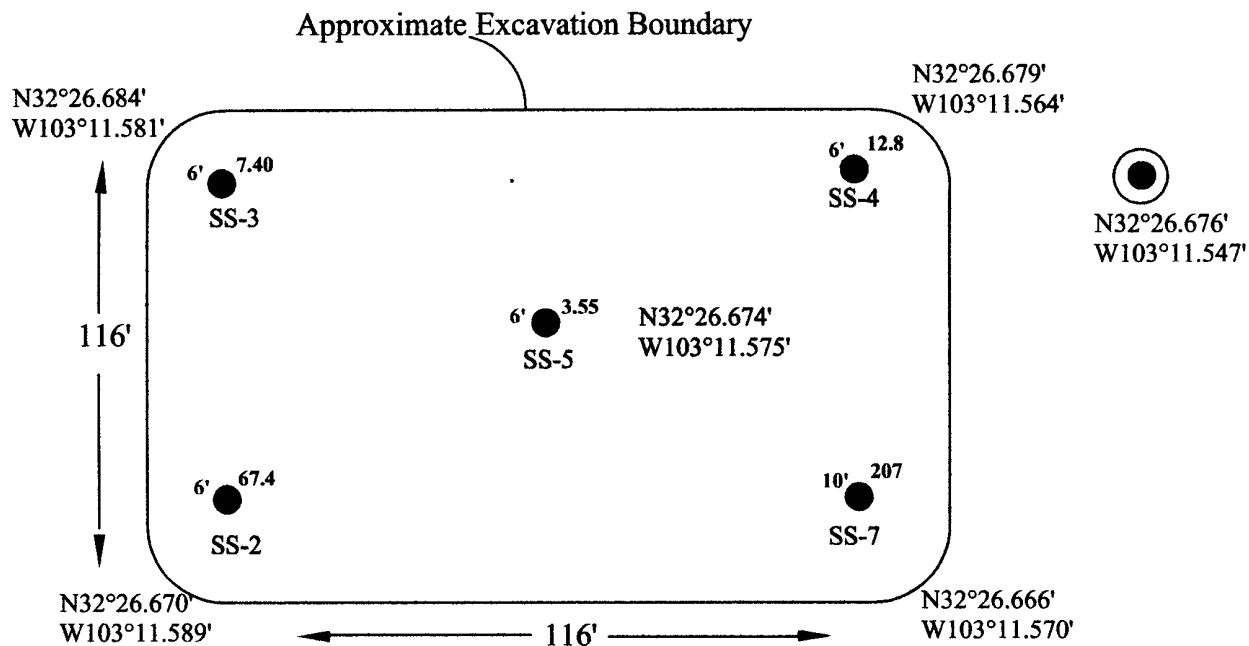
Additional Comments: All fluids were removed from the pit. The burial pit was constructed adjacent to the drilling pit. The burial pit was lined with a 12 ml liner. Impacted material was placed in the burial pit, completely encapsulated and capped with a 20 ml liner, and covered with 3 feet of topsoil to grade.
Laboratory results from soil samples collected at five (5) locations below the liner are attached.
