Pit or Below-Grade Tank Registration or Closure

Operator: <u>Saber Resources, Inc.</u> Telephone: <u>(432) 685-0169</u> e-mail address: <u>Doug@SaberResources.com</u>		
Address: <u>400 W. Illinois, Suite 950 Midland, TX 79701</u>		
Facility or well name: <u>T.D. Pope 35 #7</u> #: <u>30-025-05191</u> U/L or Qtr/Qtr <u>J</u> Sec <u>35</u> T <u>14S</u> R <u>37E</u>		
County: <u>Lea</u> Latitude <u>N 33 deg 03.545'</u> Longitude <u>W 103 deg 10.123'</u> NAD: 1977 <input type="checkbox"/> 1983 <input type="checkbox"/>		
Surface Owner: Federal <input type="checkbox"/> State <input type="checkbox"/> Private <input checked="" type="checkbox"/> Indian <input type="checkbox"/>		
<b>Pit</b> Type: Drilling <input type="checkbox"/> Production <input type="checkbox"/> Disposal <input type="checkbox"/> Workover <input checked="" type="checkbox"/> Emergency <input type="checkbox"/> Lined <input checked="" type="checkbox"/> Unlined <input type="checkbox"/> Liner type: Synthetic <input checked="" type="checkbox"/> Thickness <u>20</u> mil Clay <input type="checkbox"/> Pit Volume <u>    </u> bbl	<b>Below-grade tank</b> Volume: <u>    </u> bbl Type of fluid: <u>    </u> Construction material: <u>    <

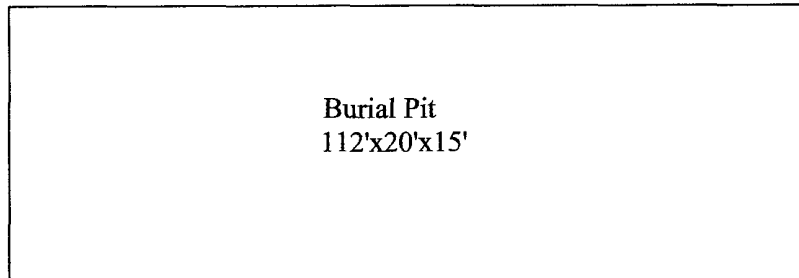
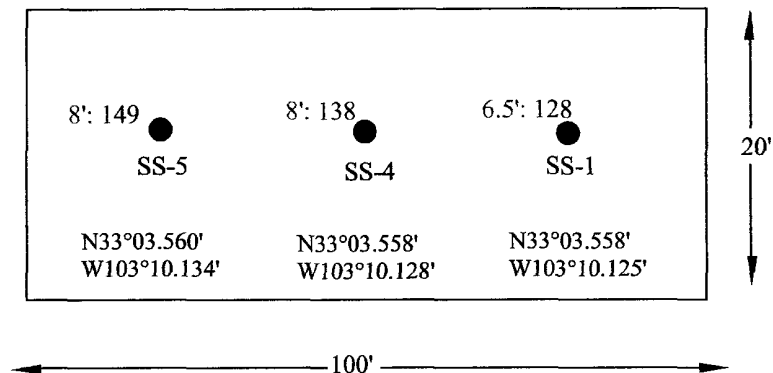
6.5': 128  
SS-1

Soil sample location taken on 03/06/07, at a depth (feet), with chloride concentration (mg/kg).

Site Drawing  
(Not to Scale)

Additional Comments: All fluids were removed from the pit. The burial pit was constructed adjacent to the drilling pit and lined with a 12 ml liner.
The liner and impacted material were placed in the burial pit, completely encapsulated and capped with a 20 ml liner, and covered with 3 feet of topsoil to grade.
Hydrocarbon impacted material was disposed at an NMOCD approved facility.
Samples were collected below the liner and results are attached with this C144 form.
