PIT  
**Closure Report**

Prepared for  
Mewbourne Oil Company

**Boris 17 State #1**  
**API # 30-025-37597**  
**Lea County, NM**

Re: Mewbourne Oil – Boris 17 State #1  
UL 'A' Sec. 17 T16S R35E Lea County, NM  
API # 30-025-37597

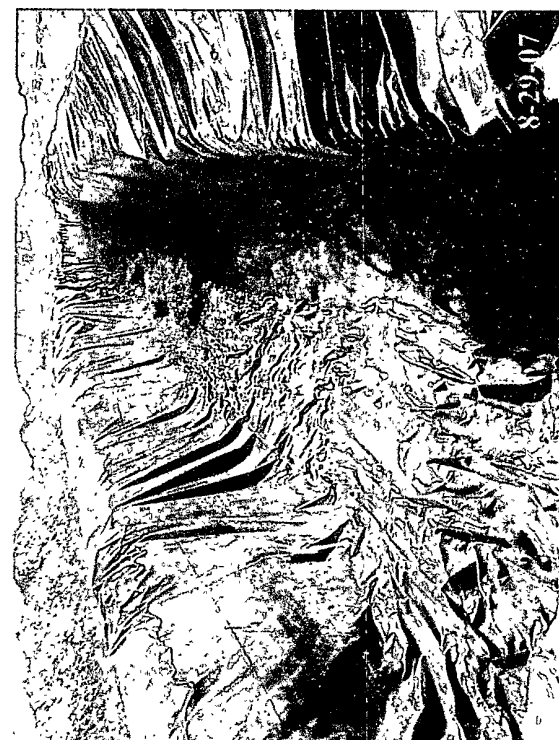
Burial pit lined with a 20 mil impervious liner.

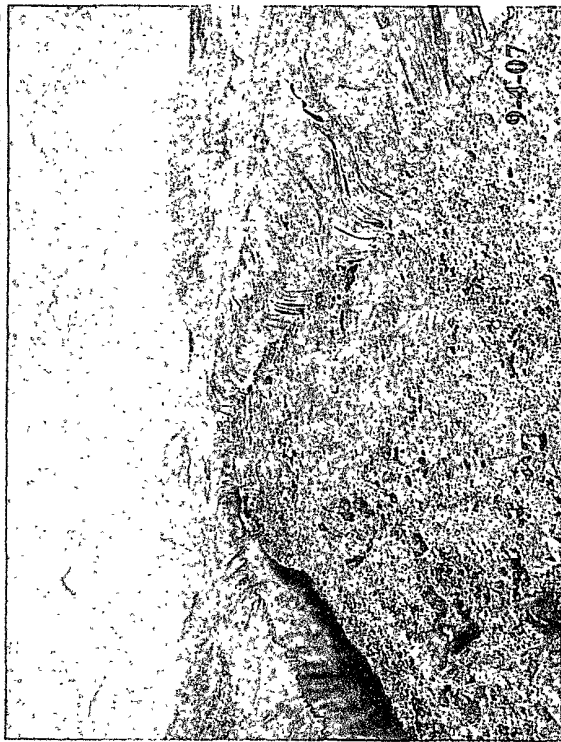
Burial pit after filled with solidified mud.

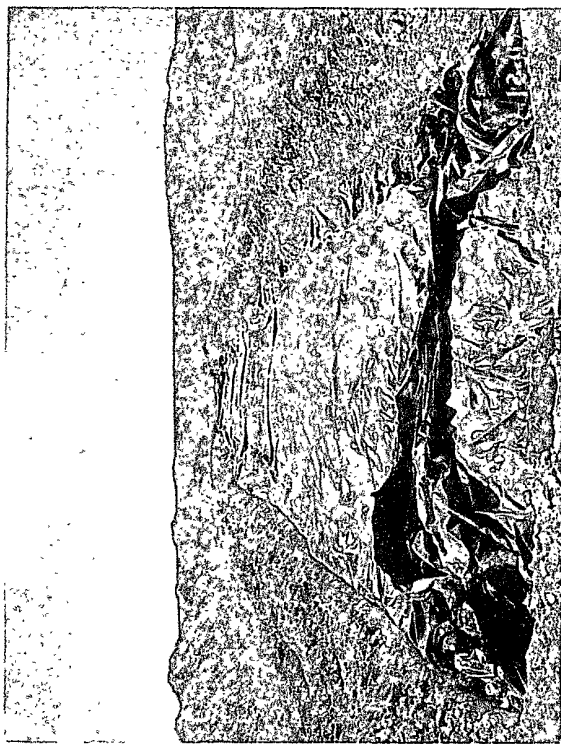
Drilling pit capped with 20 mil impervious liner.

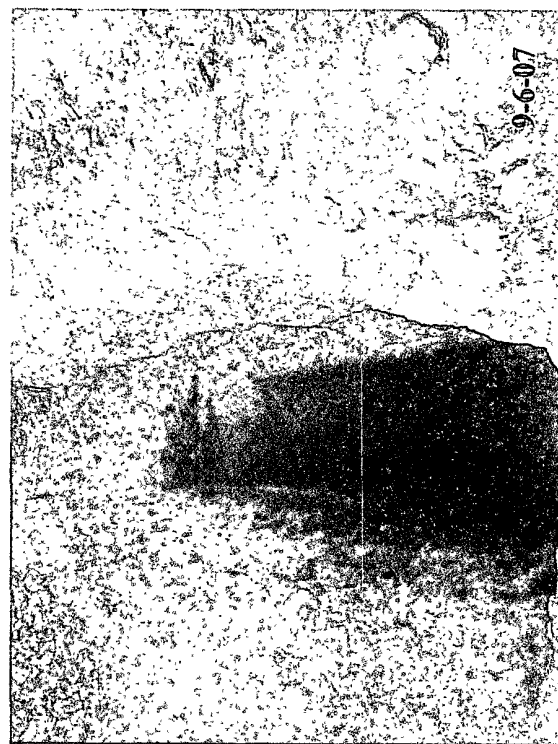
Delineation trench of Quadrant 4.

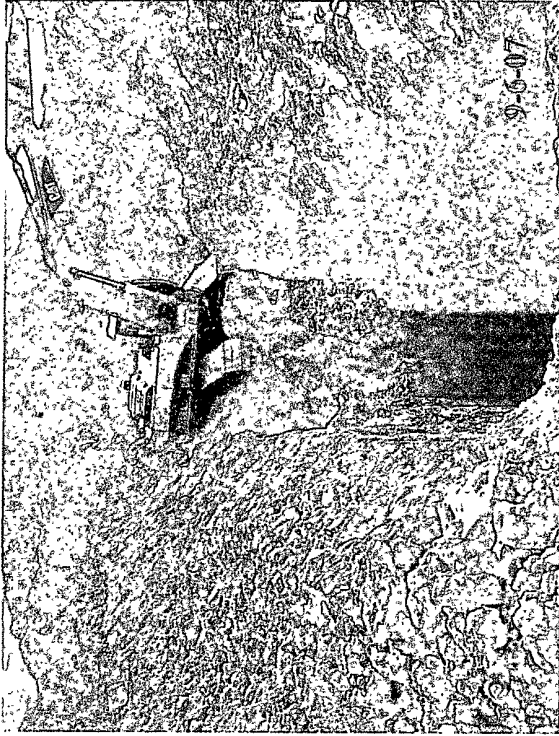
Delineation trench of Quadrant 5.

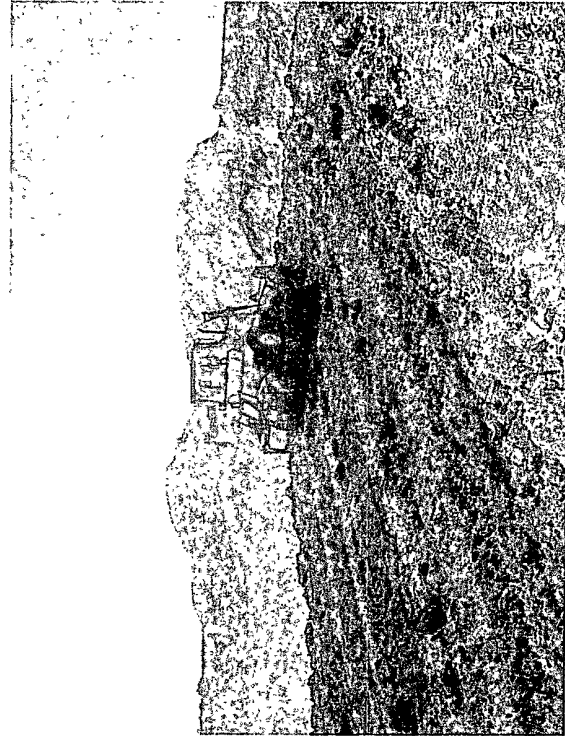
Installing red clay liner at 4' below ground surface.

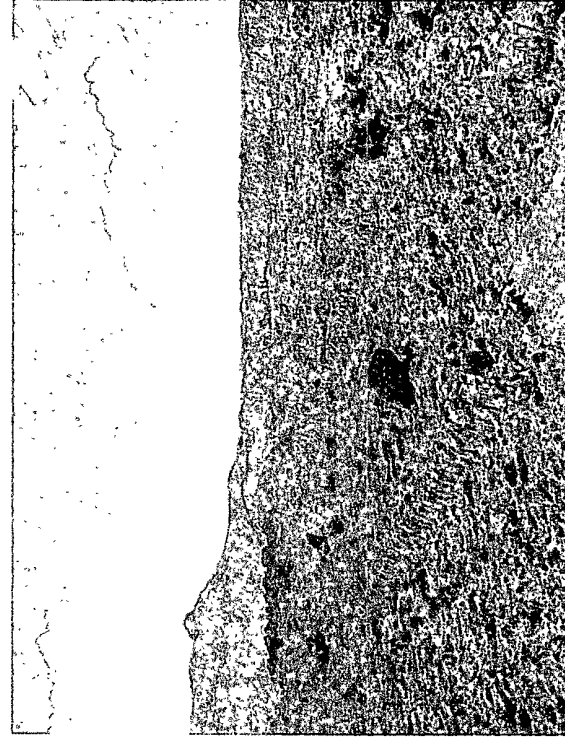
Red clay liner after installation and compaction.
