Pit or Below-Grade Tank Registration or Closure

Final Report

Re: J Cleo Thompson – Gainer 27 #1
UL 'F' Sec. 27 T10S R36E Lea County, NM
API # 30-025-38463

J Cleo Thompson
Gainer 27 #1

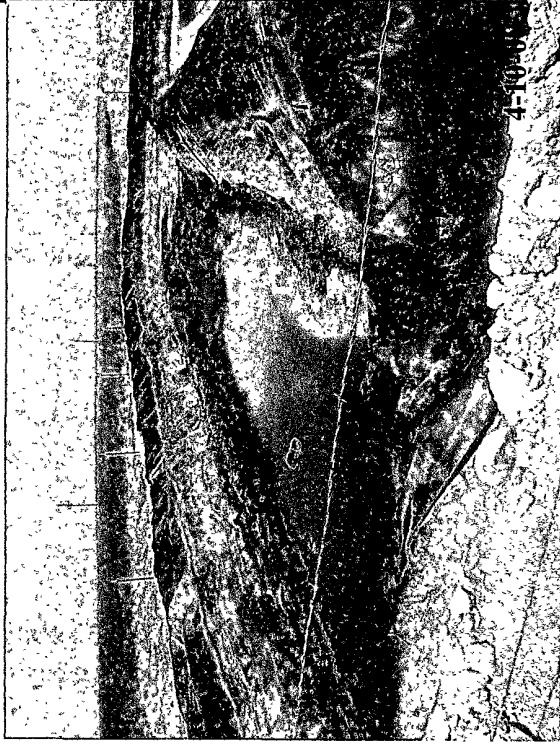
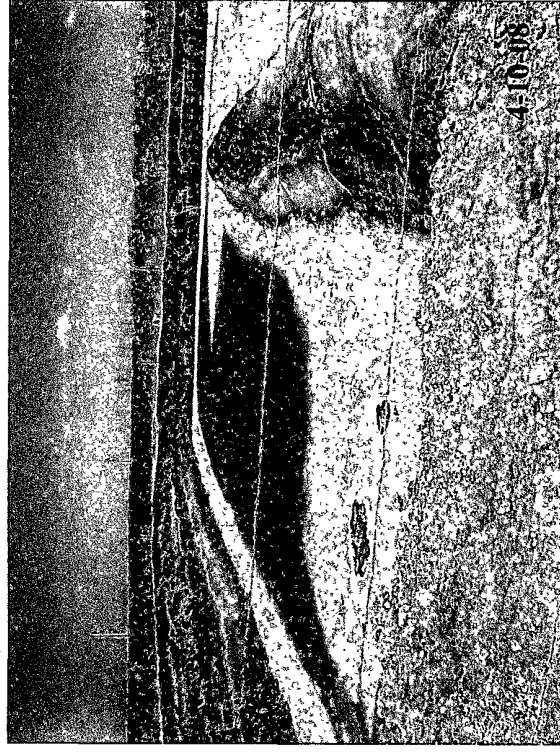
Drilling pit before closure.

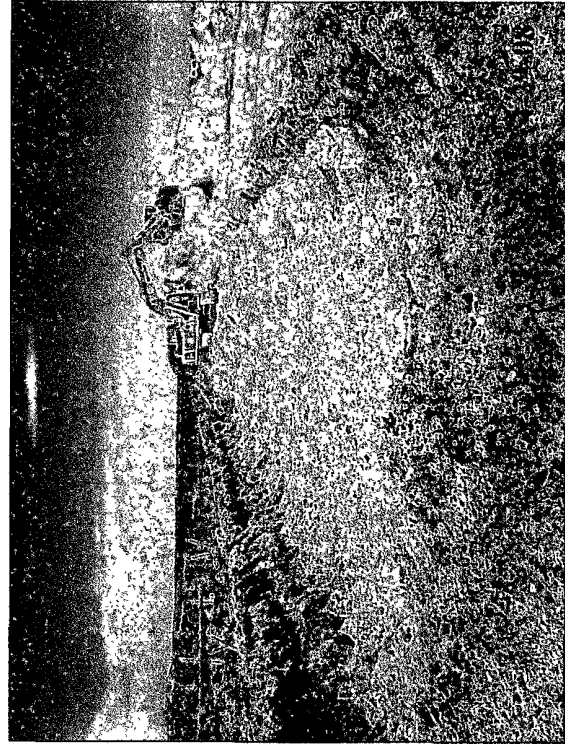
Excavation of the burial pit.

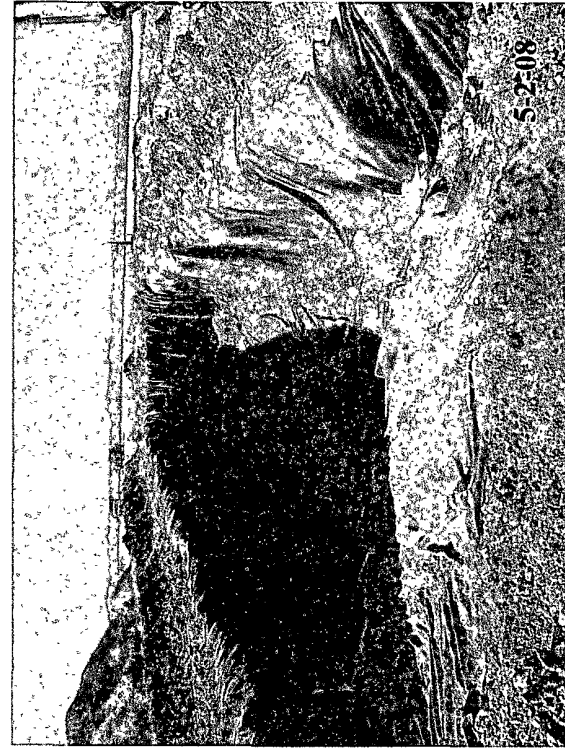
Burial pit lined with a 12 mil liner.

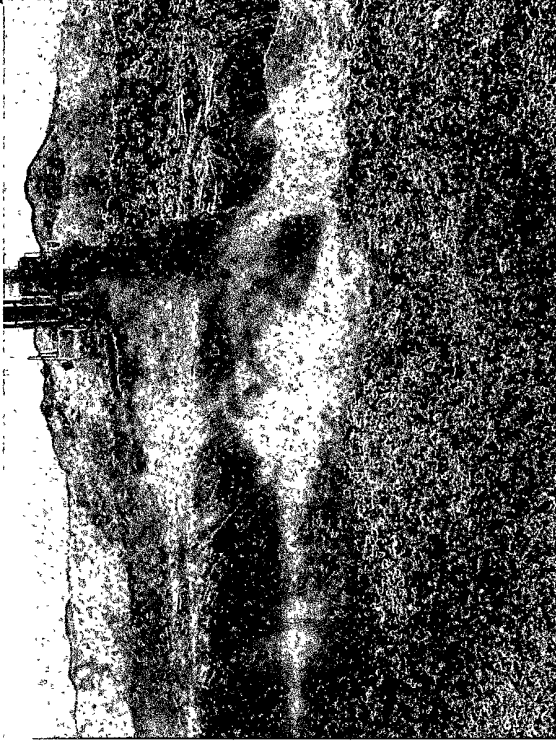
Placing drilling mud in burial pit.

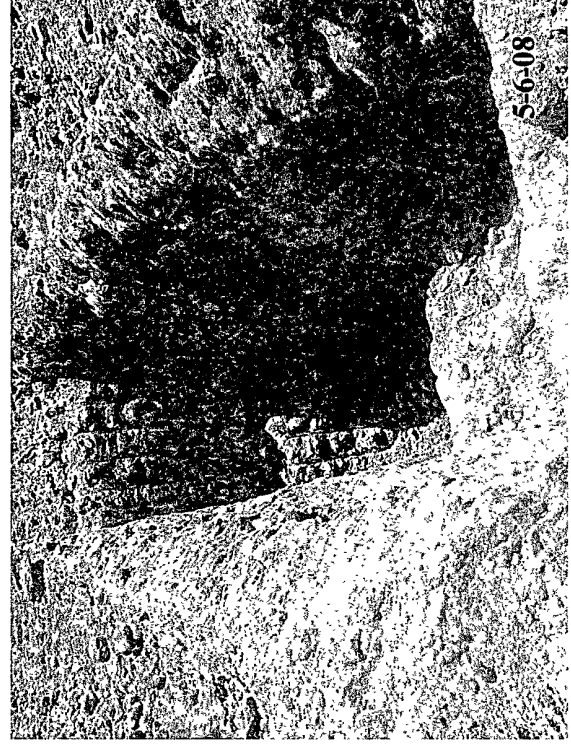
Delineation trench of TP1.

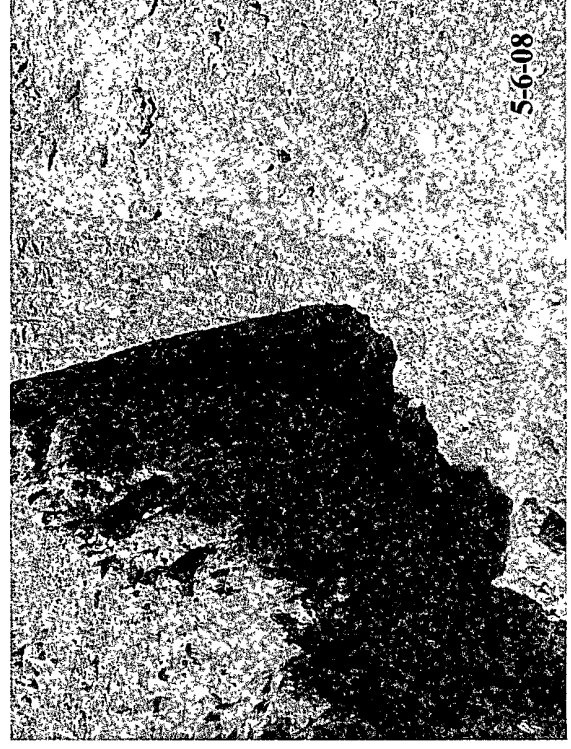
Delineation trench of TP2.

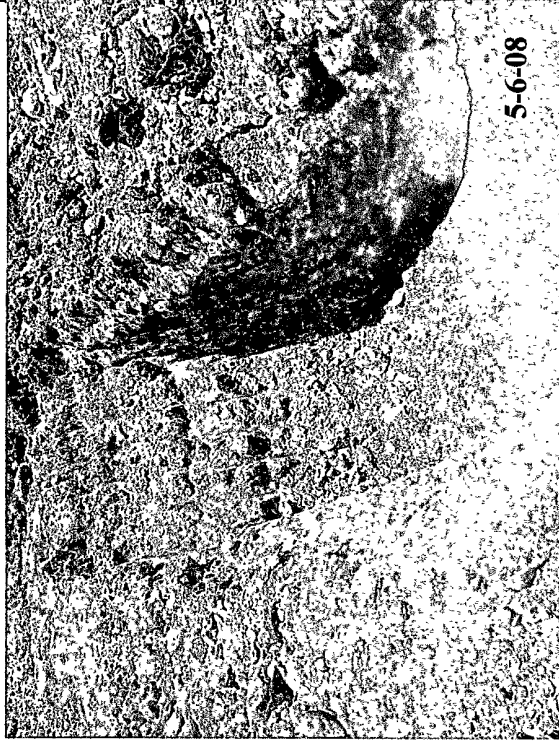
Delineation trench of TP5.

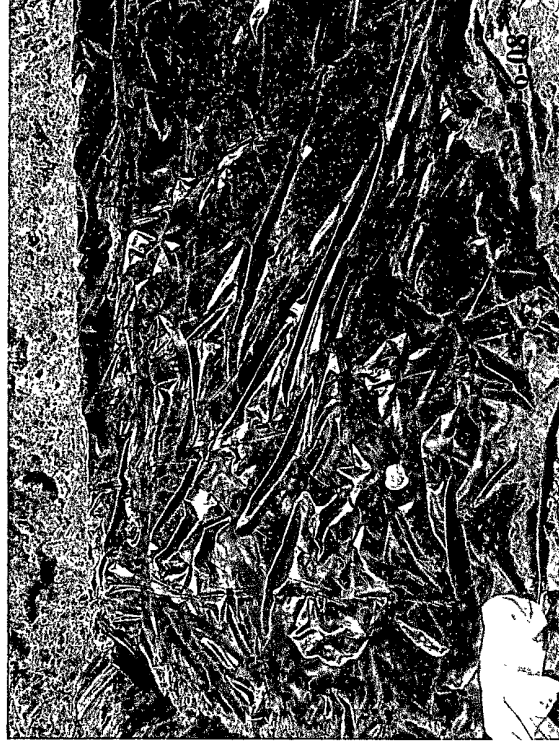
20 mil liner on TP1 & TP2 for risk based closure.

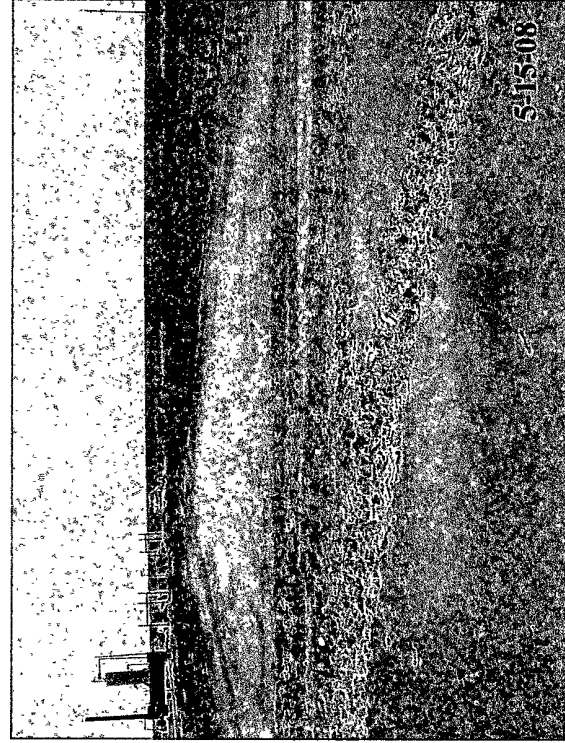
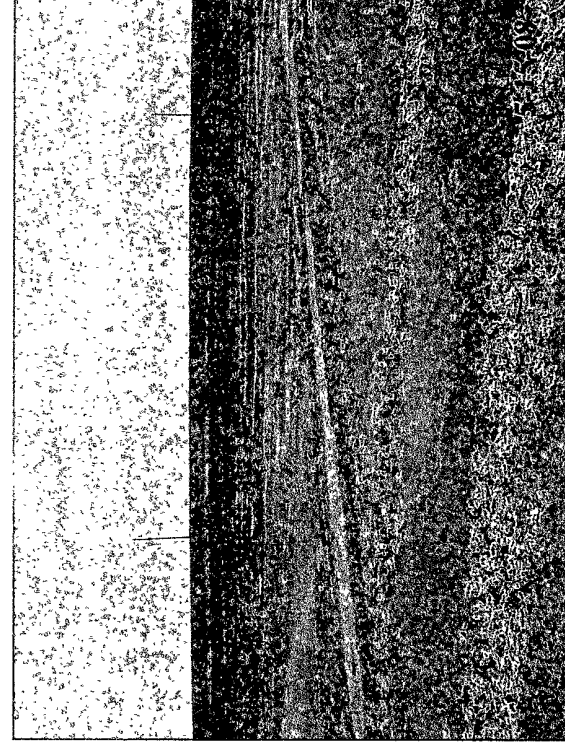
Drilling pit and burial pit after backfill and contouring.
