Pit or Below-Grade Tank Registration or Closure

RE: Work Plan to clean up Antelope Ridge Unit #12 reserve drilling pit located in Unit Letter A, Sec 33 T23S R34E of Lea County, New Mexico

Antelope Ridge Unit #12

Reserve Drilling Pit Closure Report

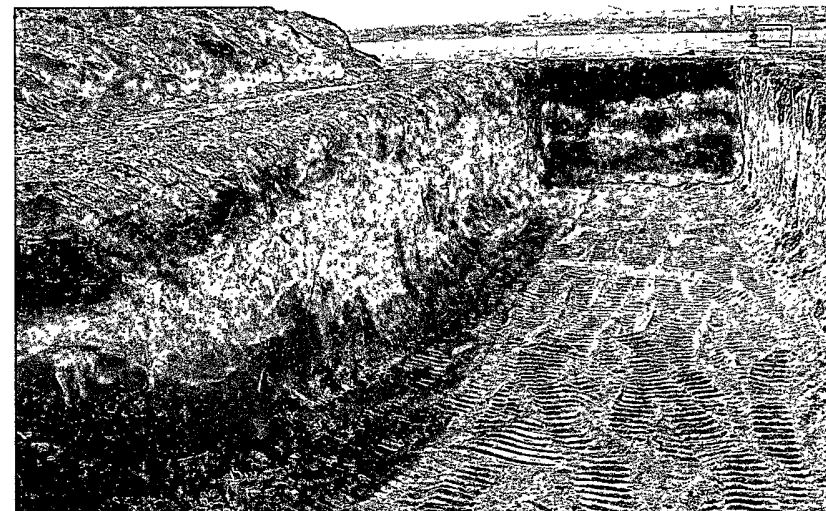
Deep bury pit (looking south)

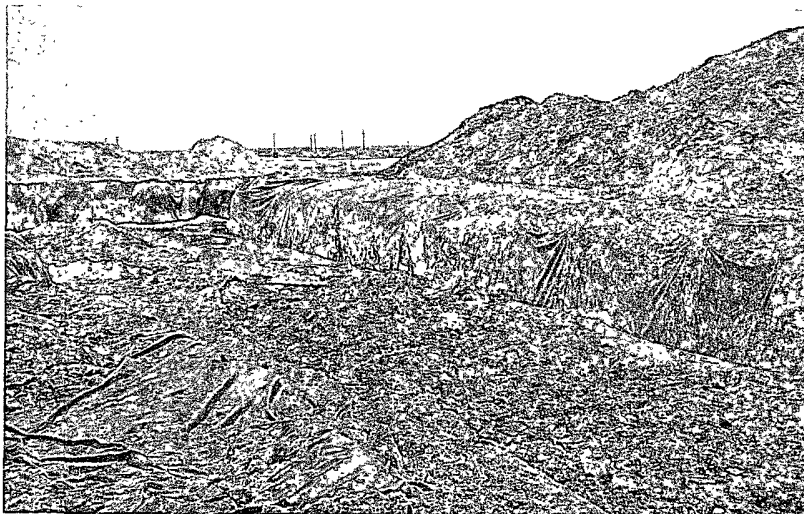
Deep bury pit with mud from drilling pit

6. *February 9, 2007– Crew continued to transfer drilling mud from reserve pit to the deep bury pit.*
7. *February 12-13, 2007 – Crew continued transferring contents from reserve drill pit to the deep bury pit.*

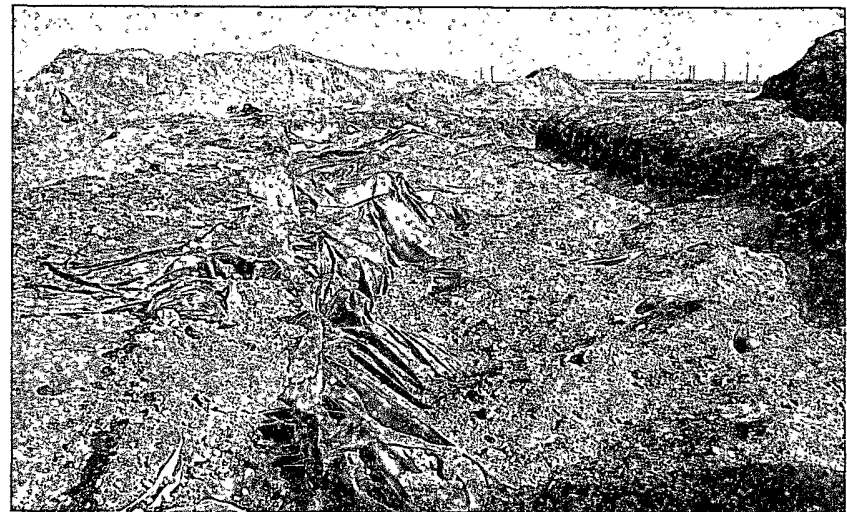
Deep bury pit with a 20mil cap

9. *February 17-21, 2007 – The deep bury pit was capped with a 20mil liner top and backfilling was done to complete coverage of the deep bury pit. Final contouring and compaction was implemented to return the site back to grade with a slight crown to prevent ponding.*

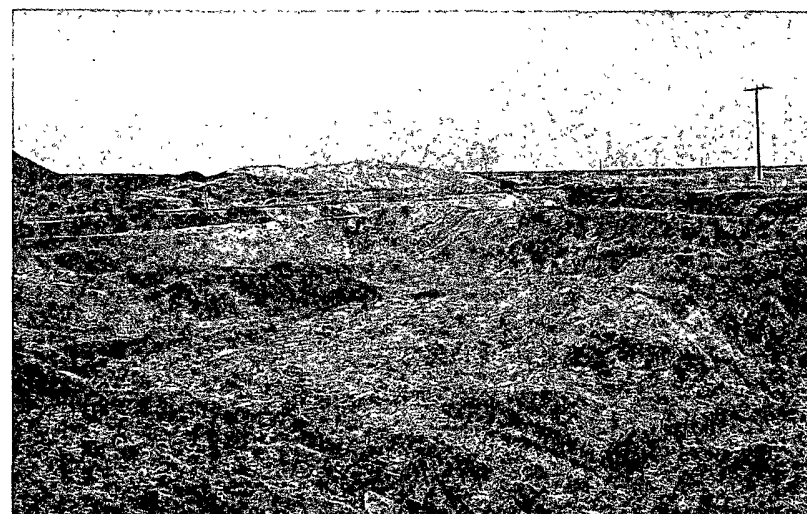
Drilling pit with contents removed (looking west)

8. *February 16, 2007 – Crew finished transferring drilling mud from reserve drill pit to deep bury pit. The bottoms of the reserve drilling pit was cleaned and final samples were taken and sent for analysis to a third party laboratory for TPH, BTEX and Chlorides for final verification of the limits met. (Please refer to attached reports, pages 8 thru 20 pages of this report.)*

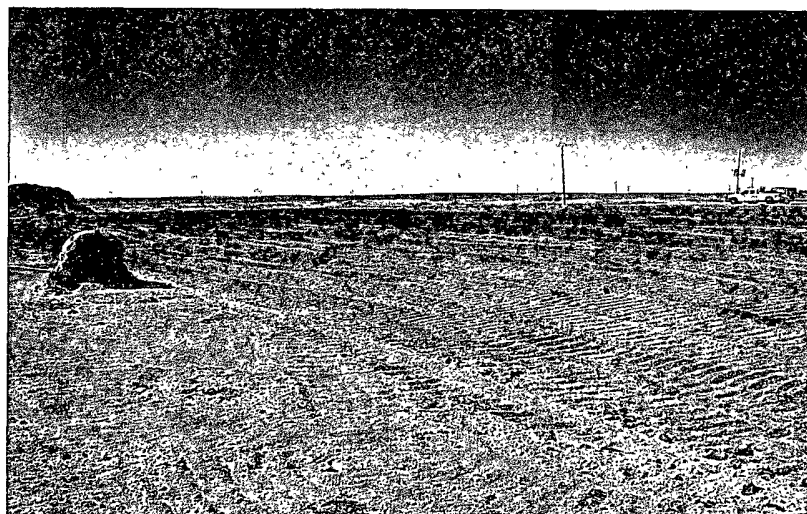
Dressed drilling pit and deep bury pit (looking northwest)

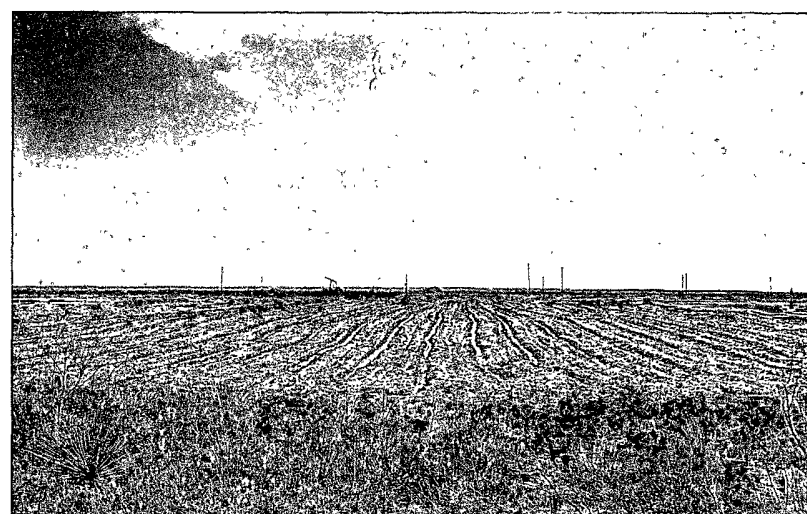
FINAL - Seeded drilling pit and deep bury pit (looking east)

The site was backfilled and compacted with clean backfill and contoured with a crown back to grade to prevent ponding on the area. The site was reseeded and should vegetate well with upcoming rains.
