# ***Final Closure Report***

*Aduddle #1 Reserve Drilling Pit, API: 30-025-30407  
Sec. 23 15S 36E - Lea County, New Mexico*

***Phoenix Environmental, LLC.***

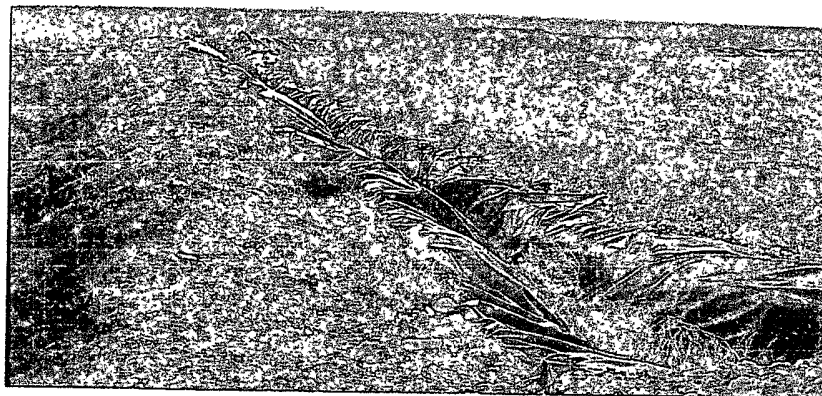
*Photo #1 Beginning View of Drying Pad*

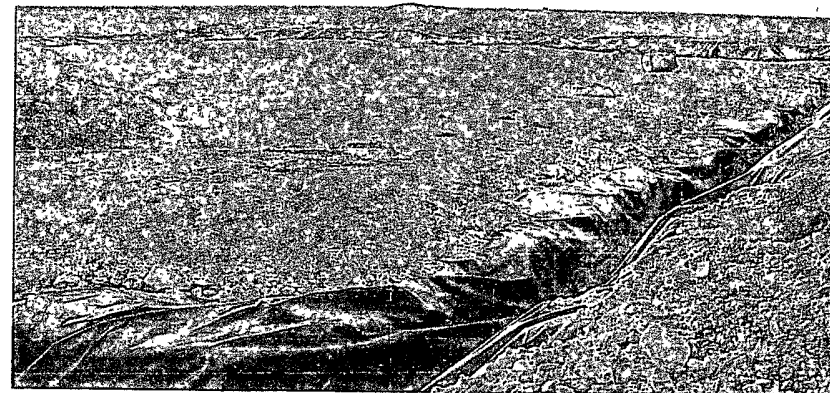
*Photo #2 Beginning View of Drying Pad*

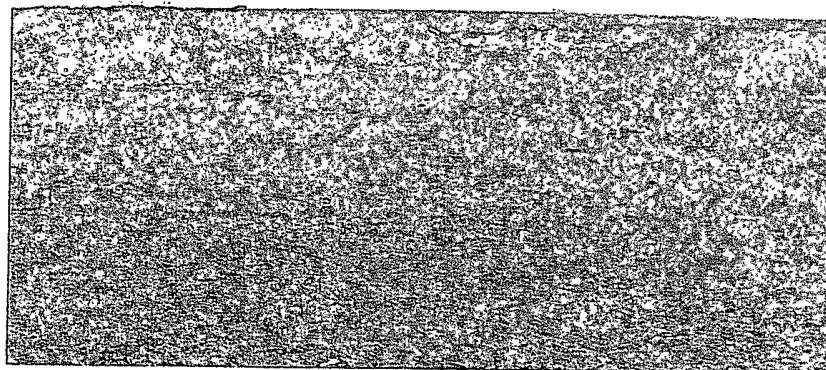
*Photo #3 Beginning View of Location*

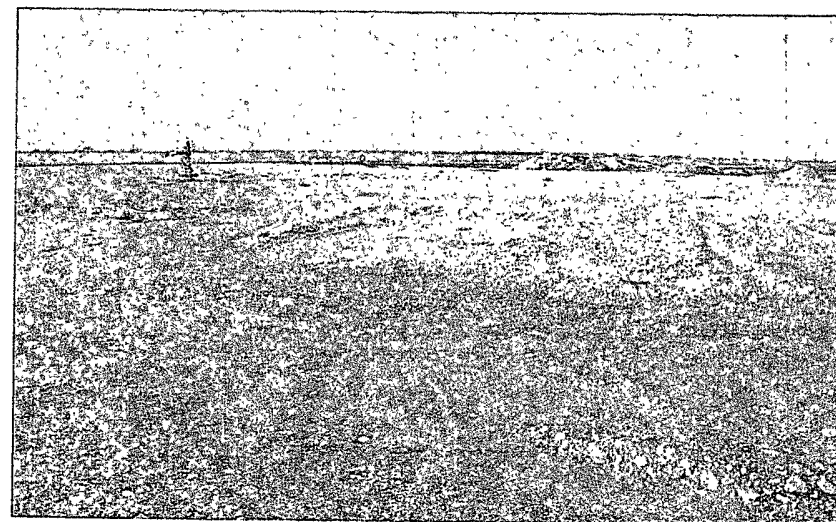
*Photo #4 Beginning View of Location*

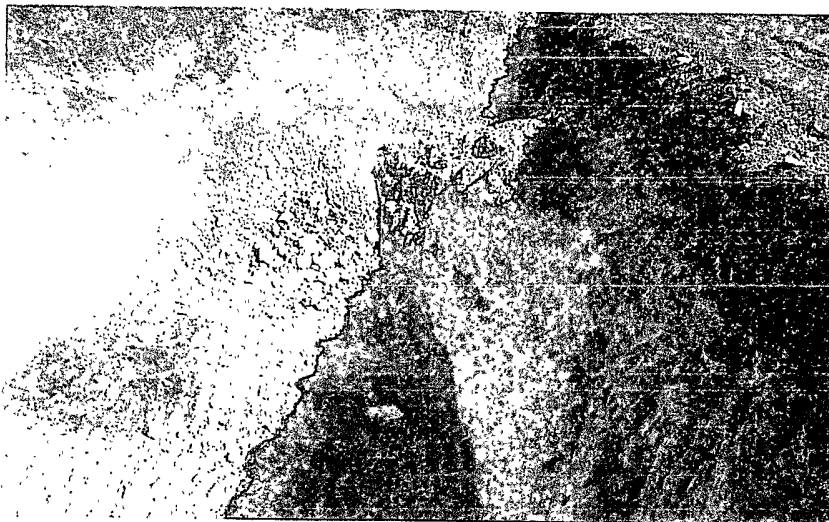
*Photo #5 Deep Bury Entombment Pit*

2. *February 15, 2008 – Crew began excavation of the deep bury entombment pit.*
3. *February 18, 2008– – Crew finished excavating deep bury entombment pit. The crew pushed caliche off pad 15 ft. outside dead man anchors into existing pit. The bottom of the deep bury pit was cleaned and dressed to prevent damage to liner. The deep bury pit was lined with 12 mil HDPE bottom. The crew transferred drill cuttings from drying pad to the deep bury entombment pit.*

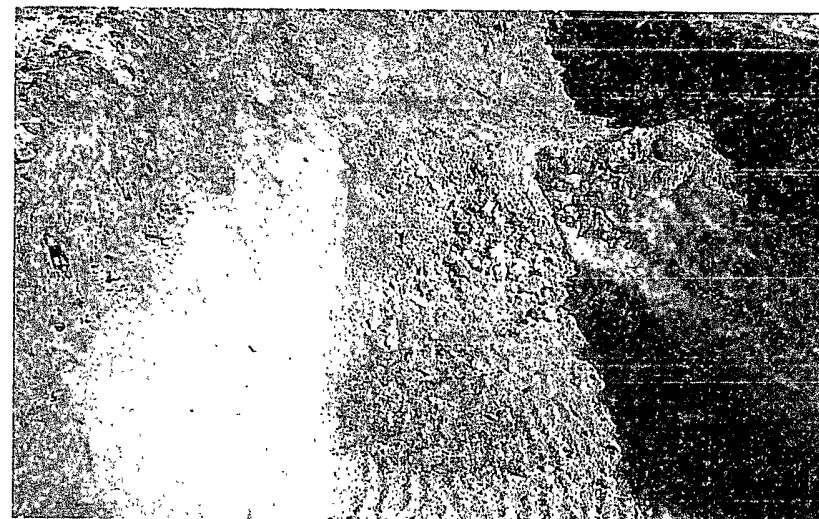
*Photo #6 Deep Bury Entombment Pit*

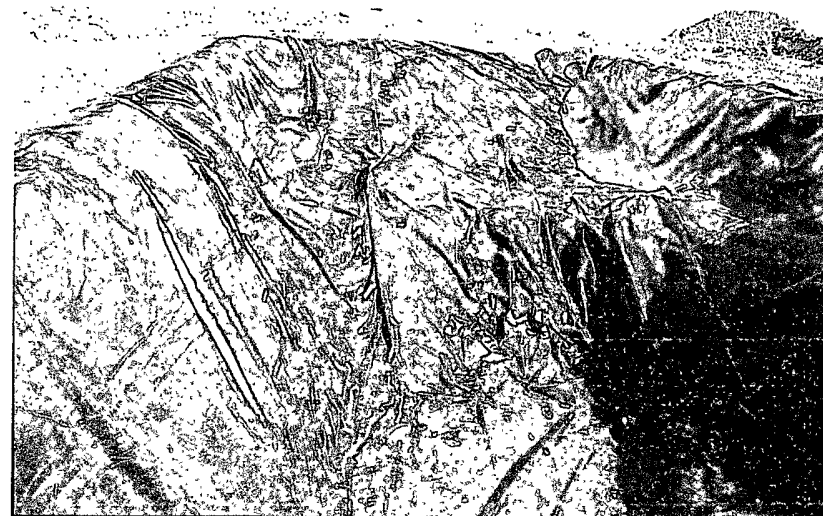
*Photo #8 Lined Deep Bury Entombment Pit*

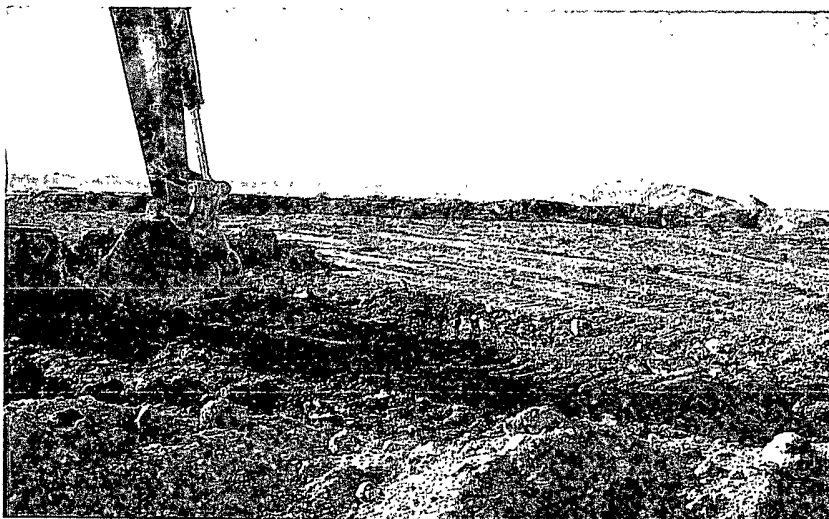
*Photo #9 Transferring Drill Cuttings*

4. *February 19, 2008 – Crew continued to transfer drill cuttings to deep bury entombment pit. Crew also pushed caliche off pad 15 ft outside of anchors.*

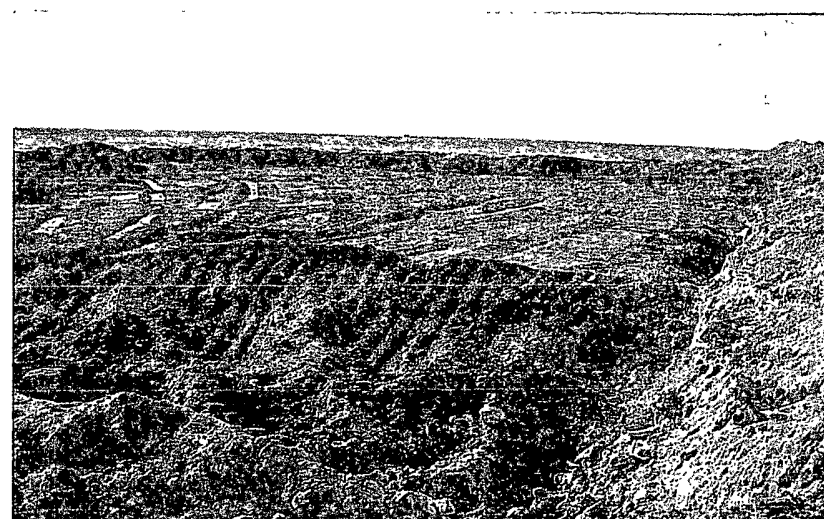
*Photo #10 Transferring Drill Cuttings*

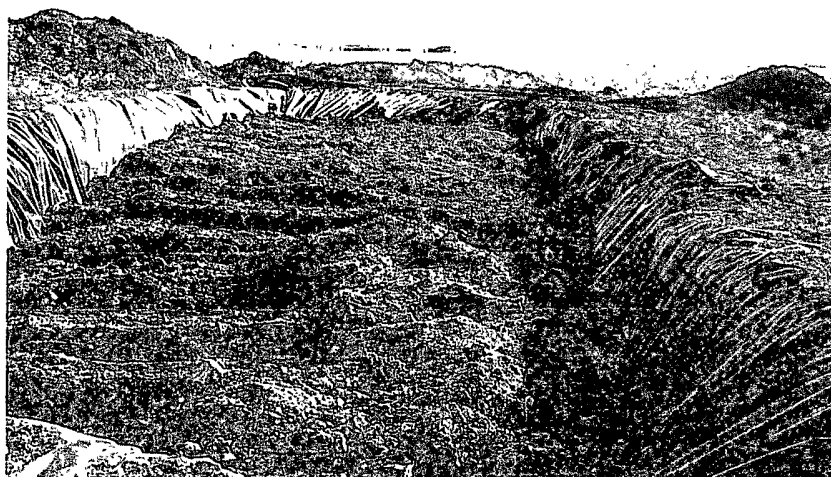
*Photo #11 Drill Cuttings in Deep Bury Entombment Pit*

5. *February 20, 2008– Crew finished transferring drill cuttings from drying pad to deep bury pit. The bottom of the drilling pad was cleaned and final samples were taken and sent to a third party laboratory for analysis Chlorides for final verification of the limits met. (Please refer to attached reports, pages 5 through 12 of this report). The deep bury pit was capped with a 20 mil HDPE top.*

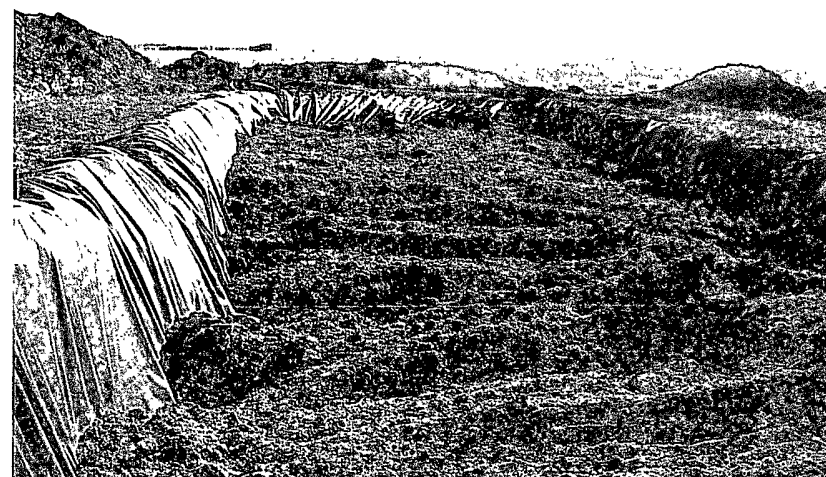
*Photo #12 Drill Cuttings in Deep Bury Entombment Pit*

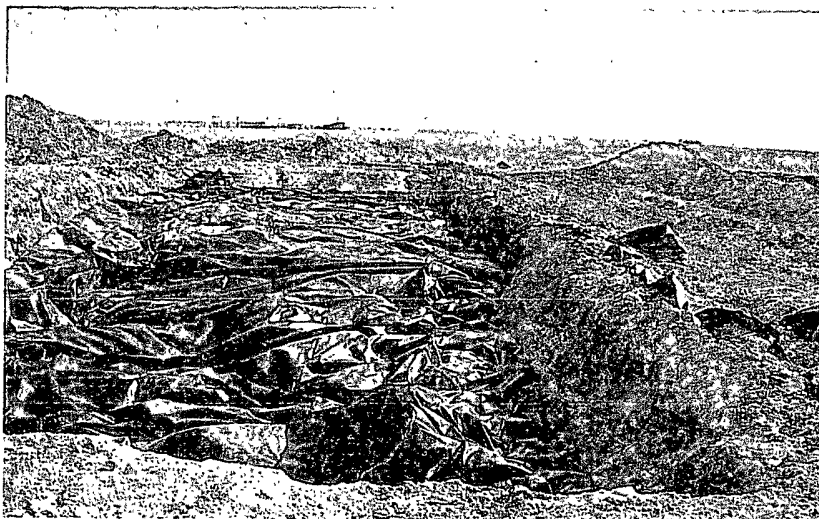
*Photo #13 Capped Deep Bury Entombment Pit*

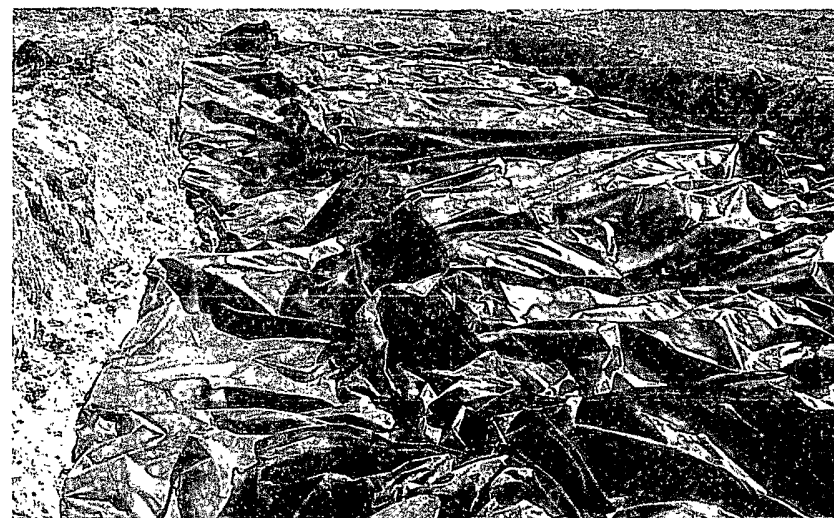
*Photo #14 Capped Deep Bury Entombment Pit*

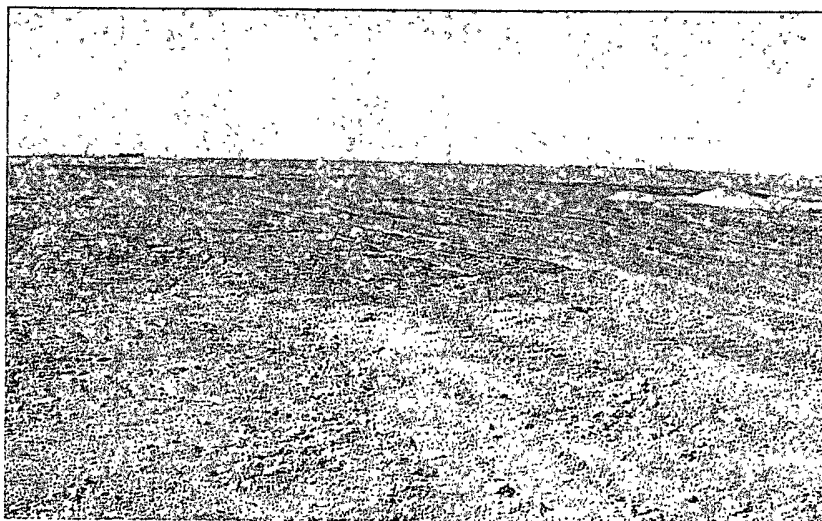
*Photo #15 Dressing Location*

6. *February 21, 2007 – Crew push in material from location to backfill drying pad and deep bury entombment pit. Final contouring and compactions was implemented to return the site back to grade. Contouring was completed with a crown to prevent rainwater ponding. Remanding caliche from pad was hauled back to caliche pit.*

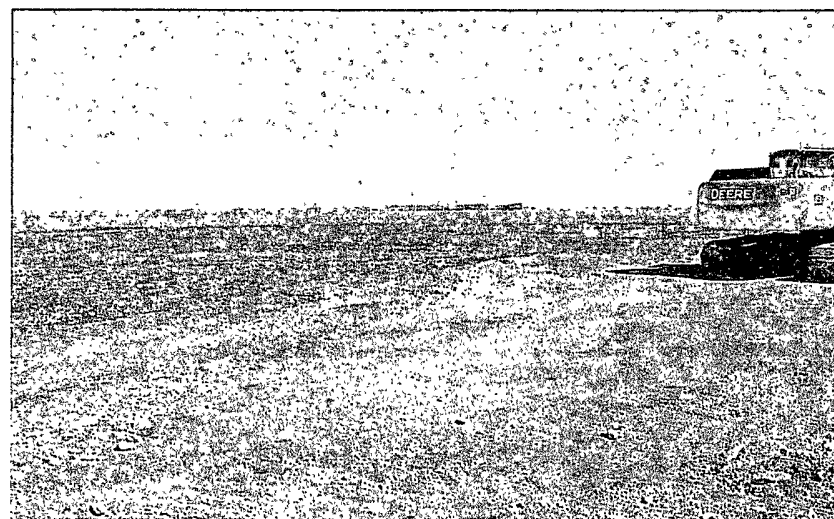
*Photo #16 Dressing Location*

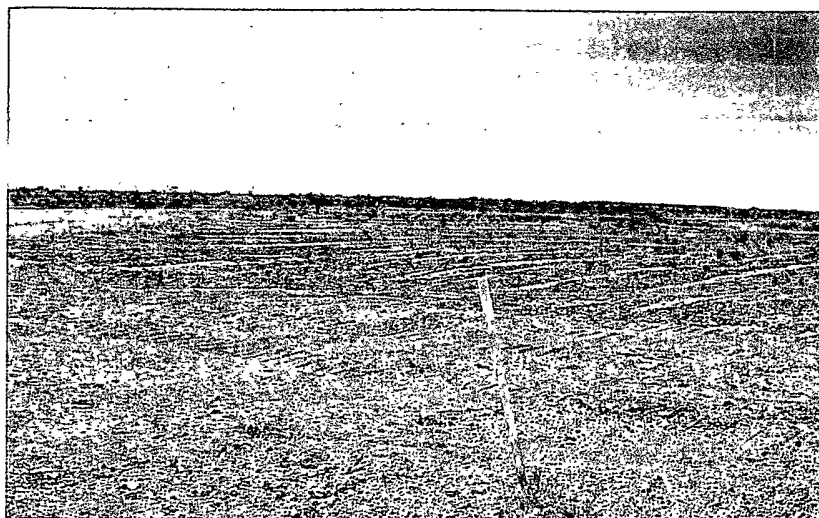
*Photo #17 Dressing Location*

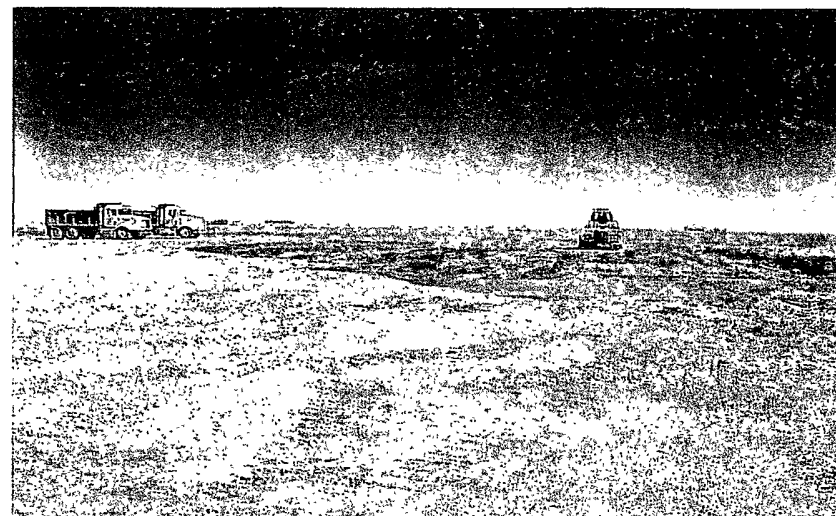
*Photo #18 Dressing Location*

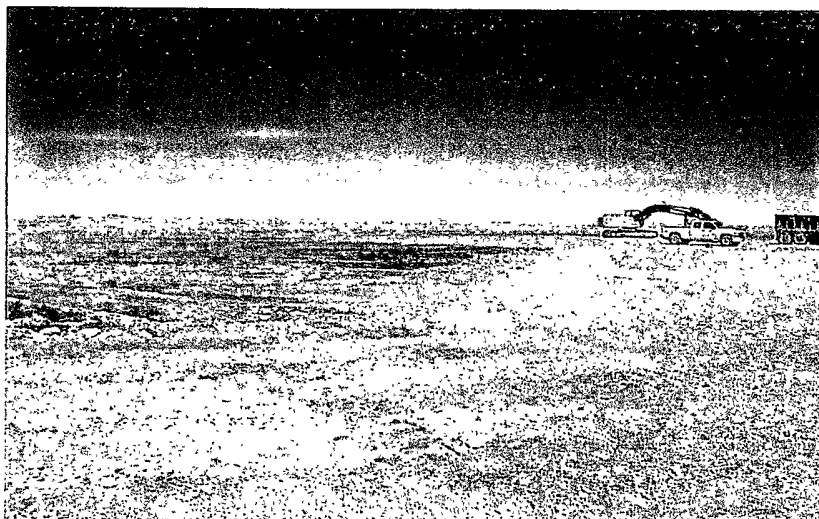
*Photo # 19 Final View of Location*

*The site was backfilled and compacted with clean backfill and contoured with a crown back to grade to prevent ponding on the area. The site was reseeded and should vegetate very well with upcoming rains.*

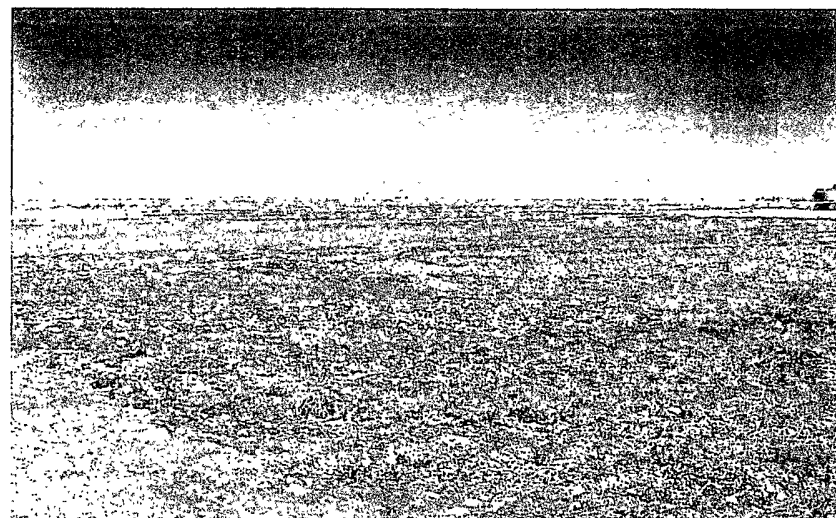
*Photo #20 Final View of Location*
