Final Closure Report

*Antero 12 Fee #3 Drying Pad, API: 30-025-38499
Sec. 12 15S 37E - Lea County, New Mexico*

Re: Cimarex Energy Co.
Antero 12 Fee #3 – Final Drying pad Closure

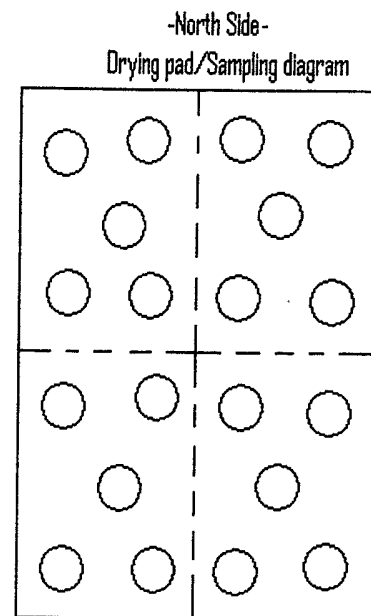
Cimarex Energy Co.
Antero 12 #3
Sampling/Location diagram

The Excavation included the removal of all mud, liner, and 6" of soil under liner.
Field samples were then performed and digging continued where necessary.
The drying pad was divided into four equal quadrants. Five samples were taken in each quad (one in each corner and one in the center) they were then combined into one composite sample for that quad.

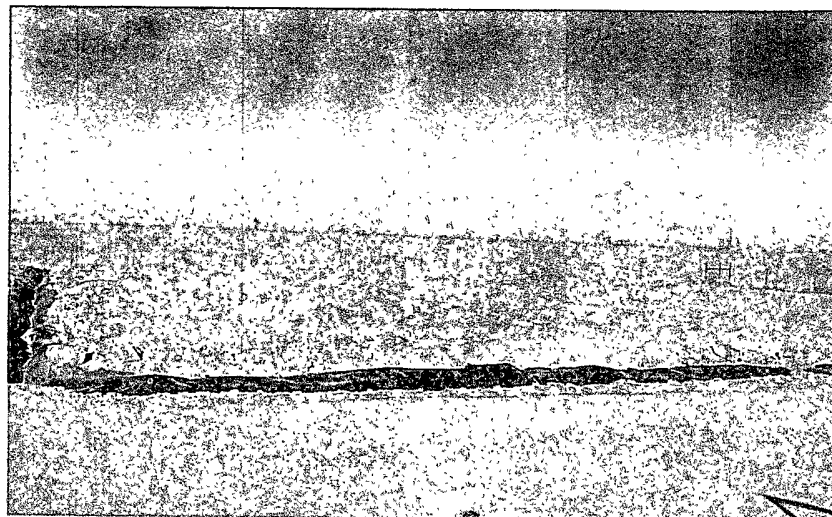
Photo #1 Beginning View of Drying Pad

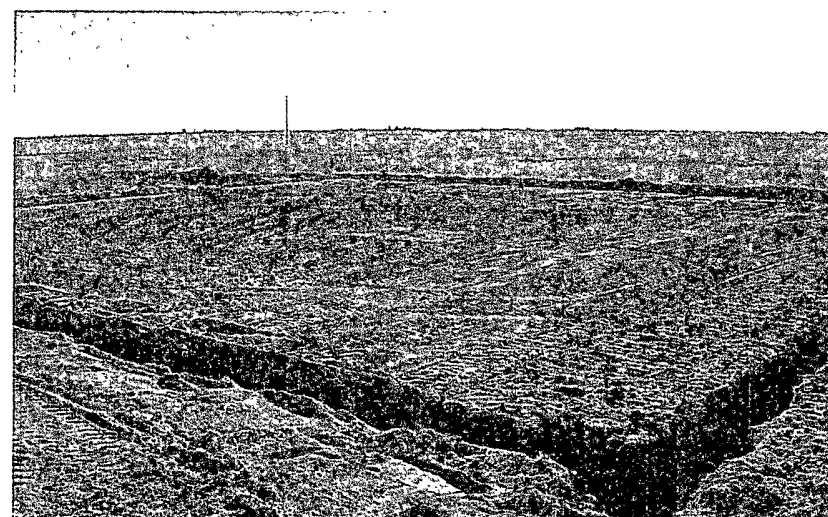
Photo #2 Drying Pad being Cleaned off

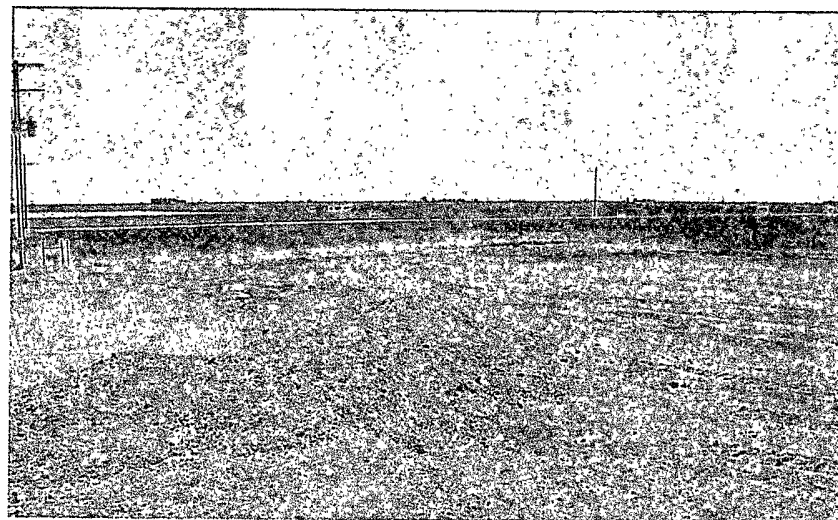
Photo #3 Dressing Location

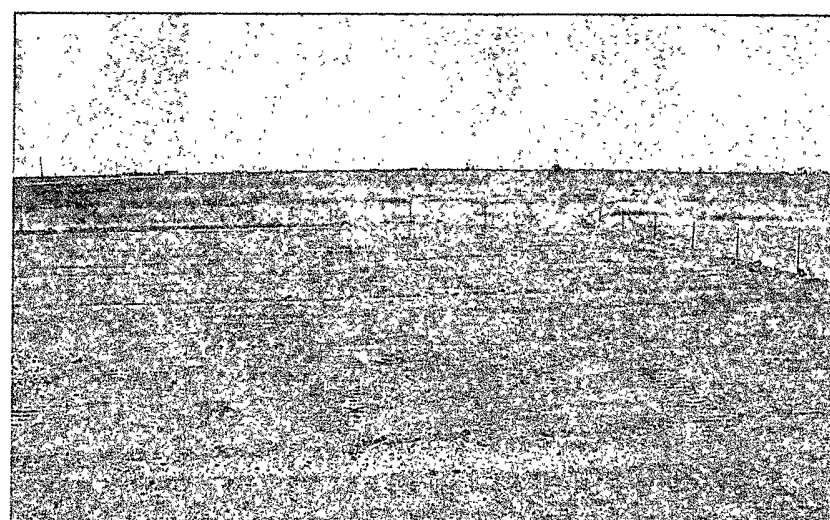
Photo #4 Final View of Location
