**RE: Remediation Proposal**

**Exxon Mobil – J. L. Greenwood #15 Release Area**

**EPI Ref. #190036**

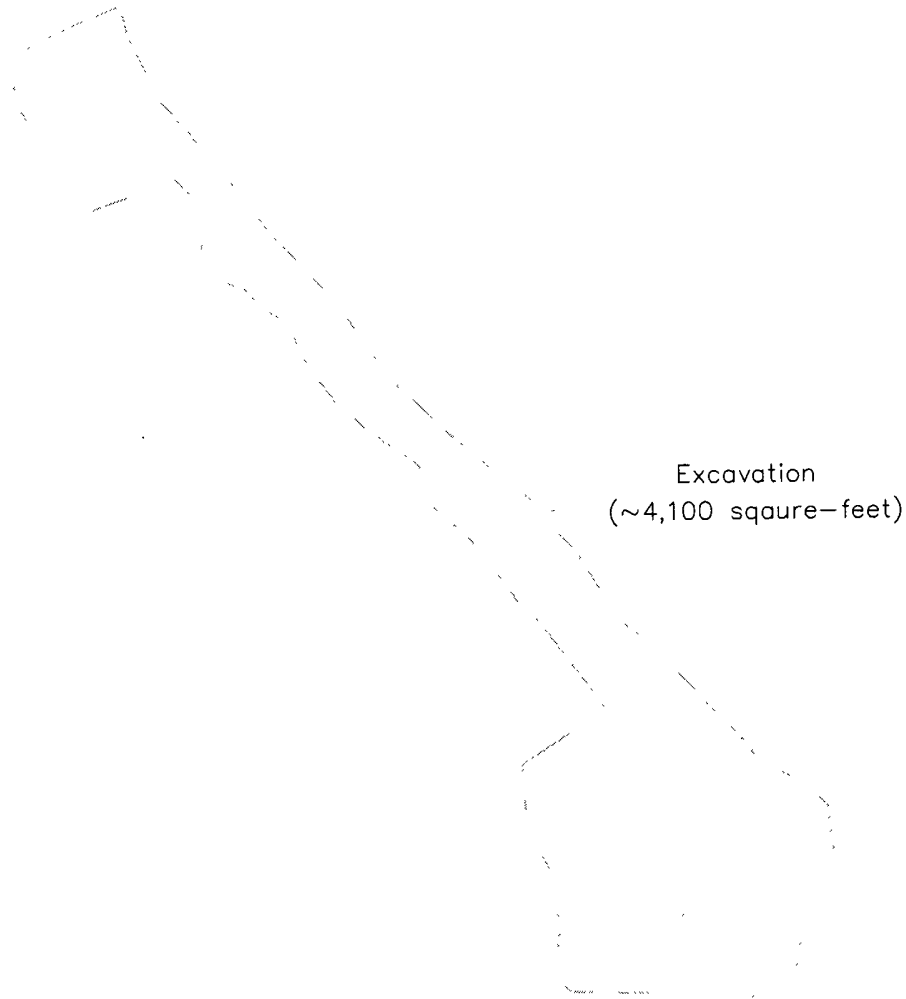
Figure 3  
Site Map  
ExxonMobil  
J.L. Greenwood #15

Legend  
Point of Release

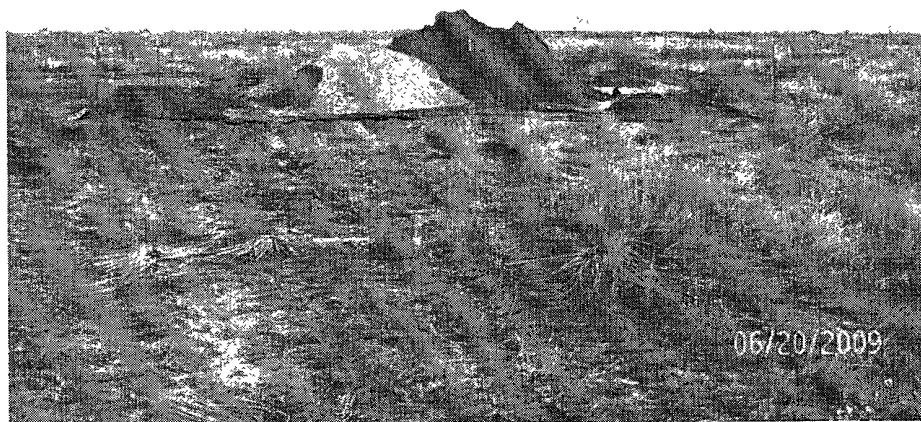
Photograph No. 3 – Impacted material stockpiled on plastic liners

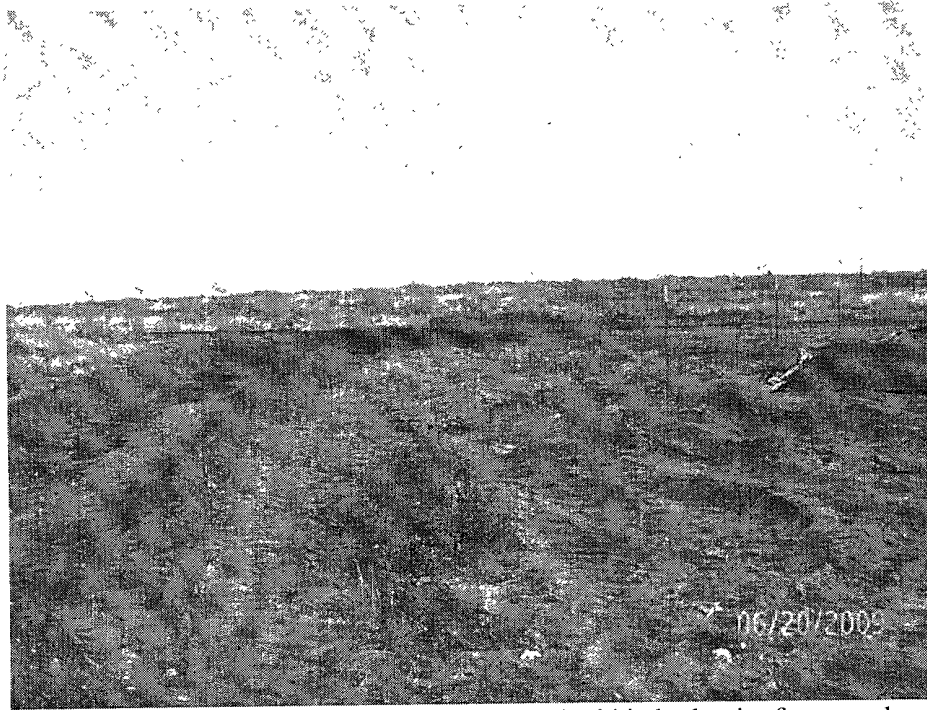
Photograph No. 5 – Stockpiled impacted material within barb wire fence enclosure
