Details of bop test

Az . State #4

Contractor: Moranco Drlg. Rig 3

Test by Yellow Jacket Tools and Services, Inc.

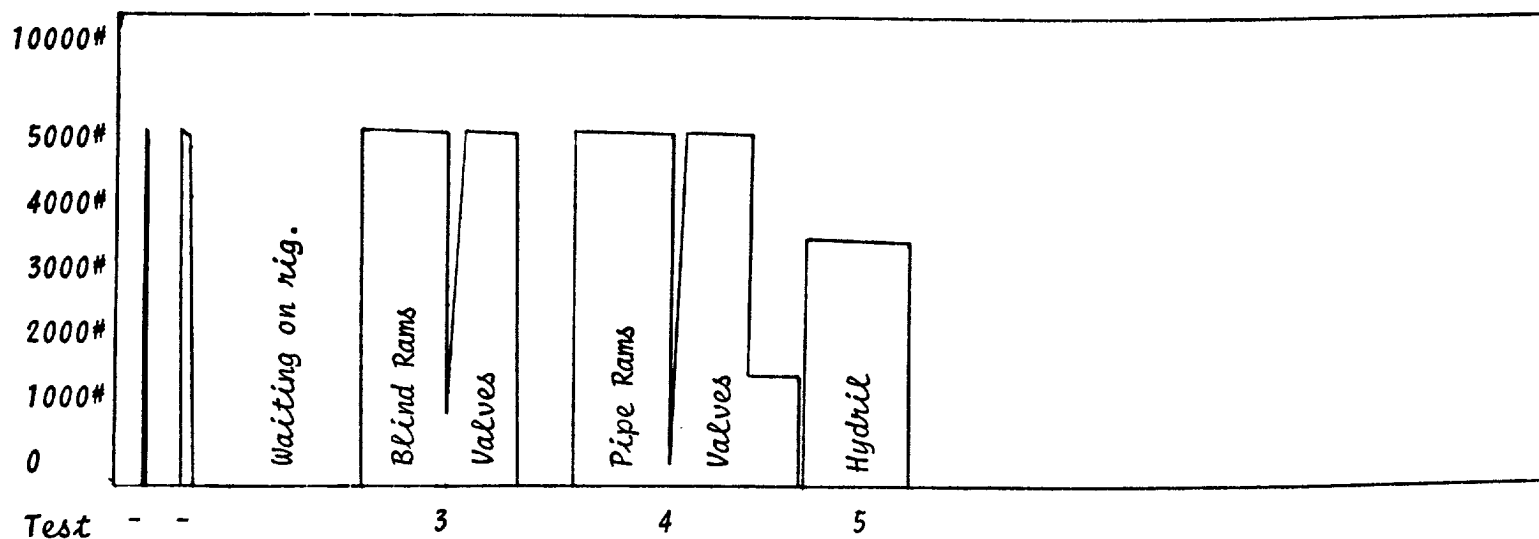
=====Transposition of the pressure recorder chart=====

The above is a transposition of the pressure recorder chart covering test to the blowout control equipment in service on your well drilling in the Maljamar Area, Roswell District, New Mexico. Test was made with test plug landed in casing head with the following test results:  
Arrived location - rig coming out of hole.

TESTING: Blind Rams with inside valve closed next to stack on kill line, outlet valve closed off choke-manifold cross, and inside wing valves closed off manifold cross - pressure applied thru guage connection.

Test #1 Pressured to 5000# with leak to flange between outside valve off stack and chokeline. Tightened.

Test #2 Repeated test. Pressured to 5000# with leak to blind flange of blind rams bop (doghouse side). Tightened.

Test #3 Repeated test. Pressured to 5000# with loss of approximately 100# during first nine minutes then
