July 26, 2019

AVRJU-190729-C-1410

SUBJECT: Remediation Closure Report for the Black Horse 7 Fed Com 1H Fire (1RP-5511), Lea County, New Mexico

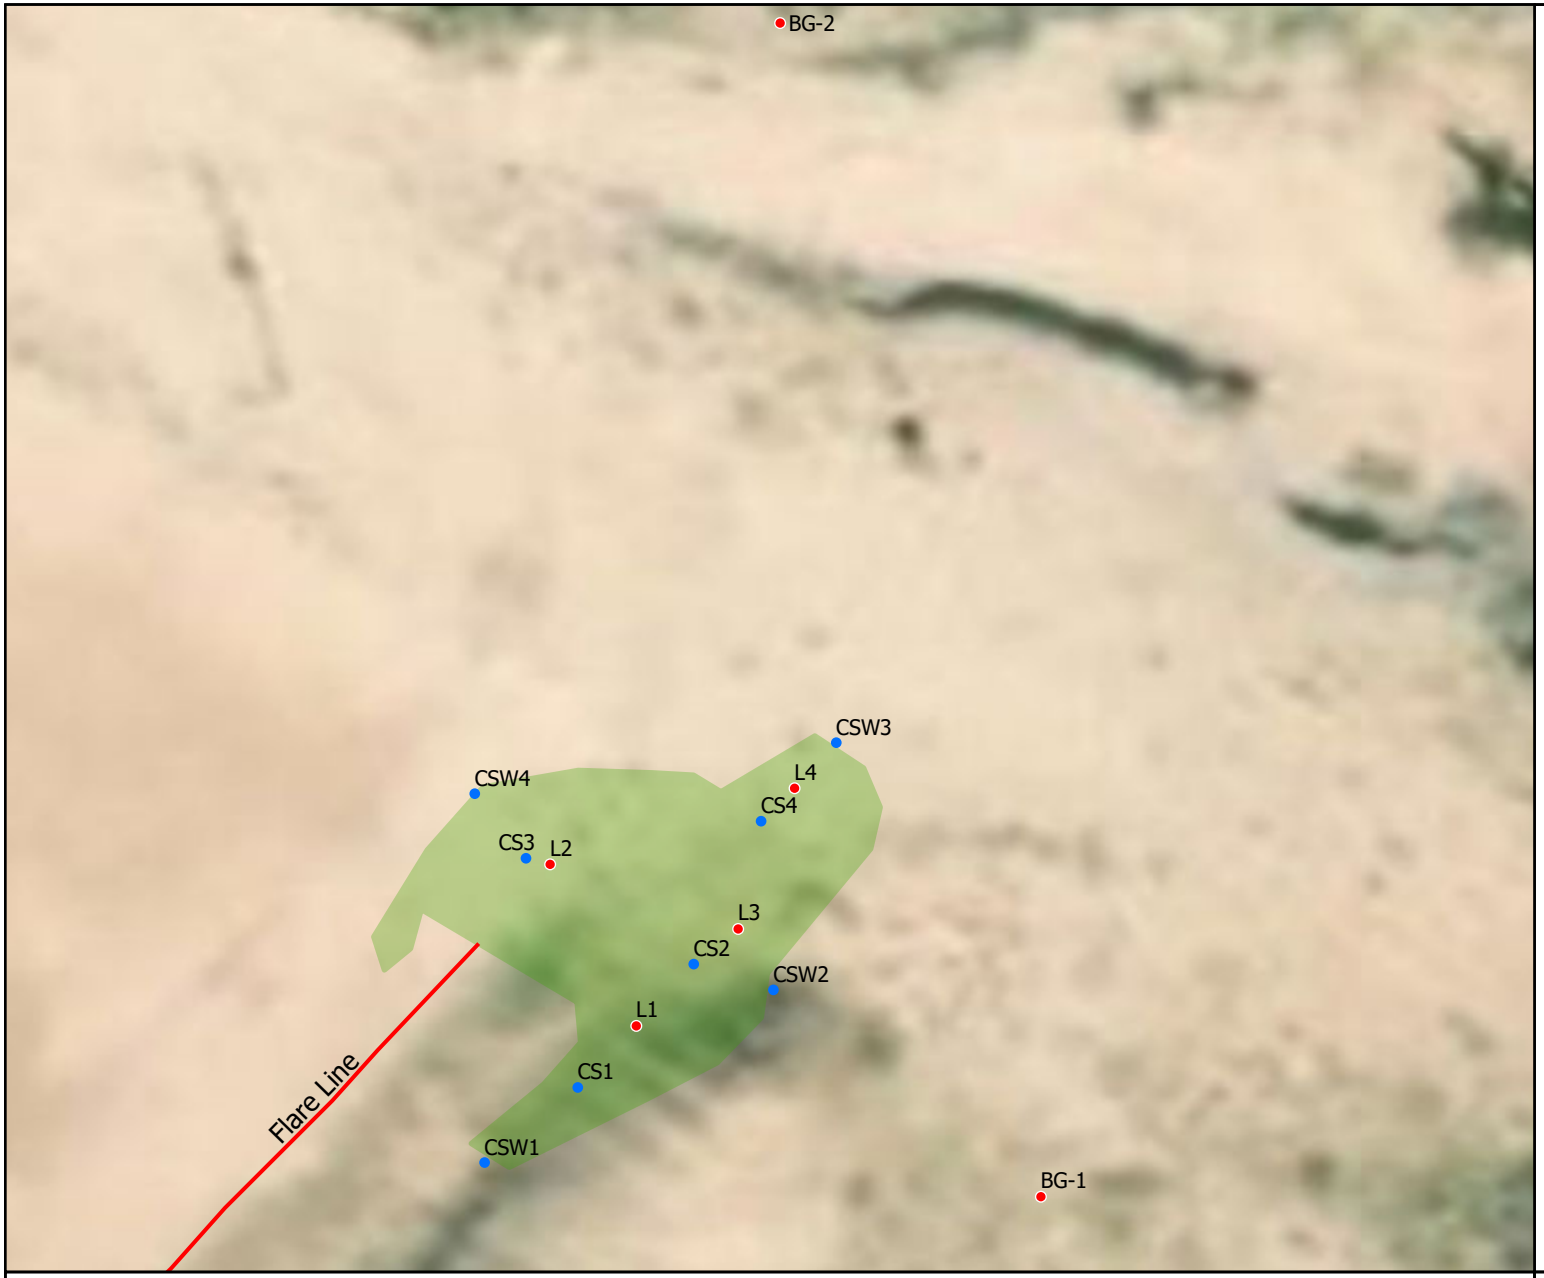
As summarized in Table 3, results indicated that an area approximately 40 feet by 10 feet had been impacted around the flare.

On June 13, 2019, SMA conducted confirmation sampling of the walls and base of the excavation, which measured approximately 400 square feet. The impacted area was excavated to a depth of 0.5 feet bgs.

Figure 3 shows the extent of the excavation and sample locations. All laboratory results are summarized in Table 3. Laboratory reports are included in Appendix D.

Contaminated soils were removed and replaced with clean backfill material to return the surface to previous contours. The contaminated soil was transported and disposed of an NMOCD permitted disposal facility.
