Release Notification

Site Name Com #91 pipeline	Site Type pipeline
Date Release Discovered 4/14/2020	API# *(if applicable)* NA 30-045-29935

Com #91 Spill Closure Report

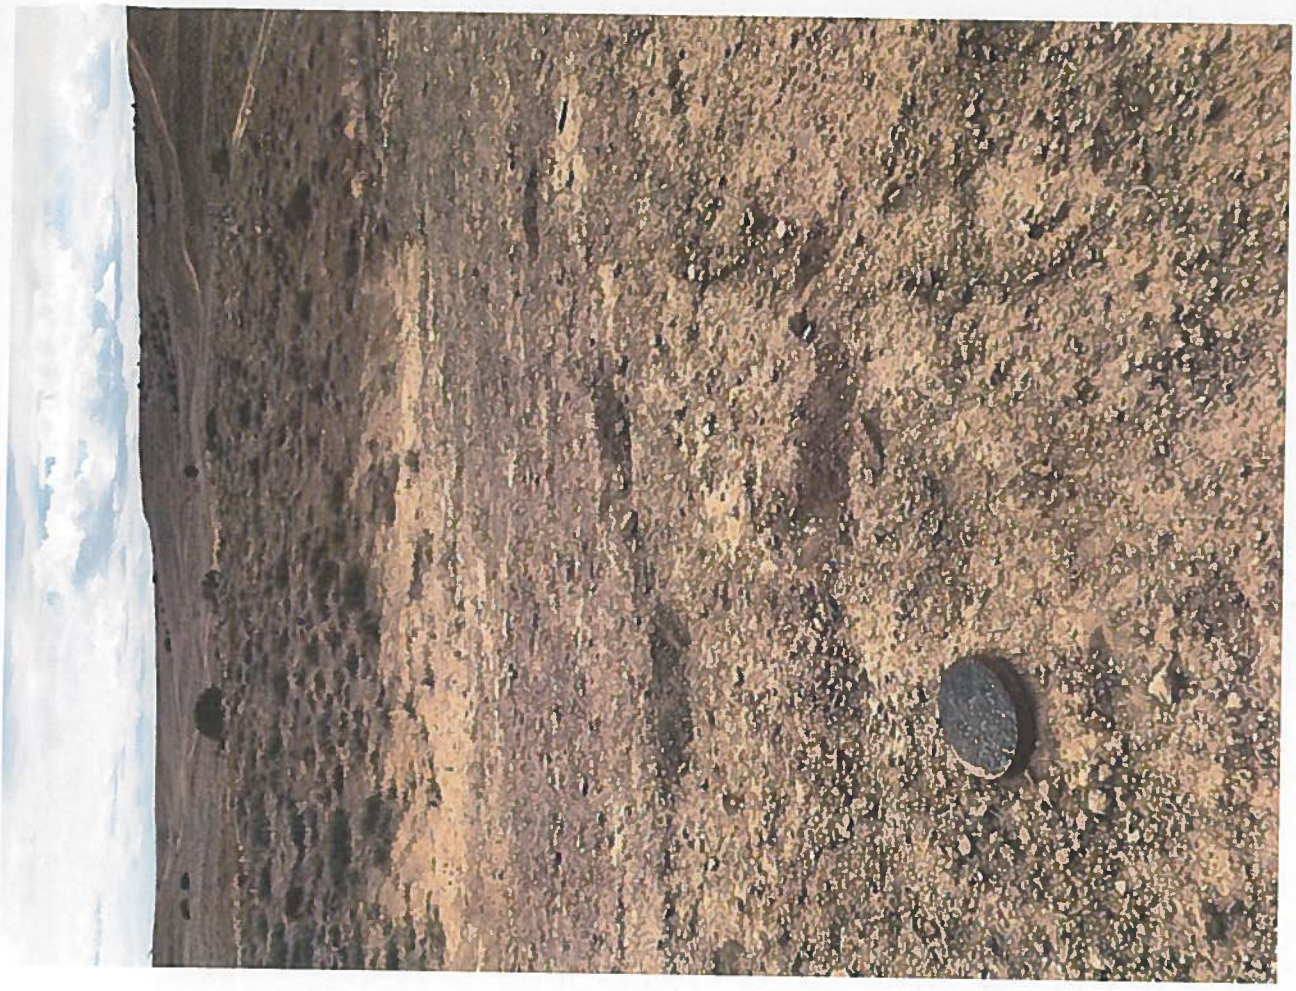
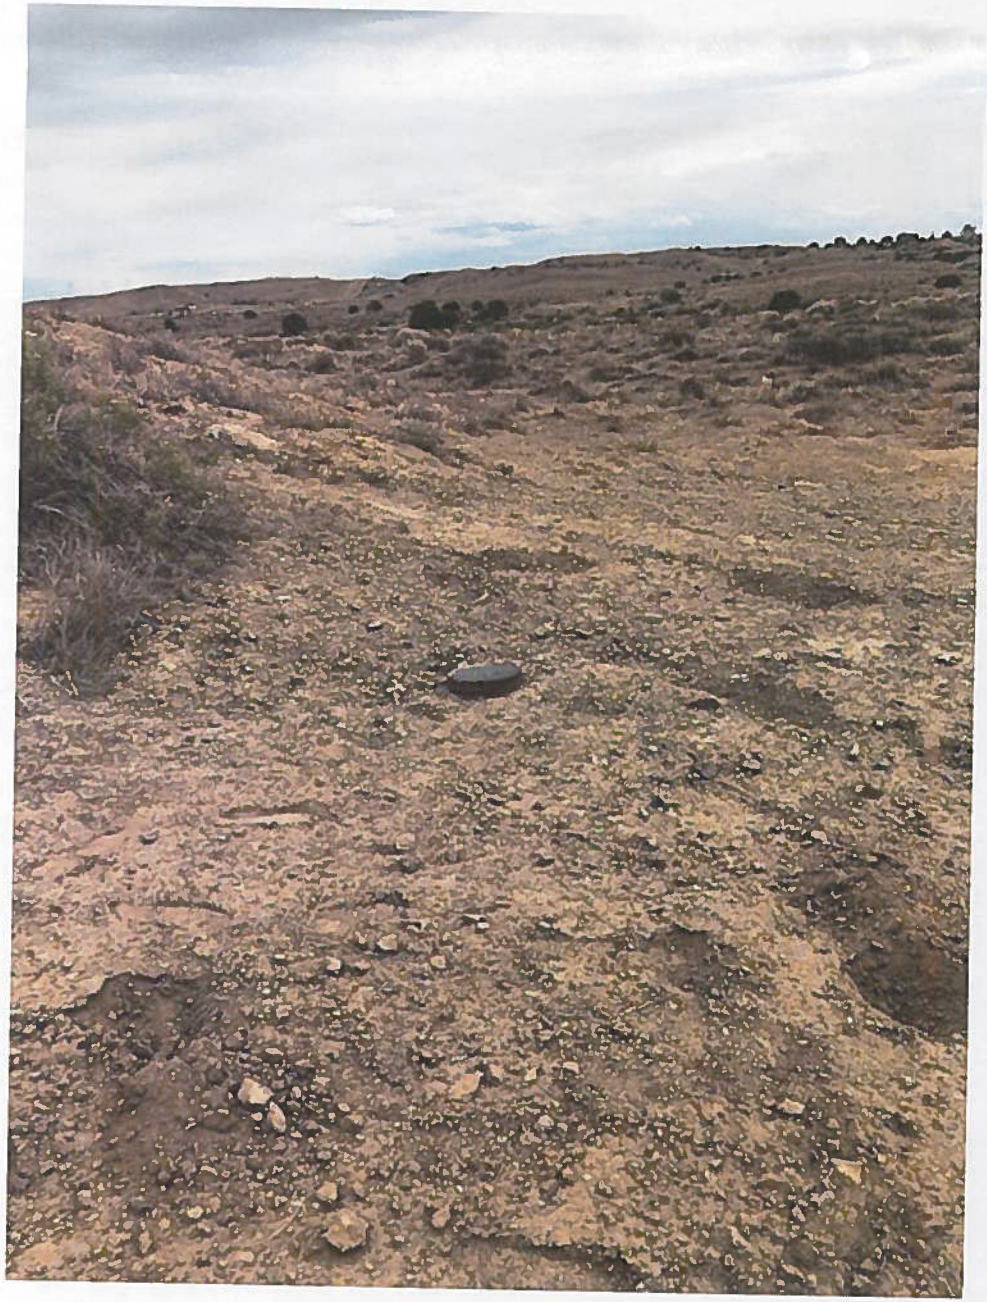
From: Kevin Smaka <kevin.smaka@icloud.com>
Sent: Friday, July 24, 2020 2:48 PM
To: Kevin Smaka
Subject: Com 91

On 4/14/2020 Dugan was notified by OCD inspectors that a potential release was occurring near the Com #91 well site. Dugan investigated the area and found a leaking valve inside a valve can. Dugan took the following actions after determining the cause of the spill:

1. Dugan personnel took the pipeline out of service, replaced the valve and constructed a fence to prevent harm to the public, wildlife and surrounding areas.
2. The affected area measured most nearly to be a rectangle 15' x 40'. 500 lbs of gypsum were applied to the soils and 80 bbls of fresh water were applied to the spill area in an effort to remediate the soils.
3. Dugan sampled the spill area on 4/24/2020. A copy of the notice has been included with this report. Sampling results indicated that all of the contaminated soils had been successfully remediated. None of the samples contained any BTEX or hydrocarbons. All contained traces of chlorides however they were all below 600 mg/kg.

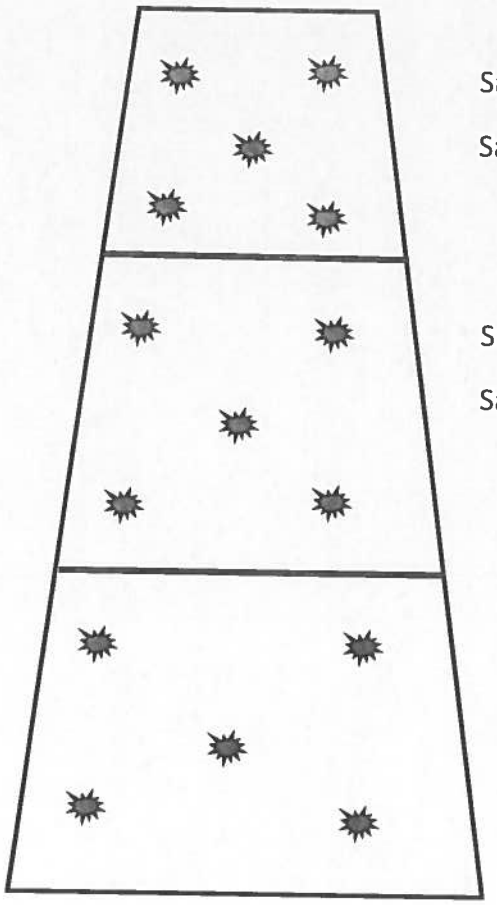
Com #91 Spill Sampling Diagram

Sampling Area #1

Sample ID: Com 91 1

Sampling Area #2

Sample ID: Com 91 2

Sampling Area #3

Sample ID: Com 91 3
