Release Notification and Corrective Action

2014 Site Assessment Report

ConocoPhillips Northeast Haynes No. 1
Rio Arriba County, New Mexico
API# 30-039-05565

February 2015 • 084272-2AS00/01 • Report No. 2

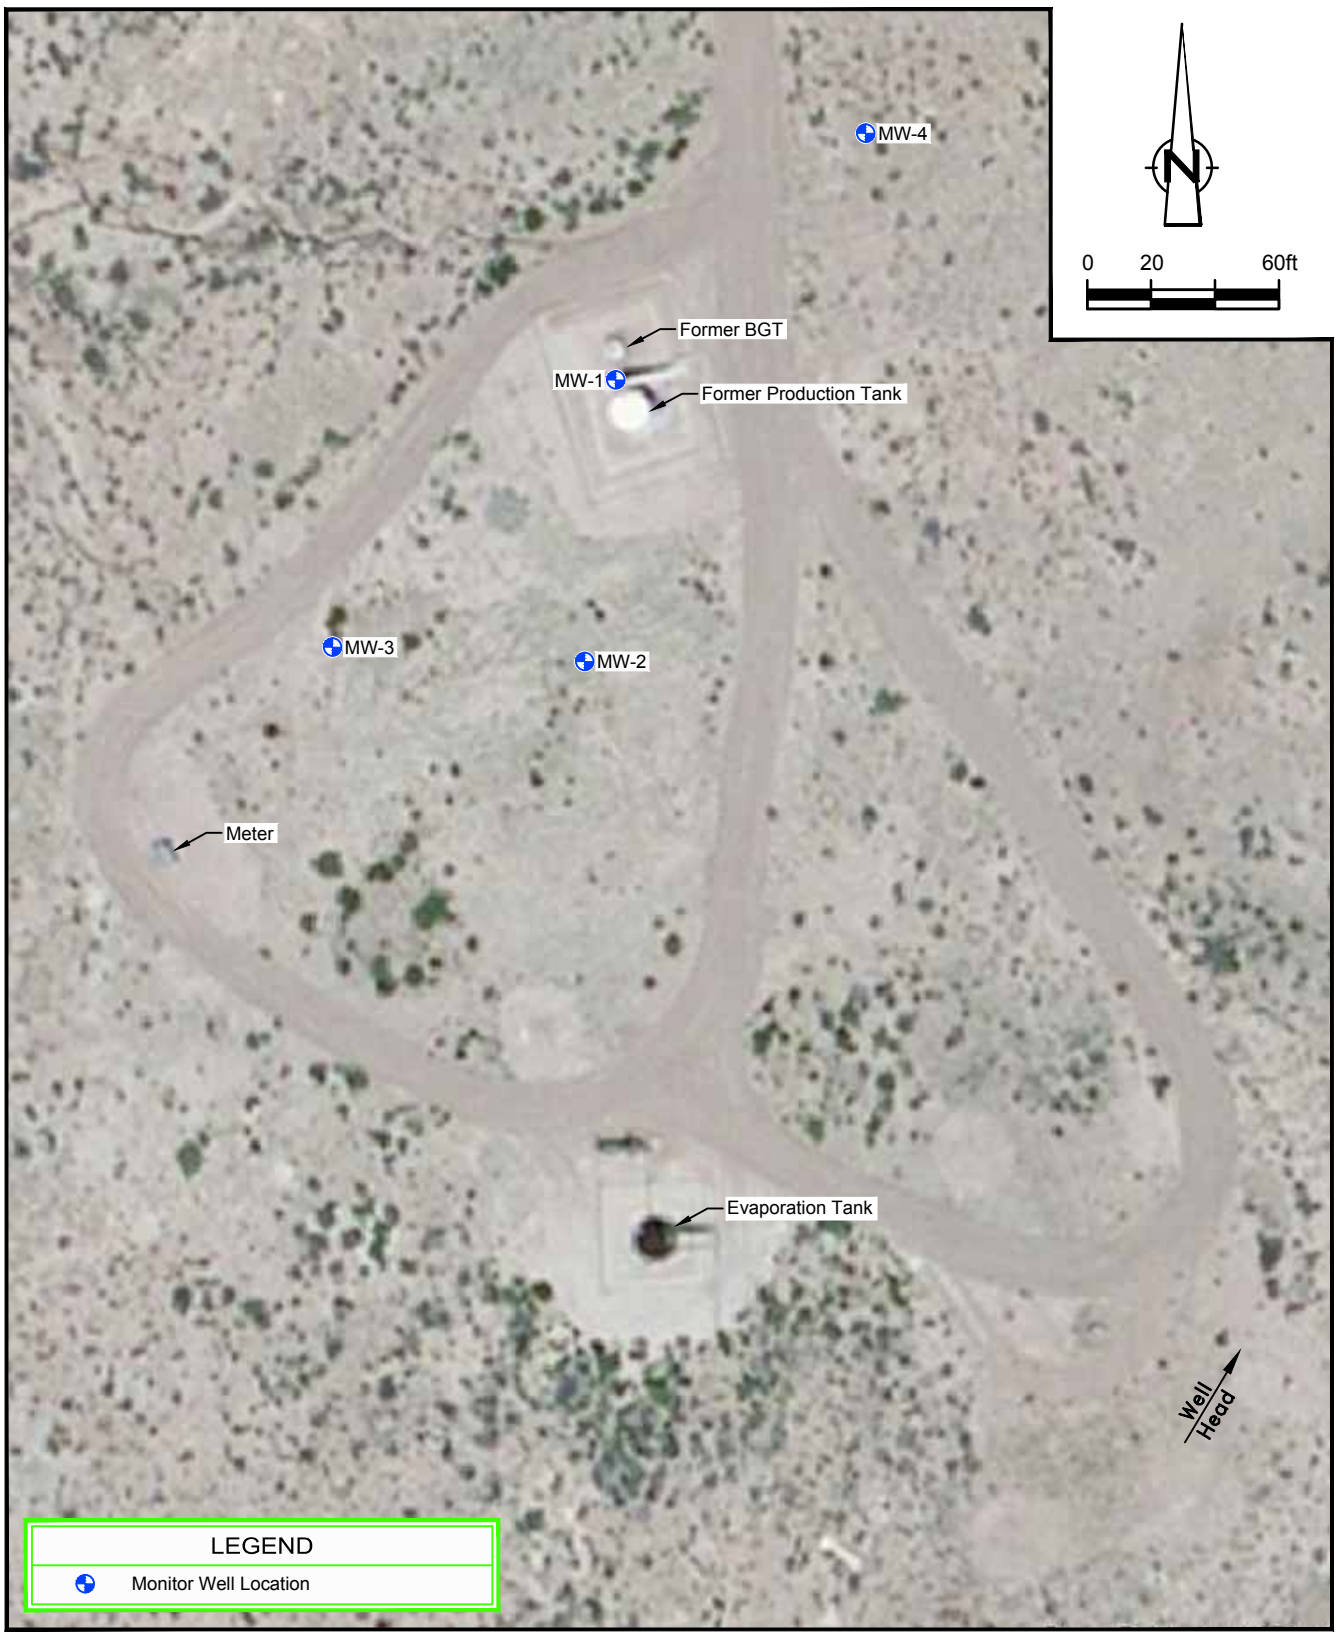
Figure 2

- Obtaining site specific training, permits, and involving appropriate stakeholders needed to complete the scope of work;
- Installing four monitoring wells to assess the extent of hydrocarbons in the groundwater (see **Figure 2**); and
- Conducting an initial groundwater monitoring and sampling event.

Between November 10, 2014 and November 12, 2014, National EWP installed four groundwater monitoring wells, MW-1, MW-2, MW-3, and MW-4, under CRA oversight. All boring locations were marked and cleared for subsurface utilities using the New Mexico One Call system and pre-drilled to a depth of 5 ft bgs by hydroexcavation. Borings were advanced using a CME-85 drill rig using hollow stem augers. Monitoring well MW-1 was installed at the approximate center of the November 2013 excavation, where a confirmation sample during the November 2013 excavation indicated impacted soils. Monitoring wells MW-2 and MW-3 were located in the presumptive down-gradient direction-in the direction of surface water flow in the adjacent ephemeral arroyo, or wash. Monitoring well MW-4 was installed in the presumptive up-gradient direction (please refer to **Figure 2)**. Soil samples were collected in five ft increments using a 2-inch diameter by 24-inch long split spoon sampler. Samples were logged by CRA personnel according to the Unified Soil Classification System. One sample from each boring was submitted for laboratory analysis (see Section 3.1 below). All cuttings generated during monitoring well installation were screened using a calibrated photo-ionization detector for appropriate disposal determination.

MONITOR WELL LOCATIONS
NORTHEAST HAYNES No.1
SECTION 9, T24N, R5W, RIO ARRIBA COUNTY, NEW MEXICO
ConocoPhillips Company

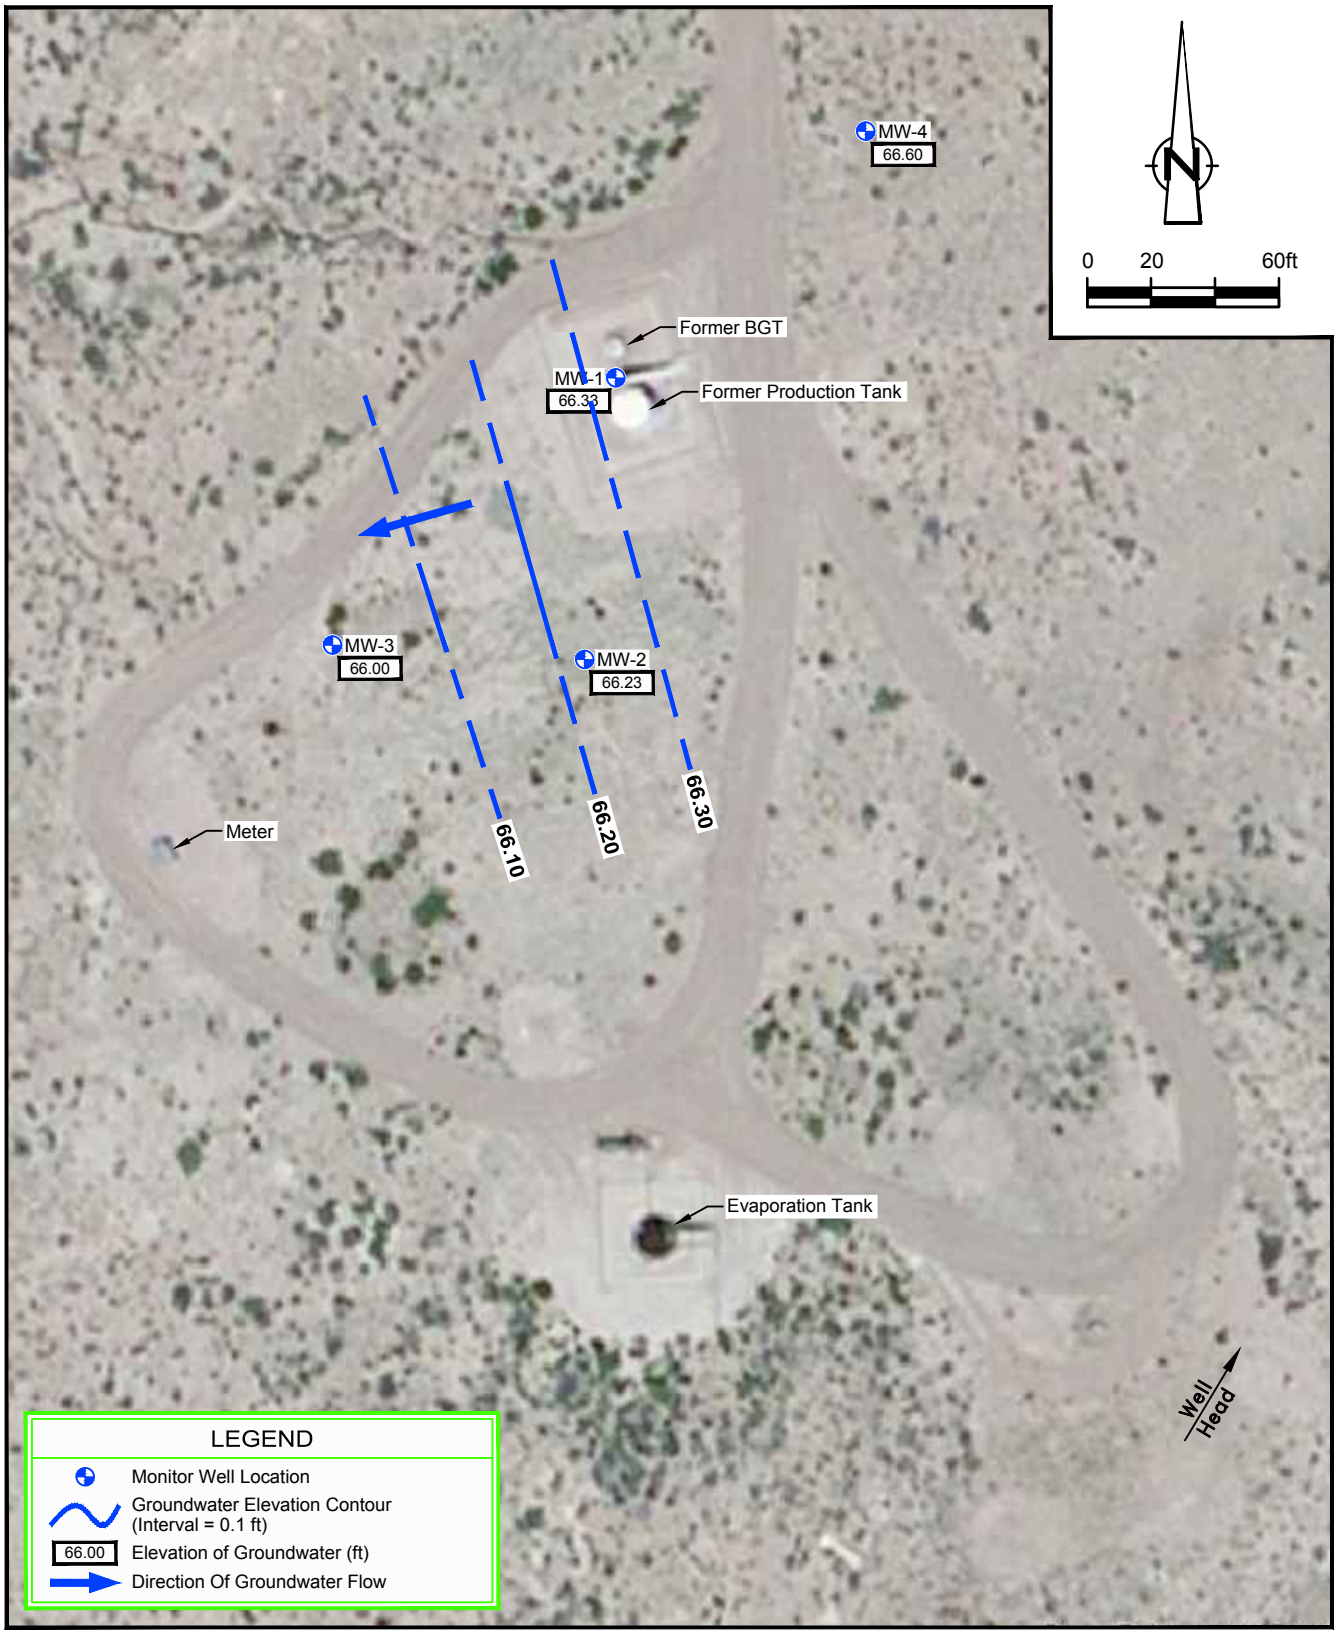
Figure 3

- Data collected during December 2014 indicate that the local groundwater gradient is to the – west southwest. Depth to groundwater was found to be approximately 30 feet bgs in Site monitor wells. The groundwater gradient was approximately 0.007 feet per foot. A groundwater potentiometric surface map reflecting December 2014 groundwater elevations is presented as **Figure 3**.
- BTEX: The NMWQCC domestic water supply groundwater quality standards for benzene, toluene, ethylbenzene, and xylenes are 0.01 mg/L, 0.75 mg/L, 0.75 mg/L, and 0.62 mg/L, respectively. In December 2014, all Site groundwater monitoring wells returned analytical results that were below laboratory detection limits for all BTEX constituents.

GROUNDWATER CONTOUR MAP - DECEMBER 2014
NORTHEAST HAYNES No.1
SECTION 9, T24N, R5W, RIO ARRIBA COUNTY, NEW MEXICO
ConocoPhillips Company

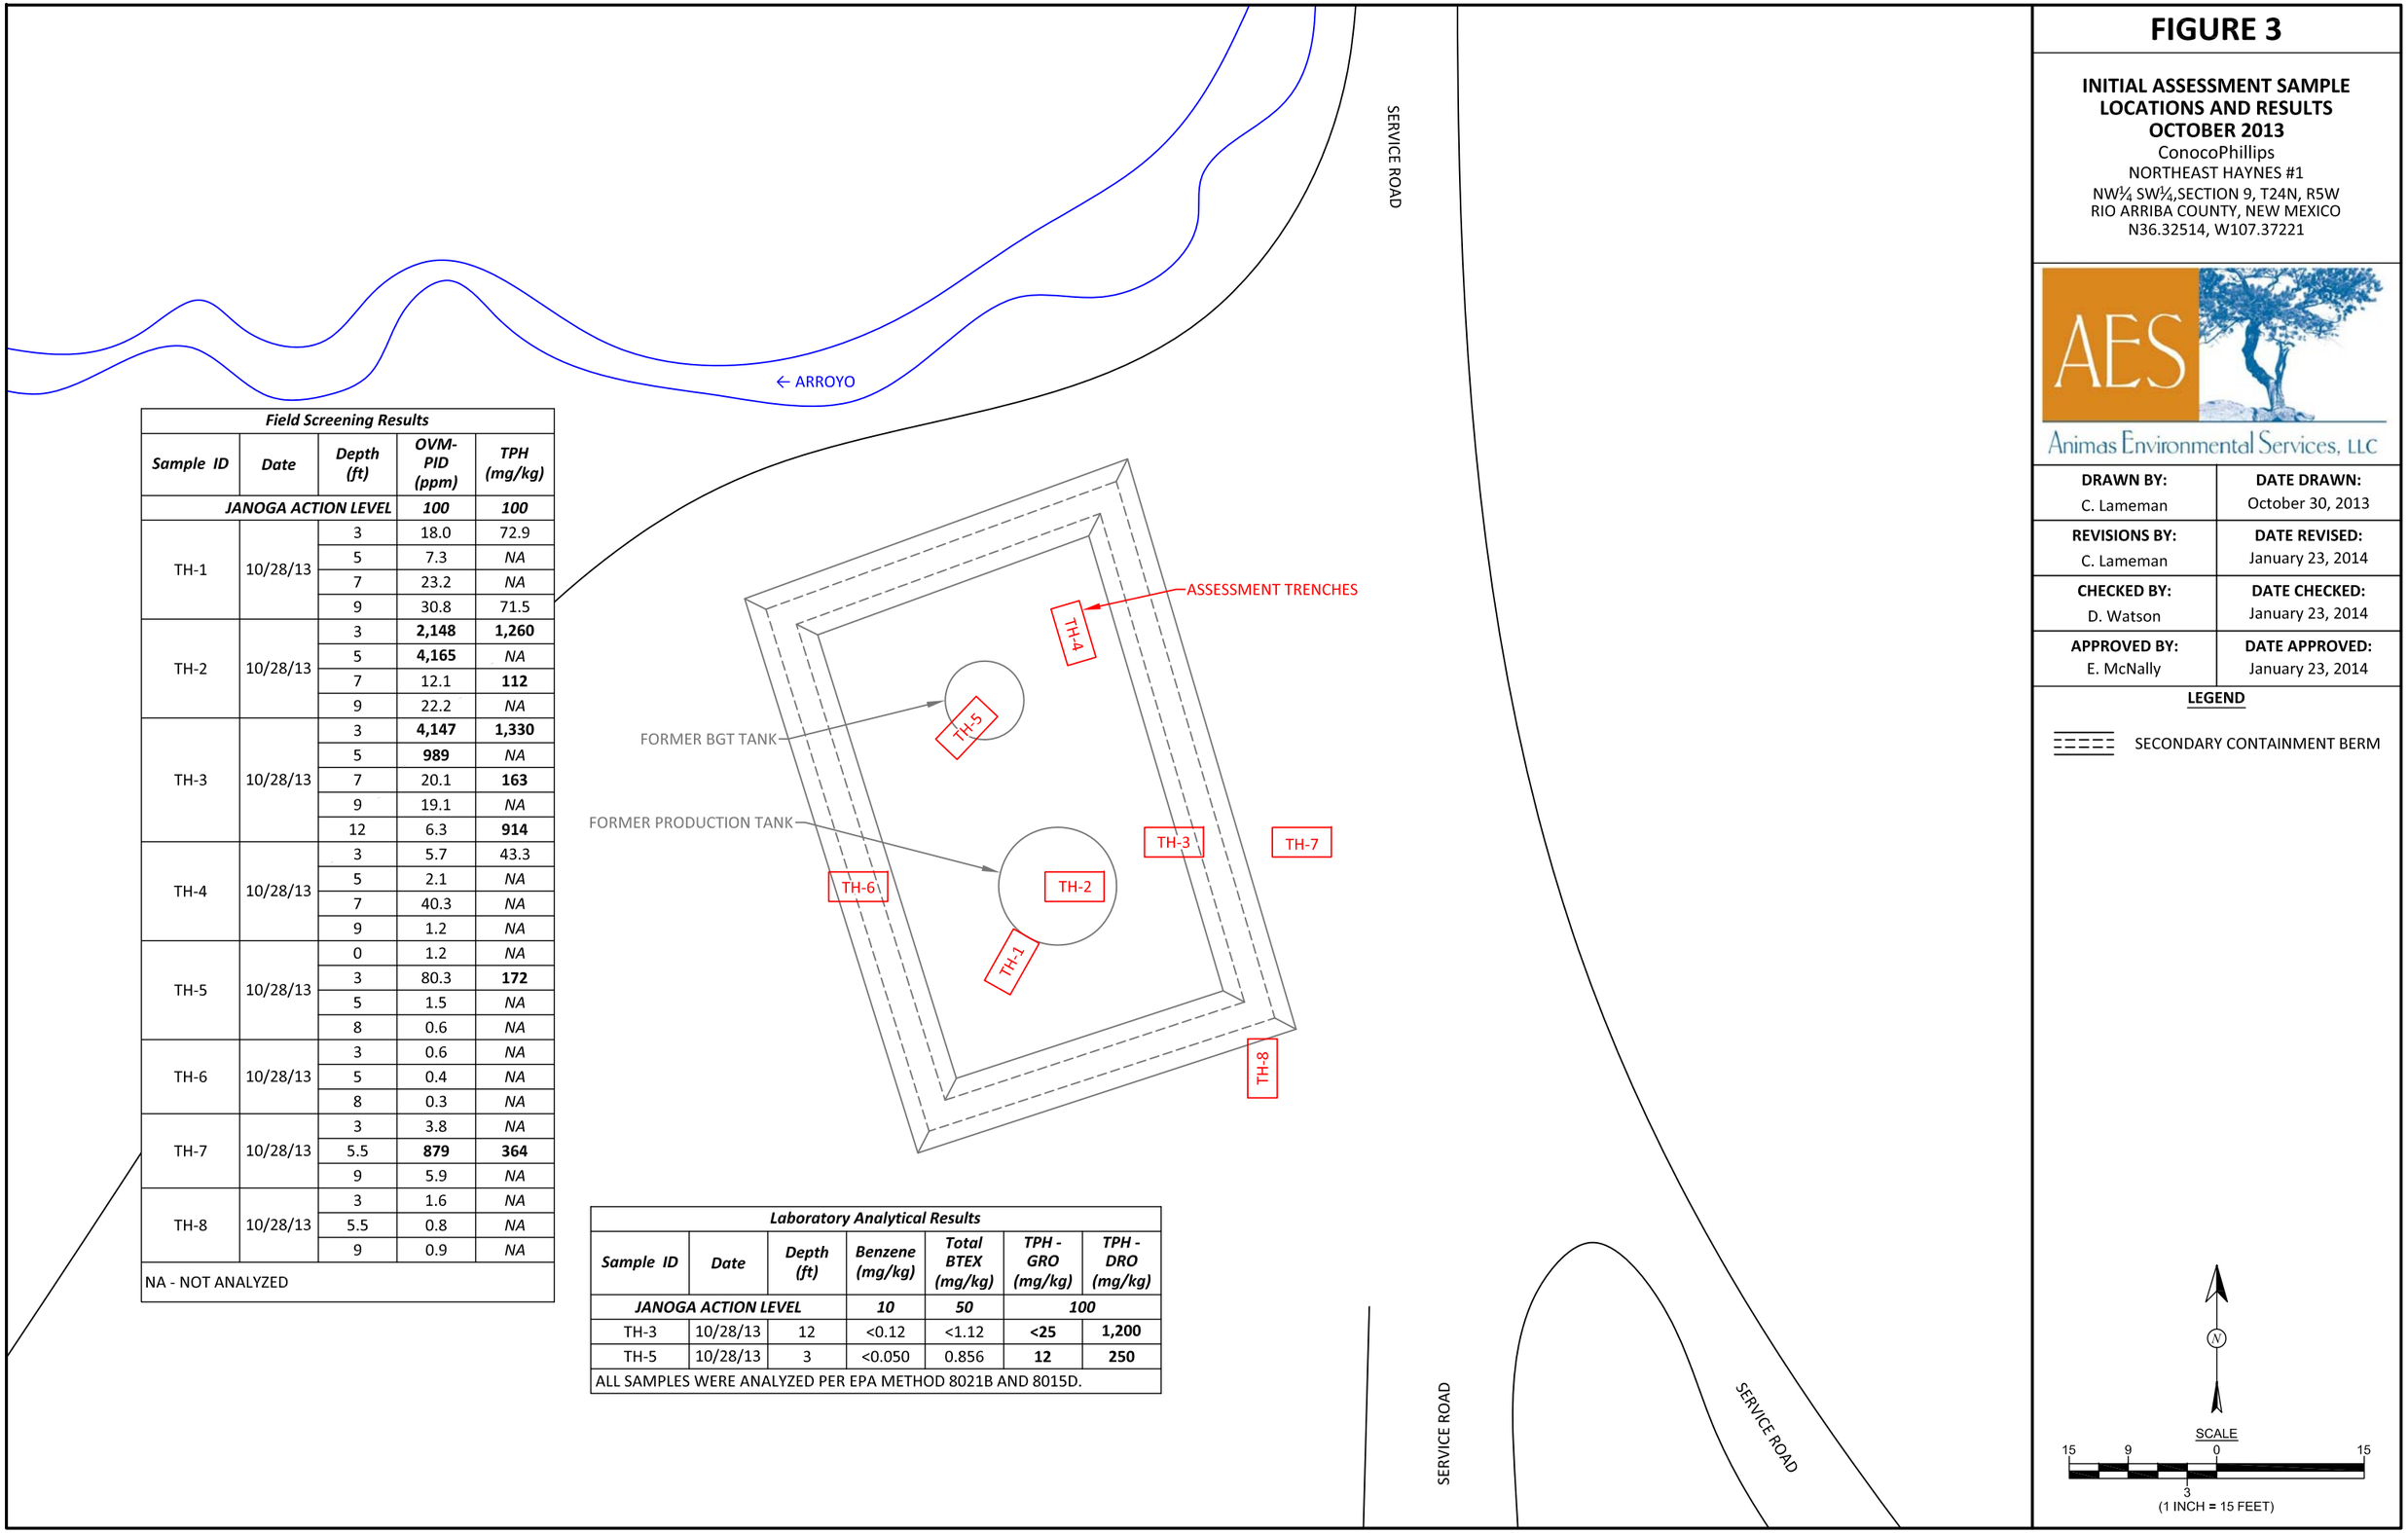
AES was initially contacted by Lisa Hunter of CoP on October 28, 2013, and on the same day, Kelsey Christiansen and Corwin Lameman of AES completed the release assessment field work. The assessment included collection and field screening of 30 soil samples from 8 assessment trenches (TH-1 to TH-8) in and around the release area. Based on the field screening results, AES recommended excavation of the release area. Sample locations are shown on Figure 3.

Field Screening Results				
Sample ID	***Date***	***Depth (ft)***	***OVM-PID (ppm)***	***TPH (mg/kg)***
JANOGA ACTION LEVEL			***100***	***100***
TH-1	10/28/13	3	18.0	72.9
		5	7.3	*NA*
		7	23.2	*NA*
		9	30.8	71.5
TH-2	10/28/13	3	**2,148**	**1,260**
		5	**4,165**	*NA*
		7	12.1	**112**
		9	22.2	*NA*
TH-3	10/28/13	3	**4,147**	**1,330**
		5	**989**	*NA*
		7	20.1	**163**
		9	19.1	*NA*
		12	6.3	**914**
TH-4	10/28/13	3	5.7	43.3
		5	2.1	*NA*
		7	40.3	*NA*
		9	1.2	*NA*
TH-5	10/28/13	0	1.2	*NA*
		3	80.3	**172**
		5	1.5	*NA*
		8	0.6	*NA*
TH-6	10/28/13	3	0.6	*NA*
		5	0.4	*NA*
		8	0.3	*NA*
TH-7	10/28/13	3	3.8	*NA*
		5.5	**879**	**364**
		9	5.9	*NA*
TH-8	10/28/13	3	1.6	*NA*
		5.5	0.8	*NA*
		9	0.9	*NA*

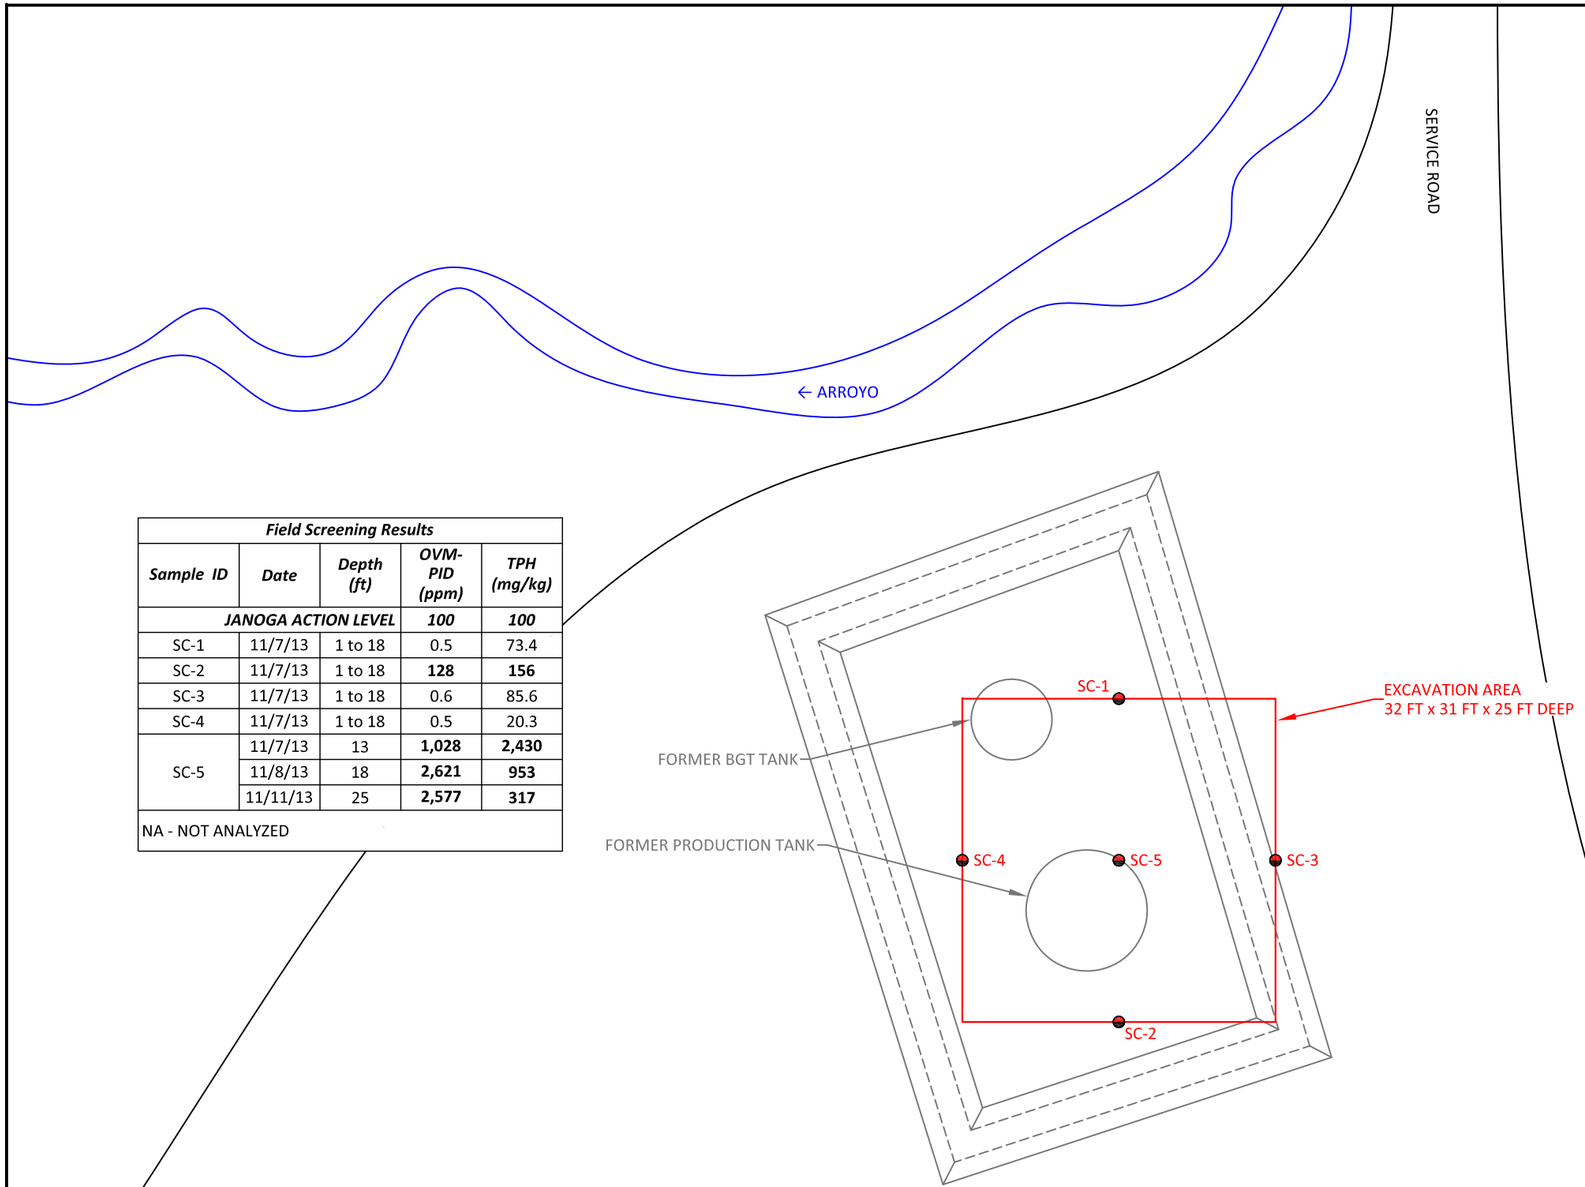
Hydrocarbon impacted soils above the JANOGA/NMOCD RRALs were noted in a composite sample collected November 7, 2013 (sample SC-5, Figure 4-AES summary report, **Appendix A**) at the base of the approximately 918 cubic foot excavation. Soils from this excavation were transported to a regional land farming facility by the SJBU for remediation and the excavation was backfilled with clean soils.

Field Screening Results				
Sample ID	***Date***	***Depth (ft)***	***OVM-PID (ppm)***	***TPH (mg/kg)***
JANOGA ACTION LEVEL			***100***	***100***
SC-1	11/7/13	1 to 18	0.5	73.4
SC-2	11/7/13	1 to 18	**128**	**156**
SC-3	11/7/13	1 to 18	0.6	85.6
SC-4	11/7/13	1 to 18	0.5	20.3
SC-5	11/7/13	13	**1,028**	**2,430**
	11/8/13	18	**2,621**	**953**
	11/11/13	25	**2,577**	**317**
NA - NOT ANALYZED

Laboratory Analytical Results						
Sample ID	***Date***	***Depth (ft)***	***Benzene (mg/kg)***	***Total BTEX (mg/kg)***	***TPH - GRO (mg/kg)***	***TPH - DRO (mg/kg)***
JANOGA ACTION LEVEL			***10***	***50***	***100***	
SC-1	11/7/13	1 to 18	<0.050	<0.25	<5.0	<10
SC-2	11/7/13	1 to 18	<0.050	<0.25	<5.0	19
SC-3	11/7/13	1 to 18	<0.050	<0.25	<5.0	<10
SC-4	11/7/13	1 to 18	<0.050	<0.25	<5.0	<10
SC-5	11/11/13	25	<0.12	17	**490**	**880**
ALL SAMPLES WERE ANALYZED PER EPA METHOD 8021B AND 8015D.

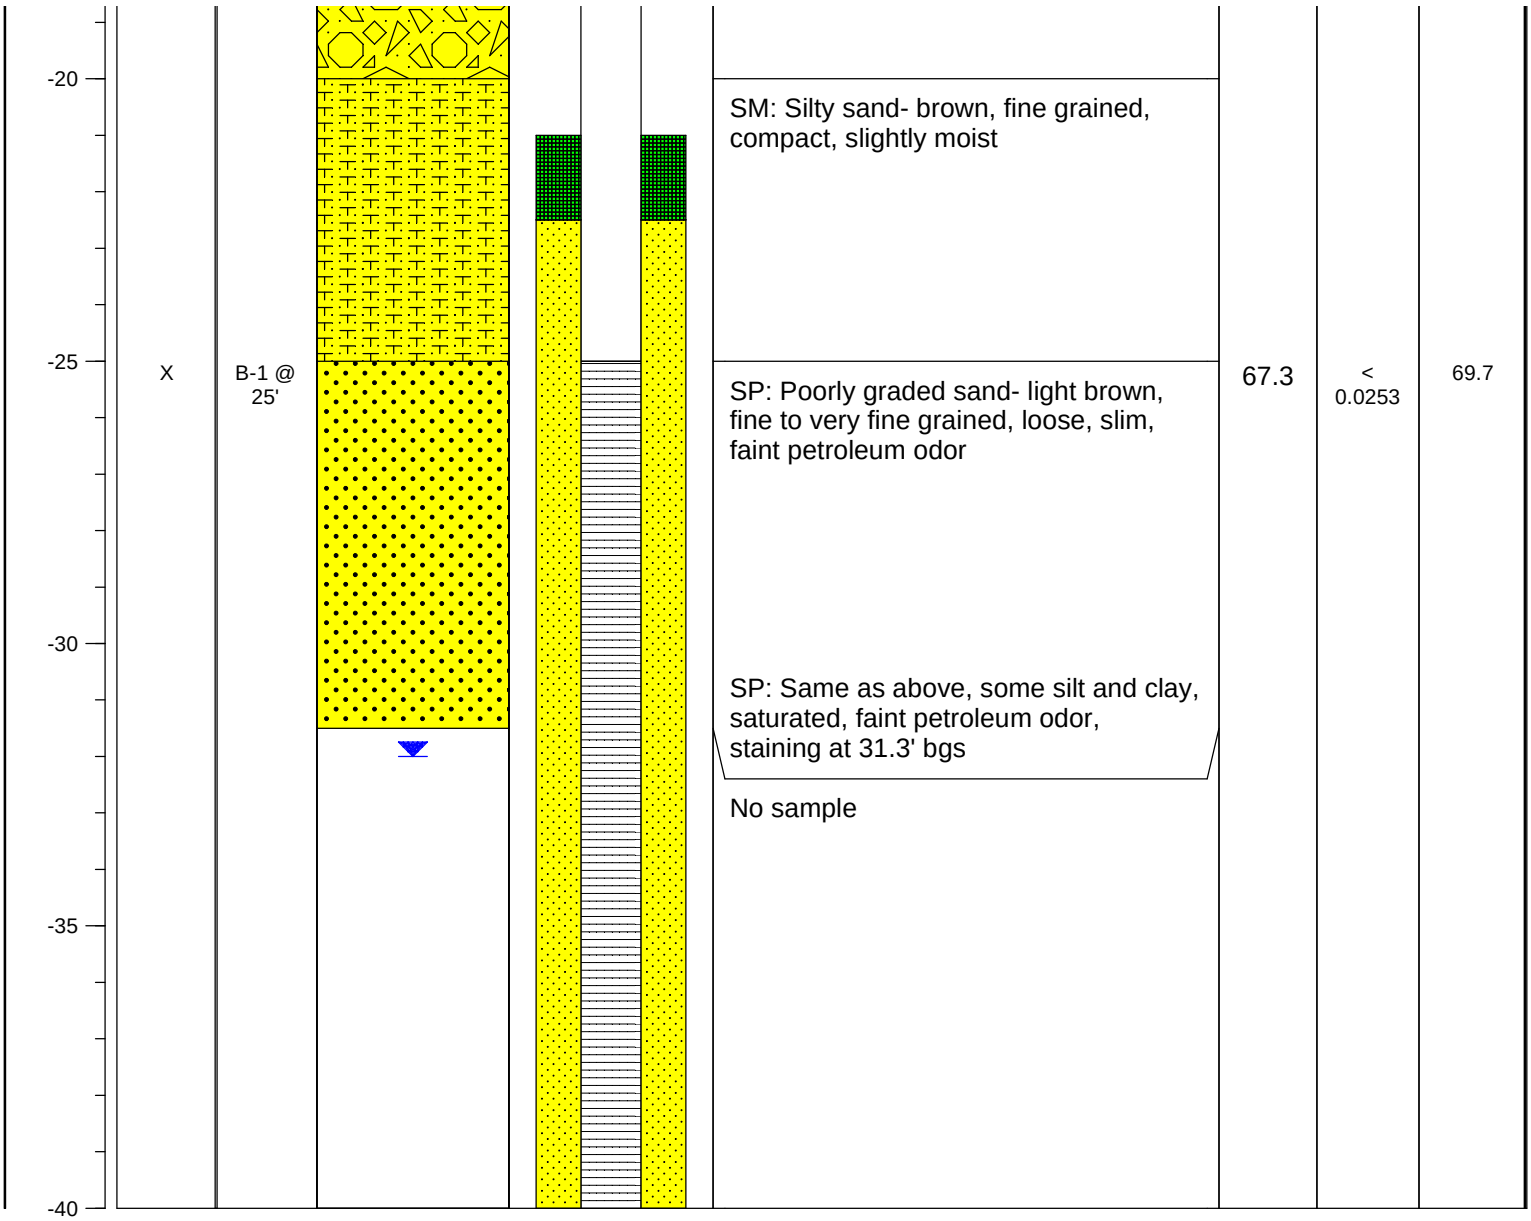
SOIL BORING NO: MW-1
DRILL TYPE: CME-85
Hollow Stem Auger
BORE HOLE DIAMETER: 7 7/8"
DRILLED BY: National EWP
DATE/TIME HOLE STARTED: 11/10/2014
DATE/TIME HOLE COMPLETED: 11/10/2014

DEPTH (bgs) - ft	SAMPLE TO LAB	SAMPLE ID	STRATAGRAPHIC SEQUENCE	COMPLETION INFORMATION	CLASSIFICATION AND DESCRIPTION	PID (ppm)	Total BTEX (mg/kg)	Total TPH (mg/kg)
-20					SM: Silty sand- brown, fine grained, compact, slightly moist			
-25	X	B-1 @ 25'			SP: Poorly graded sand- light brown, fine to very fine grained, loose, slim, faint petroleum odor	67.3	< 0.0253	69.7
-30					SP: Same as above, some silt and clay, saturated, faint petroleum odor, staining at 31.3' bgs			
-35					No sample			
-40

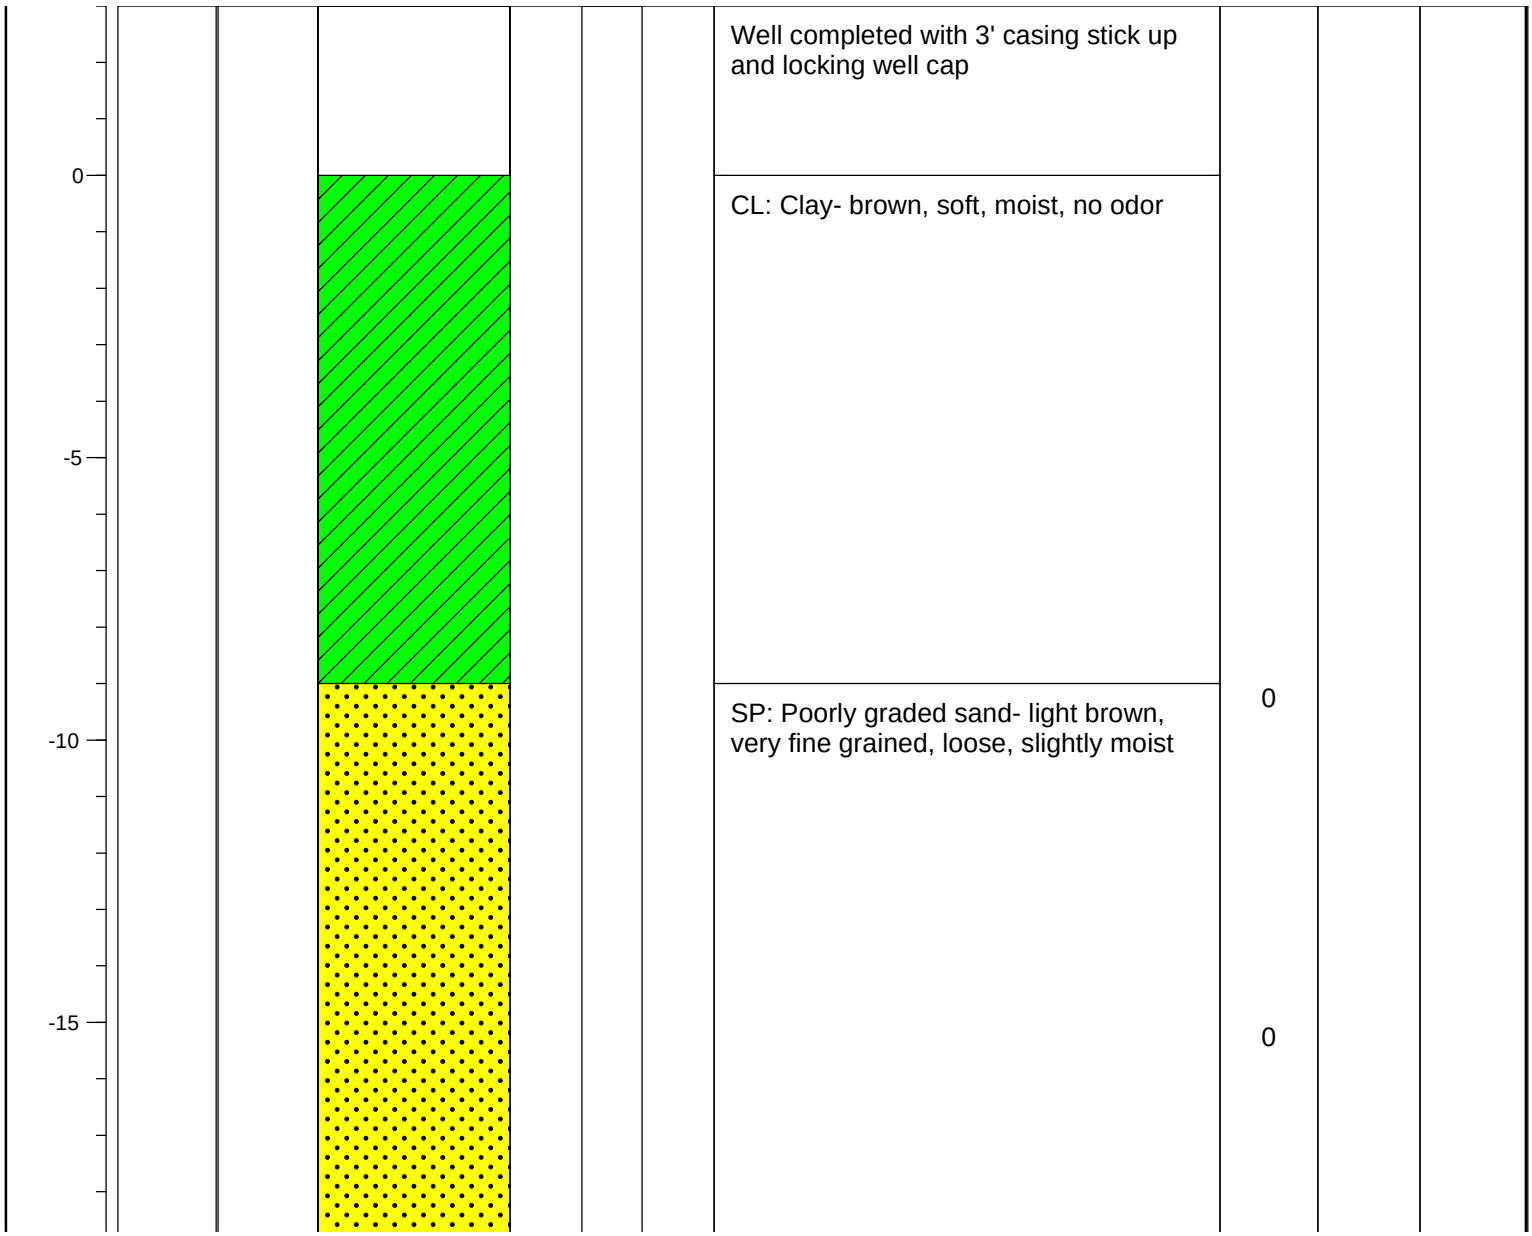
SOIL BORING NO: MW-2
DRILL TYPE: CME-85
Hollow Stem Auger
BORE HOLE DIAMETER: 7 7/8"
DRILLED BY: National EWP
DATE/TIME HOLE STARTED: 11/10/2014
DATE/TIME HOLE COMPLETED: 11/10/2014

DEPTH (bgs) - ft	SAMPLE TO LAB	SAMPLE ID	STRATAGRAPHIC SEQUENCE	COMPLETION INFORMATION	CLASSIFICATION AND DESCRIPTION	PID (ppm)	Total BTEX (mg/kg)	Total TPH (mg/kg)
0					Well completed with 3' casing stick up and locking well cap			
					CL: Clay- brown, soft, moist, no odor			
-5								
-10					SP: Poorly graded sand- light brown, very fine grained, loose, slightly moist	0		
-15						0

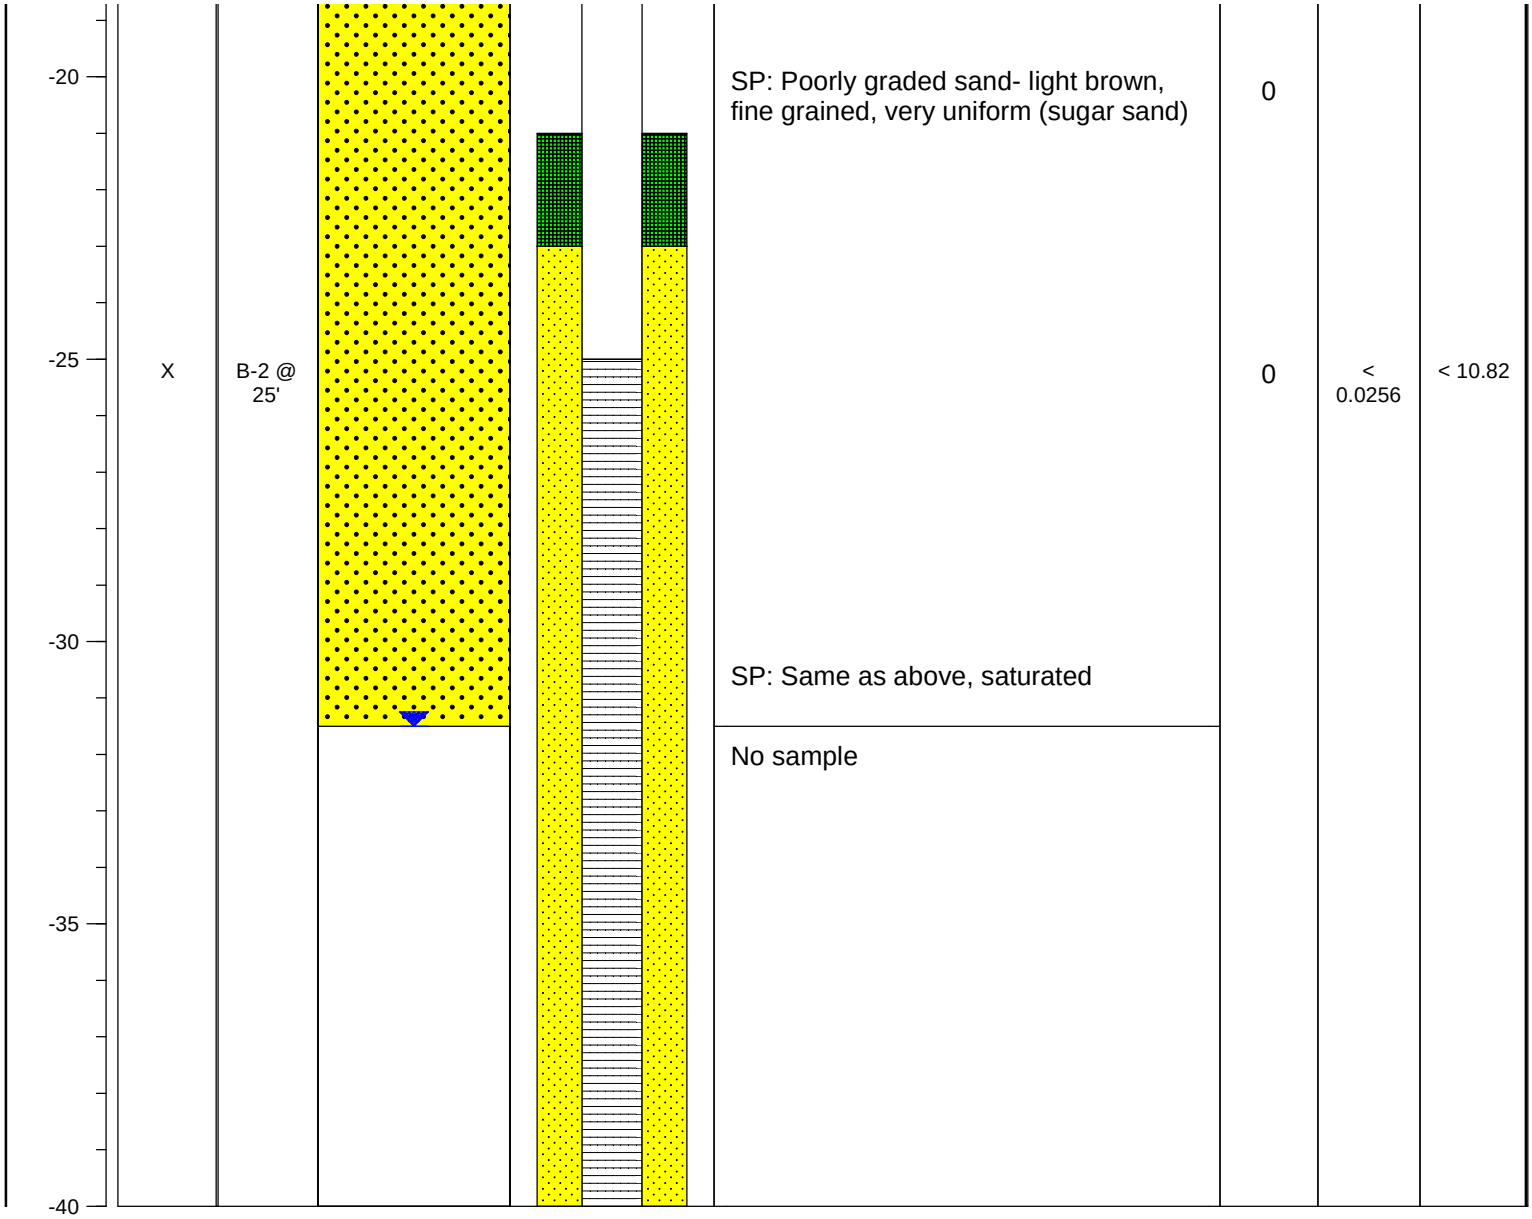
DEPTH (bgs) - ft	SAMPLE TO LAB	SAMPLE ID	STRATAGRAPHIC SEQUENCE	COMPLETION INFORMATION	CLASSIFICATION AND DESCRIPTION	PID (ppm)	Total BTEX (mg/kg)	Total TPH (mg/kg)
-20					SP: Poorly graded sand- light brown, fine grained, very uniform (sugar sand)	0		
-25	X	B-2 @ 25'				0	< 0.0256	< 10.82
-30					SP: Same as above, saturated			
-35					No sample			
-40

PROJECT NAME: Northeast Haynes No. 1
LOCATION: Rio Arriba County, New Mexico
FIELD LOGGED BY: Jeff Walker
SURFACE ELEVATION (msl): No Survey Data Available
GROUNDWATER ELEVATION (msl): 30' bgs
REMARKS: Located in presumptive down-gradient direction
COORDINATES: 36.325722, -107.373027

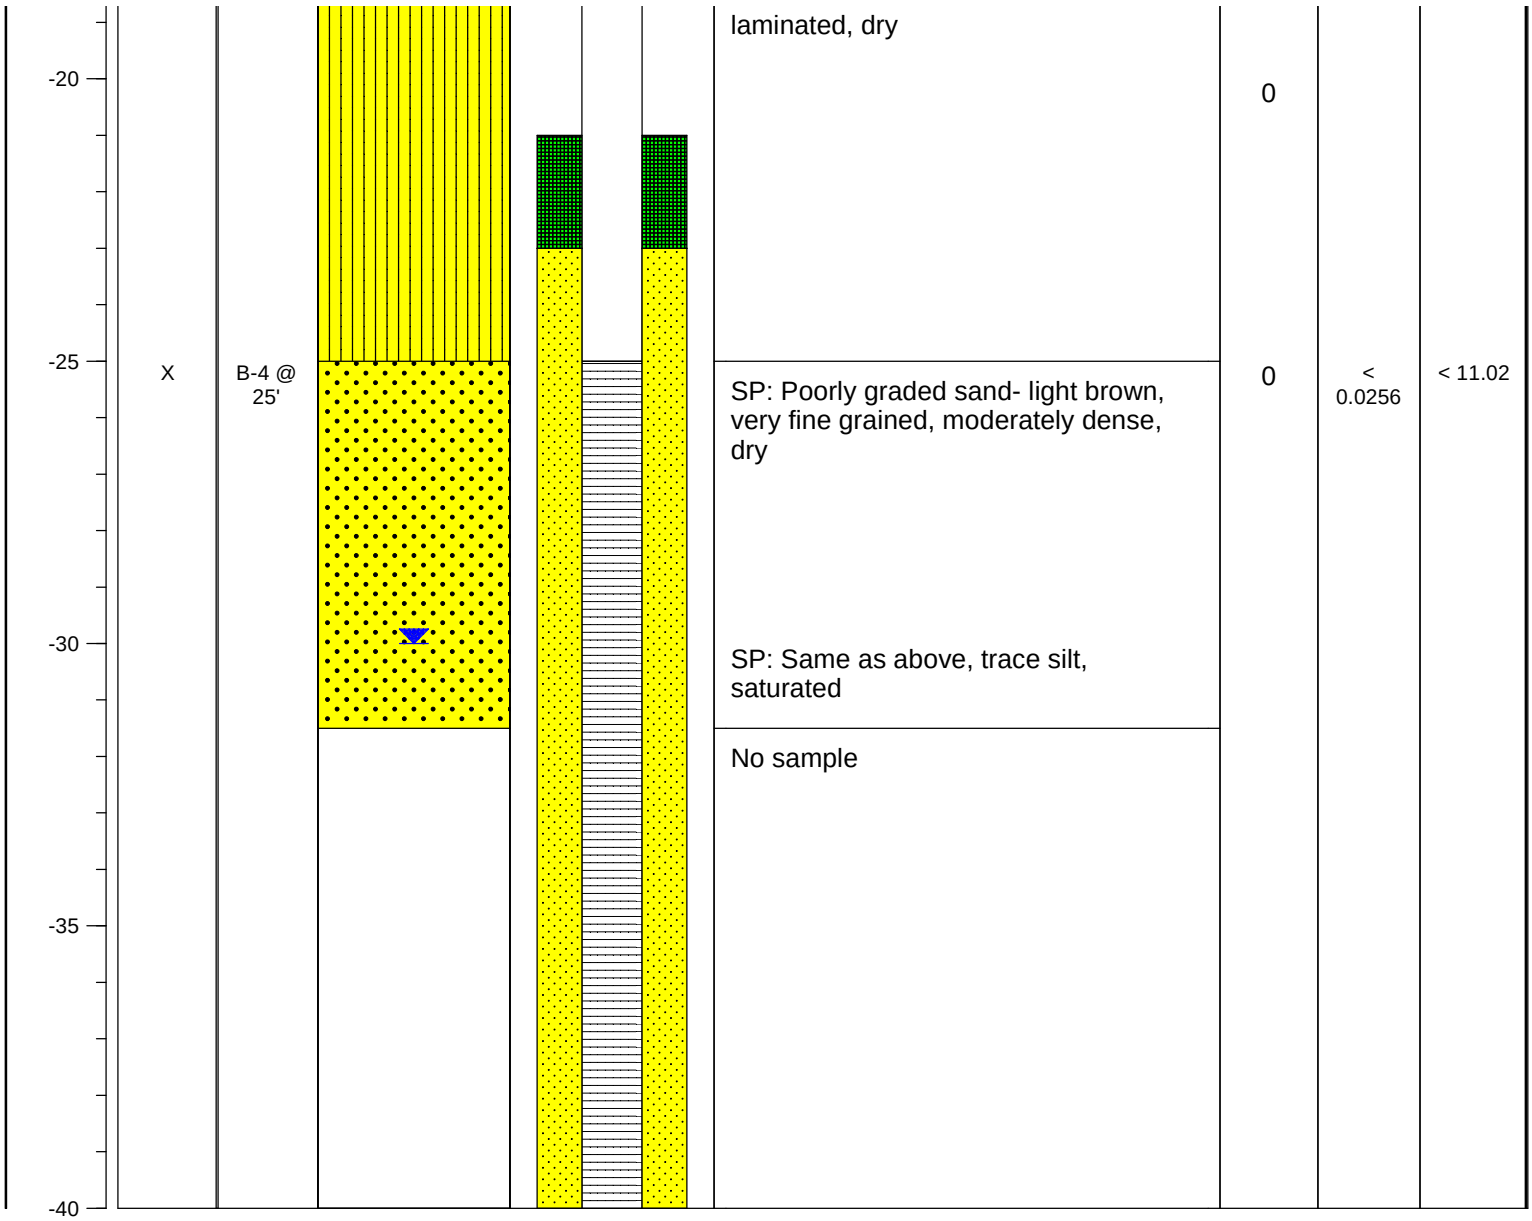
SOIL BORING NO: MW-4
DRILL TYPE: CME-85
Hollow Stem Auger
BORE HOLE DIAMETER: 7 7/8"
DRILLED BY: National EWP
DATE/TIME HOLE STARTED: 11/11/2014
DATE/TIME HOLE COMPLETED: 11/11/2014

DEPTH (bgs) - ft	SAMPLE TO LAB	SAMPLE ID	STRATAGRAPHIC SEQUENCE	COMPLETION INFORMATION	CLASSIFICATION AND DESCRIPTION	PID (ppm)	Total BTEX (mg/kg)	Total TPH (mg/kg)
-20					laminated, dry	0		
-25	X	B-4 @ 25'			SP: Poorly graded sand- light brown, very fine grained, moderately dense, dry	0	< 0.0256	< 11.02
-30					SP: Same as above, trace silt, saturated			
					No sample			
-35								
-40
